INVENTORY FORM FOR STATE HISTORIC SITES SURVEY

Captain Clash's Warehouse

Centreville Landing

QA-433

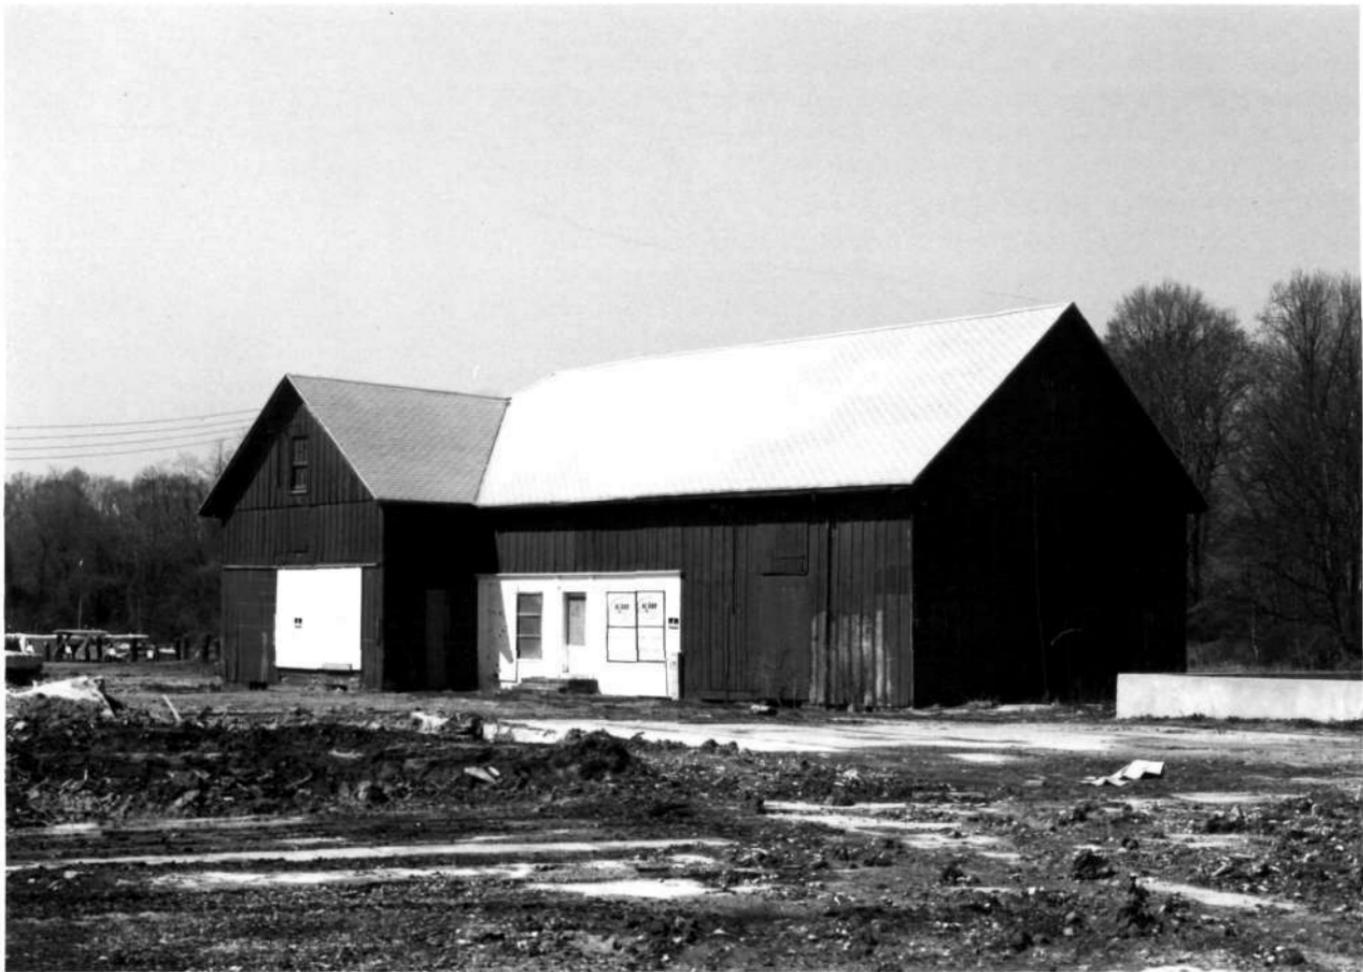
View from East

The east facade of the original building, facing away from the creek, is covered with vertical board-and-batten siding. There is a 20th century glass-and-panel door to the left flanked by simple pilasters and a pair of large

multi-pane store windows. At the north end of this facade there is a 20th century batten door on the first floor and an early batten door with wrought strap hinges on the second floor. The eaves oversail and are left exposed; the roof is covered with asphalt shingles.

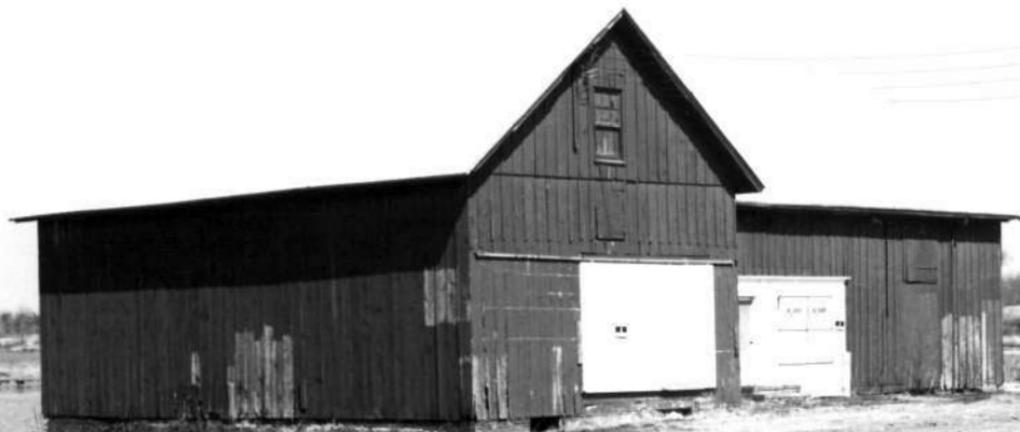
Clash Warehouse
Centreville Wharf
Orlando Ridout V 1981
View from South

There are no openings on the south facade. The siding consists of vertical board sheathing with battens along the upper portion of the wall, outlining a one-story gable roofed shed that at one time extended to the south, parallel to the waterfront. The brick foundation is continuous across the facade; the eaves oversail and are left exposed.
