MARYLAND HISTORICAL TRUST  
DETERMINATION OF ELIGIBILITY FORM

Property Name: Oakland Road Tenant House Inventory Number: CARR-1688  
Address: Oakland Road-Liberty Reservoir City: Eldersburg Zip Code: 21784  
County: Carroll USGS Topographic Map: Finksburg  
Owner: Unknown Is the property being evaluated a district? \_\_\_ yes  
Tax Parcel Number: Unknown Tax Map Number: Unknown Tax Account ID Number: Unknown  
Project: 239 Pleasant Valley Road Demolition/Carroll County Agency: Carroll County Department of Planning  
Site visit by MHT staff: X no \_\_\_ yes Name: \_\_\_\_\_ Date: \_\_\_\_\_  
Is the property is located within a historic district? \_\_\_ yes X no

Name Oakland Road Tenant House  
Continuation Sheet

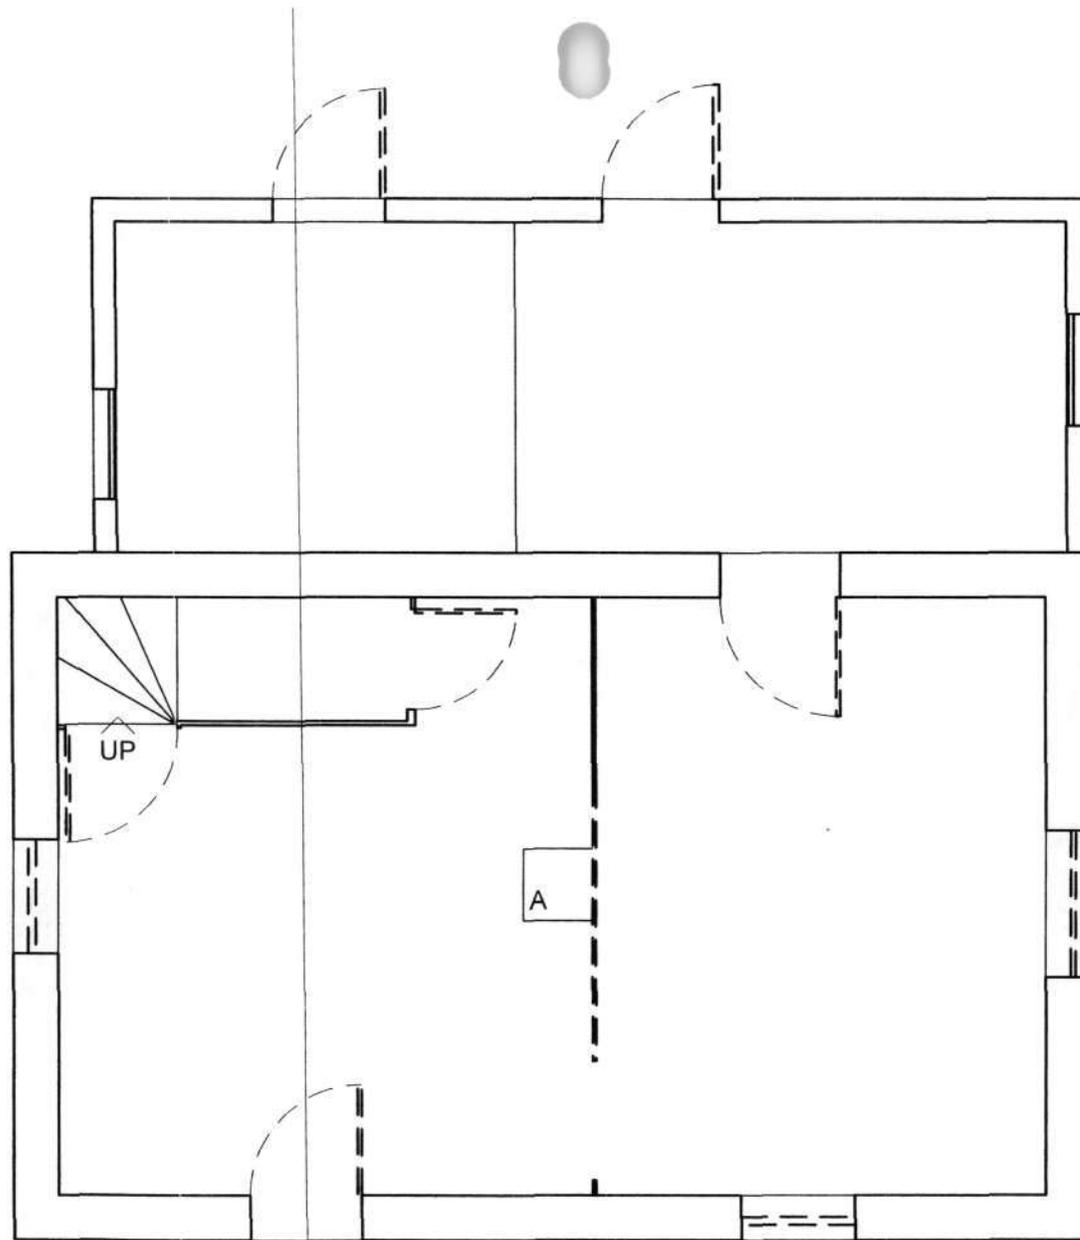
FIRST FLOOR PLAN - MEASURED BY MARCIA MILLER AND KEN SHORT - DRAWN BY KEN SHORT - JANUARY 2004

A. BASE OF CHIMNEY  
STACK SURVIVES, FLUSH  
WITH FLOOR.

B. PORCH AND STEPS  
MISSING.

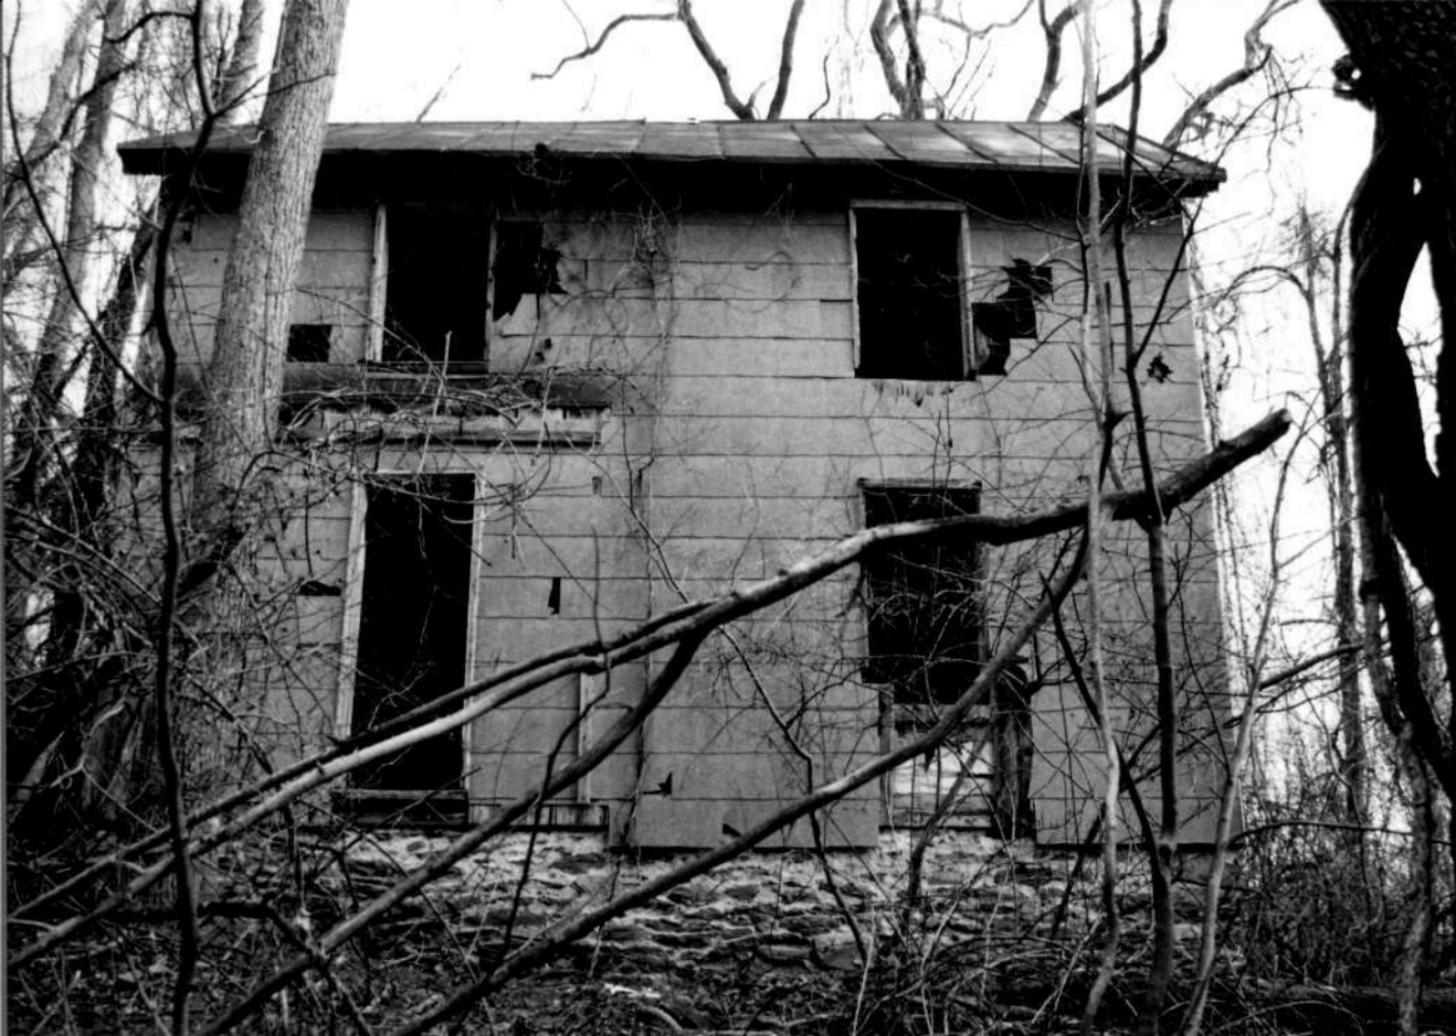
1/4

West elevation

The house is a two-story, two-bay by one-bay log structure with a rubble stone foundation, asbestos shingles over vertical boards with wire nails, and a gable roof with a north-south ridge and V-seam metal. The chinking has whitewash. The west elevation has a doorway on the first story, in the north bay, and a window in the south bay. There was once a one-story, one-bay porch added at the doorway after the siding had been put on. The second story has two window openings and the eaves are open. The north elevation has one window opening on both the first and second stories. The gable end has brick-pattern asphalt shingle siding over weatherboards, with no window opening. The north elevation of the east addition has a small window opening. The east elevation of this addition has a doorway to the south and a window to the north. The roof has V-seam metal. The east elevation of the log house, on the second story, has no openings. The south elevation of the addition has a window opening, and the south elevation of the log house has a window opening on both the first and second stories. The siding is mostly missing from the gable end and the eaves are open.

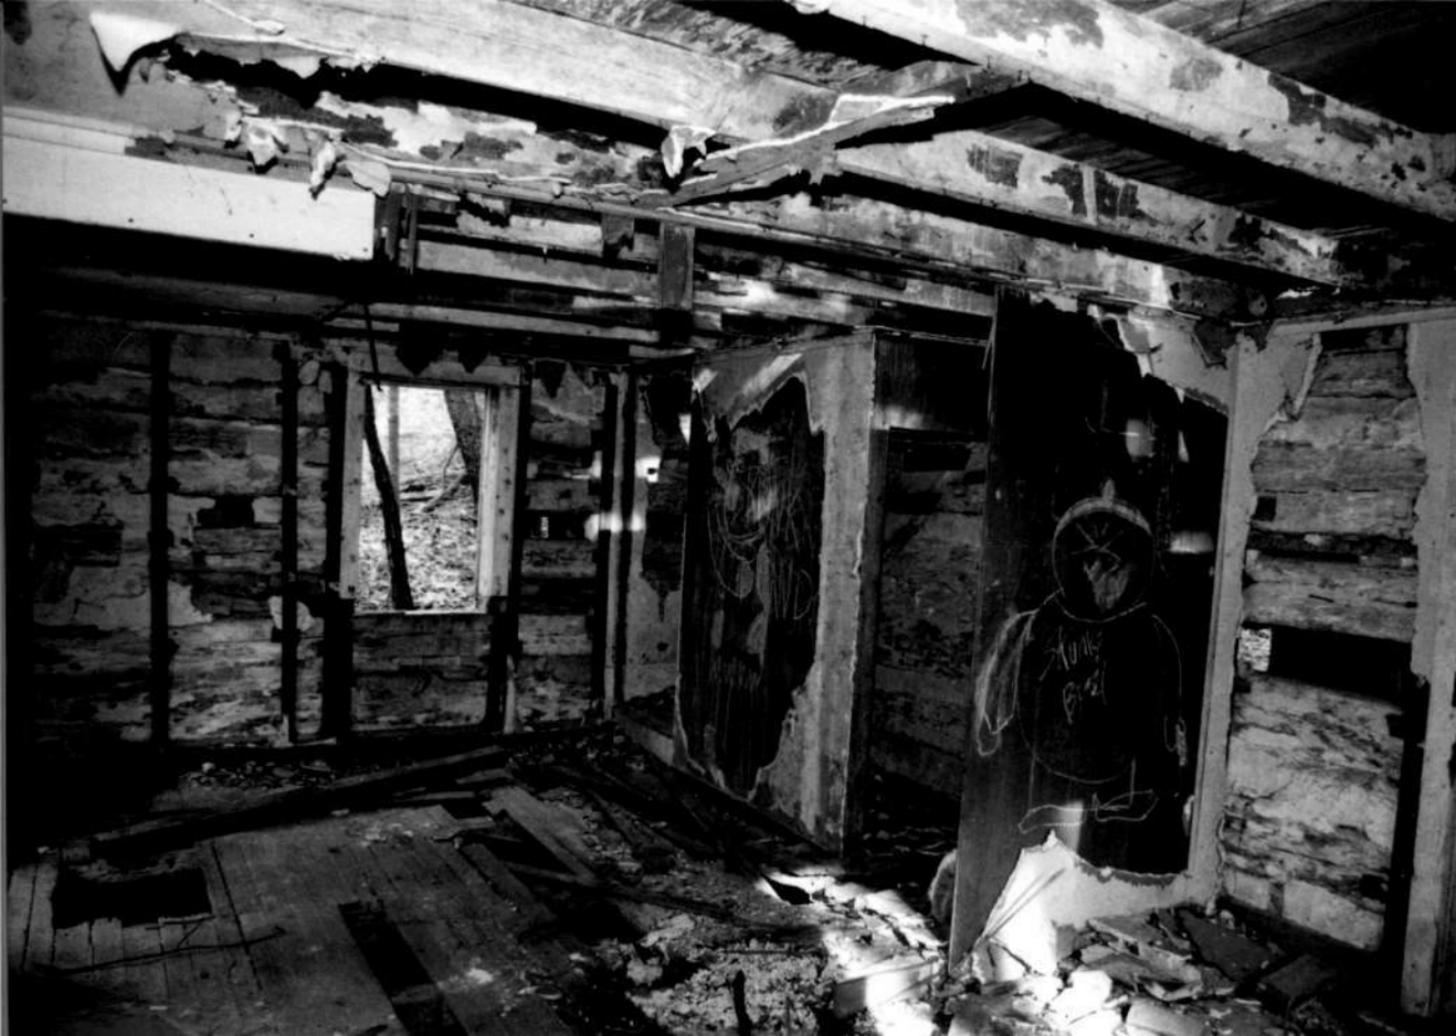
CARR-1688  
Oakland Rd. Tenant House  
Oakland Rd  
Carroll Co, MD  
Ken Short  
Jan. 2004  
MD SHPO  
First story, vw. NE  
3/4

There is no cellar to the building, merely a crawl space. The first story has  $\frac{3}{4}$ -round log joists that run east-west and are set on top of a 1-inch-thick board on the stone foundation. The tongue-and-groove floor is blind-nailed with cut nails. The boards are random-width pine or fir, 3 inches to 4 inches wide, and run north-south. The house has a two-room plan with a partition wall that runs east-west, though much of the wall is now missing. It is constructed of beaded-edge, vertical, tongue-and-grooved boards that are  $3\frac{1}{2}$  inches to  $4\frac{1}{2}$  inches wide, are nailed to the joists at the top with cut nails, and are toe nailed to an approximately 1-inch square board at the bottom. This board is, in turn, nailed to the floor above the joist. The board wall is painted an olive green. There was a door opening at the west end of this partition wall. The logs are hewn on their sides, have V-notch corners, and are heavily whitewashed. The chinking is all of wood, with pieces of tongue-and-groove board and slab wood, some with the bark, mostly laid horizontal and set in mortar. The walls and ceiling were furred out and sheet rocked at an unknown period. The flooring above and the joists were originally exposed and painted. The north room was painted blue and the south room a forest green. Both rooms have two shades of this color so there are at least two layers of paint. The flooring above is circular-sawn. The first story baseboard is plain. There was a small brick chimney in the center of the house, on the north side of the partition wall, and it was only large enough for a stove. It has been taken down to the floor level. The bricks are stored in the closet and have whitewash, suggesting that the chimney was never plastered. There is an enclosed winder stair in the northeast corner, and the boards are identical to the partition wall and have chatter marks. The stringer is nailed to the board wall from the exterior with cut nails. The doors to both the stairs and the closet beneath them are missing. There are stamped iron hinges that survive; they have three knuckles and loose joints. The stairs are constructed with cut nails. The window frames are constructed with wire nails. The sash and sills are missing. There is plain head cut trim. The jamb boards on the window frames are 1-inch thick and are toe nailed with cut nails at the bottom. The front door is missing. The south end window is much taller than the other openings and the plain trim is side cut. The frame has wire nails. The upper floor is patched in the center of the south end.

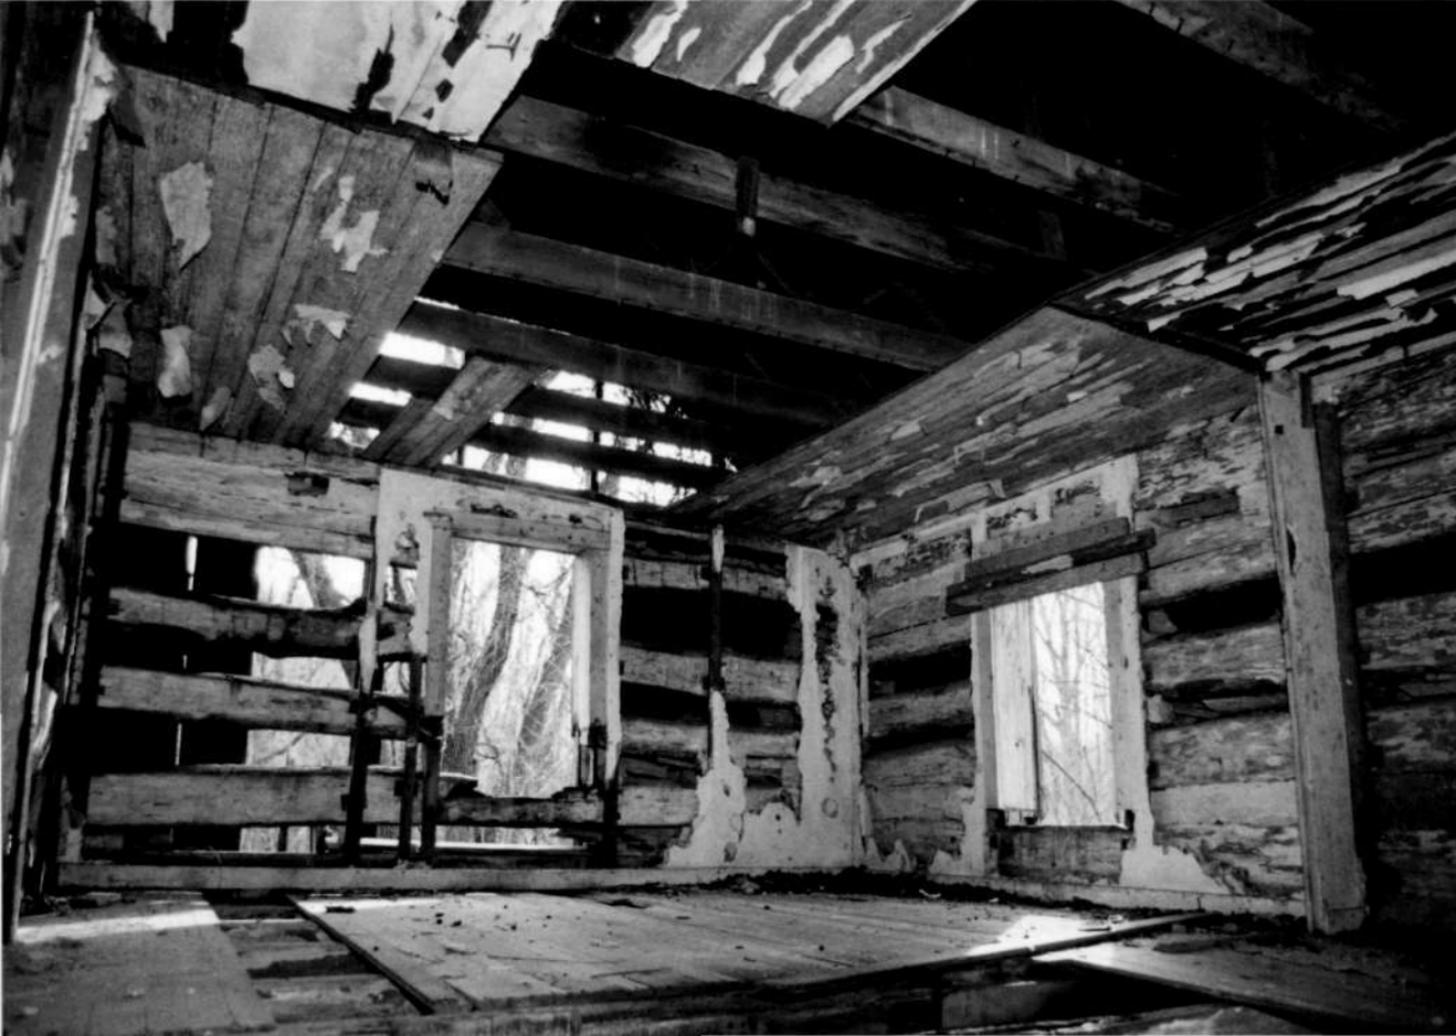
4/4

Second Story, NW SW

The second story has a two-room plan with the same flooring, baseboard, and walls as the first story. The north end is painted red and the south end painted white. There is a board ceiling that matches the board wall of the first story, and it is blind-nailed. There is a break in the ceiling in the center where a board partition wall was located, but most of it is now gone. There is no evidence that the stairs were closed off from the north chamber. The second story was also furred out and sheet rocked, and there were never windows on the east elevation. There was also no access to the attic. The rafters are sawn and are mitered at the ridge. They support rough board shingle lath and wood shingles.
