MARYLAND HISTORICAL TRUST
DETERMINATION OF ELIGIBILITY FORM

Property Name: 4330 Maple Dam Road Inventory Number: D-741
Address: 4330 Maple Dam Road Historic district: ___ yes no
City: Cambridge Zip Code: 21613 County: Dorchester
USGS Quadrangle(s): Blackwater River
Property Owner: Allen and Brenda Nelson Tax Account ID Number: 004102
Tax Map Parcel Number(s): 30 Tax Map Number: 62
Project: Proposed Tower Site: Bucktown, Dorchester County, Maryland Agency: Maryland Dept. of Budget and Management
Agency Prepared By: A.D. Marble & Company
Preparer's Name: Stacey Streett and Stephanie Foell Date Prepared: 6/24/2005
Documentation is presented in: Proposed Tower Site: Bucktown, Dorchester County, Maryland
Preparer's Eligibility Recommendation: ___ Eligibility recommended Eligibility not recommended
Criteria: ___ A ___ B ___ C ___ D Considerations: ___ A ___ B ___ C ___ D ___ E ___ F ___ G
Complete if the property is a contributing or non-contributing resource to a NR district/property:

Residence at 4330 Maple Dam Road (D-741)
Proposed Tower
Bucktown, Dorchester County, Maryland
Blackwater River USGS Quadrangle

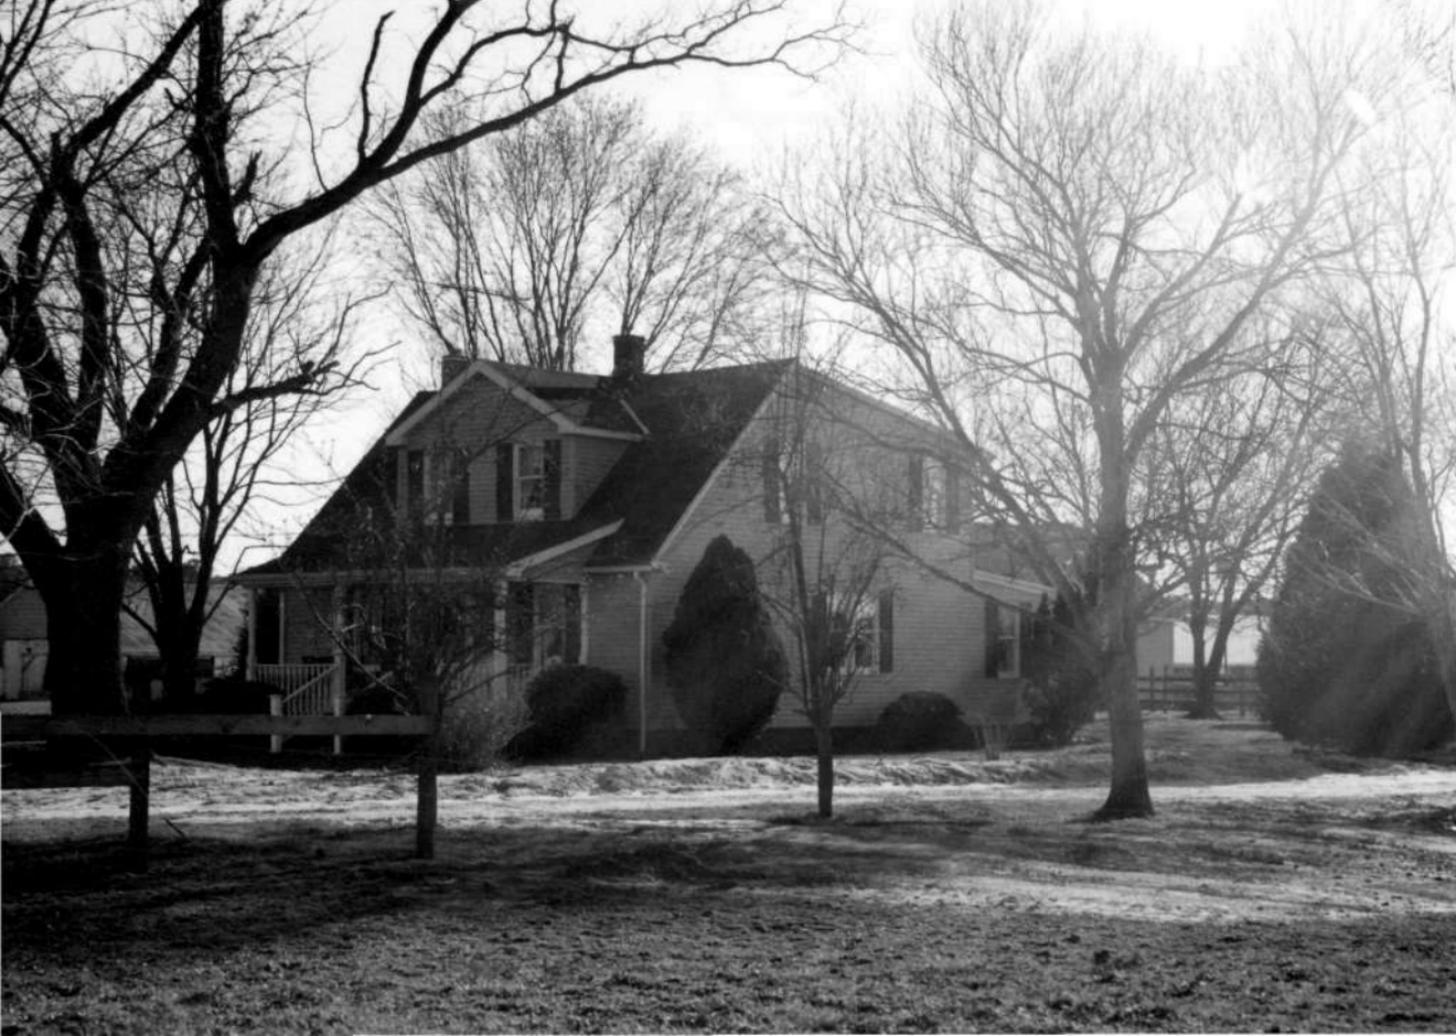
1/3

The west elevation has been modified by a modern addition. A one-story, shed-roof porch enclosure is adjacent to the north end of the west elevation. A one-story-by-one-bay-wide, shed-roof enclosure is located on the south elevation, around the base of the exterior chimney. A side entrance is located on this projection.

A low-pitched gable roof tops the building. However, it is more steeply pitched on the east slope than on the west slope due to the modern alteration on the west elevation. Asphalt shingles cover the roof, which has a wide eave overhang. Gable returns accentuate the cornice on the cross gable. An interior, brick chimney stack rises from the ridge of the roof and an exterior, cinder-block chimney is located on the south elevation; a chimney pot pierces the top of the chimney stack. A television antenna is located adjacent to the exterior chimney.

Northeast elevation

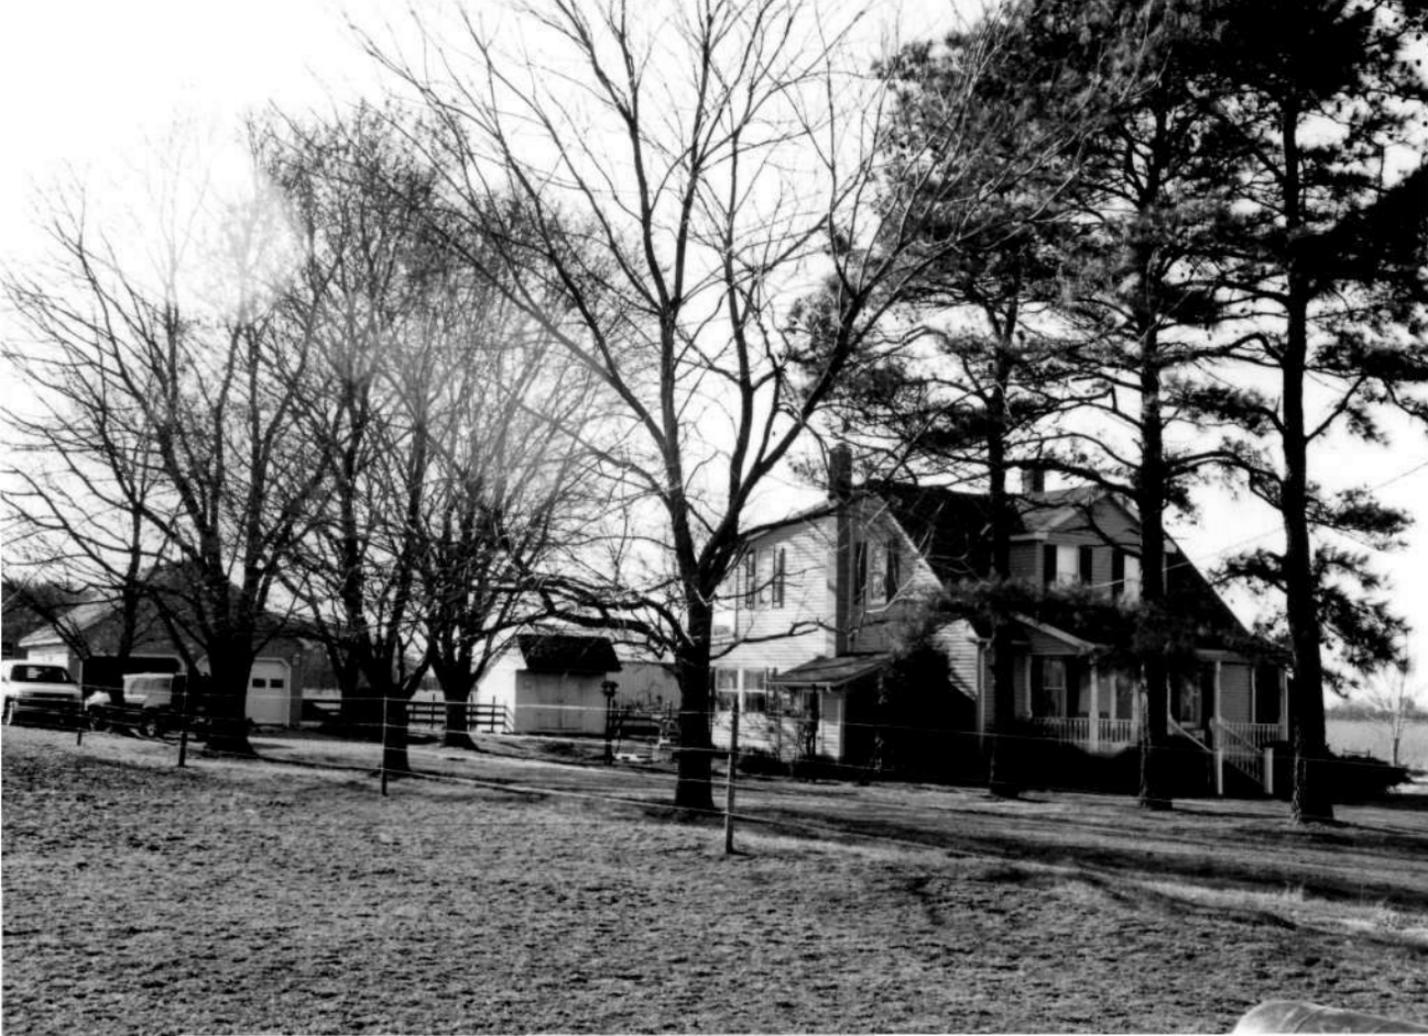
2/3

Ornamental foundation plantings surround the residence. A variety of mature, deciduous trees shade the property parcel. A gravel driveway is parallel to the south elevation of the residence. Mature coniferous and deciduous trees border the driveway. A two-bay, gable-front garage is located at the end of the driveway. Several agricultural outbuildings are located on the property parcel. A gable-front, frame shed is located northwest of the residence, and a metal, pole barn is adjacent to the shed. Agricultural fields surround the property parcel. An equestrian field is located south of the driveway.

View of southeast elevation and outbuildings

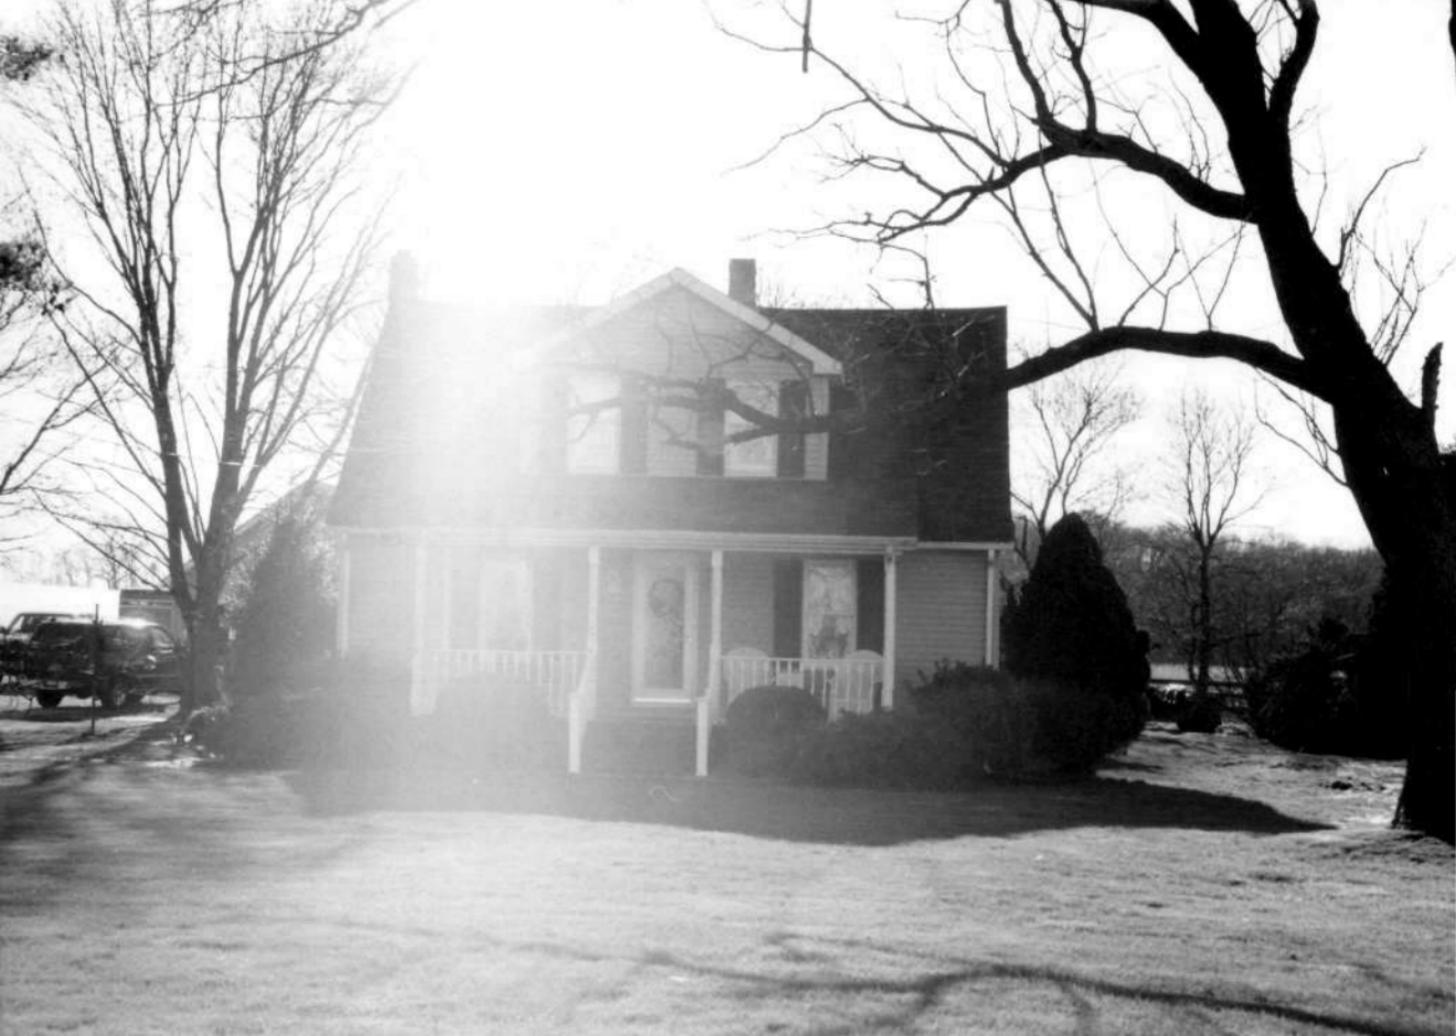
3/3

The one-and-one-half-story, vernacular residence at 4330 Maple Dam Road (D-741) is located on a parcel of land on the west side of the road. The residence faces east. It was constructed in 1930. The building is three bays wide by three rooms deep. The façade is dominated by a full-width porch topped with an extended roof and a central, cross-gabled dormer which projects from the attic story on the façade of the roof. Turned spindle posts and balustrade support the porch overhang. The main entrance is located at the center of the façade.

Vinyl siding clads the residence. Fenestration consists of single and paired, replacement, one-over-one, double-hung sash windows. A pair of windows pierces the dormer. Shutters flank all windows on the building.

Facade
