Capsule Summary
SM-886
Oraville Store
Oraville
Private

circa 1900

Inventory No. SM-886

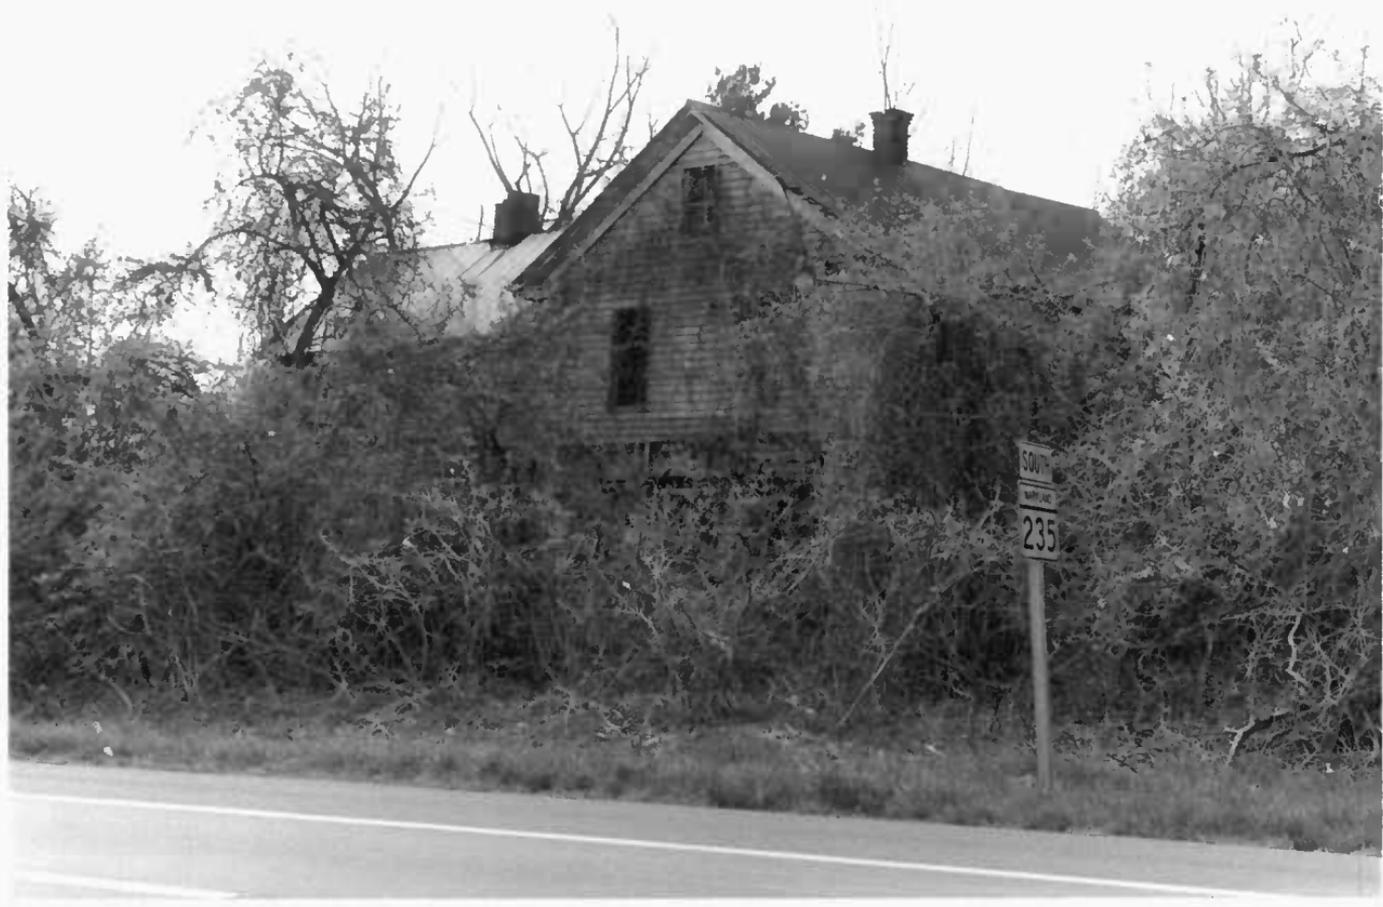
1 of 2

Looking S

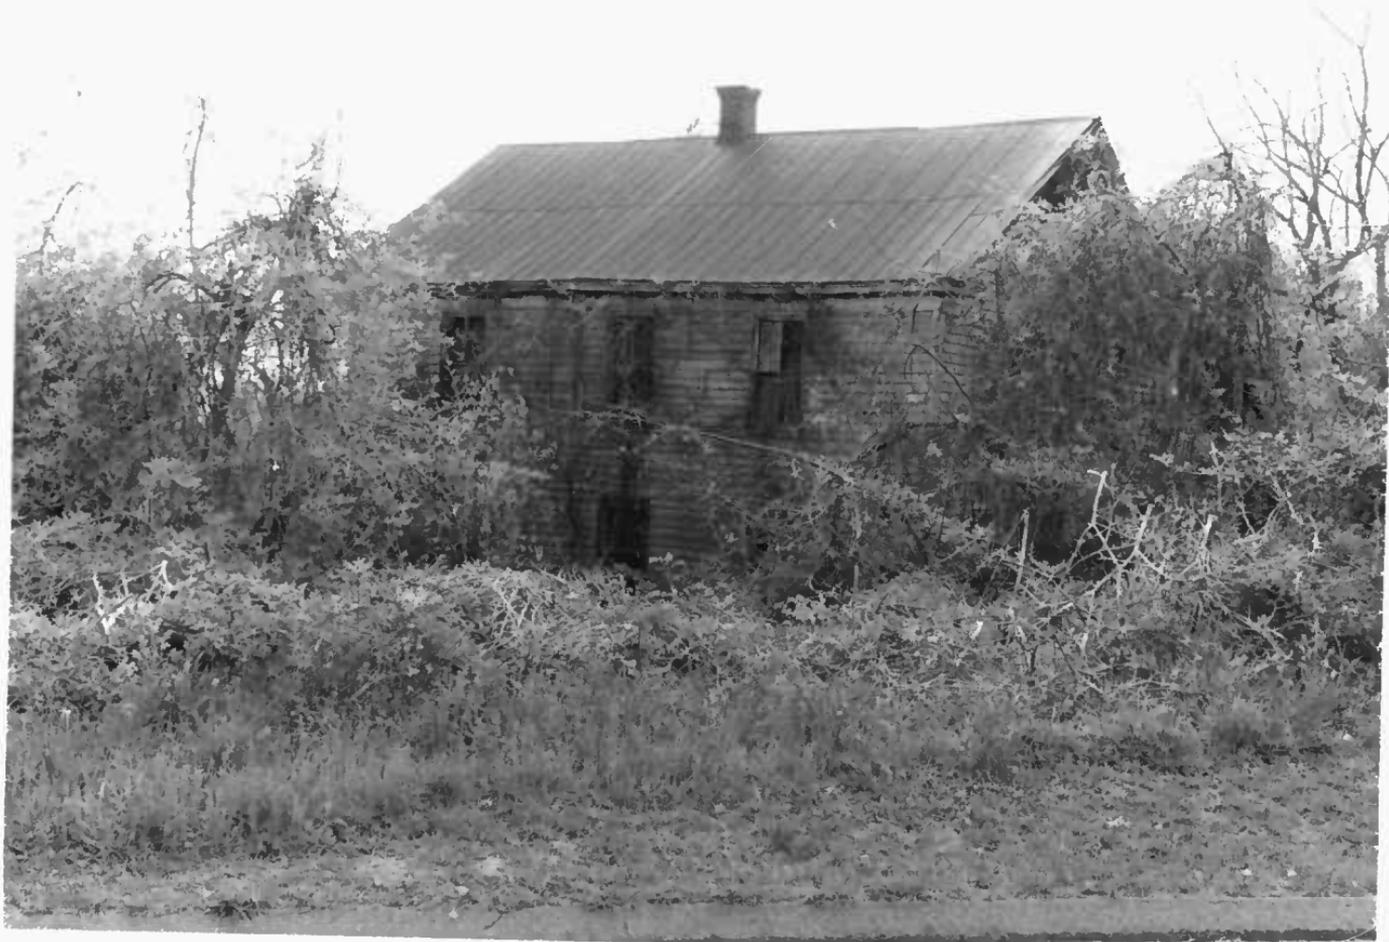
2 of 2

The west elevation of the main block is pierced on the first and second floors by three two-over-two, double-hung sash windows.

Looking E
