INDIVIDUAL PROPERTY/DISTRICT
MARYLAND HISTORICAL TRUST
INTERNAL NR-ELIGIBILITY REVIEW FORM

Property/District Name: Tharpe Property Stone Ridge Survey Number: HA-1721
Project: GTA, Stone Ridge Agency: US Army Corps of Engineers
Site visit by MHT Staff: no yes Name _____ Date _____

**Maryland Historical Trust
State Historic Sites Inventory Form**

***Tharpe Property
Harford County, MD***

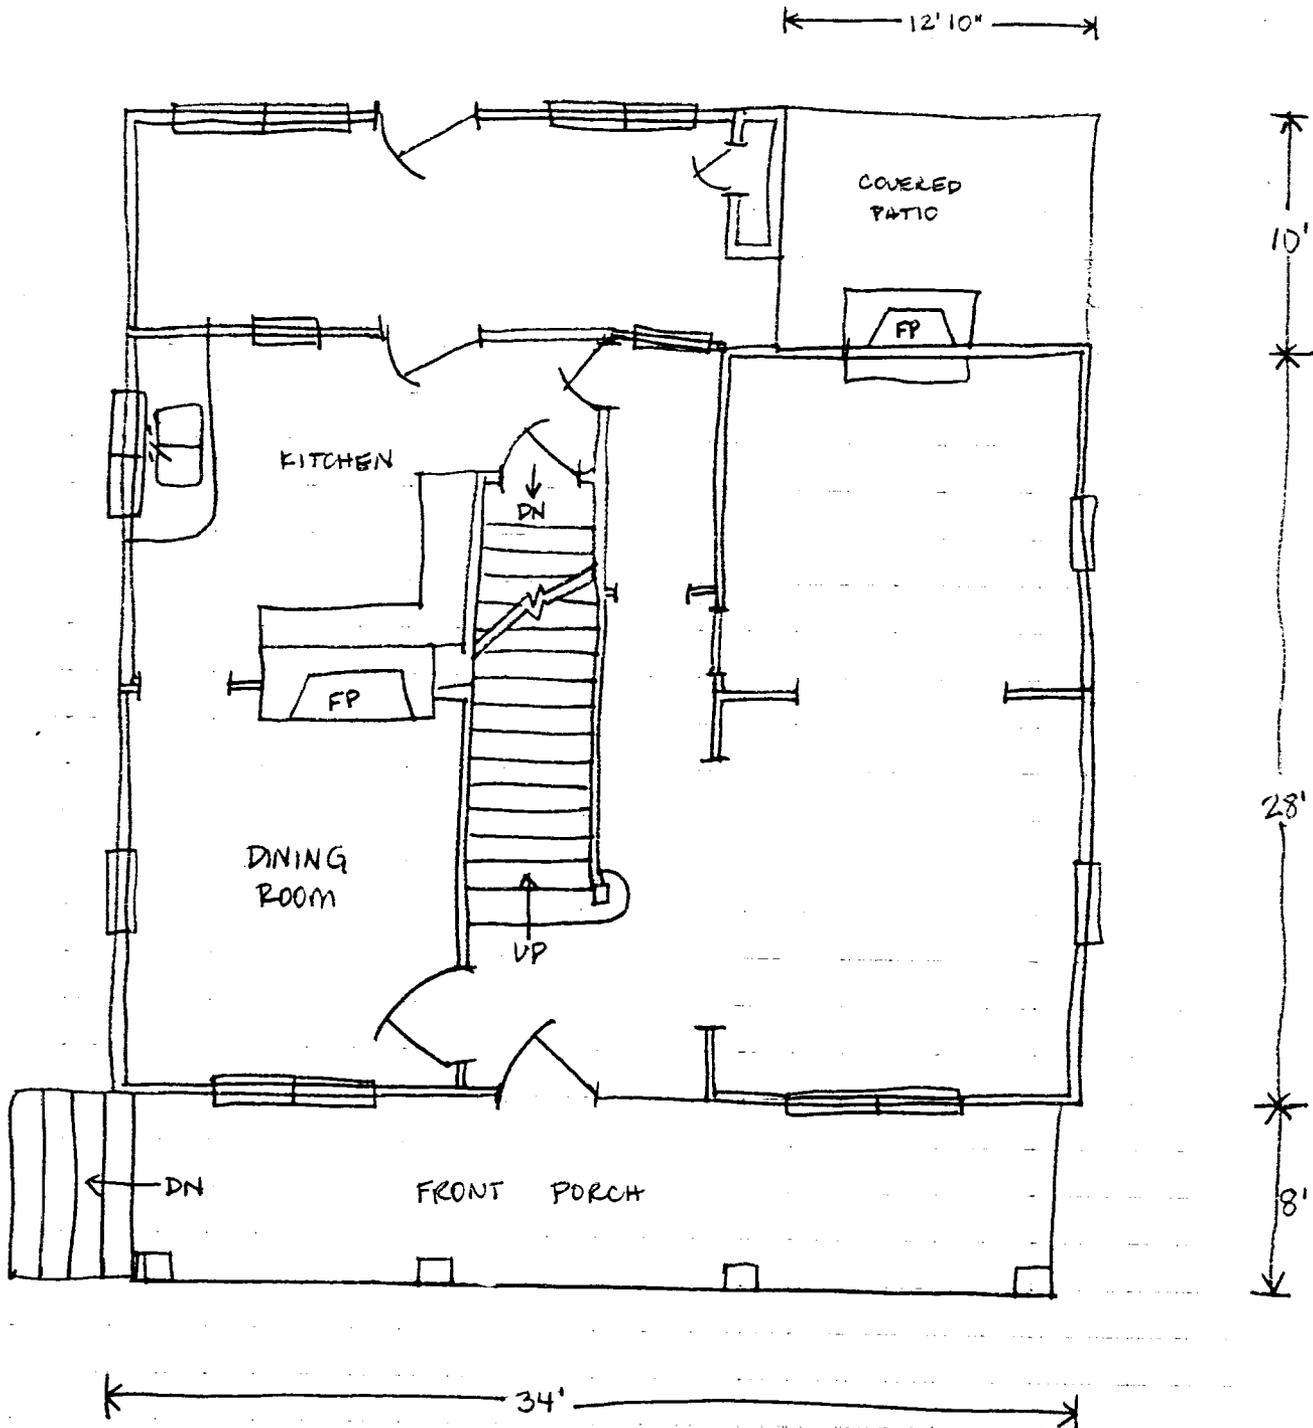
FIRST FLOOR

Inside the house, the first floor is divided into approximately four equal, almost square rooms, flanking a wide stair hall running through from front-to-back.

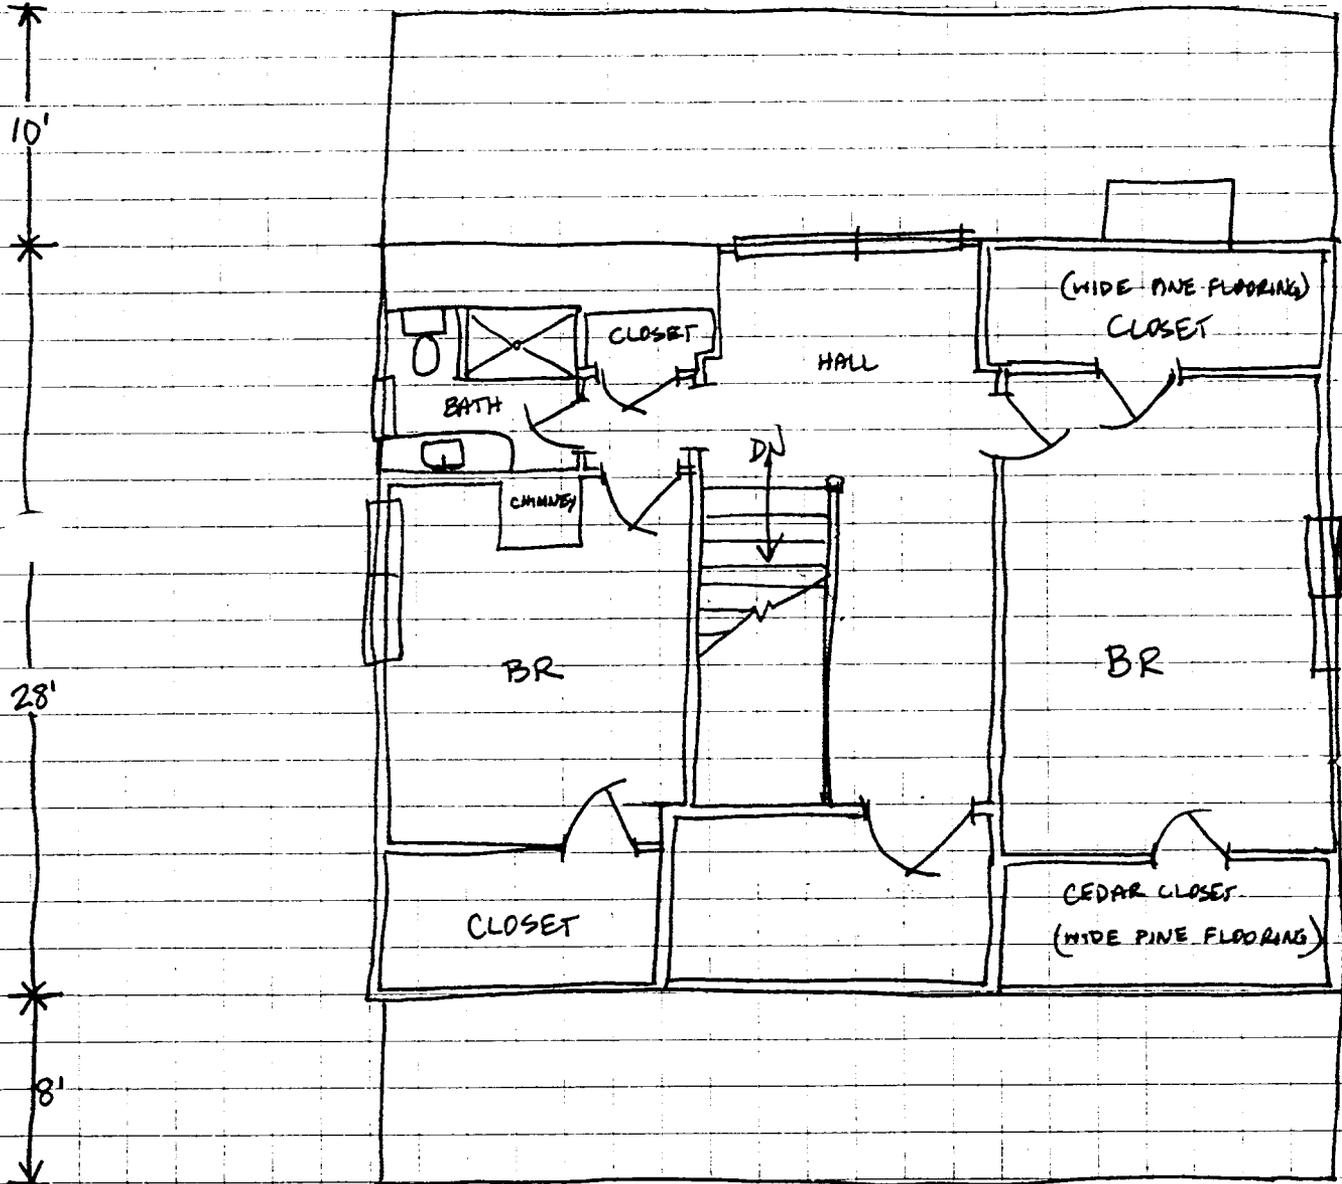
SECOND FLOOR

Upstairs there are two main bedrooms, one on each side of the wide stair hall. Each has walk-in closets under the eaves. The bathroom is located in the SW corner and the dining room chimney projects into the smaller bedroom. At the west end of the stair hall, a paired window wall dormer provides light and head room, as does a triple window wall dormer at the east end of the hall in a small nursery/sewing room.

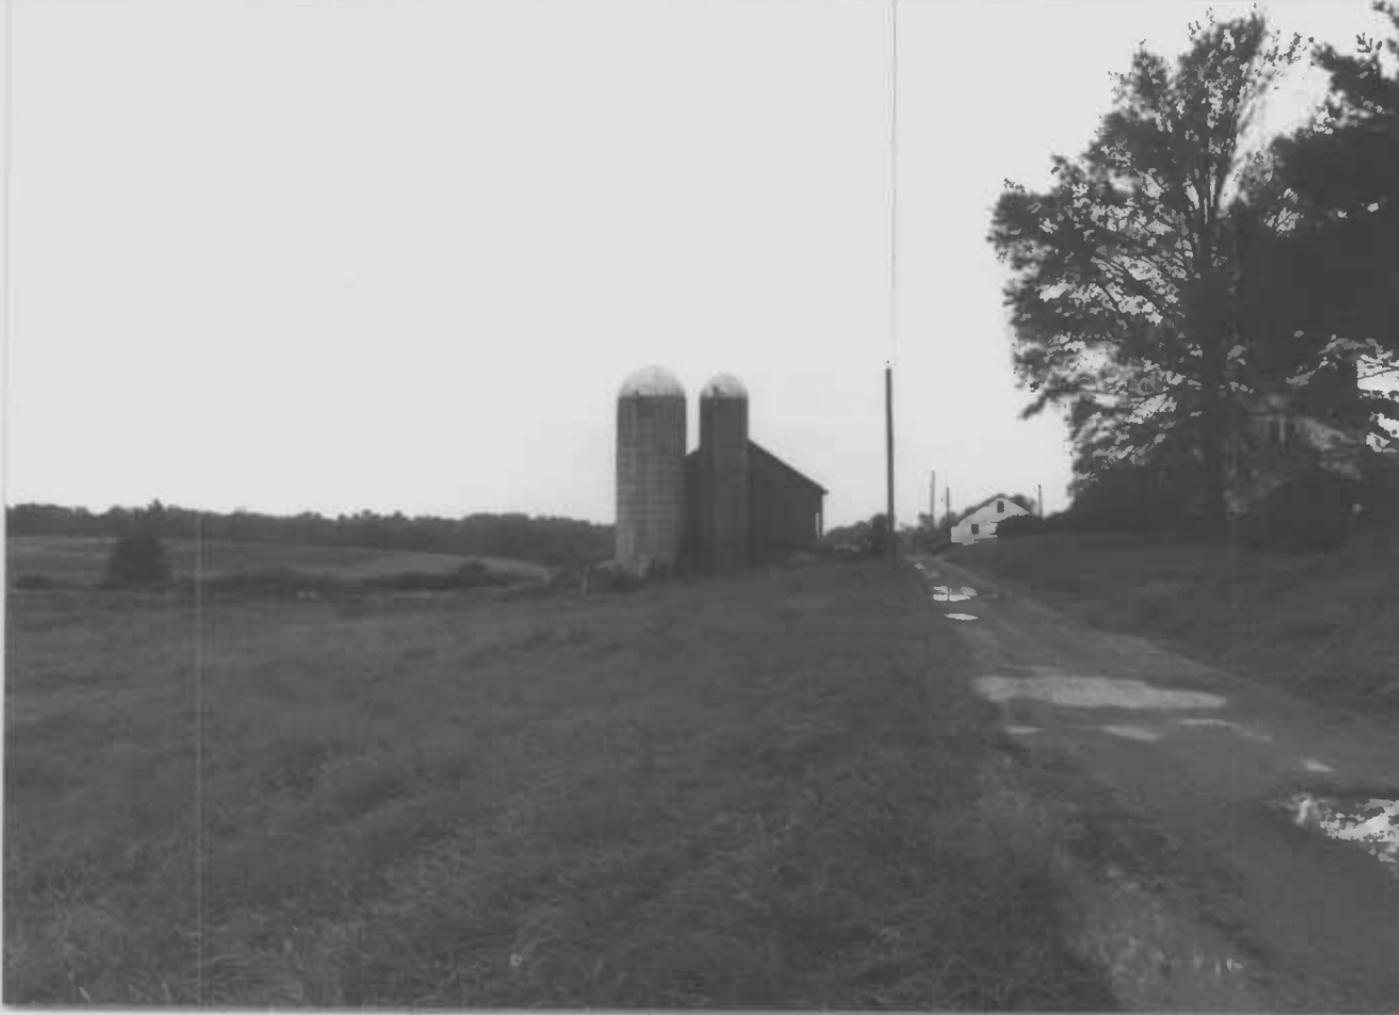
HA-1721

Looking south down driveway entering farm.
House on right, main barn @ center, and farm pond
on left side of photo

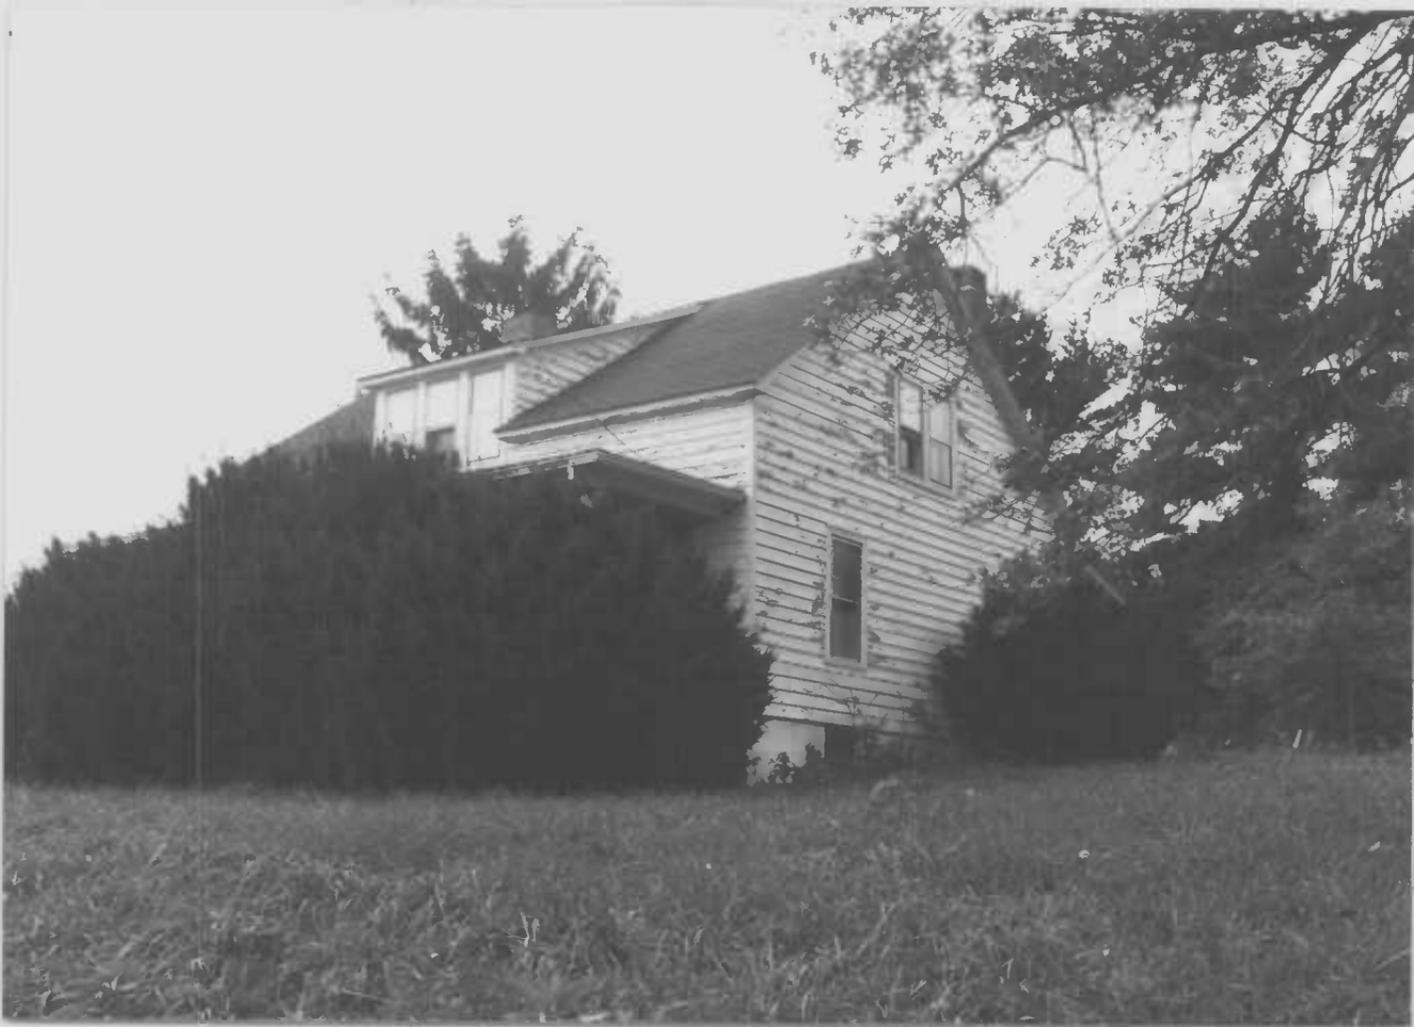
HA-1721

NE corner of main house

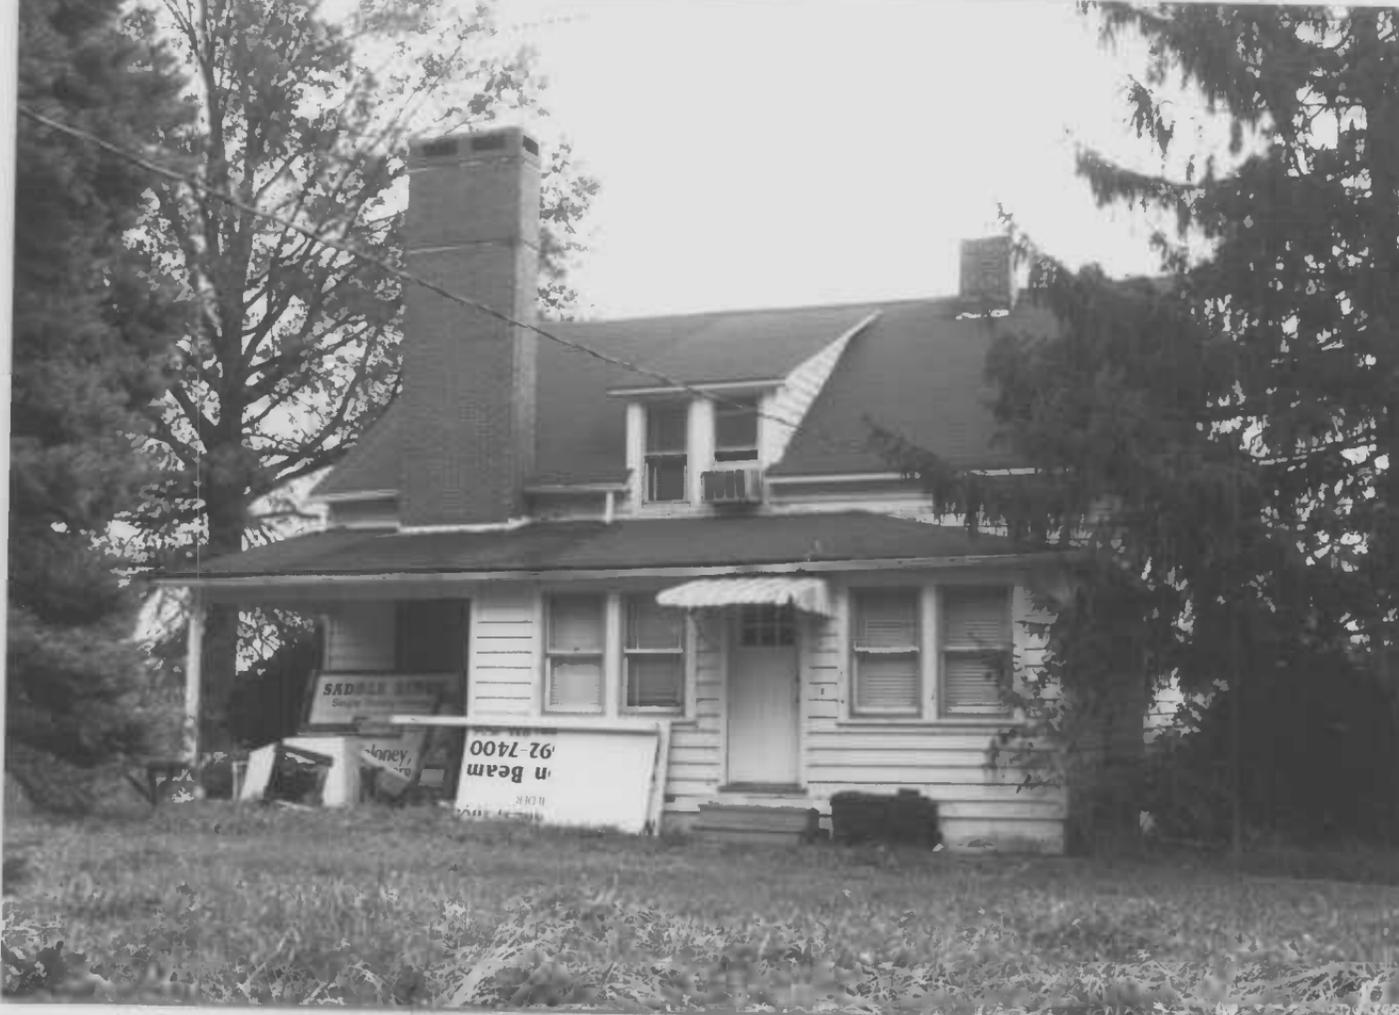
Rear elevation (west) of main house)

Enclosed porch @ right.

An extension on the back of the house appears to be an enclosure of a back porch. The continuation of the roof to the north end of the house has created a covered, concrete patio.

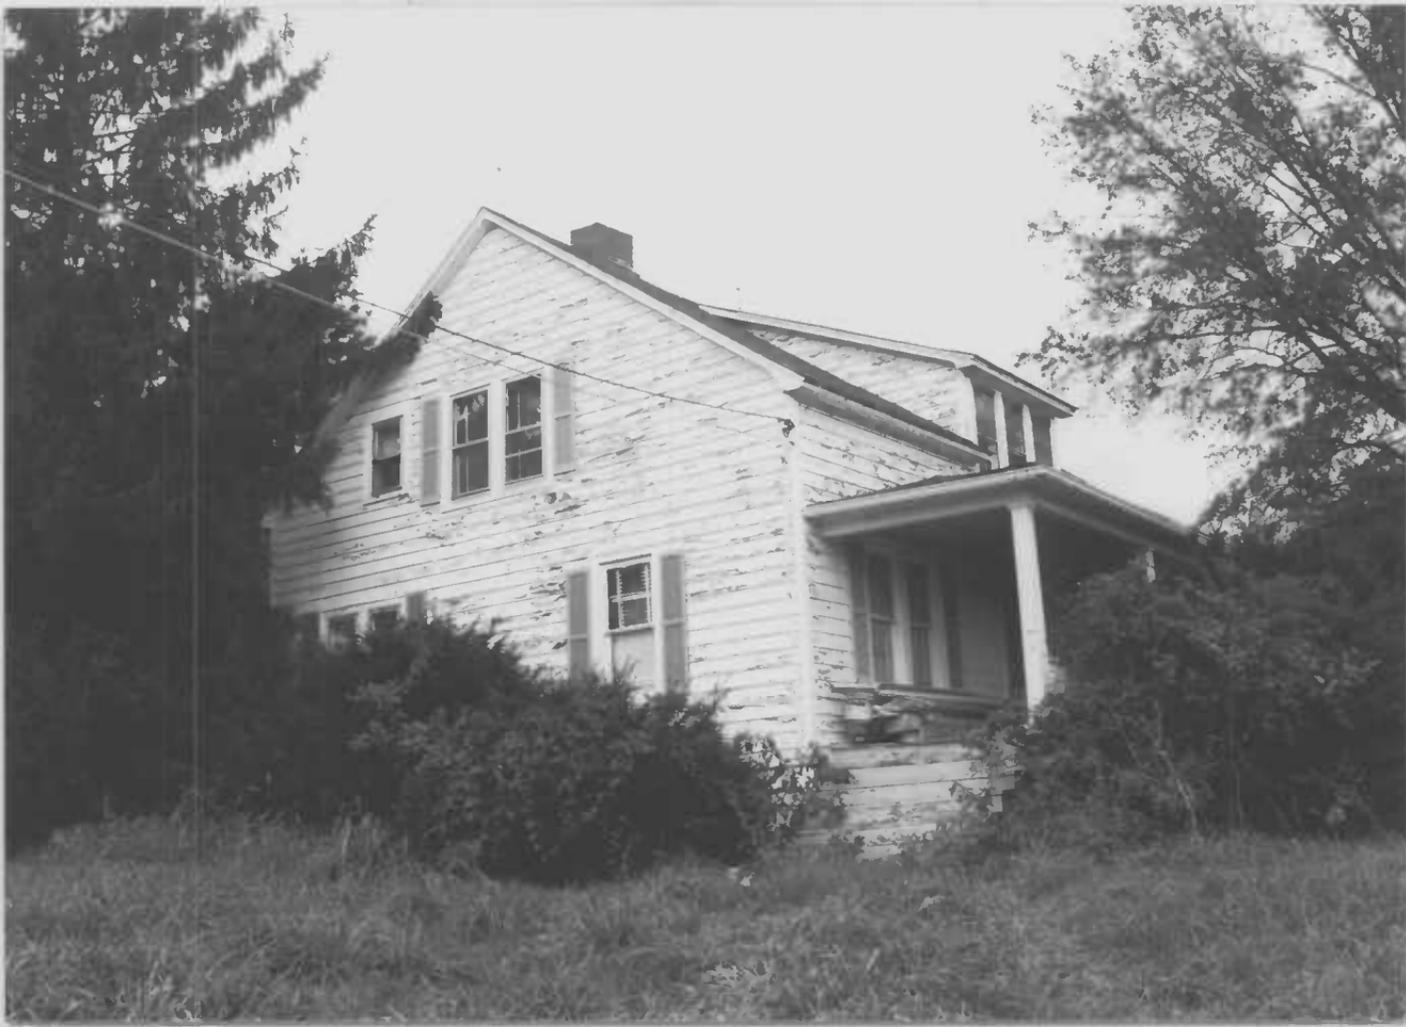
HA-1721
Tharpe Property
Howard Co MD
C Wingate 10/99
MD SHPO

SE corner of main house.

Steps leading up to front porch.

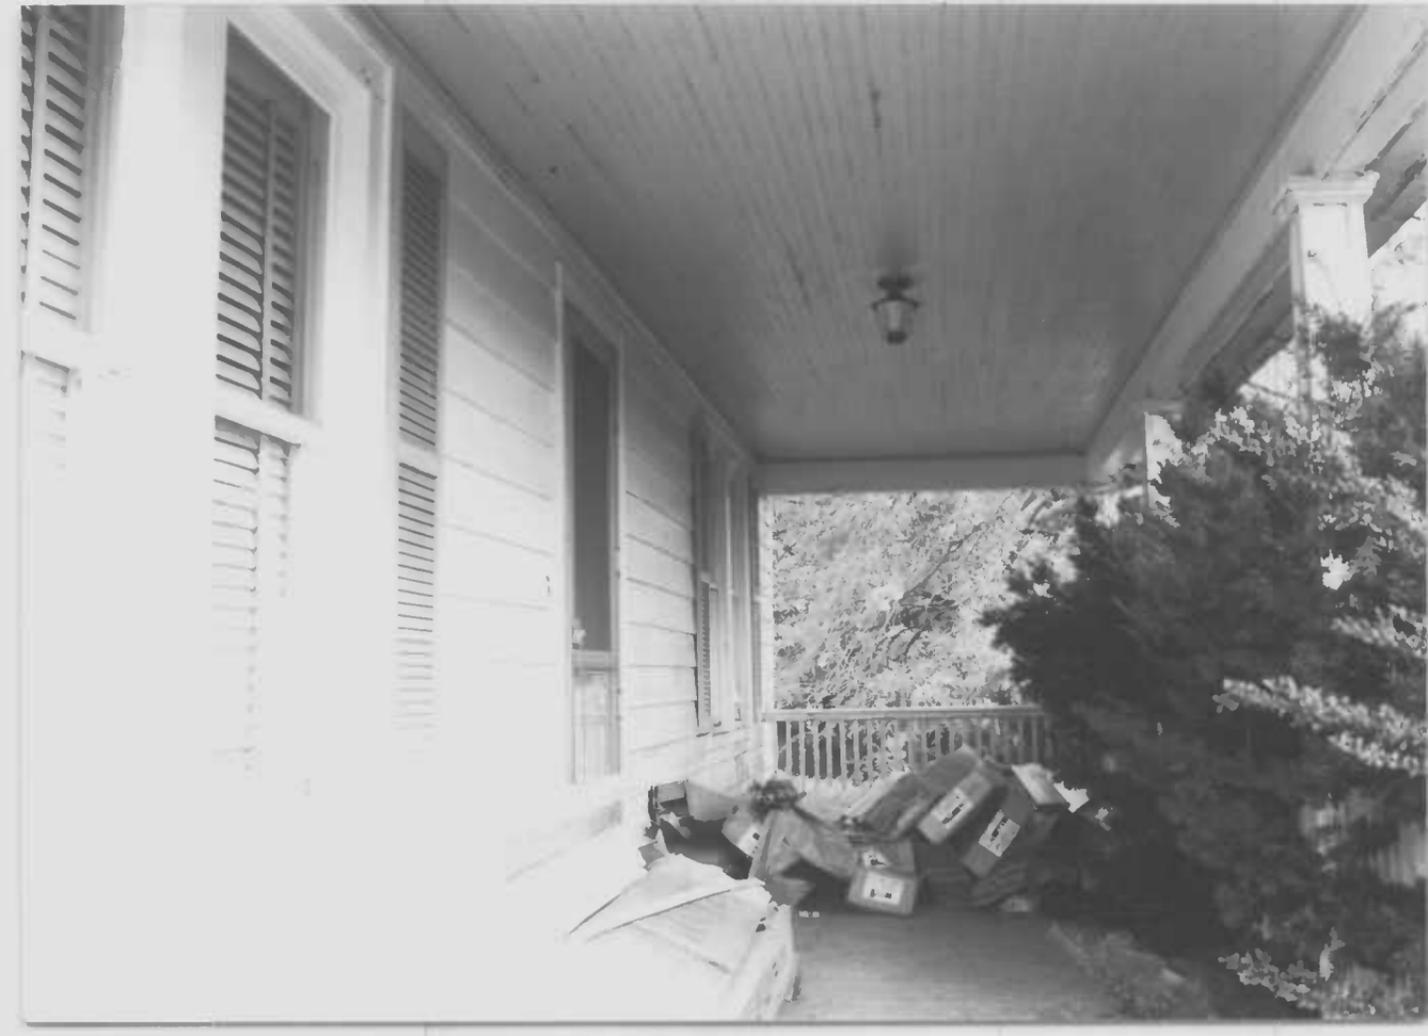
HA-1721

Front porch

The c. 1930, vernacular frame dwelling (34' x 28' plus porch and addition) has late Bungalow style features in its raised foundation, wide porch with square piers, paired windows and wall dormers. The eight-foot deep porch extends the full width of the dwelling and is accessed by wide steps ascending the south end. The porch roof is a typically shallow-pitch, hipped roof and is supported by four square piers. The dwelling foundation is poured concrete. The wooden siding is wide clapboard and the paint is peeling. Vinyl shutters have been nailed to the south and east side windows and triple-track aluminum storm windows have been installed on most window frames, except those opening on the front porch, which appear to have had removable wooden storm/screens.

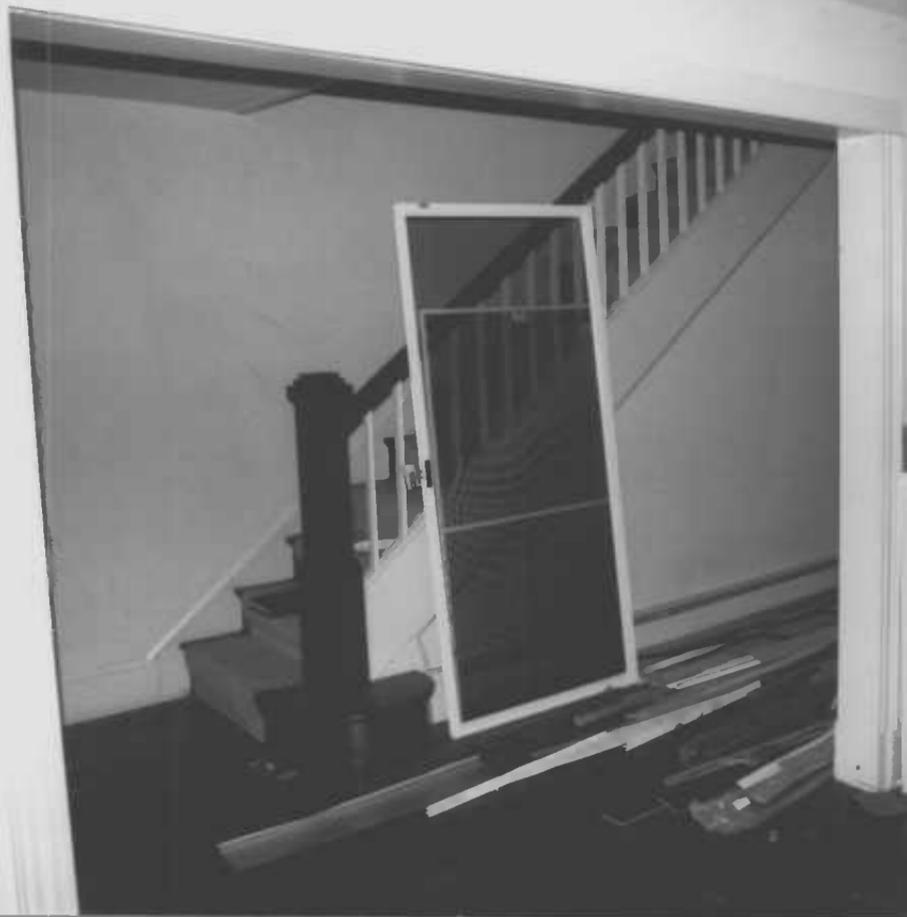
HA-1721

View from front parlor back toward
stair hall.

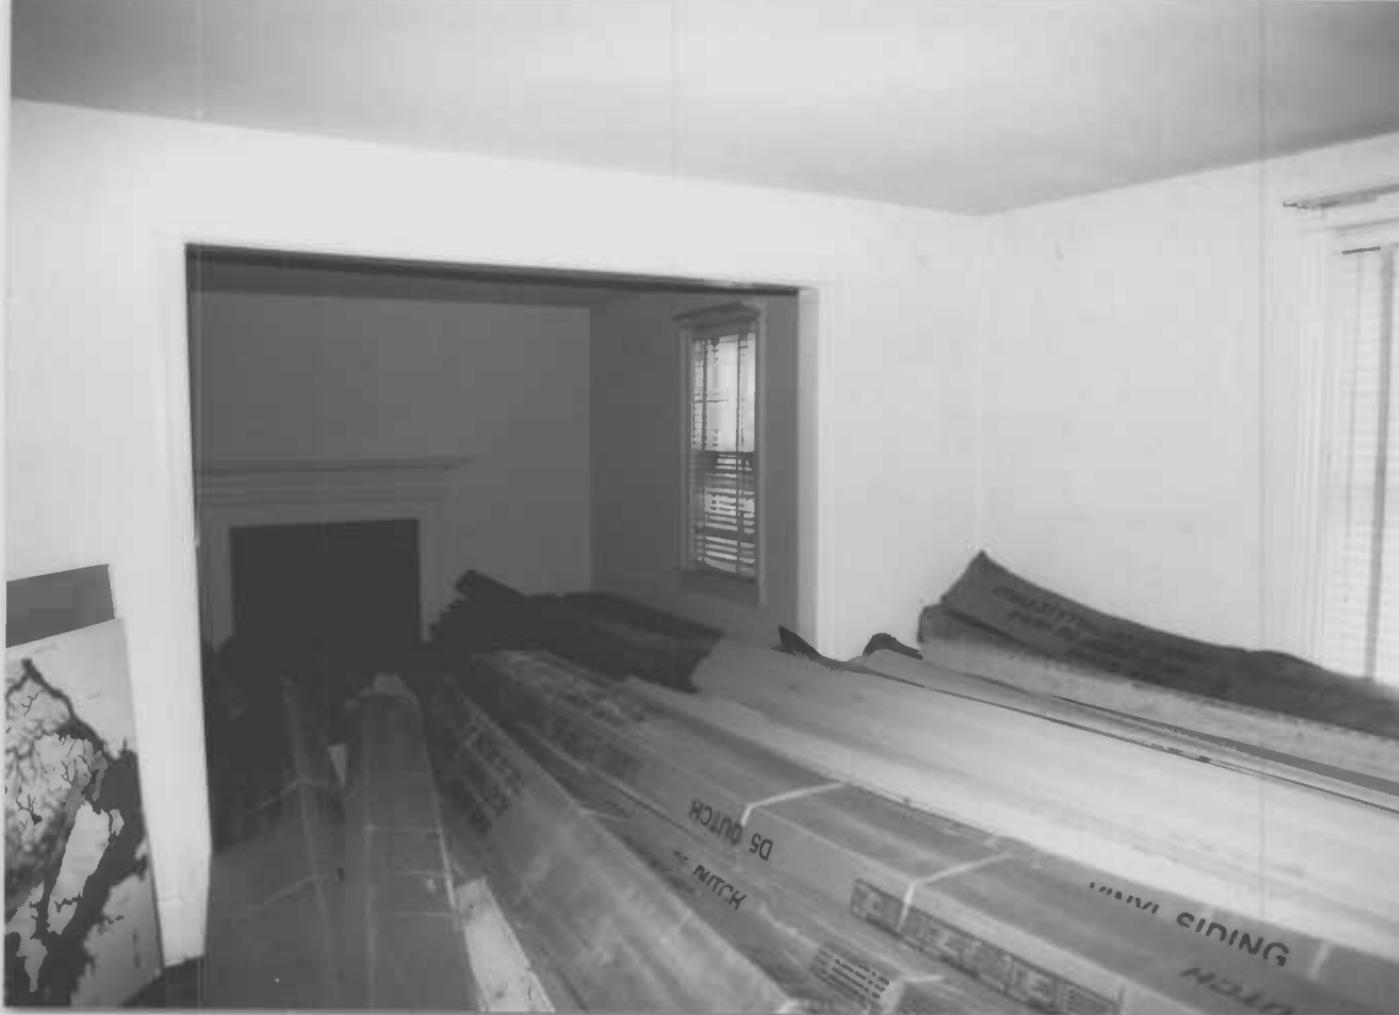
View from front parlour into back
parlour. Fireplace is connected
to broad ^{exterior} chimney in covered patio

The house has two chimneys, one very large exterior one of a hard-fired brick serving the fireplace at the west end of the double parlor and another of softer brick (probably original) extending above the main ridge, serving the dining room fireplace.

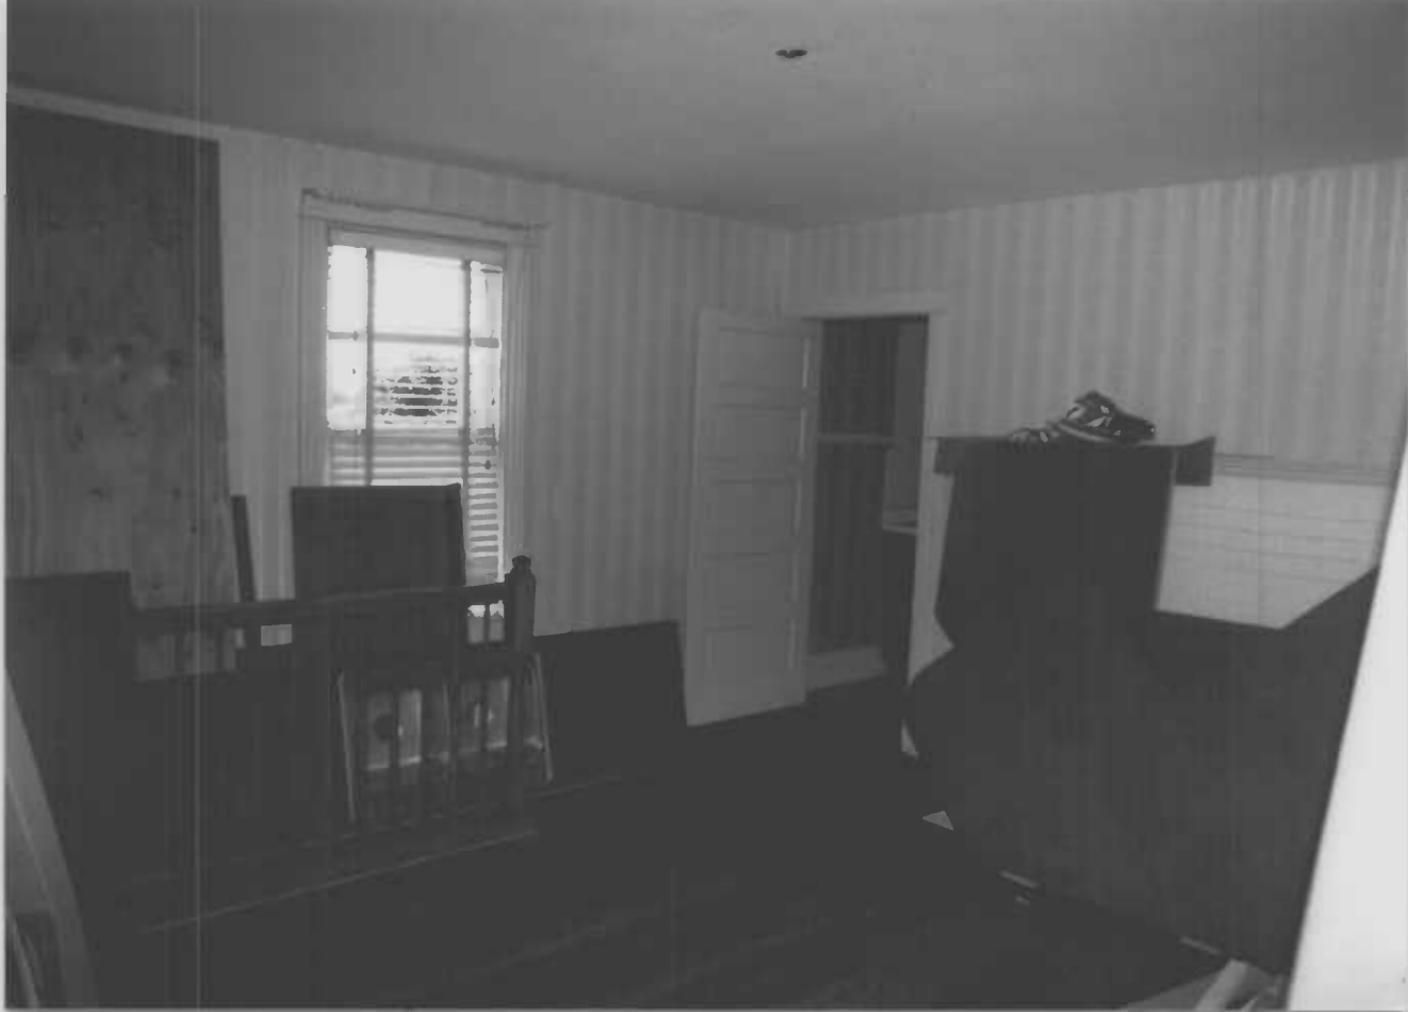
HA-1721

Dining Room of main House looking
SW toward kitchen door.

Misc. new construction bldg. parts stored
in room ~~cover~~ brick FP @ right

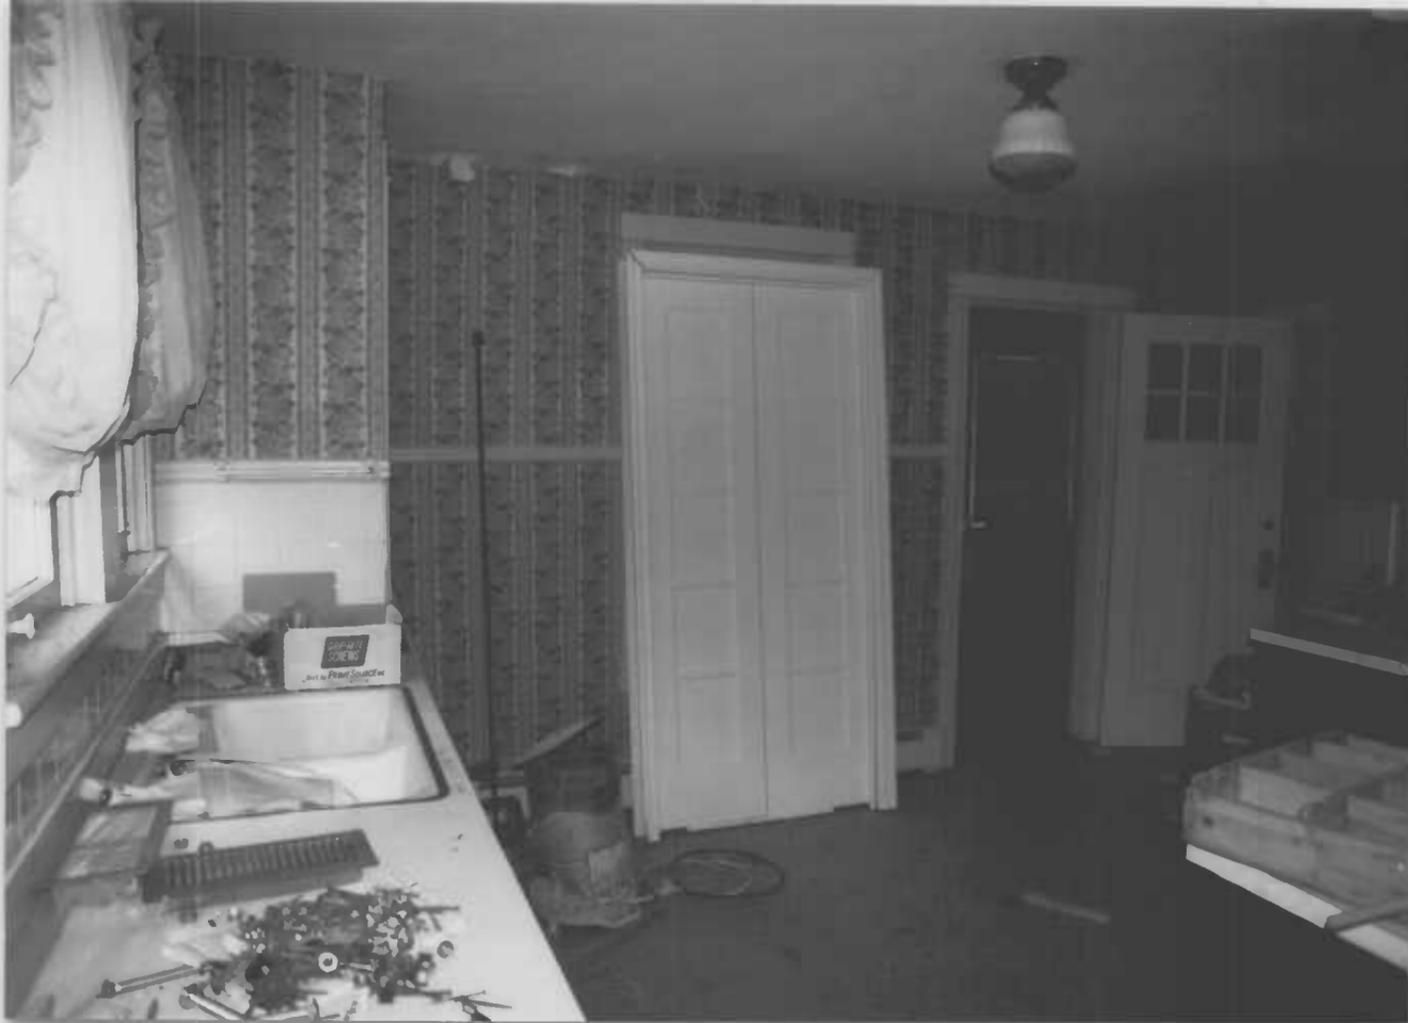
HA-1721

Kitchen of main house looking west
toward enclosed porch

The kitchen has dark-stained, plain front cabinets with copper accent hardware and sheet vinyl on the floor. There is a basement accessible from the kitchen via a two-panel door. The door from the kitchen to the enclosed porch at the rear is the taller, two-panel and glass entry door style and the trim inside the enclosed porch is plain stock. The enclosed porch has wall-to-wall carpet.

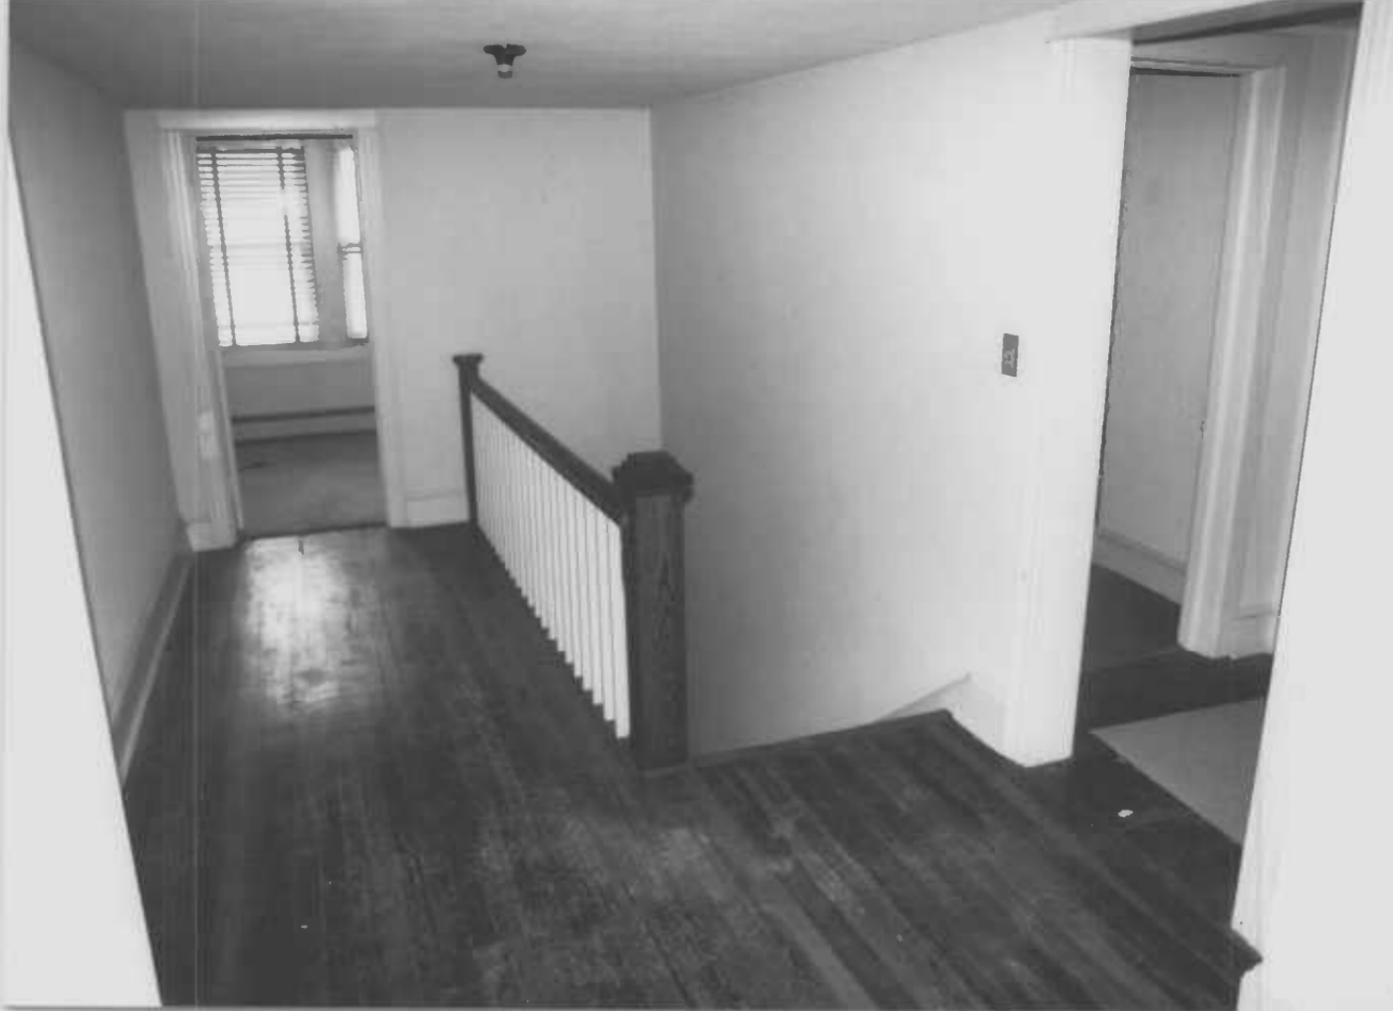
HA-1721

2nd stair hall in main house
looking east

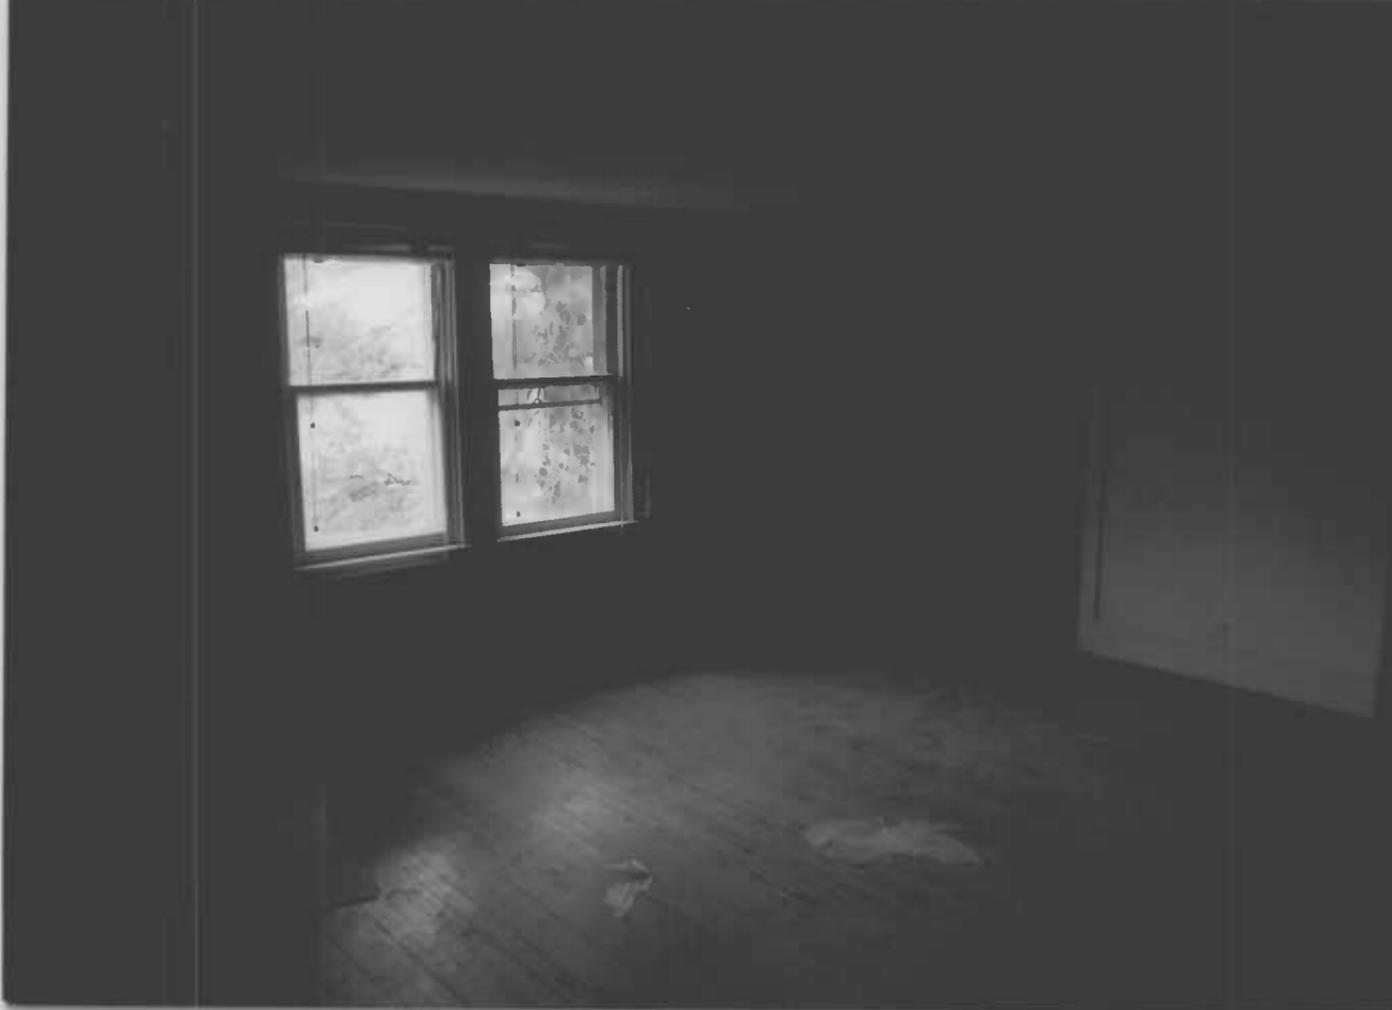
HA-1721

2nd floor ~~east~~ north BR of Main House

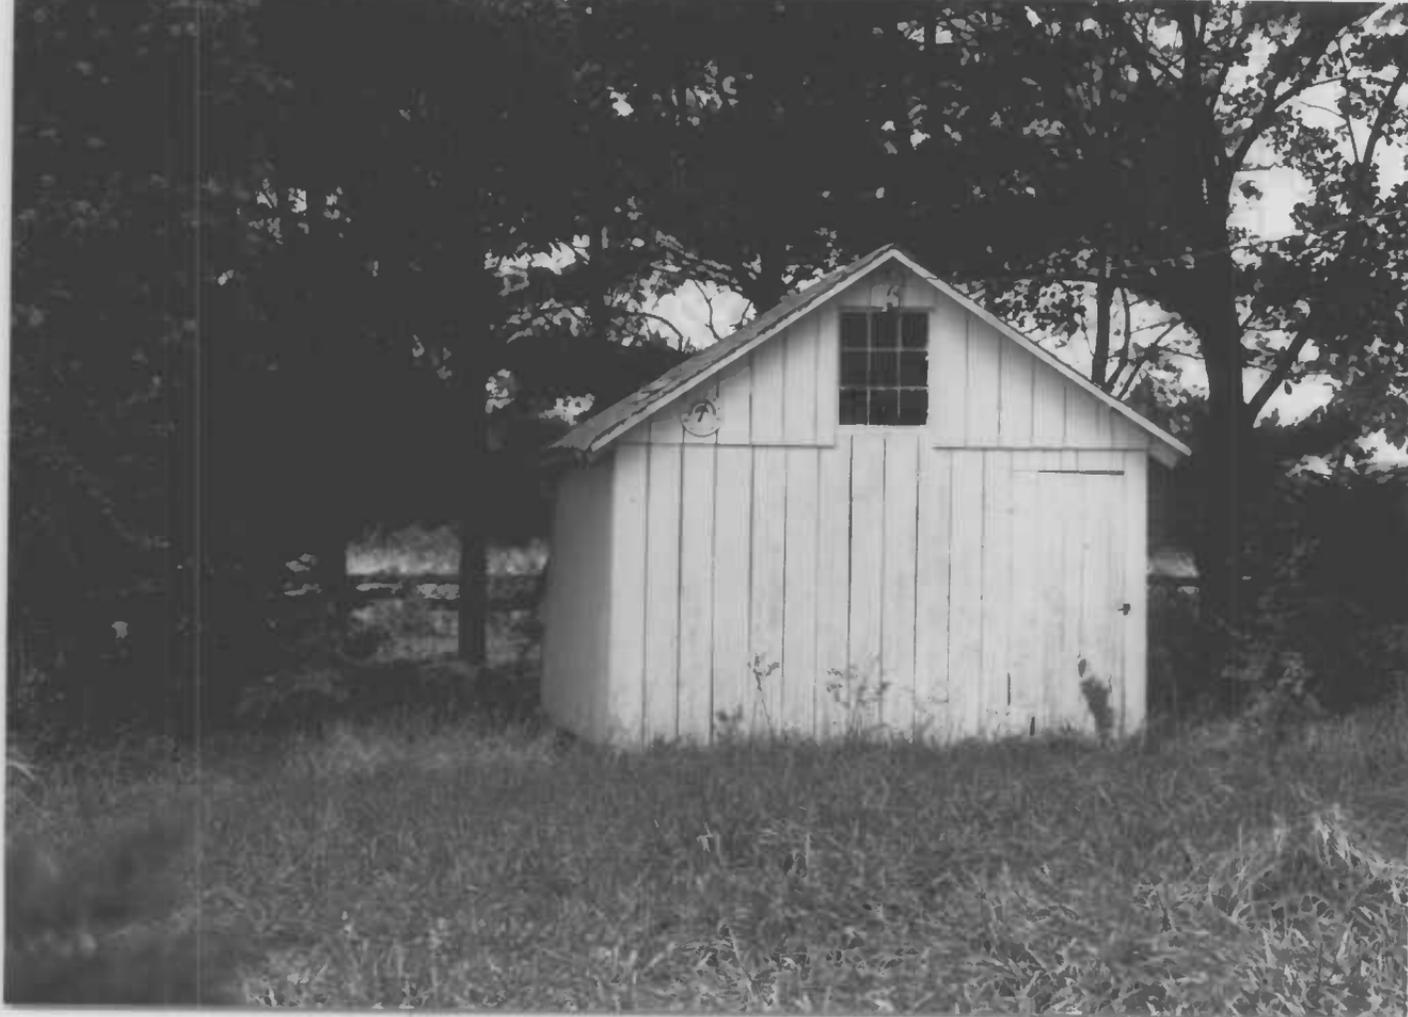
1HA-1721

Tool shed west of house

Located directly behind (west of) the house, the small, gable-roofed shed has vertical plank siding.

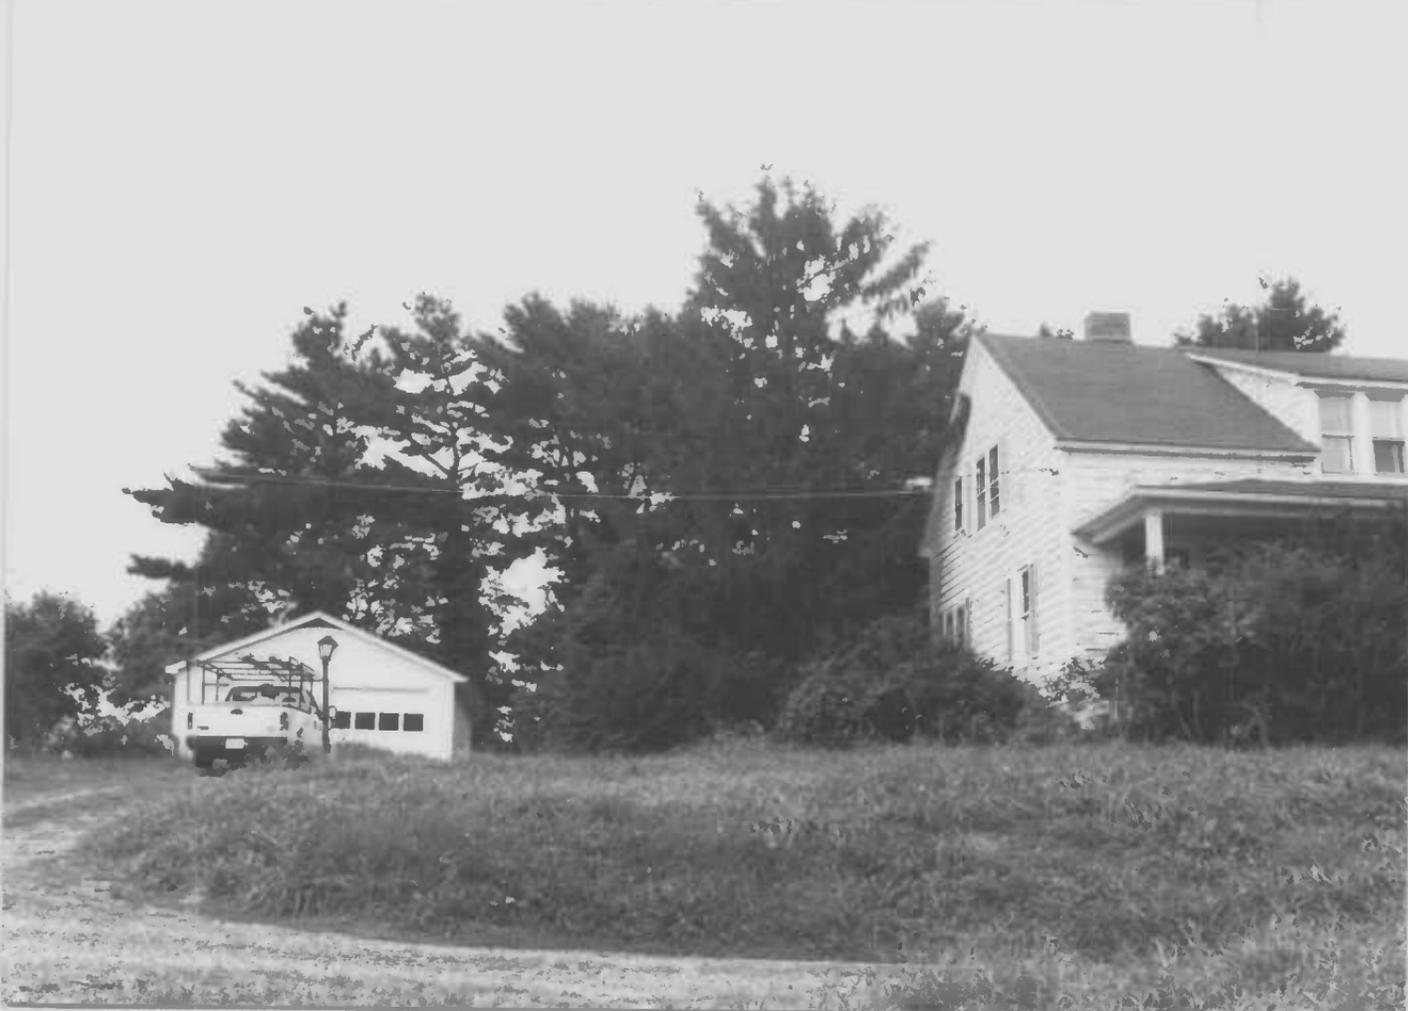
HA-1721

SE corner of ^{house and the} garage

The typical, two-car, detached garage is covered with vinyl siding and has a concrete block foundation, composite shingle, shallow-pitch gable roof and wooden doors for vehicles and pedestrians.
