INDIVIDUAL PROPERTY/DISTRICT
MARYLAND HISTORICAL TRUST
INTERNAL NR-ELIGIBILITY REVIEW FORM

Property/District Name: Tharpe Property Stone Ridge Survey Number: HA-1721
Project: GTA, Stone Ridge Agency: US Army Corps of Engineers
Site visit by MHT Staff: no yes Name _____ Date _____

**Maryland Historical Trust
State Historic Sites Inventory Form**

***Tharpe Property
Harford County, MD***

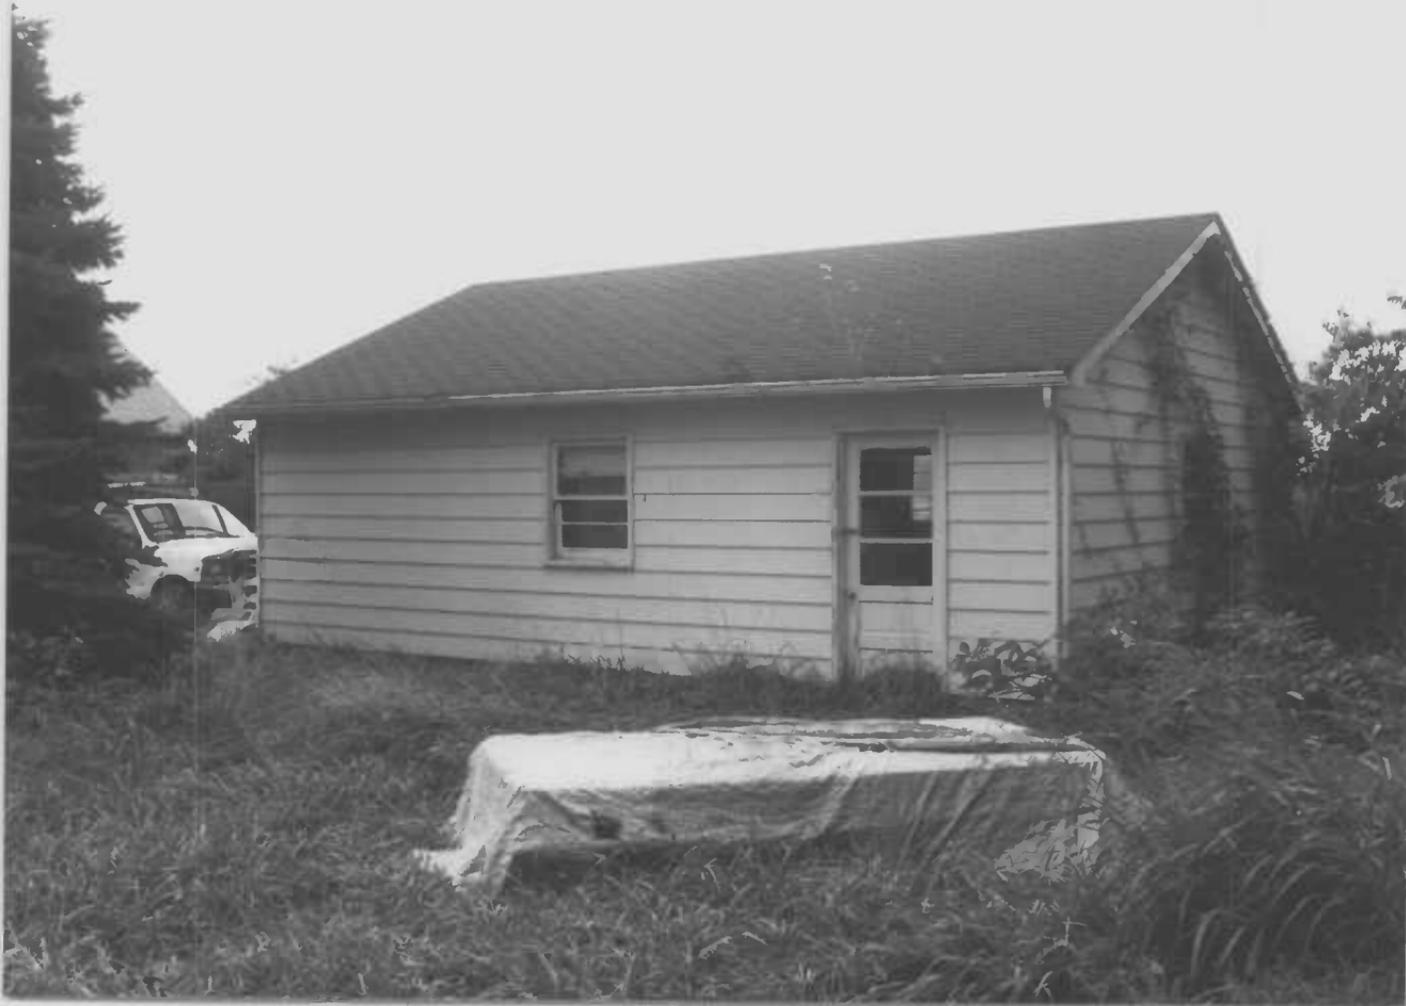
HA-1721

NW corner of garage

The typical, two-car, detached garage is covered with vinyl siding and has a concrete block foundation, composite shingle, shallow-pitch gable roof and wooden doors for vehicles and pedestrians.

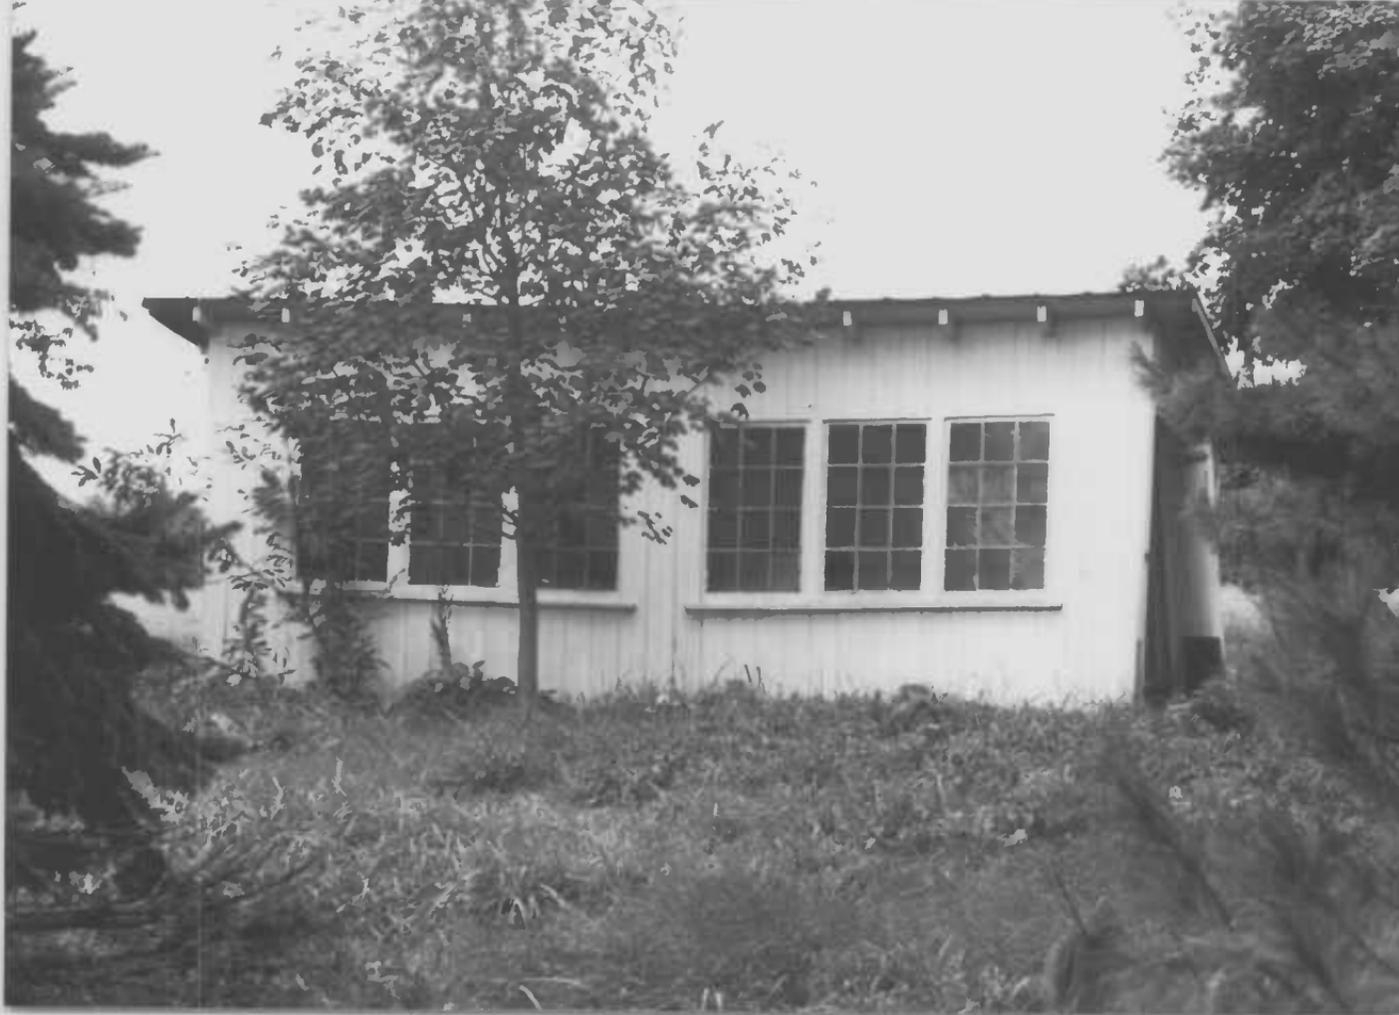
HA-1721

Stud for chickens/turkeys
located NW of house

Located off to the NW of the main house, this shed, used for housing chickens and turkeys, has rotted flooring, a full bank of east-facing windows and doors on each end.

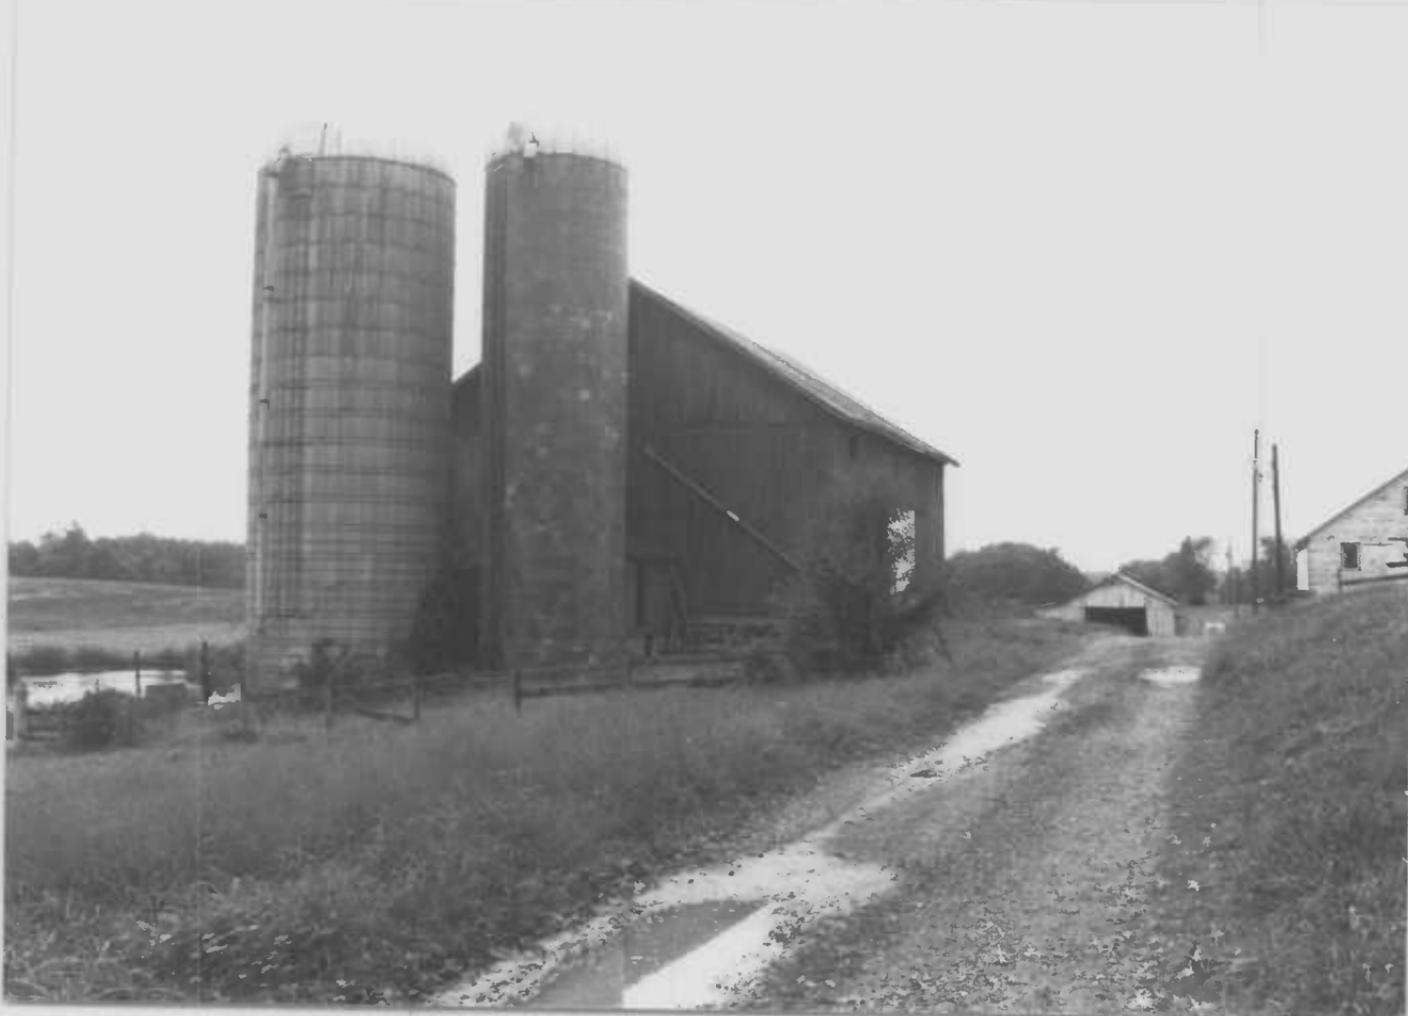
HA-1721

View of farm pond, silos, main dairy barn,
driveway, small corn crib and granary
looking south

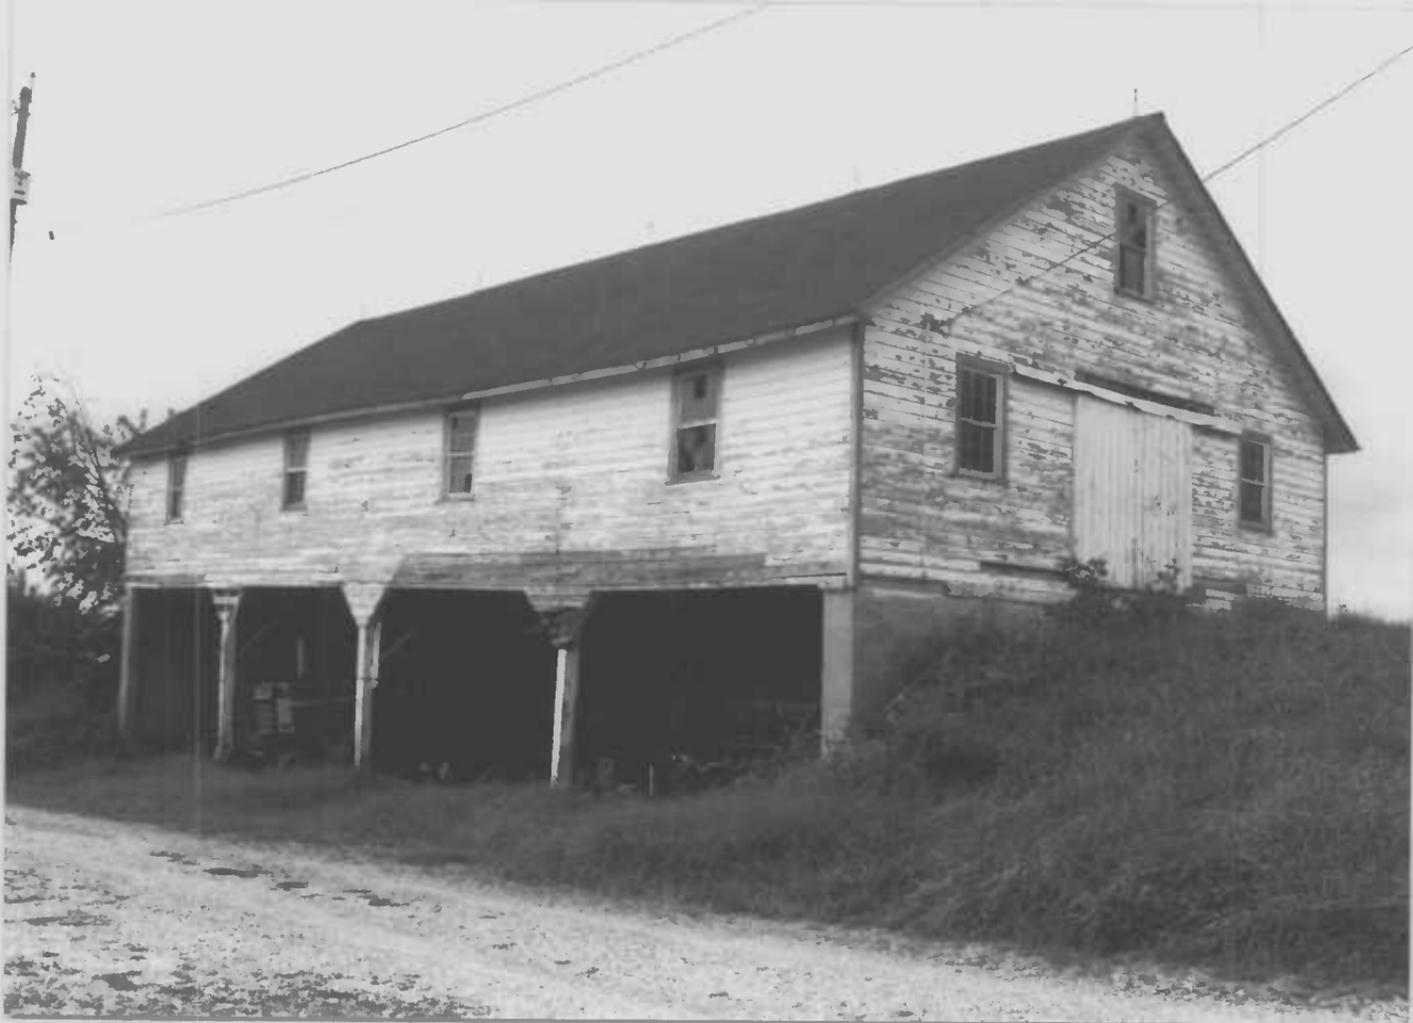
HA-1721

Granary - NE corner
(and Equipment Storage below)

This banked building has a lower equipment storage area opening east to the driveway. The upper level is accessed by a sliding door at the north end. After stepping up into the building, the framing is exposed. The open room is lighted by small, 6/6 windows. Not all sash match, implying some were replaced or were recycled from other structures. The gable ends have single, 6/6 attic windows. The window trim and eaves had been set off with red paint that has now worn thin.

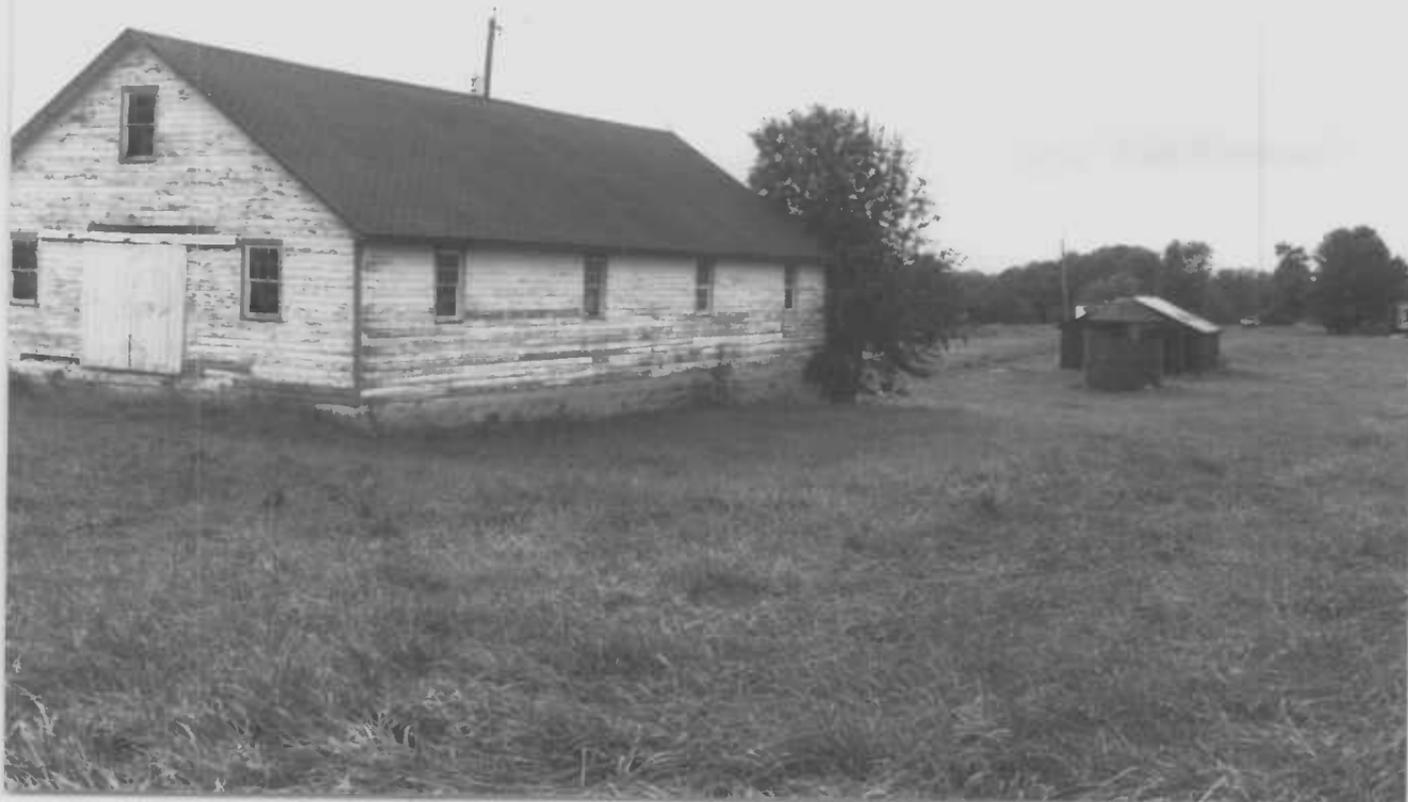
HA-1721
Tharpe Property
Harford Co MD
L Wingate 10/99
MD SHPO

View looking south with granary in
foreground and corn crib beyond.

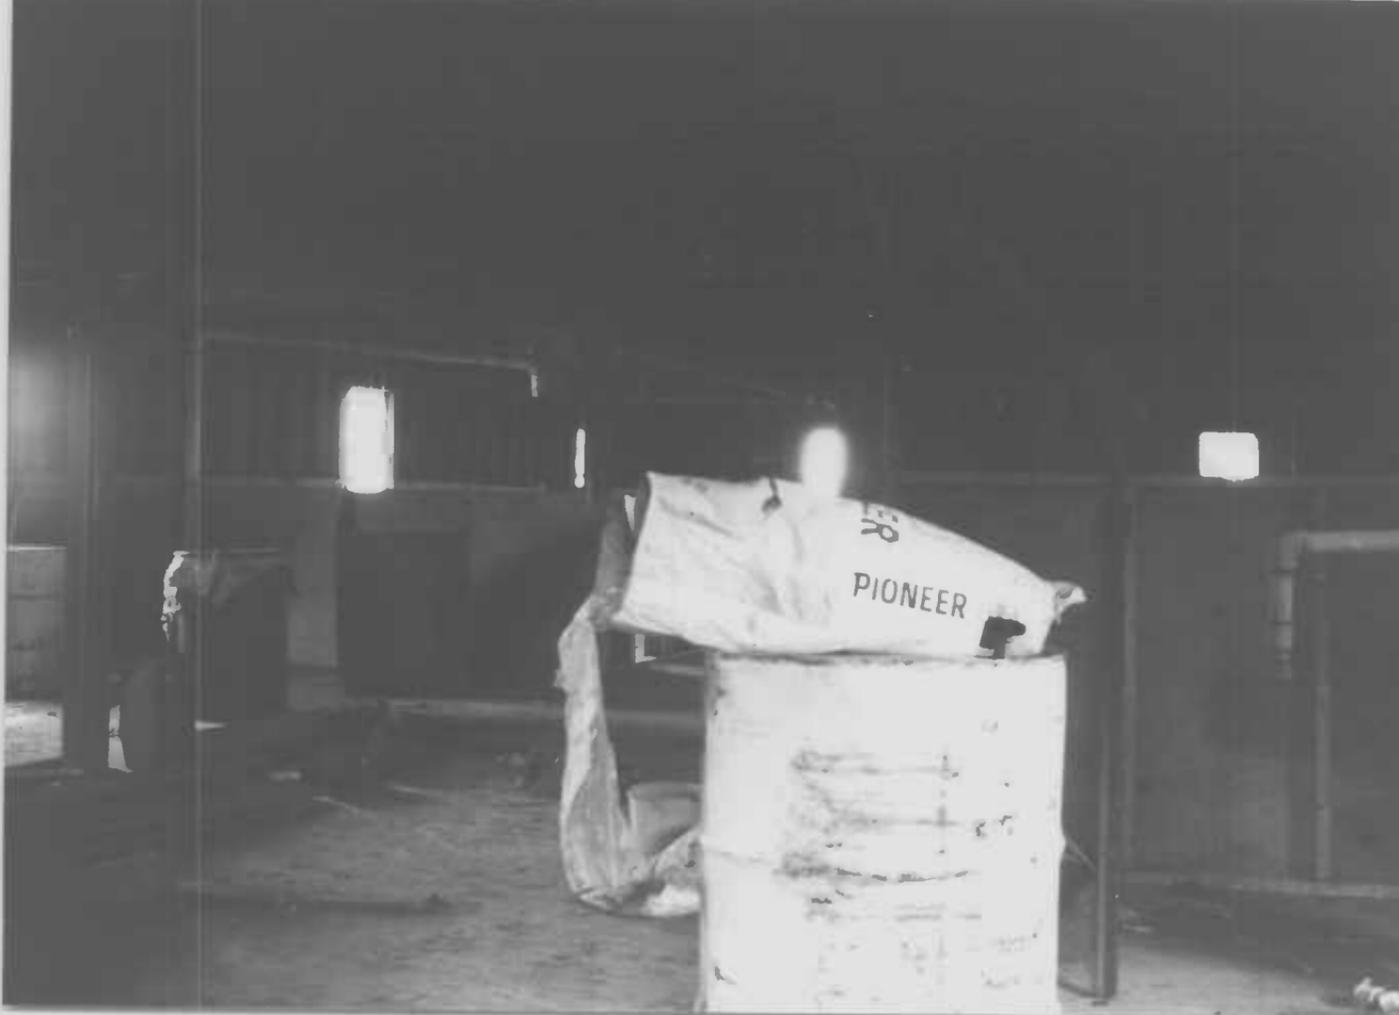
HA-1721

Inside granary looking south.

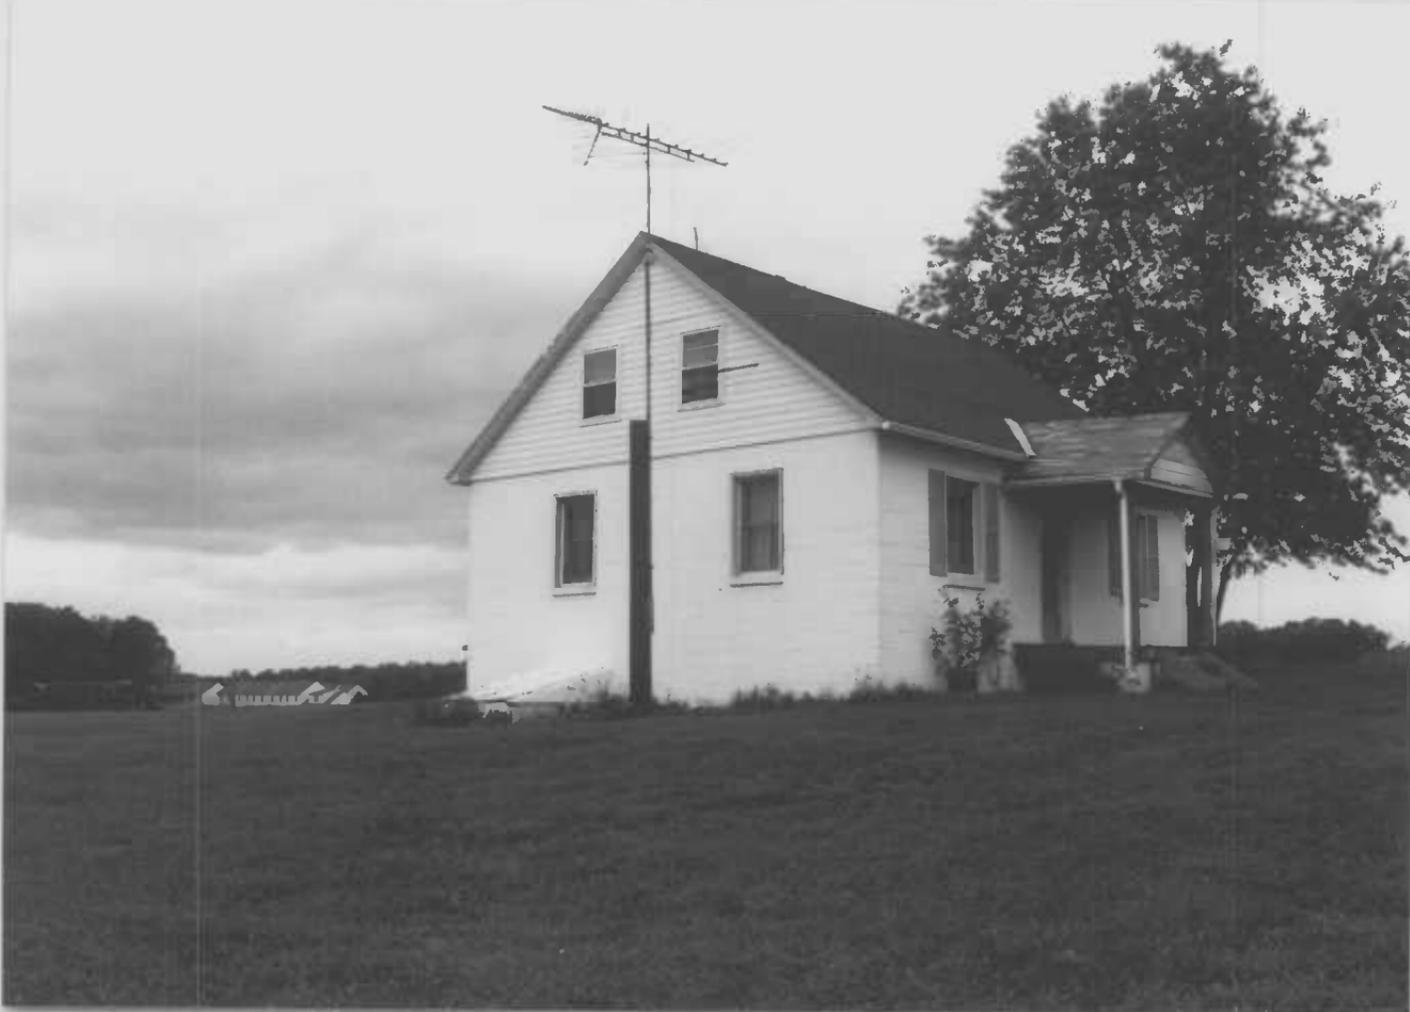
HA-1721

Tenant House

Tom houses on adjacent parcel can be seen
at left.

A small, concrete block dwelling sits facing north at the end of the gravel driveway. It appears to be a compact, well-kept, 1 ½ story house with vinyl shutters matching those on the main house.

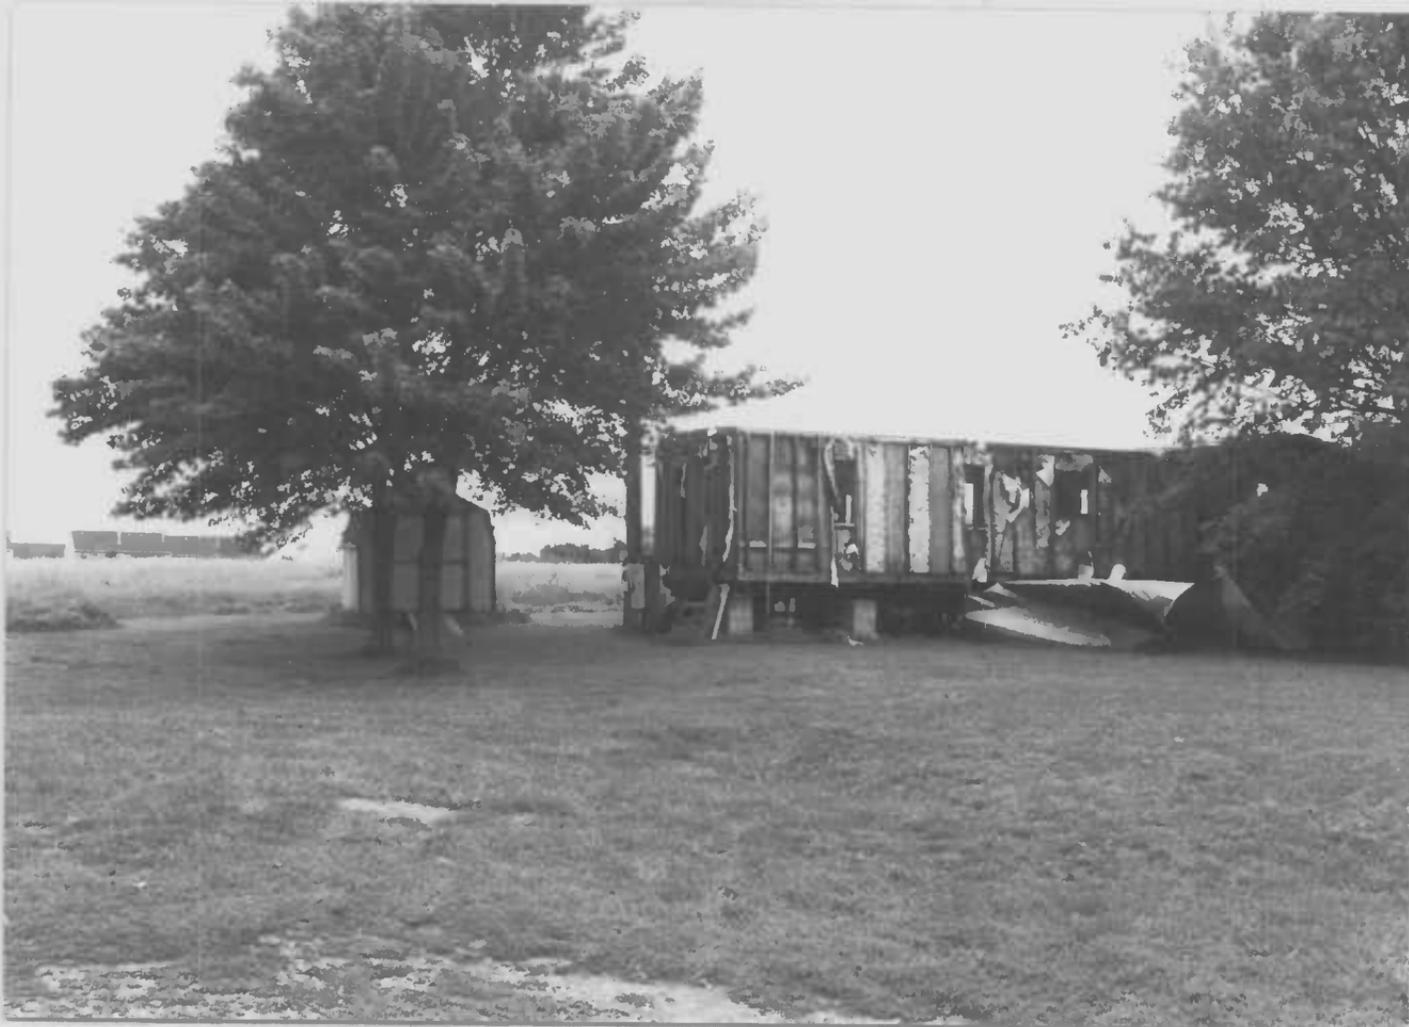
1/A-1721
Tharpe Property
Harford Co MD
L Wingate 10/99
MD SHPD

Remains of mobile home at south end of driveway
near Tenant House. Townhouses on the
adjoining parcel to the west can be seen in
background at left.

The shell of a trailer sits atop concrete block piers. The windows are gone and most of the siding has come off, exposing the batt insulation.

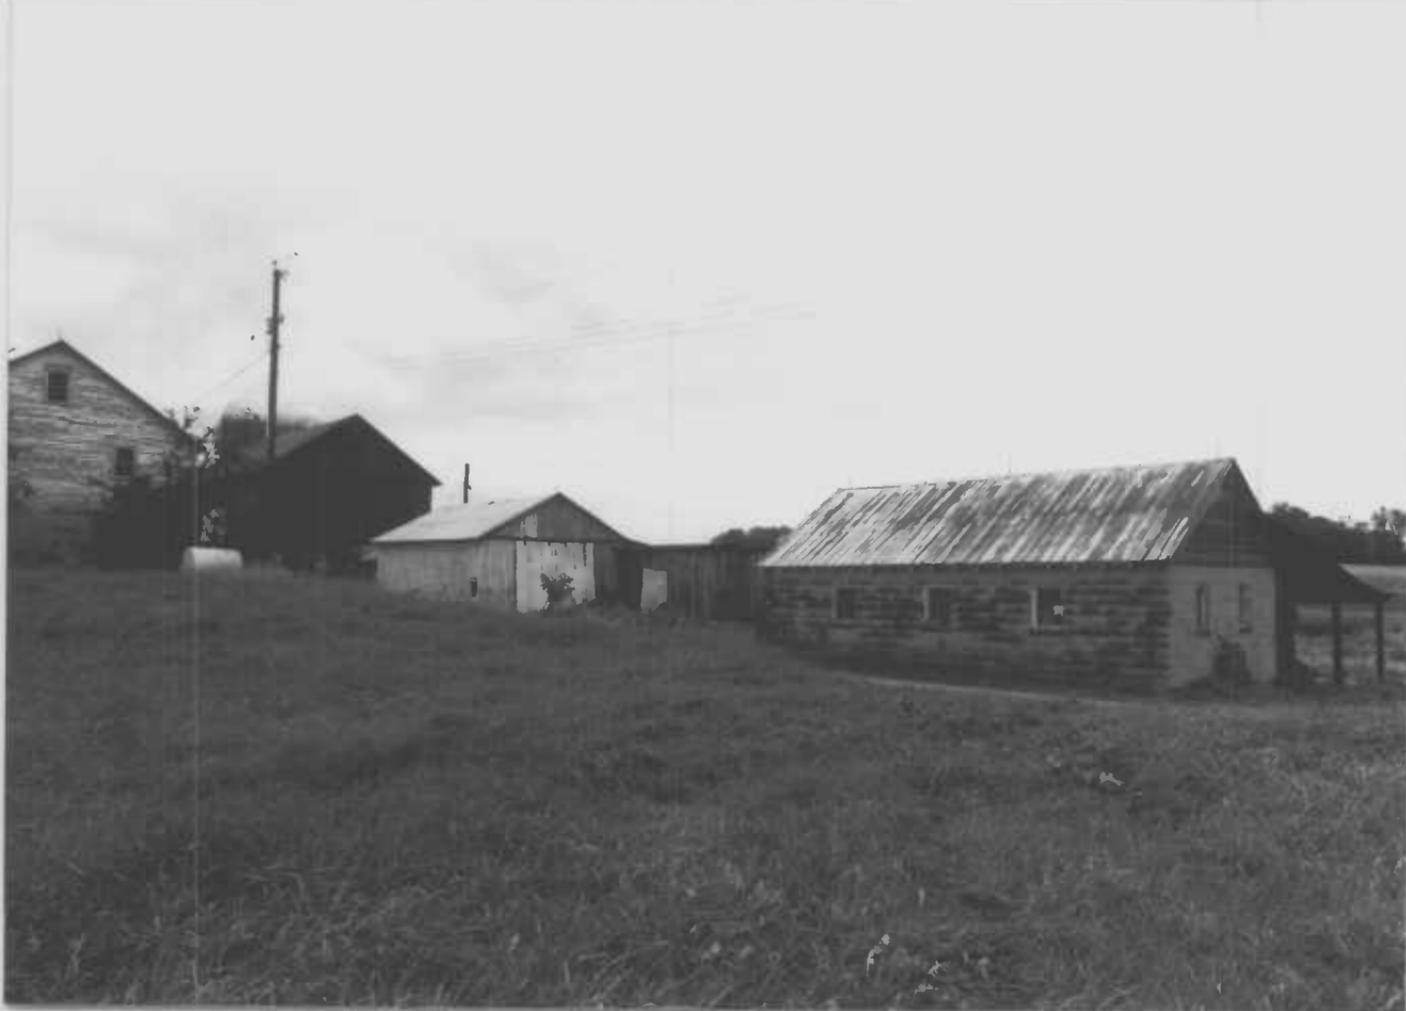
HA-1721

Looking NE across driveway from ^{Detached} Corn Crib
at concrete block Workshop at right
and white corn crib. Main Dairy Barn
in background and Granary @ left

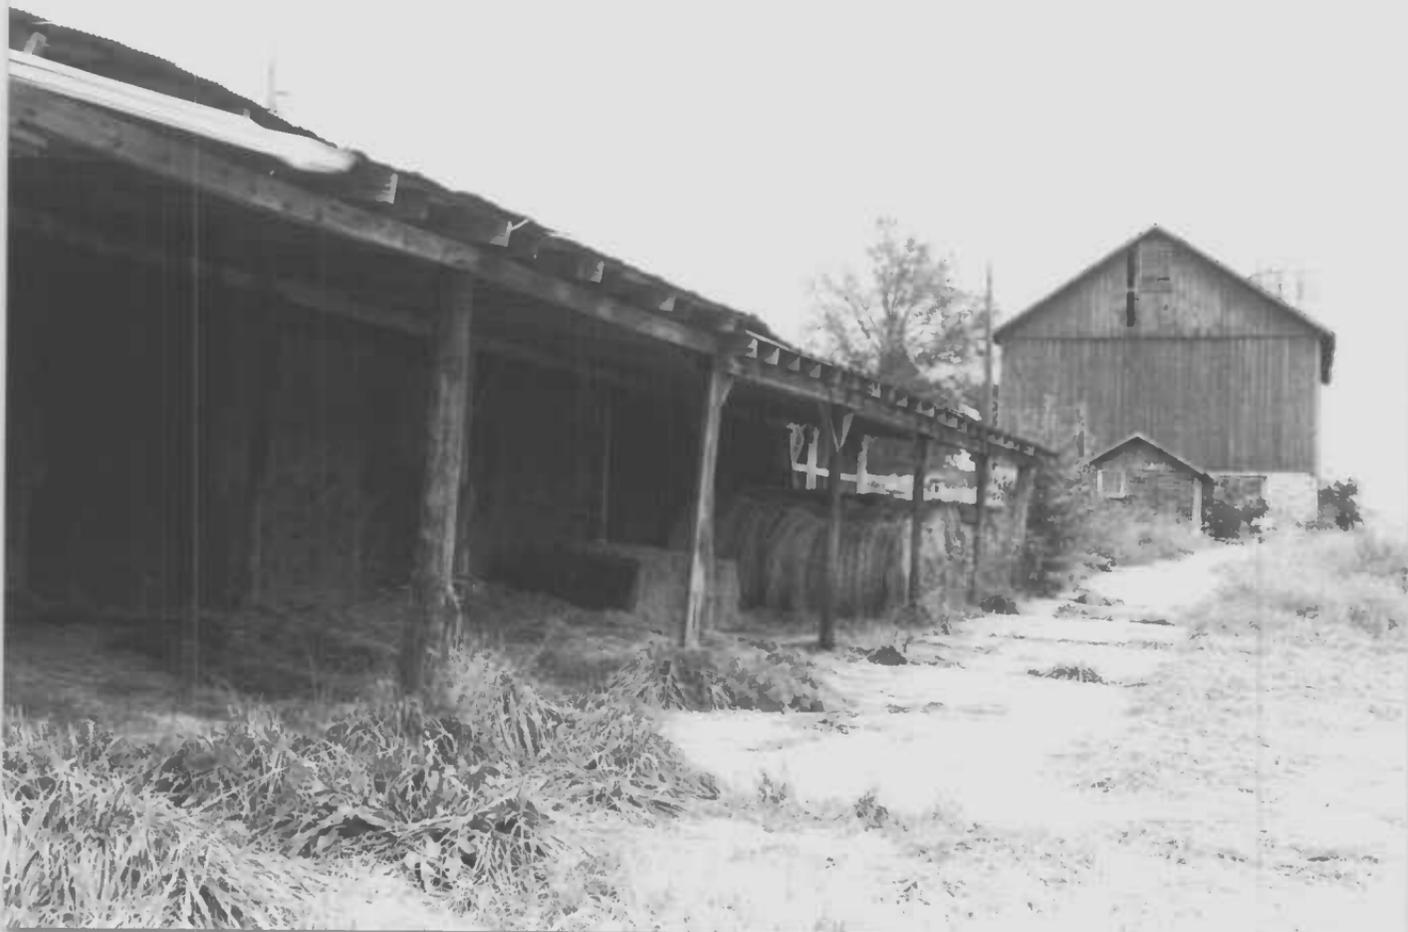
HA-1721

Open shed on east side of workroom and
concrete path leading north to main
dairy barn

This structure is a small collection of attached outbuildings. There is an open animal shelter at the NE corner, an open pole shed (now used for straw storage) on the SE corner, a concrete block work room with nine-pane sash and brick window sills at the SW corner, and an older corn crib sided using wire nails at the NW corner. All are covered with standing seam metal roofs.

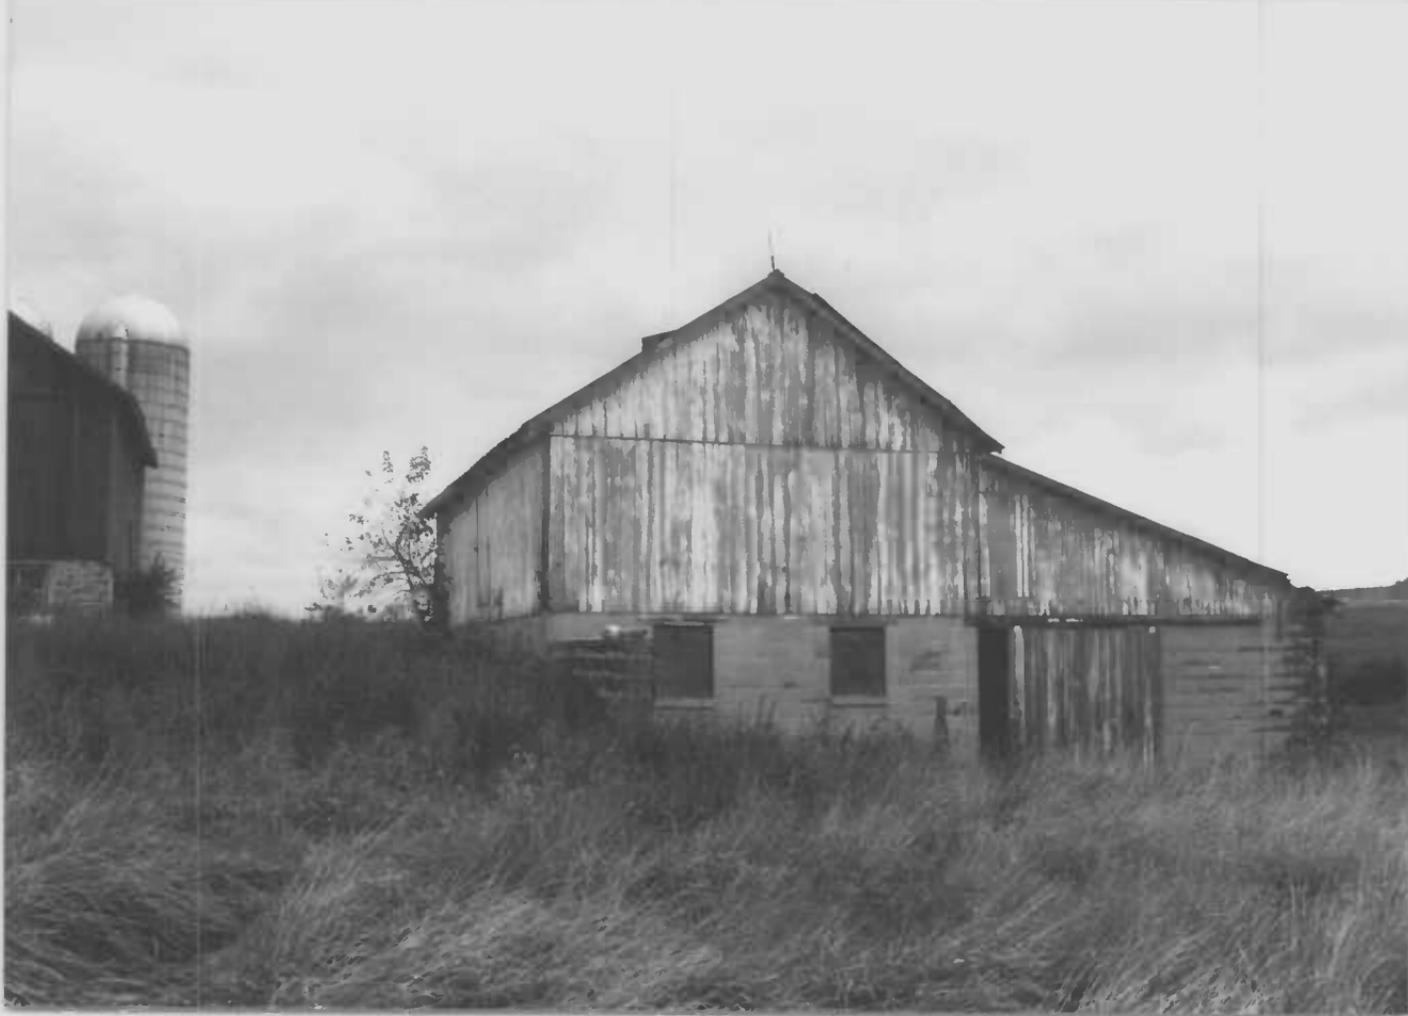
HA-1721

SW corner of ^{secondary} smaller barn used for
younger animals. Main dairy barn @ left.

The banked, gable barn used for young animals has a shed-roofed extension to the east. It has a concrete block foundation and a standing seam metal roof.

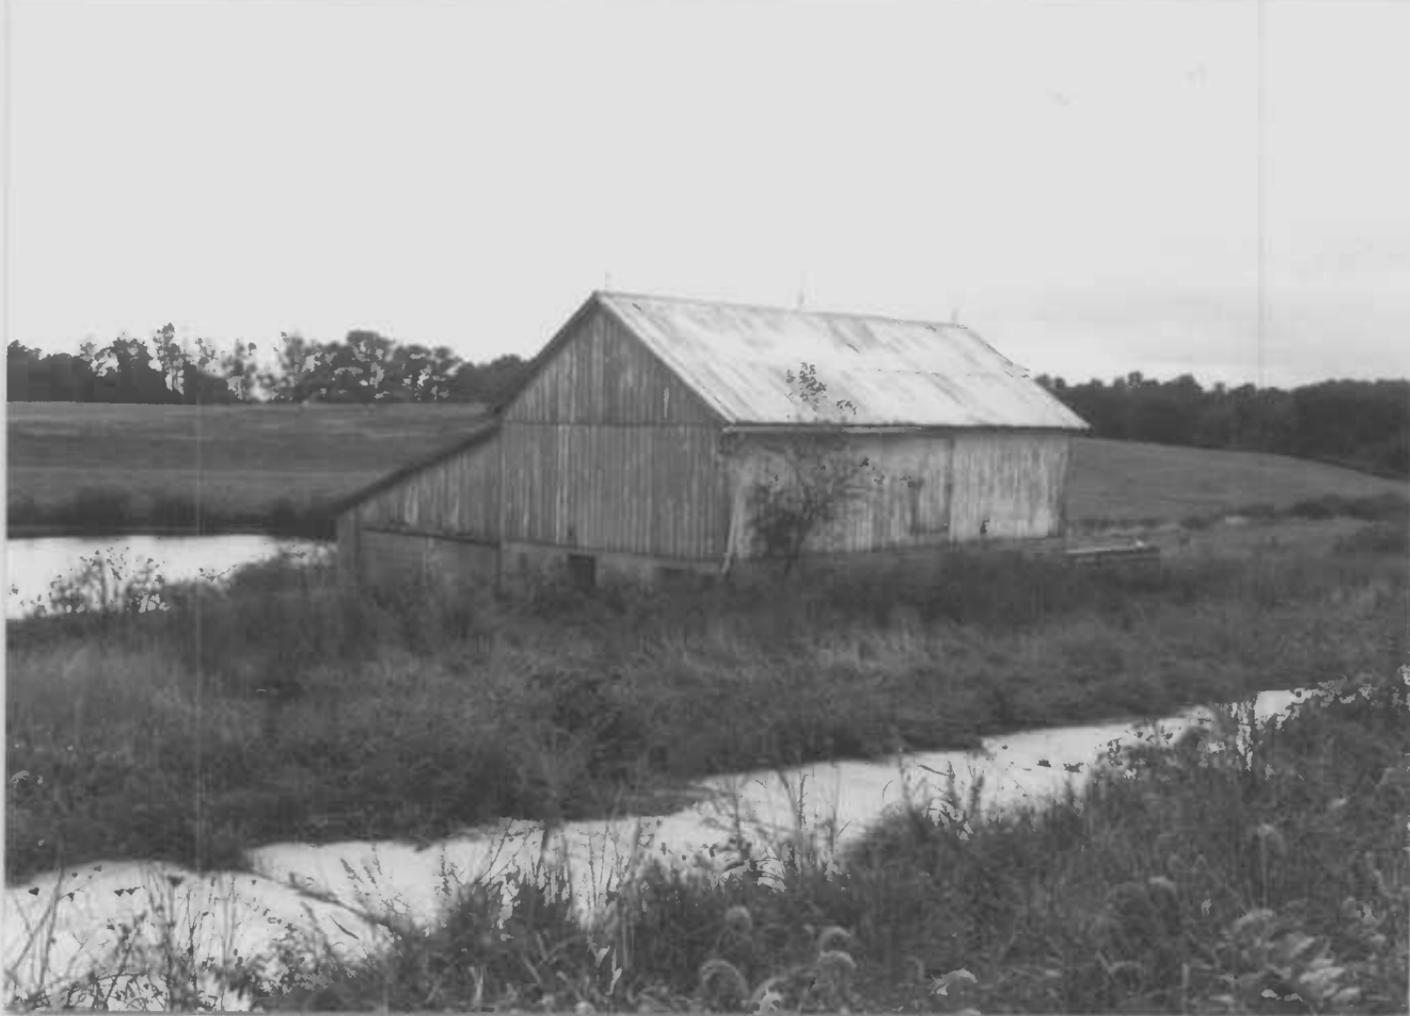
HA-1721

Small er barn used for younger animals.

View looking SE.

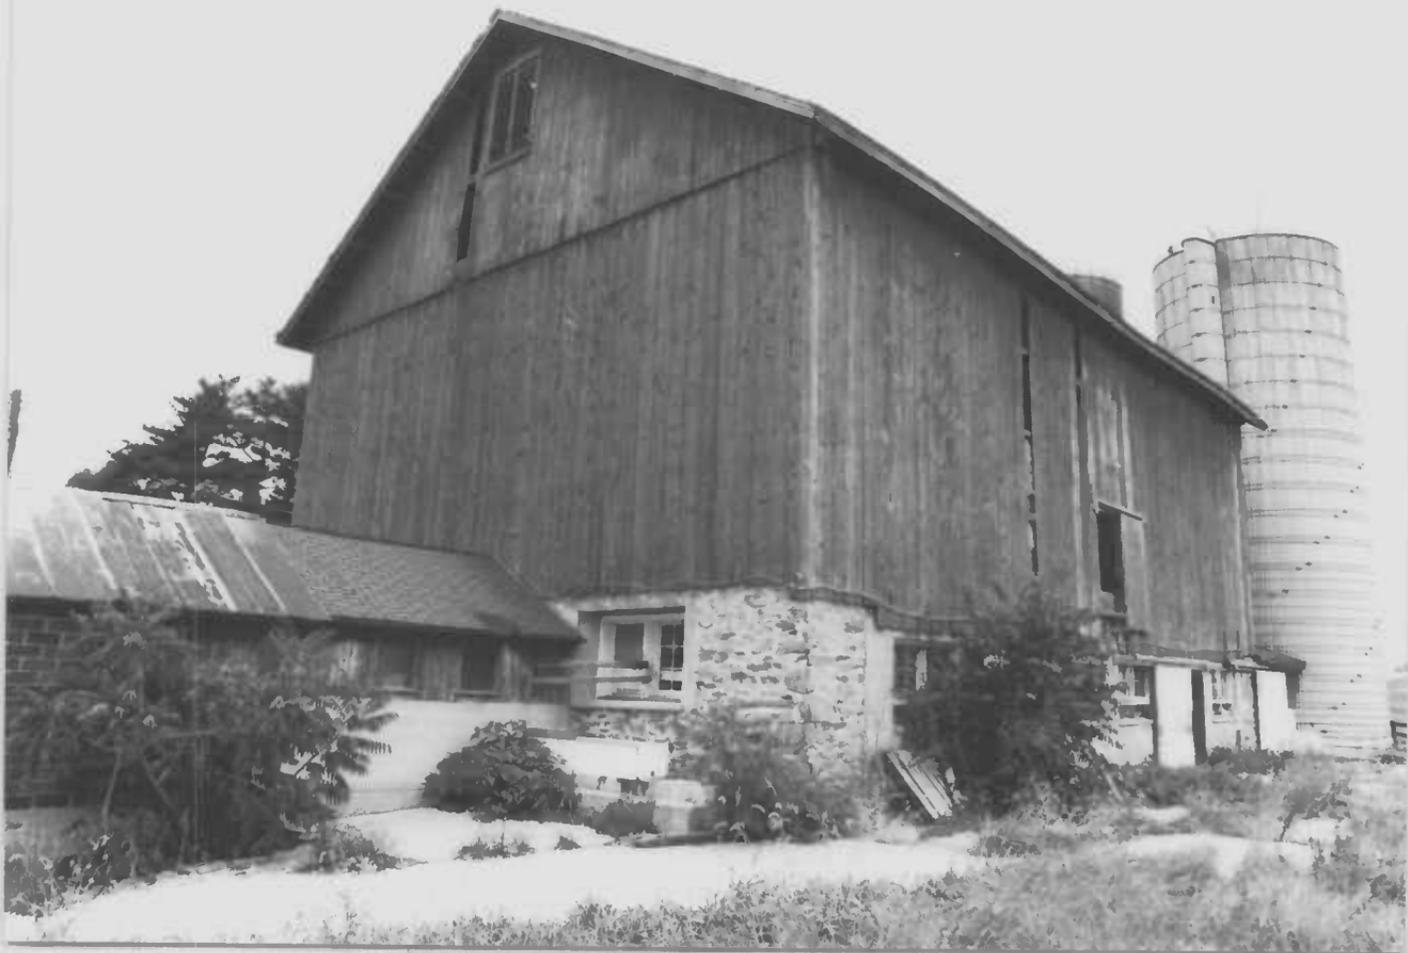
HA-1721

Dairy House at left with covered walkway into ~~building~~

~~pasture~~ lower level

At the south end are two additions. The first is a frame addition, an enclosed walkway, with a concrete block foundation. Then further south is a glazed block addition, the dairy house, with a poured concrete foundation. Milk was stored here, awaiting transportation, and the milking equipment was washed up in this building.

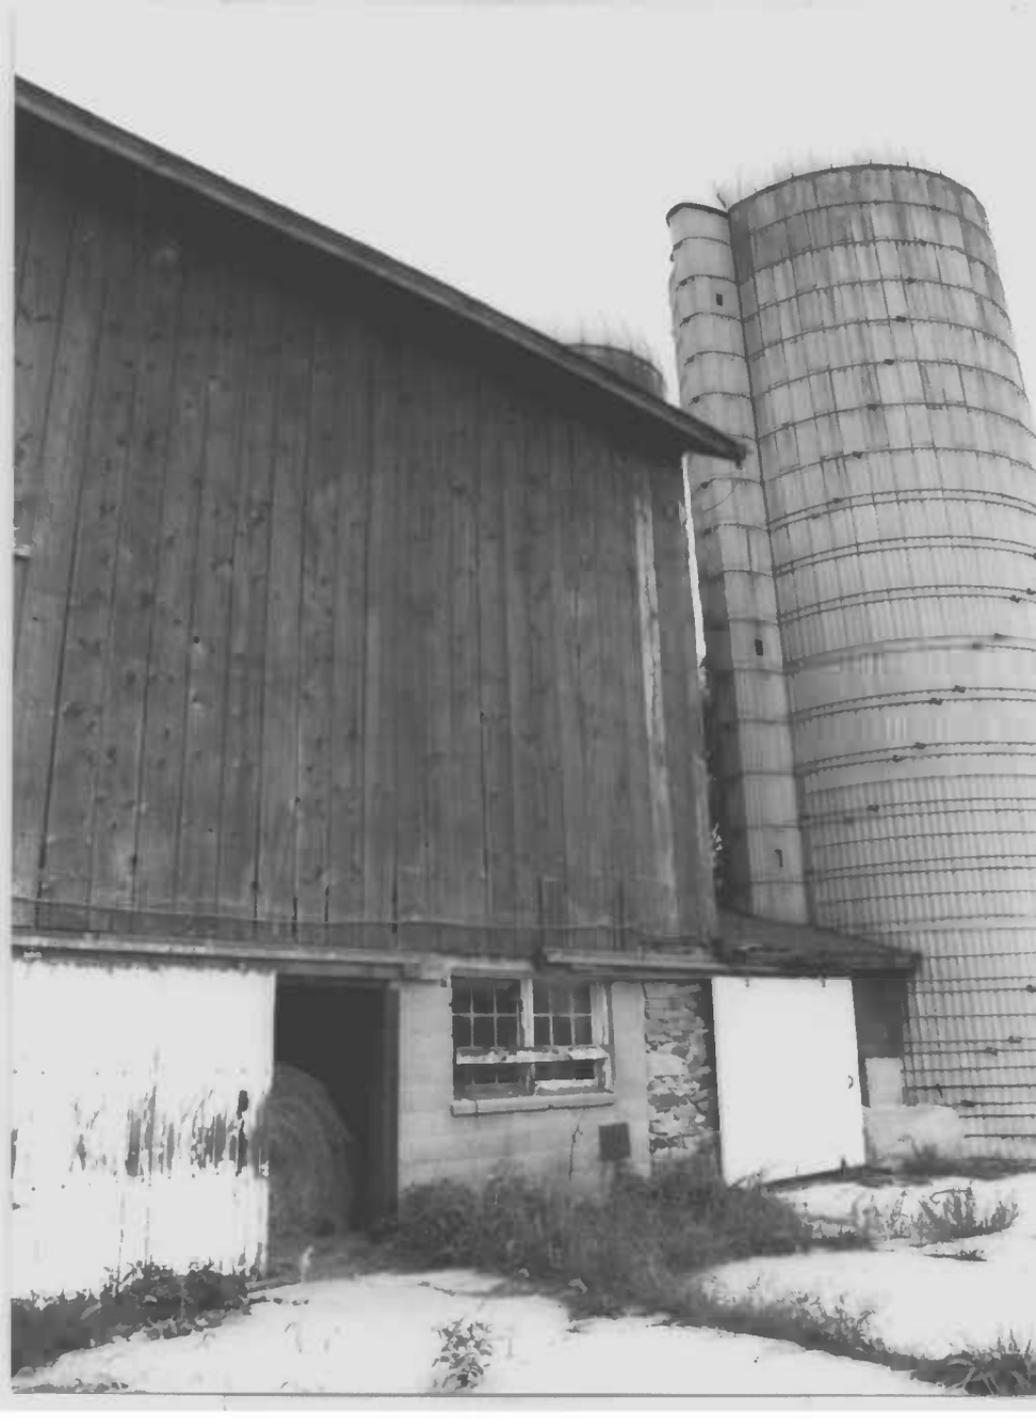
HA-1721

Main Dairy Barn - NE corner
Entrance to milking parlour/
stanchion stalls

The lower level was enclosed with concrete block along the east side to create a milking barn, where the cows were both housed and milked, complete with troughed concrete floor, metal pipe stanchion dividers, beaded board ceiling, parged walls, ceiling fans and lights. It opens out onto a concrete pad that is connected to a sloped concrete walk/driveway leading between the structures to the south. The lower level windows were added or enlarged on the north, east and south sides.

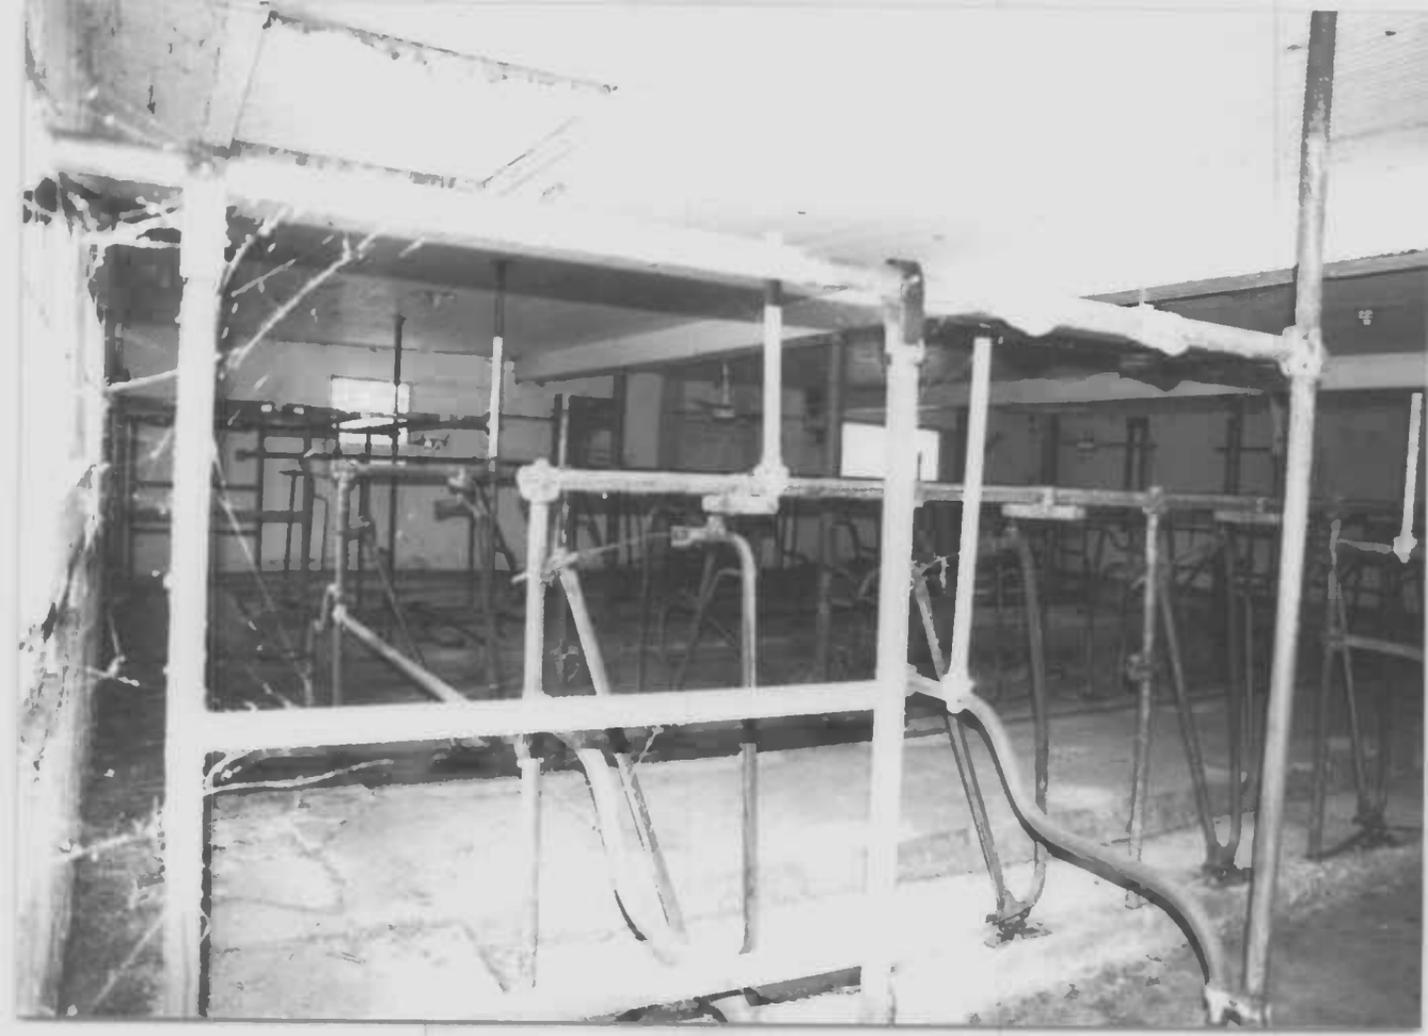
HA-1721

Looking toward south end of milking parlour.
Lower level of Main Dairy Barn.
stanchion stalls/
