INDIVIDUAL PROPERTY/DISTRICT
MARYLAND HISTORICAL TRUST
INTERNAL NR-ELIGIBILITY REVIEW FORM

Property/District Name: Tharpe Property Stone Ridge Survey Number: HA-1721
Project: GTA, Stone Ridge Agency: US Army Corps of Engineers
Site visit by MHT Staff: no yes Name _____ Date _____

**Maryland Historical Trust
State Historic Sites Inventory Form**

***Tharpe Property
Harford County, MD***

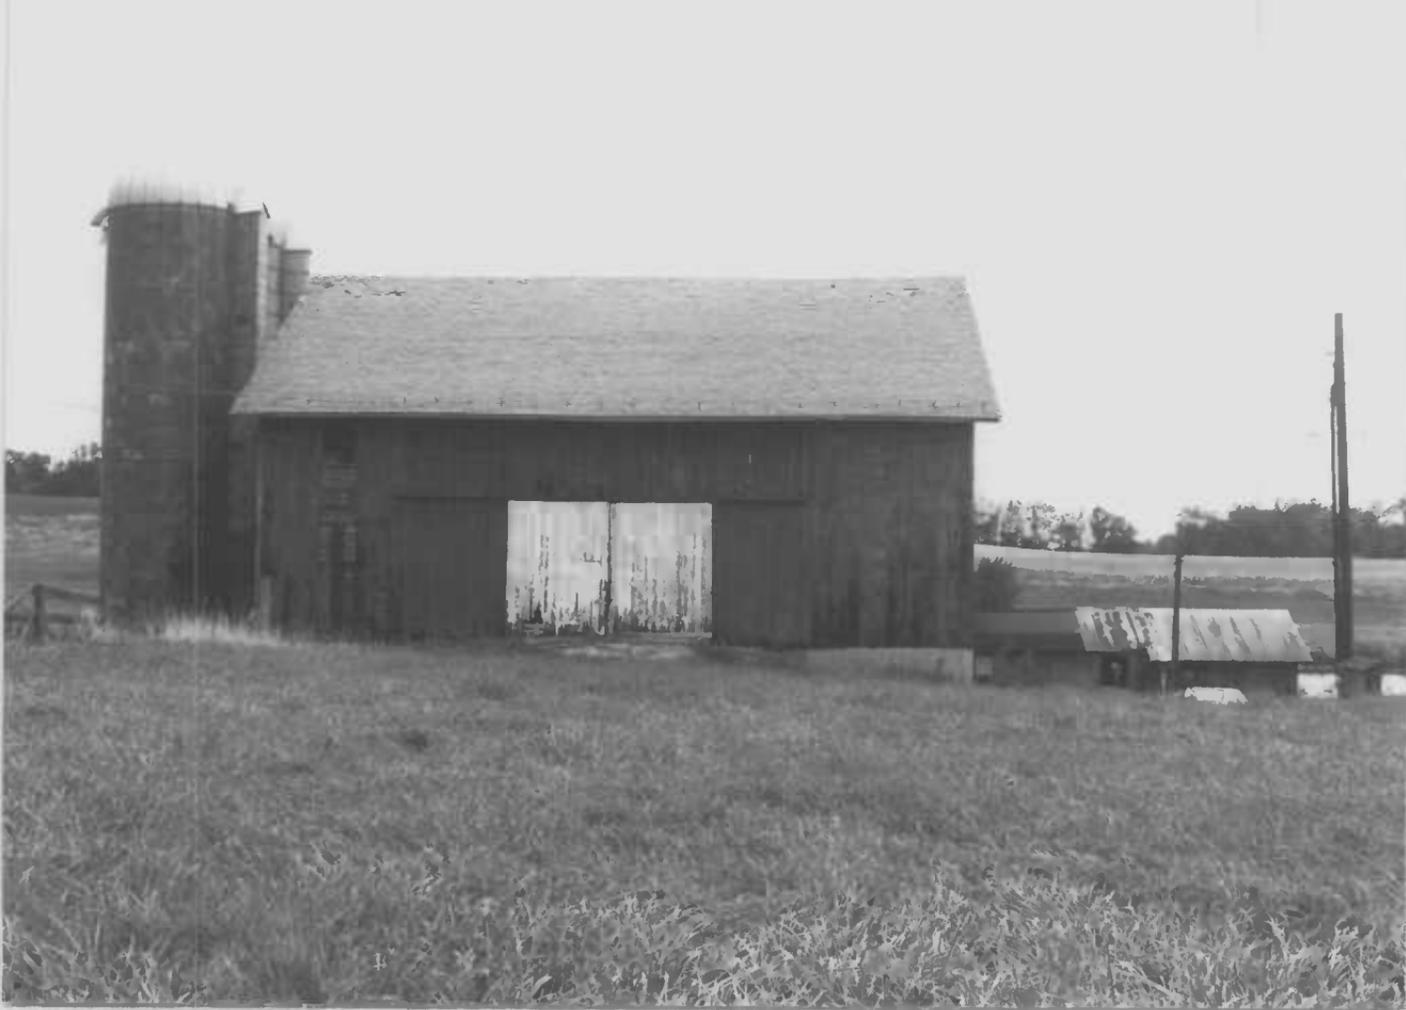
HA-1721

West elevation of main dairy barn.

Silos at left and walkway and milk house
@ right

At the north end of the barn is a small link connecting to two upright silos. The older (c.1930s) western one is glazed block and the eastern one is a stave silo, "corrugated" concrete vertical panels bound together with clamped wire bands, on a poured concrete foundation. Both have metal roofs.

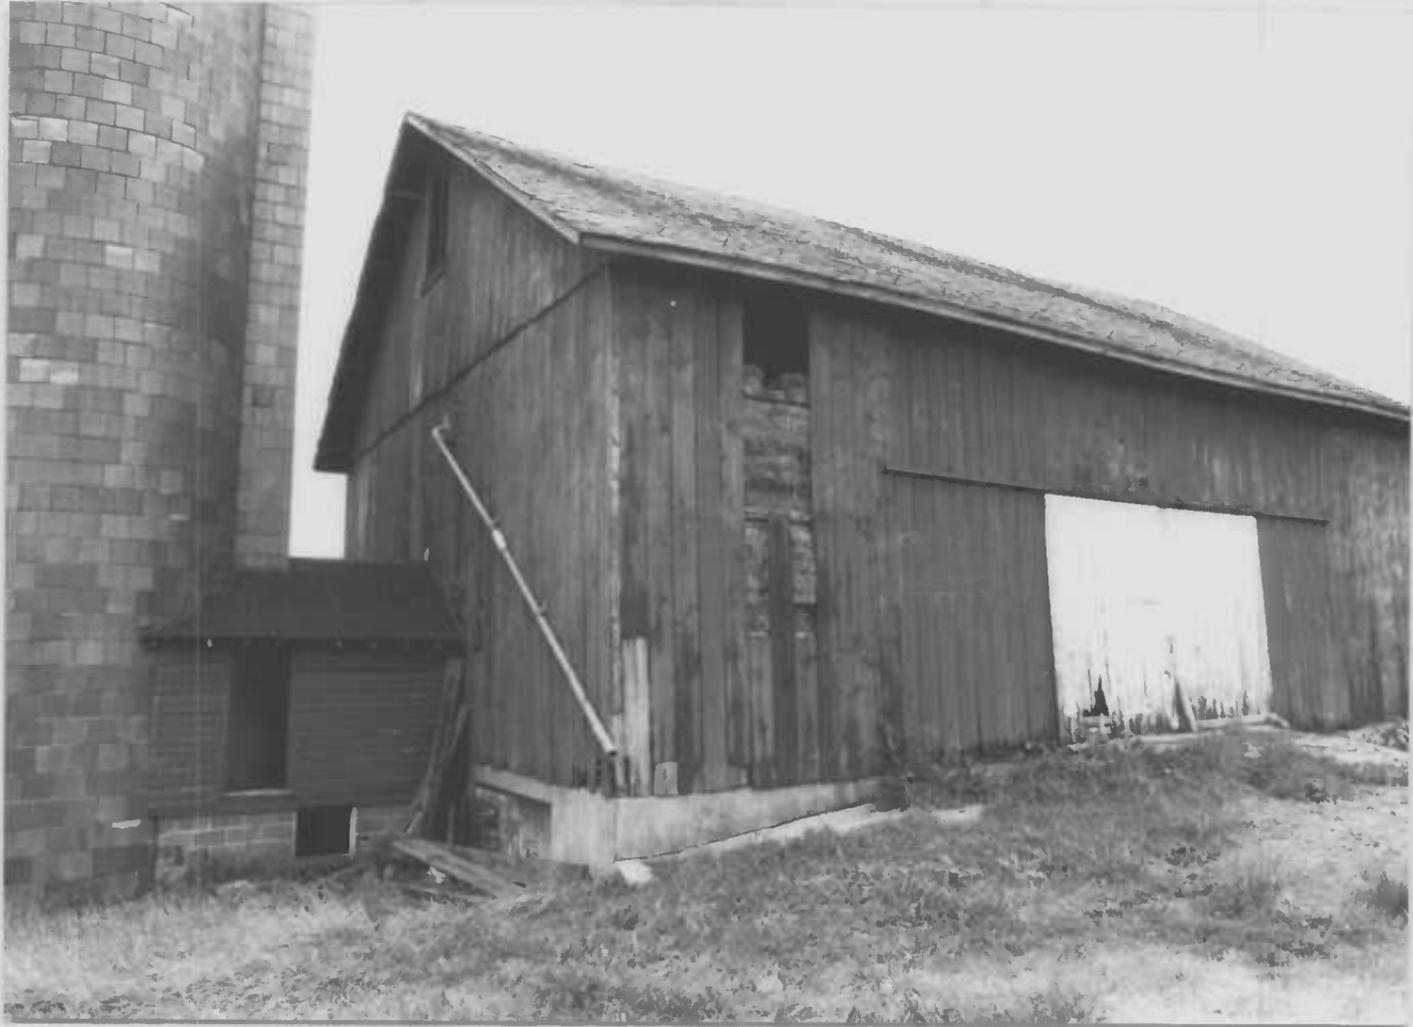
HA-1721

NW corner of Main Dairy Barn

The banked barn has evolved over time. It retains its slate roof. The original foundation of the approximately 45' x 62' barn is stone, although the stone is only visible at the SE and NE corners, as the remainder has been parged or covered with additions. The original mortar is fairly hard, tan in color, and there are a variety of aggregate sizes and colors. Portions of the exposed stonework have been repointed with a portland mortar. Some of the foot-wide, rough sawn, vertical siding has been replaced, such as on the west and north sides of the barn. The newer siding is circular sawn, while the older siding has rough, straight saw marks, as seen on the east side and the center of the north side. Almost all the nails are wire nails. Although some cut nails can be found.

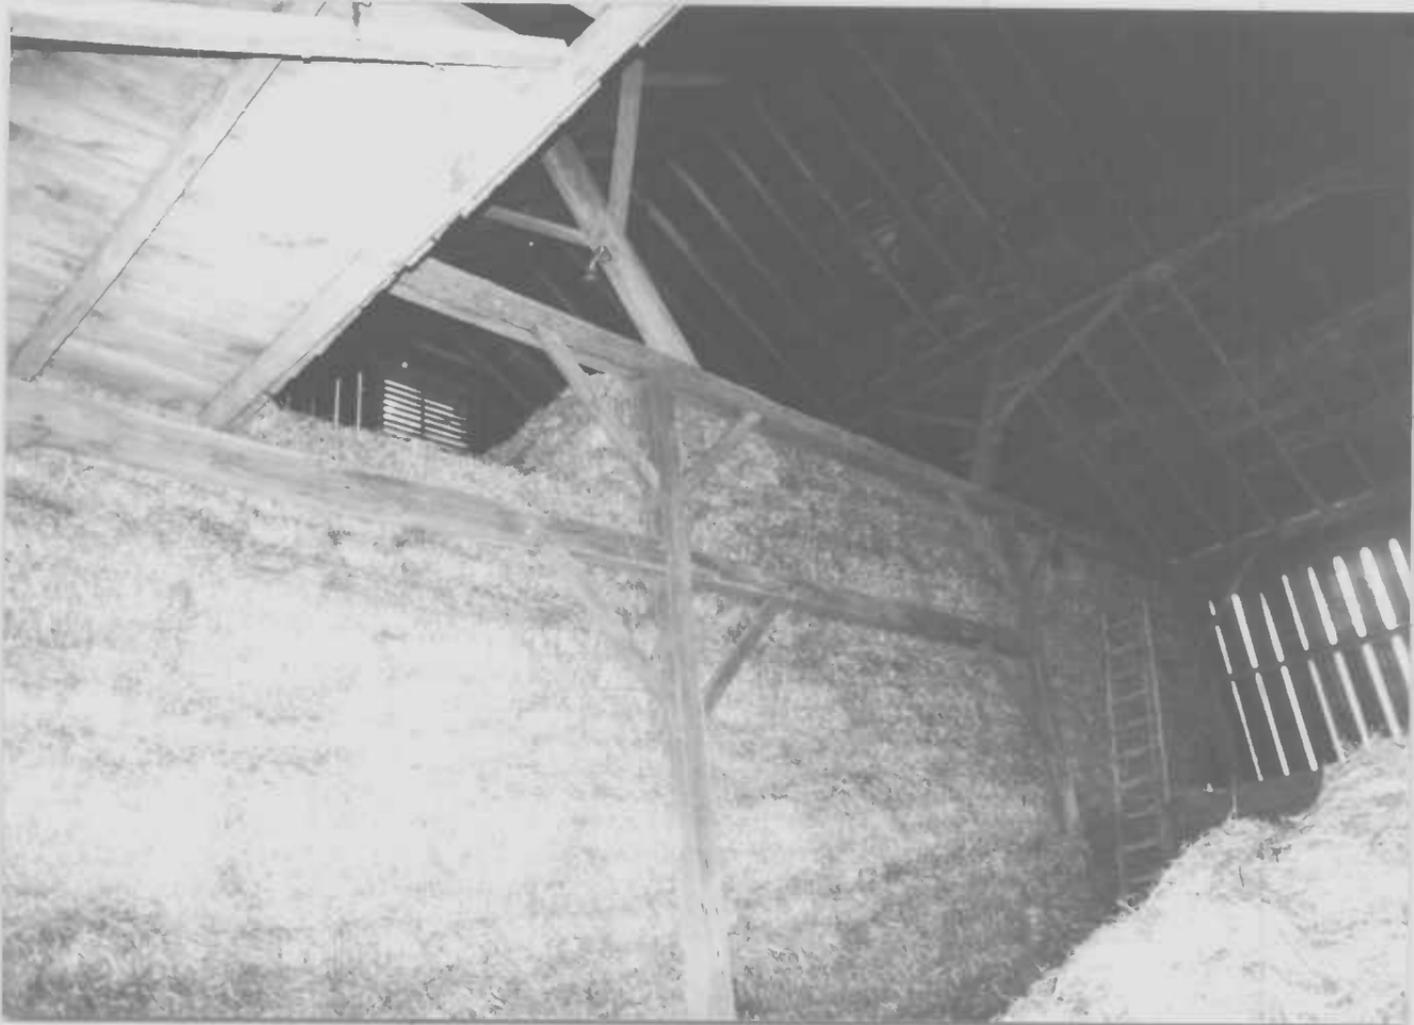
HA-1721

Main Dairy Barn

Looking toward NE corner
