MARYLAND HISTORICAL TRUST  
NR-ELIGIBILITY REVIEW FORM

Property Name: Harrison Farm #2 Inventory Number: T-1140

## **T-1140. Harrison Farm #2**

# Maryland Historical Trust Maryland Inventory of Historic Properties Form

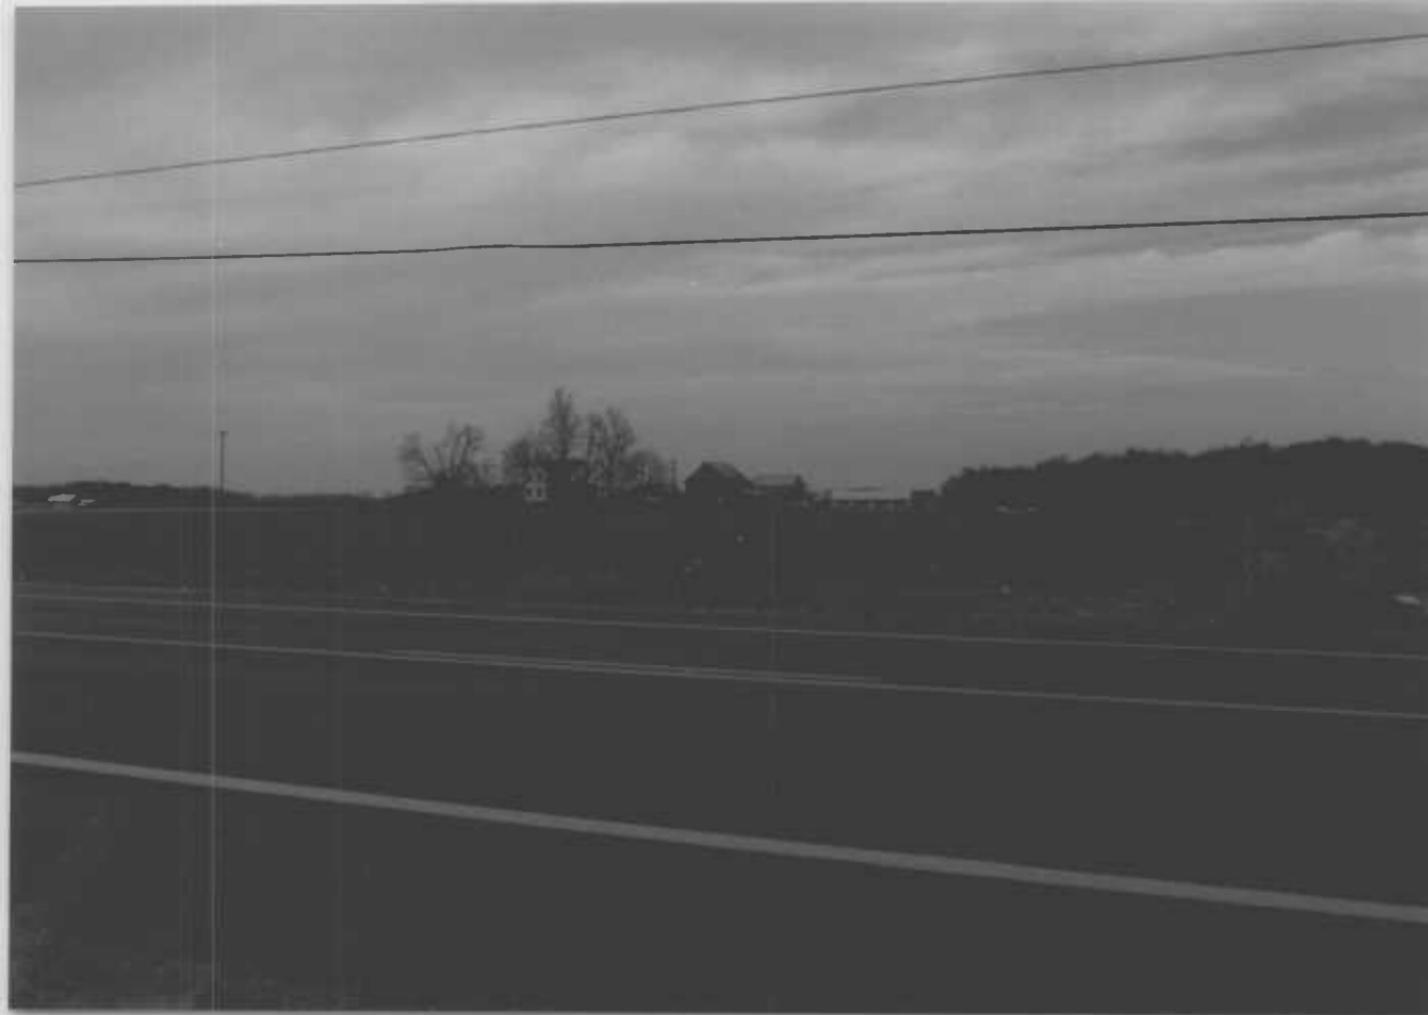
1/4

Farmstead, view  
to North

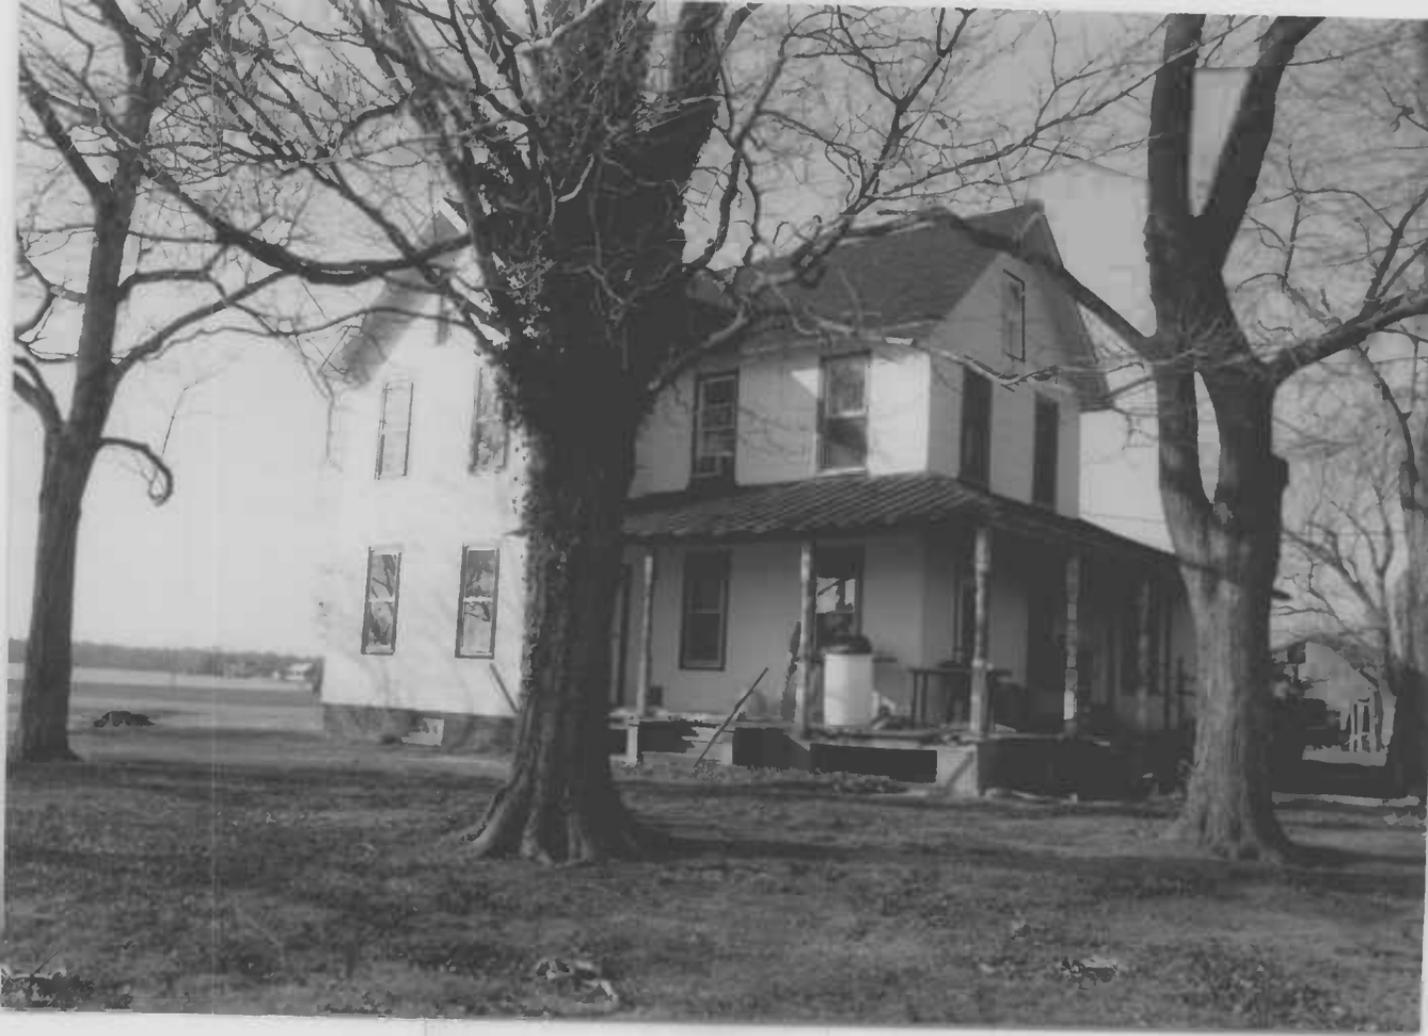
2/4

House, South and West  
elevations

The house is a 2½-story frame vernacular building constructed on a continuous brick foundation in a T-plan. The house has a wrap-around porch supported by turned wood posts and is partially enclosed; a metal hand pump is mounted on the porch's east side. There is a shed roof concrete block addition to the rear (north side). The house has two brick chimneys: one exterior and one interior. Characterized by irregular fenestration on all elevations, windows in the house include six-light casement windows and metal double hung sash (1/1 lights) windows. The house is clad by asbestos shingles and the roof is clad by composition shingles.

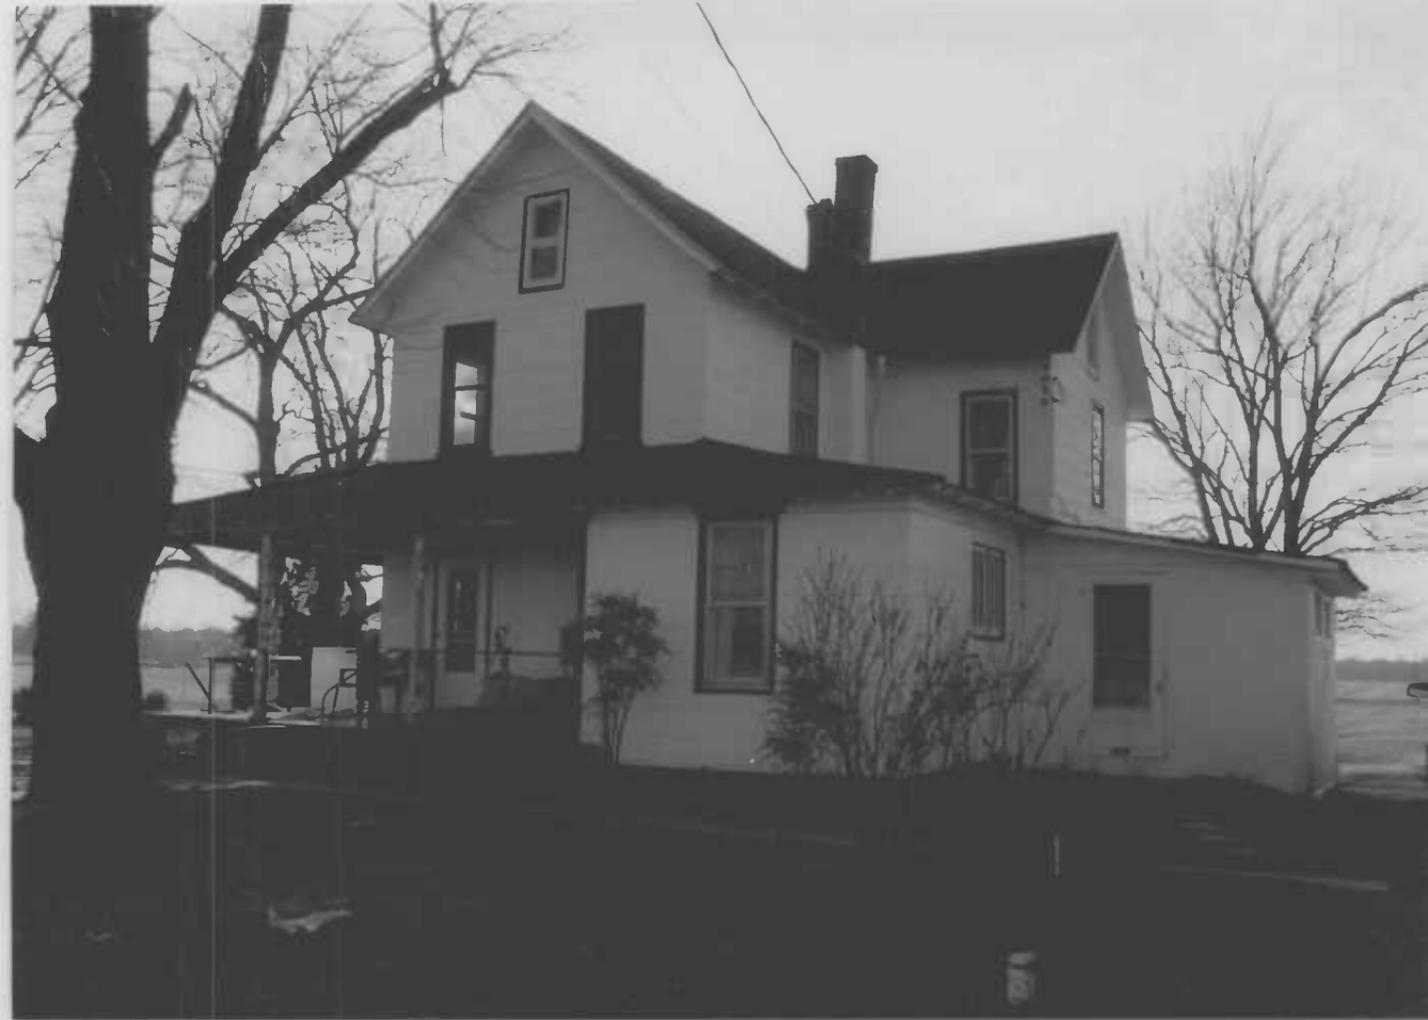
3/4

House, West and North  
elevations

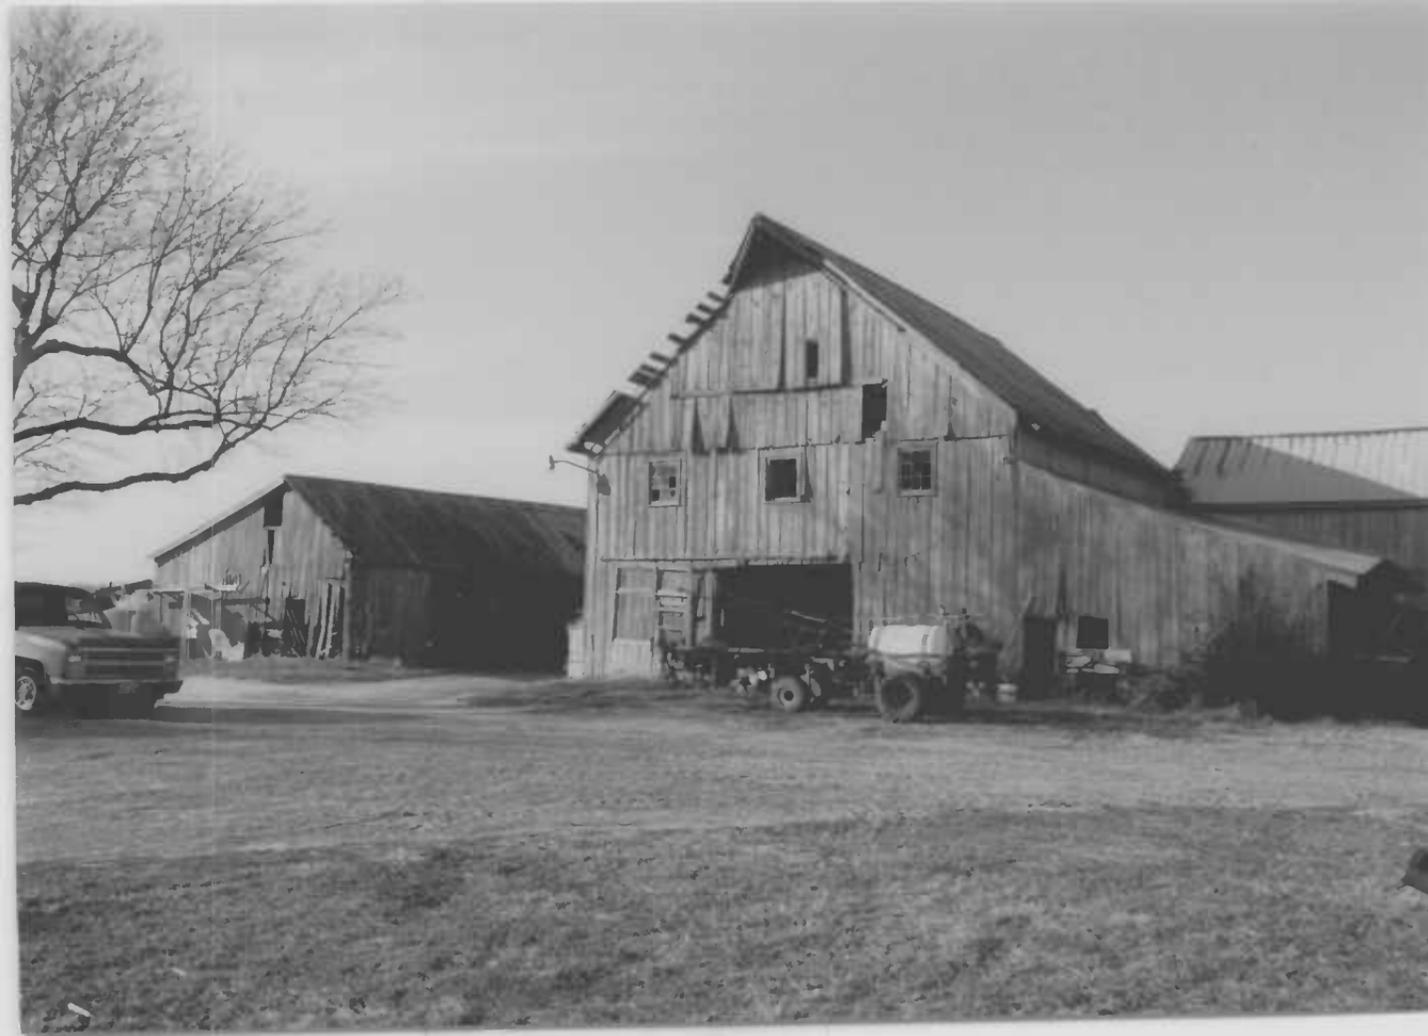
4/4

Agricultural Buildings, view  
to NW

The agricultural buildings are located north and east of the house and are separated from it by an unsurfaced drive. The barns are wood frame buildings. The southernmost barn is a gable end entry barn with a hay hood and a side (east) shed roof addition. The barn roof is clad by standing seam metal. The second barn is also a gable end entry barn with a standing seam metal roof and it is located immediately north of the first barn.

There is an open, side gabled garage/shed located north of the house and west of the barns. The shed is clad by vertical plank siding and its roof is clad by wood planks. On the eastern margin of the agricultural buildings, there is a concrete block (modern) storage building.
