CARR-1584

Wakefield Valley Rd., New Windsor Vicinity

Maryland Historical Trust
State Historic Sites Inventory Form

historic Bail-Repp Farm

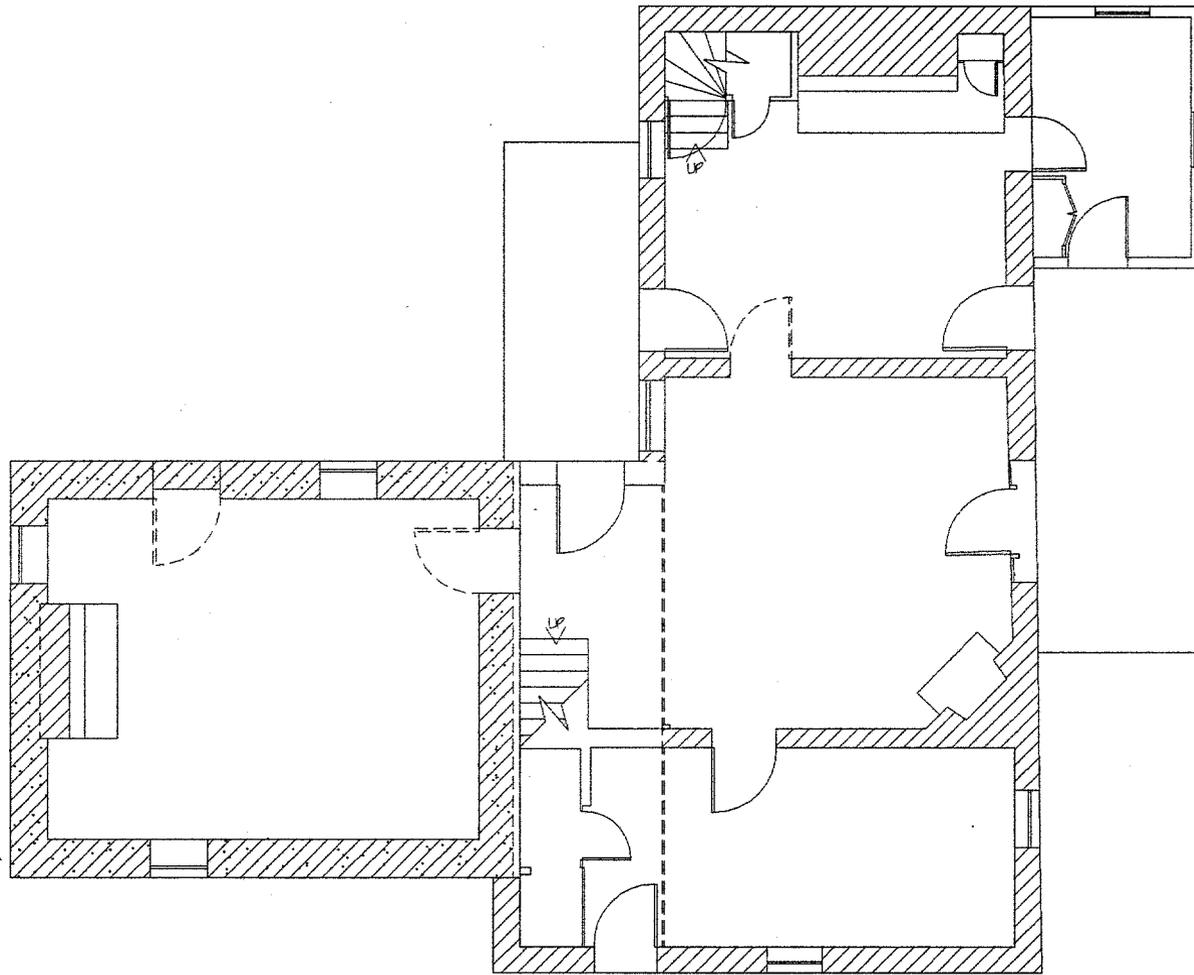
SECOND FLOOR PLAN
NOVEMBER 1997

The second story is laid out with a center passage with three rooms along the west side and one room in the stone section to the east. The landing at the north side of the passage has three winder stairs in the northwest corner leading up to the doorway to the north chamber. The window on the landing has a quirked Greek ovolo and bead on the window frame. The door to the northwest chamber has a typical architrave but it is narrower on the south side where it butts up against the landing of the attic stairs above. This door was nicely grained. Some of this graining has been exposed when the heat of the recent fire bubbled later paint. The Suffolk latch on this door is now gone. There are four steps up from the landing to the passage. The door on the west leading to the center chamber has an architrave with an ovolo and covetto back band and beaded interior edge. The typical six panel door here was also grained and it is hung on plain cast iron butt hinges. The lock is gone. The door to the east chamber is a typical six panel door hung on plain cast iron butt hinges. The norfolk latch is now gone from here. The door has quirked Greek ovolo and bead right on the frame. There is an enclosed two run stair to the attic with a landing on the north end. The stair has a beaded edge vertical board door hung on plain cast iron butt hinges. It has head-cut architrave with a beaded interior edge. The lock is gone.

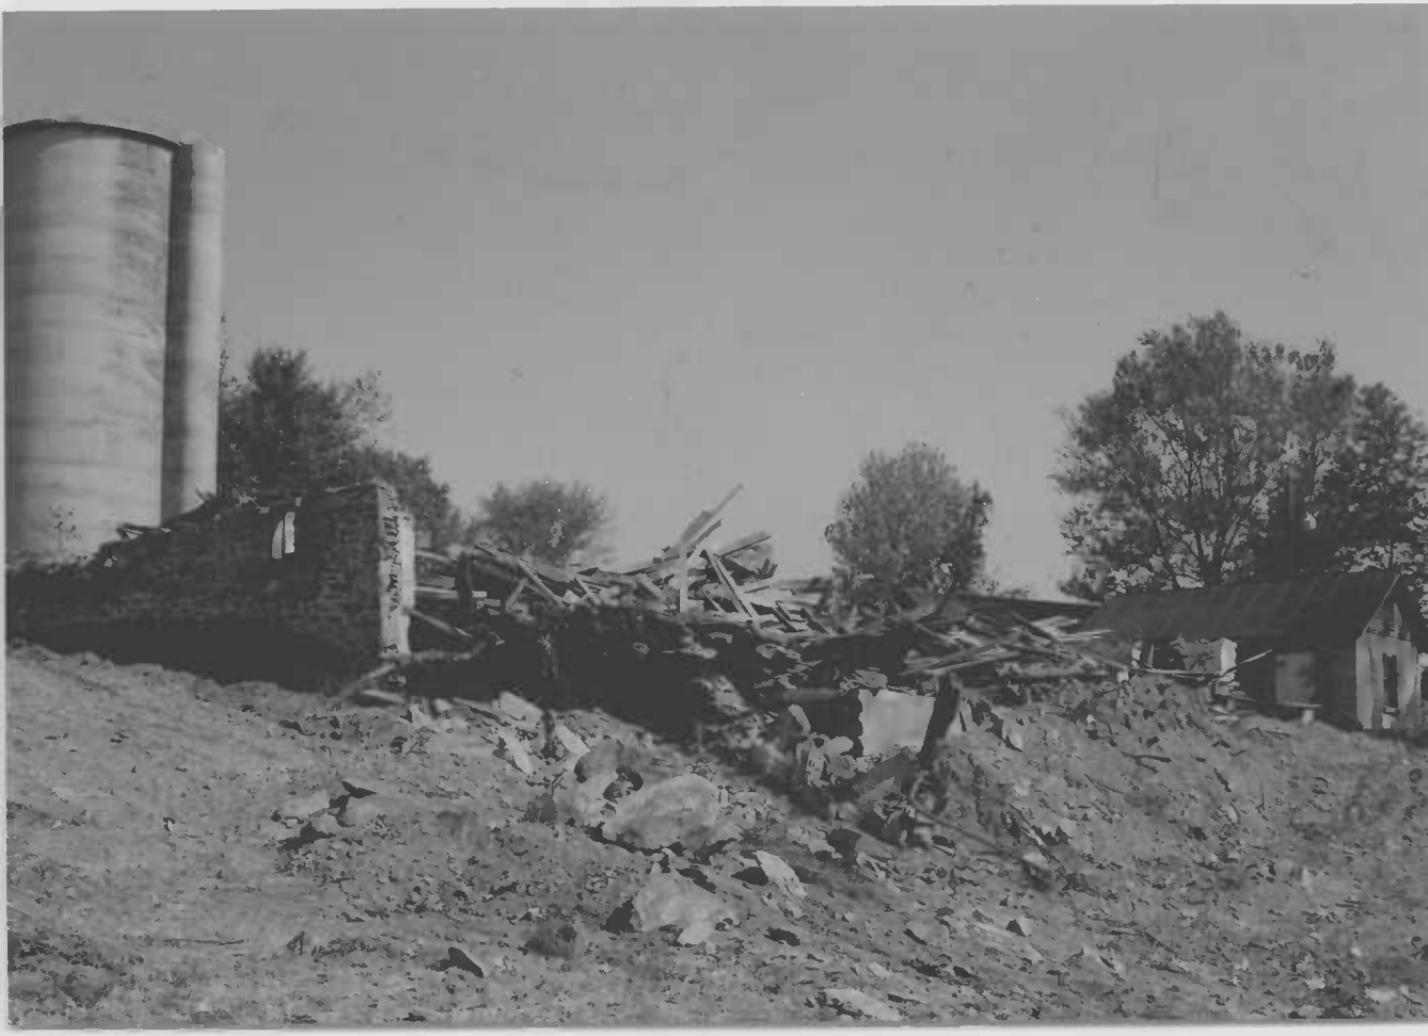
1 OF 16

Neg. Loc.: Maryland Historical Trust
Barr Run - W $\frac{1}{2}$, S. Elevations

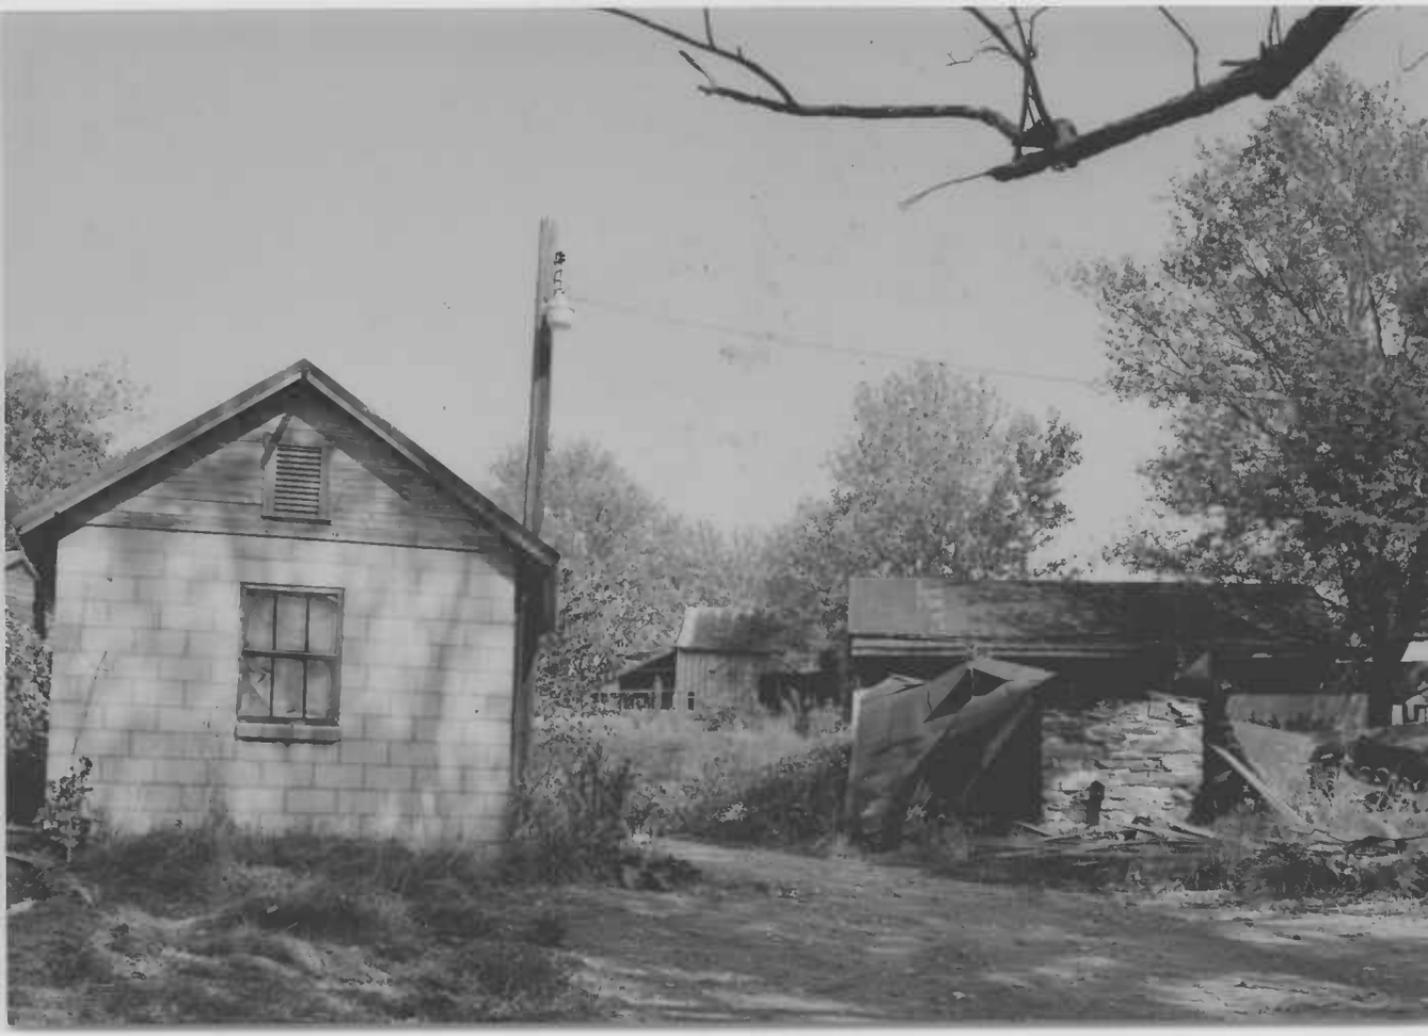
2 OF 16

Neg. loc.: Maryland Historical Trust
Site view from S. w/ Milk Room,
Poultry House & Barrack

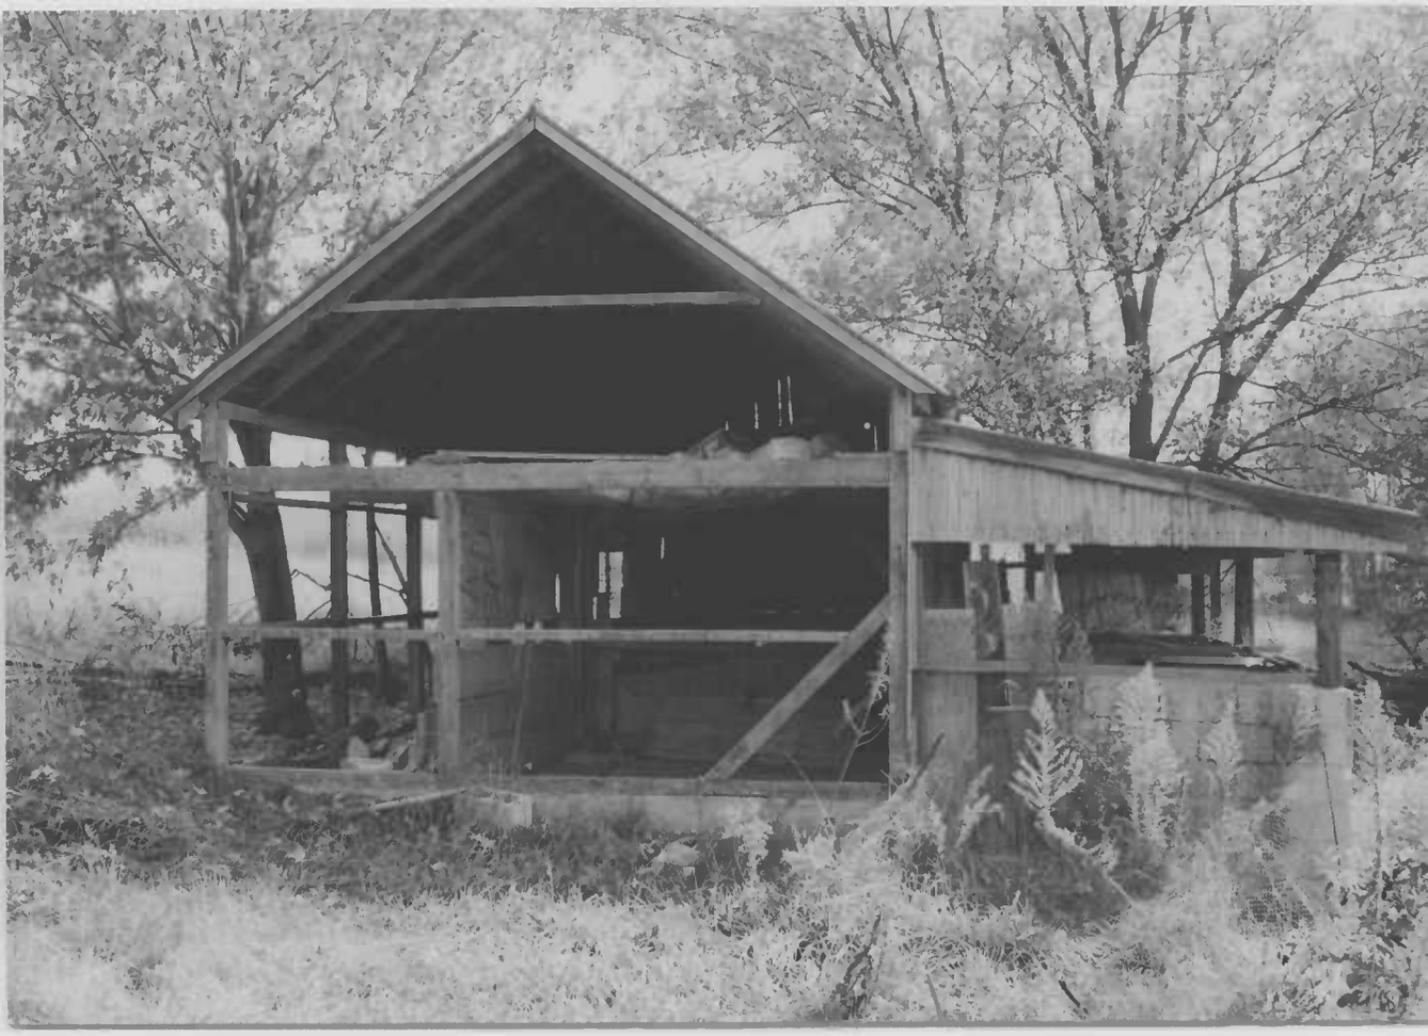
3 OF 16

Neg. Loc.: Maryland Historical Trust
Poultry House - W. Elevation

There's a poultry house approximately 30 feet west of the corn crib and 20 feet north of the 2 sheds. It has a concrete foundation; a circular sawn balloon frame and a gable roof of corrugated metal with an east/west ridge. It has vertical board siding, but this siding is now missing from the west and north elevations. The building was constructed in two stages. It had a door on the east elevation set to the north and an isle that ran along the north with 4 pens along the south. In the center is a wood stair that leads up from the north to the south to a loft. The roof framing is of 2 by 4 rafters mitered at the ridge. The east end has a sash sawn morticed and tenoned and pegged frame. The loft joists are toenailed with wire nails. The east end appears to have been a hog pen. There's a shed roof addition on the south with inverted V seam metal roofing. It covers CMU pens and there's no siding. There are treated round log posts on top of the CMU walls that support the roof of this shed.

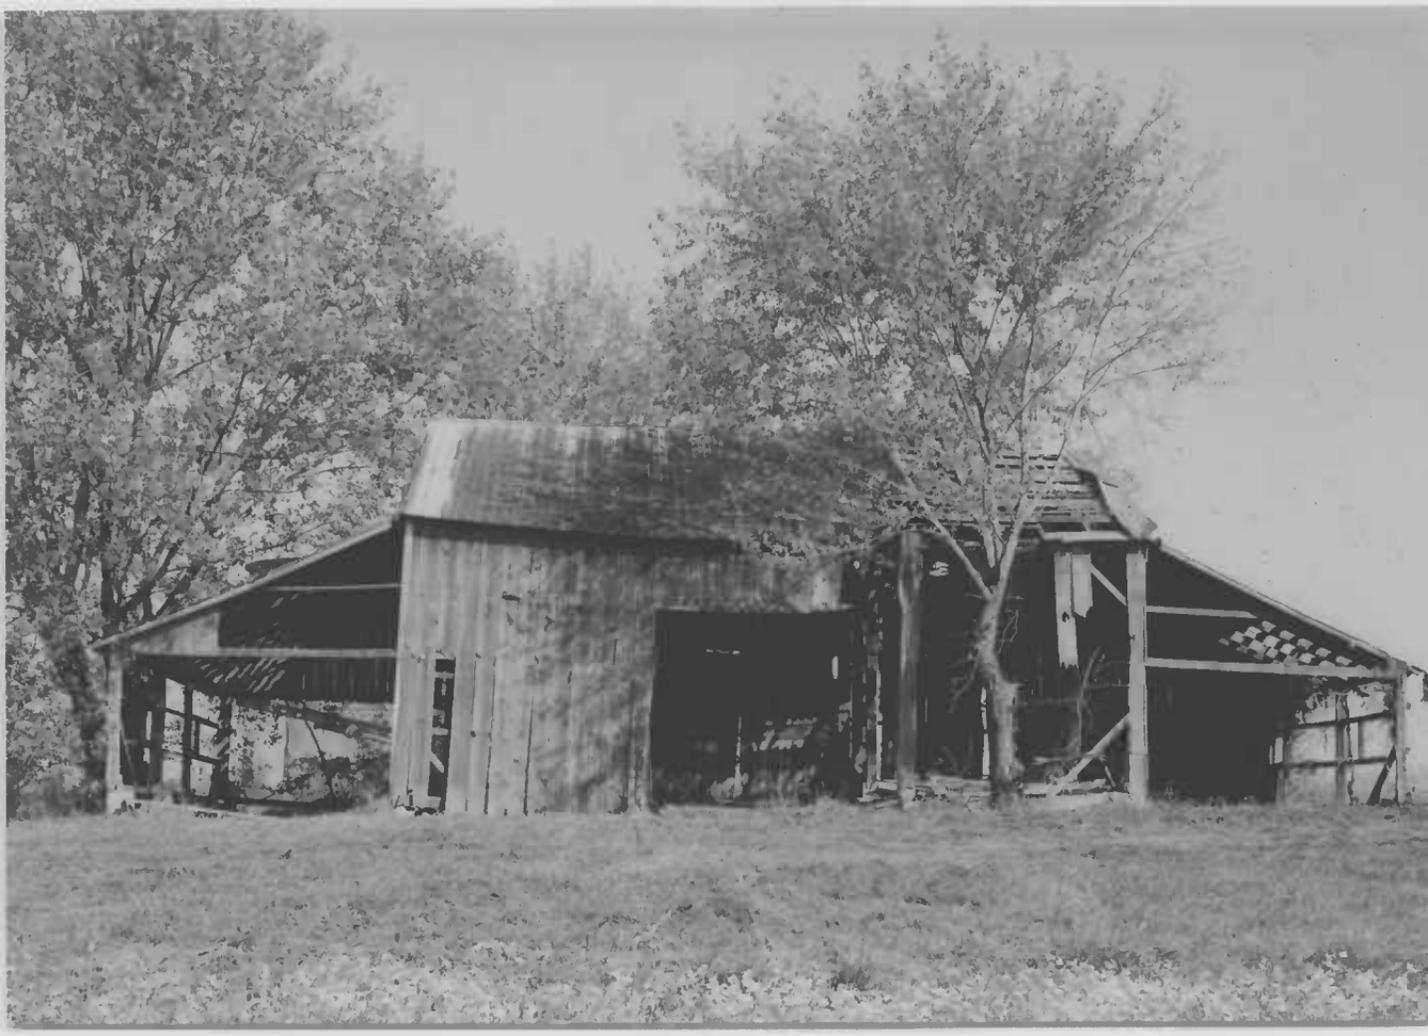
4 OF 16

Barrack - S. Elevation.

About 120 feet north of the poultry house/hog pen is a barrack. It is a three bay by one bay one story structure with vertical board as siding and a gable roof of both corrugated, metal and inverted V seam metal with an east/west ridge. There are shed roof wings on both the east and west ends. The building has a low stone foundation, while the sheds are set on concrete piers. It has vertical board siding. The south elevation had double wagon doors in the center bay. These still survive on the north elevation and are hung on rollers. The interior of the building has a center wagon floor with a mount to each side. It is built with simple bents of three posts with up and down braces. The bents are constructed of hewn reused

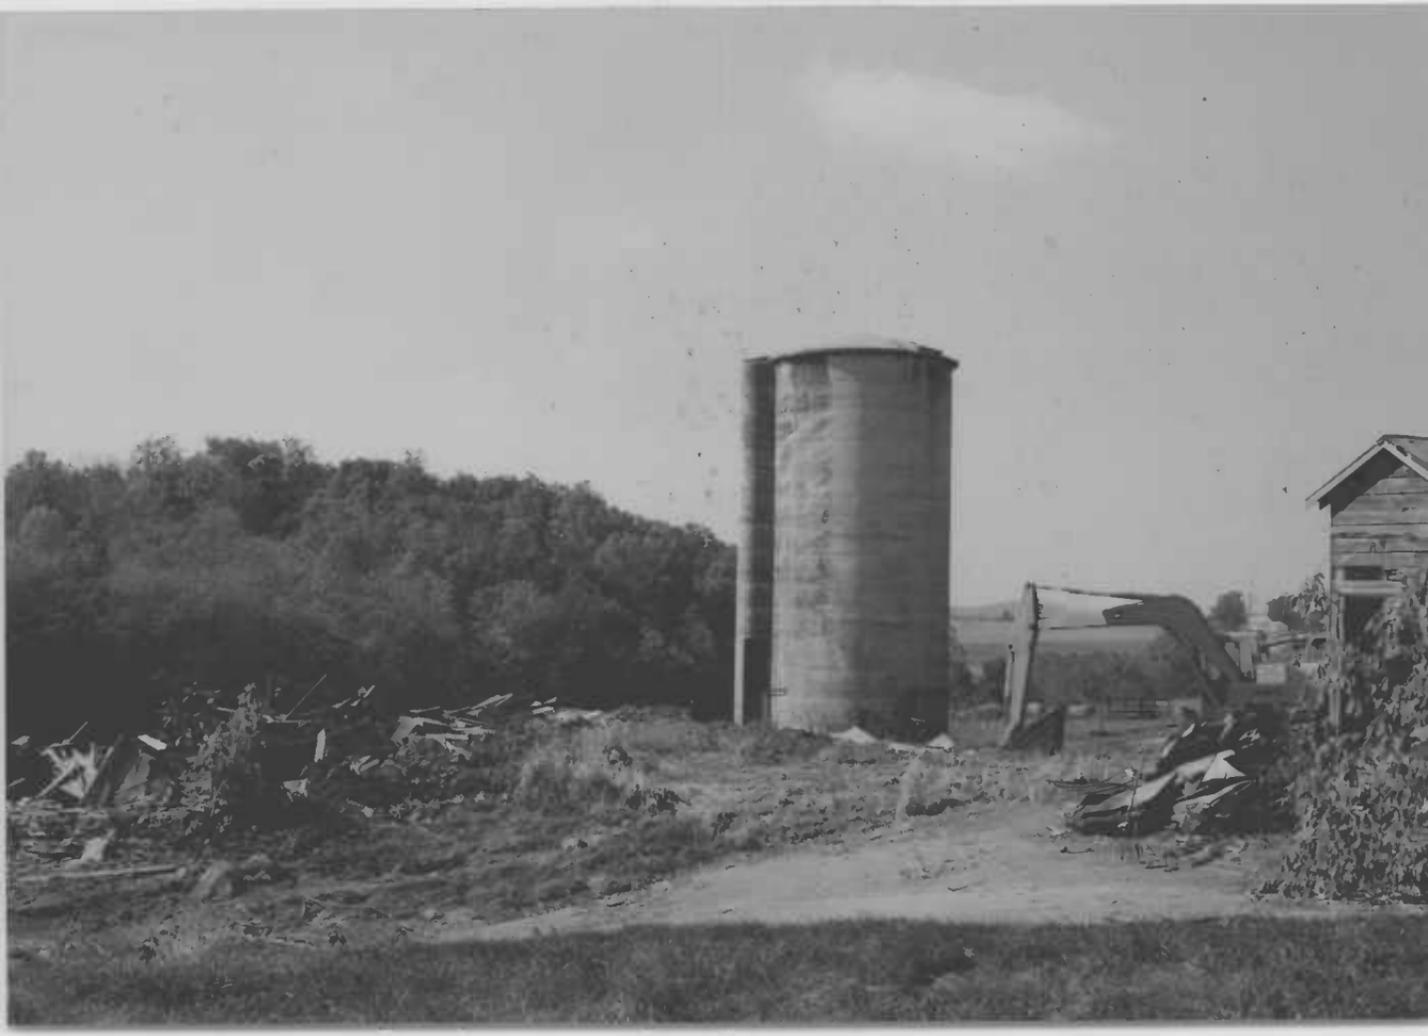
5 OF 16

Barn Ruins & Silo - VW West

The barn had recently been demolished when field work was done. The forebay faced south. There were stone walls on the east, west and north elevations of the lower story, and the upper story had beaded edge and center vertical board siding. The east elevation has two window openings; both with circular sawn jambs. The east wall has a sawn wood peg rail set into it and there is a circular sawn wood box near the southeast corner. The wall has a pocket for one summer beam that was set in the center. The west elevation has two window openings that are shorter than those inside. Each of these window openings had a 4-light sash. It appears that the south end of the west elevation had a door opening and that the stone wall continued to the south as a barnyard wall. It appears that all the stone work is too thin as though it was all built at once. There are remains of metal stanchions in the lower story. At the northwest corner of the barn the foundation has been extended to the north about 4 feet 1 1/2 inches, and the stone is not too thin to the original foundation, thus there are two north walls running parallel to each other with a gap between them of about 2 feet 4 inches. The original barn on this foundation was about 30 feet 7 1/2 inches wide, while the later barn on the expanded foundation was about 34 feet 9 inches wide. There is a concrete silo on the north side to the west of the barn foundation. About 4 feet east of the barn is a CMU milk house with a gable roof of standing seam metal that has a north/south ridge. The south elevation has a 3/3 metal sash and has German siding in the gable end with a wood louver vent. The east elevation has a beaded edge in center vertical board door on machine made strap hinges in the south bay. There are three 3/3 sash to the north of this door. The north elevation is identical to the south elevation. The west elevation has a door like that on the east elevation in the south bay but has no windows. The interior is divided into two rooms by a wall running east/west and all of the walls are plastered.

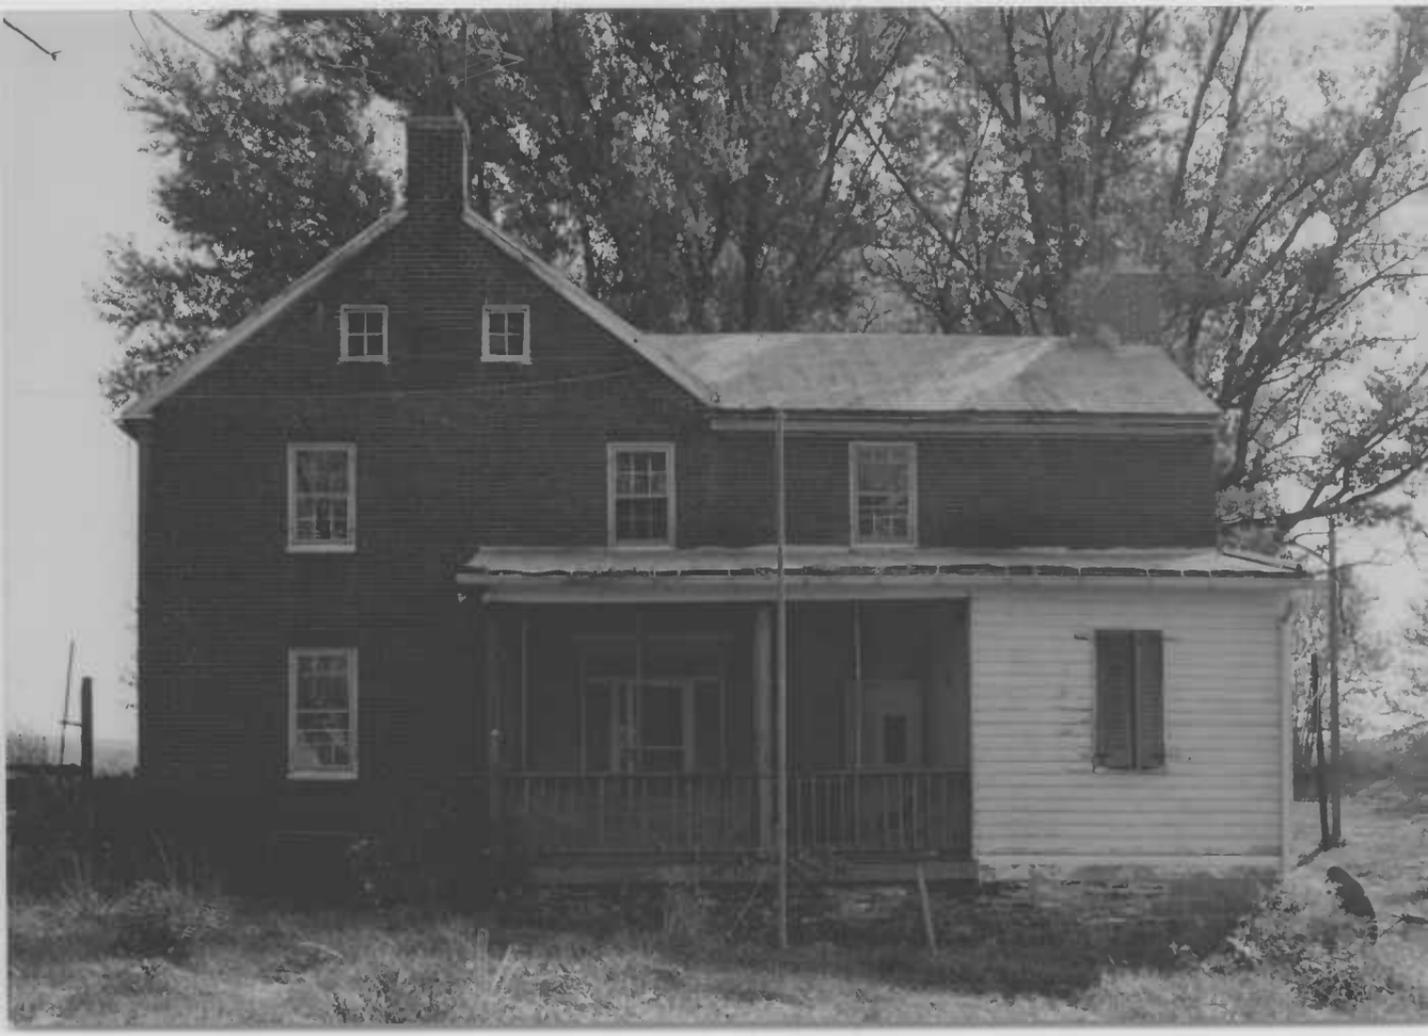
6 OF 18

Neg. Loc: Maryland Historical Trust
House - W. Elevation

The west elevation has a rubble stone foundation that stair steps down to the south. The brick wall above is of 4 to 1 common bond. On the first story, the north bay has a typical 9/6 sash. The north center bay opening has been widened and now has a six paneled door; two center panels of which are now glazed. There is a six light transom and side lights of three lights above one panel. The panels have ogee and bevel molds. The bricks here are penciled and to this work even covers the portland repointing. The south center bay has a six panel door with the two center panels now glazed. There are ghosts of a Suffolk latch with lima bean cusps. The opening has a wood sill and a splayed brick jack arch. The south bay has an enclosed porch with weather boards. There is a 9/6 sash covered with blinds on

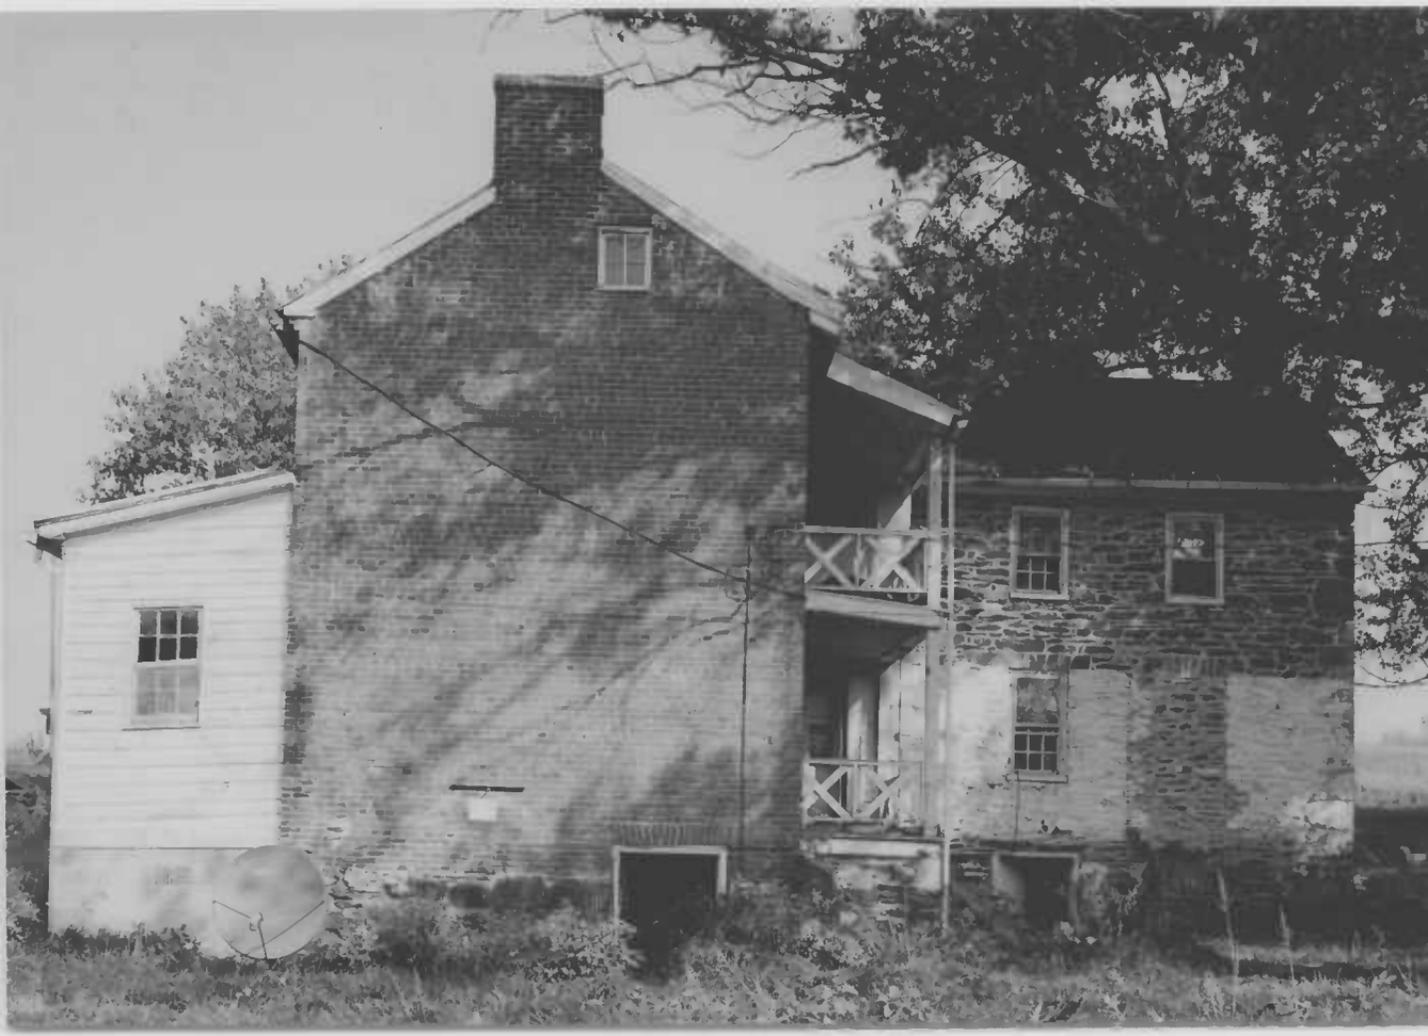
7 OF 16

Neg. Loc.: Maryland Historical Trust
House - S. Elevation.

The south elevation of the brick section has a beaded edge vertical board door set east of center in the foundation. The door has a mortised and tenoned and pegged frame. The wall above is primarily 4 to 1 common bond brick. To the west, below the first floor level is a slightly protruding U shaped stone with brick and portland cement infill around it. The stone is set in a square opening in the brick wall and appears to be a stone sink. The south end of the enclosed porch has a 6/6 sash. There are no openings on the first and second stories of the brick section. The gable end has an interior brick chimney in the center with a 4-light sash set to the east. There are tapered rig boards at the eaves.

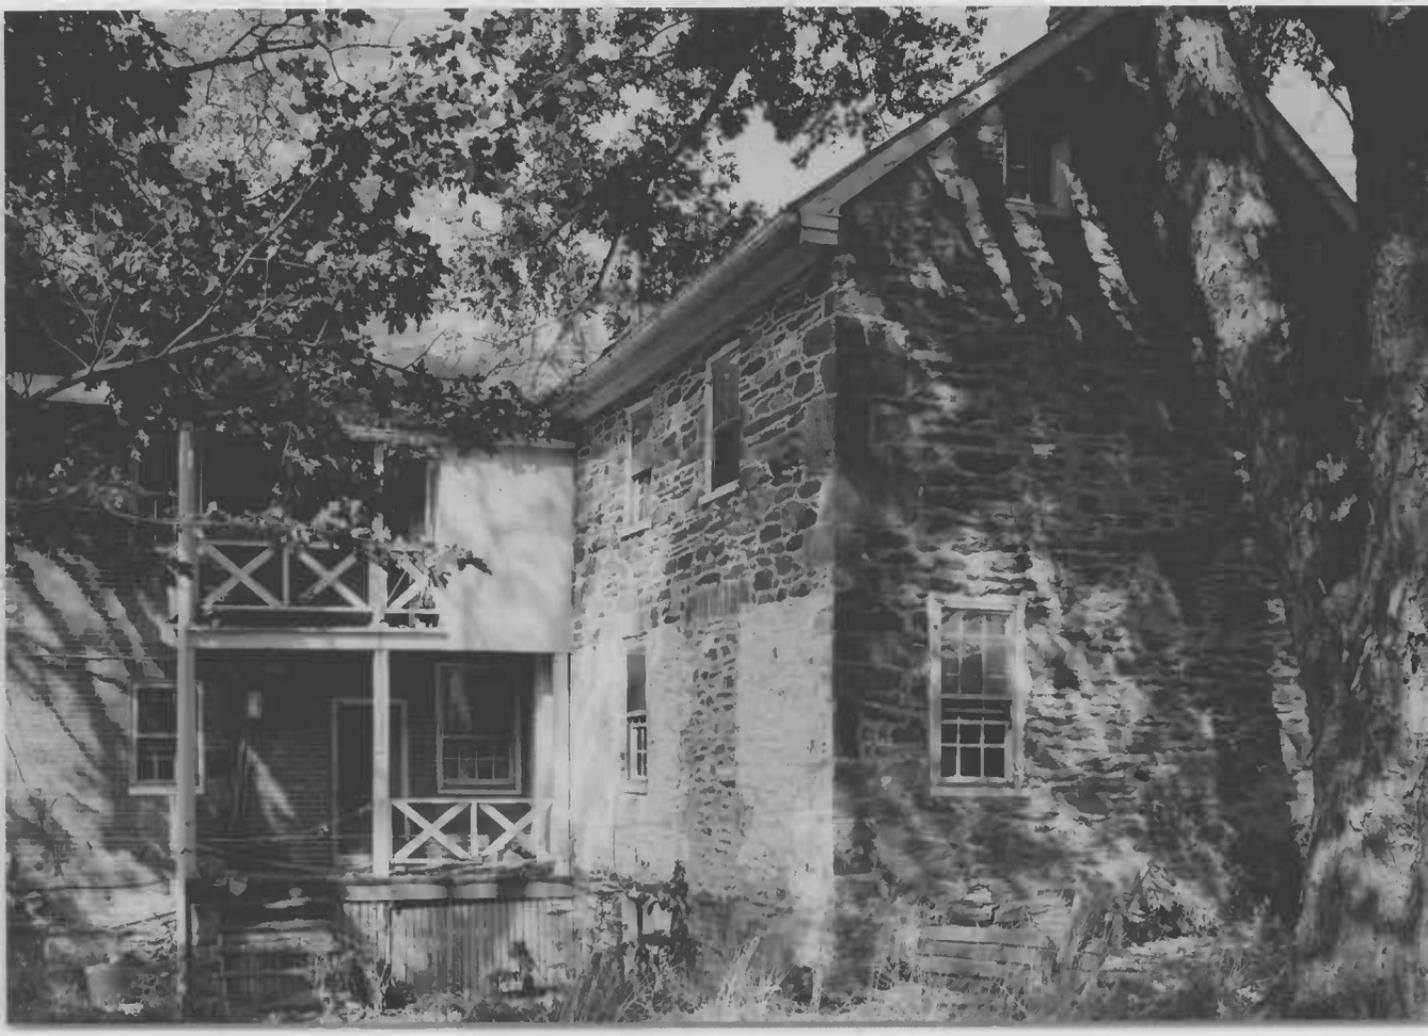
8 OF 16

House - E. Elevation

The east elevation of the brick ell is three bays and the walls are primarily 4 to 1 common bond brick. On the first story, the south bay has a typical 6/6 sash. The center bay has a six panel door that has now been cut to create a Dutch door. The doorway has a stone sill and a splayed brick jack arch. The north bay has a 12/8 double hung sash with a splayed brick jack arch that is not as wide as the current opening indicating the window has been widened. On the second story, the south bay has a typical 6/6 sash. The center bay has a six panel door hung on cast iron butt hinges. The north bay is enclosed with V groove vertical board siding. The south elevation of this enclosure has a 3-light casement window. There is a two story porch on this elevation. The north end of the porch butts the stone section and the south end is in the center of the south bay. The porch has square posts with cross buck balusters in the railing and has a shed roof that continues the pitch of the ell roof. The porch soffit has boards nailed to the bottom sides of the rafters. There is a wood box cornice.

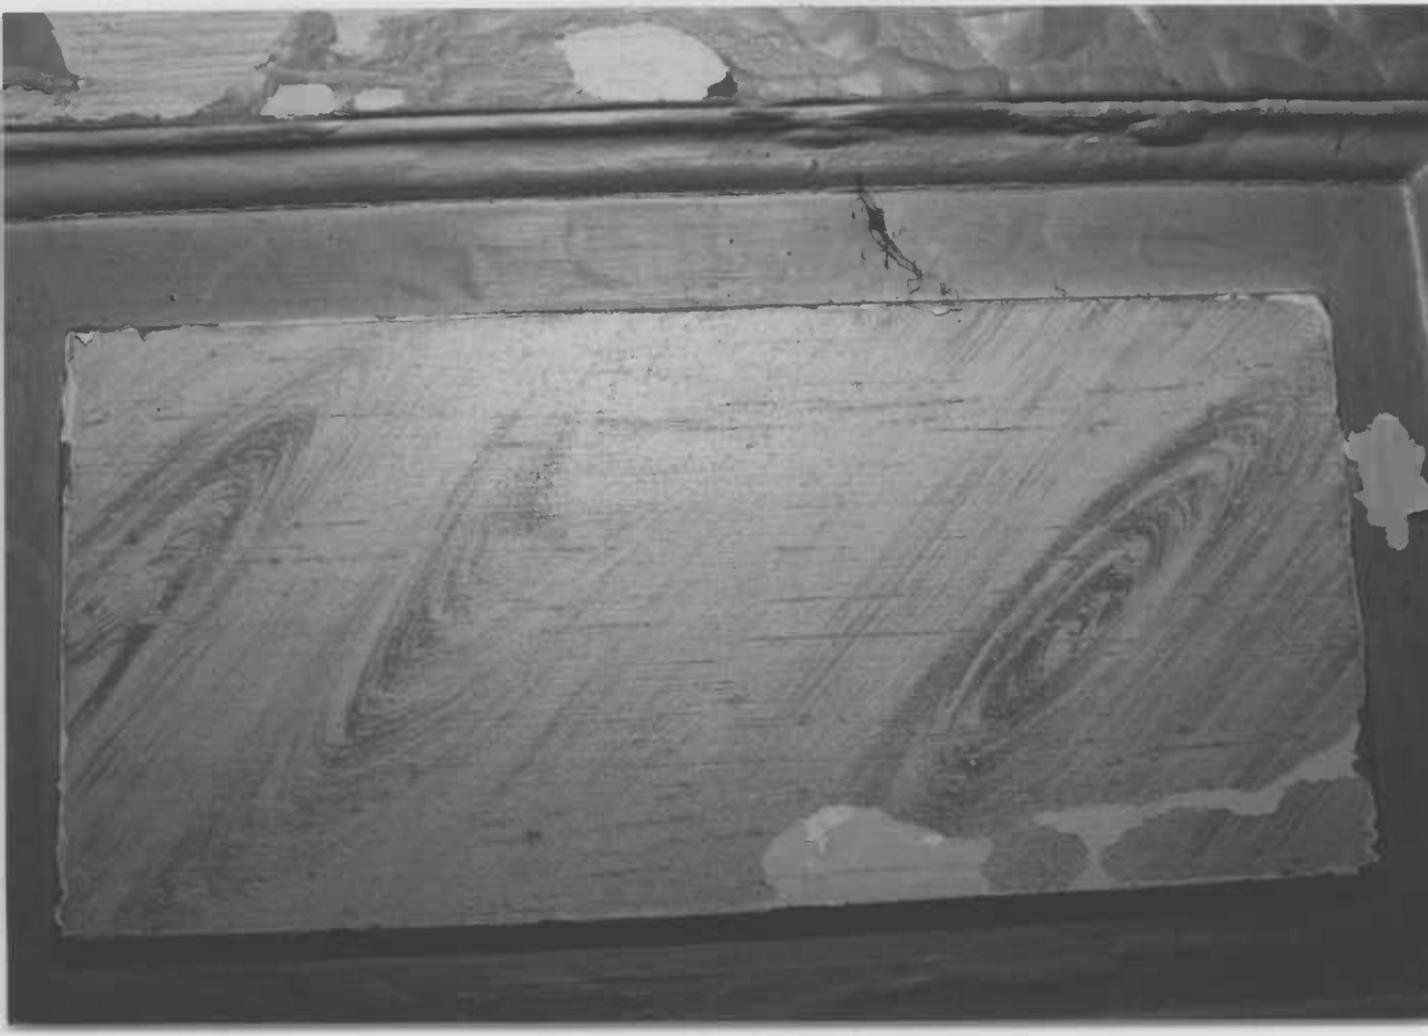
90F16

N. Chamber door garning

The north chamber has a random width floor that runs east/west. The windows have a quirked Greek ovolo and bead on the window frames that is not exactly like the stone section, but is very similar. The door has the typical architrave. The doorway on the south elevation of this room has a plain mitered architrave with a beaded interior edge. The door has four panels. It is hung on stamped plate butt hinges and the lock is gone. The center chamber is the same floor as the north chamber. There is quirked ovolo and covetto on the window frames and on the east door back band. The north door architrave is identical to that on the north side of this doorway.

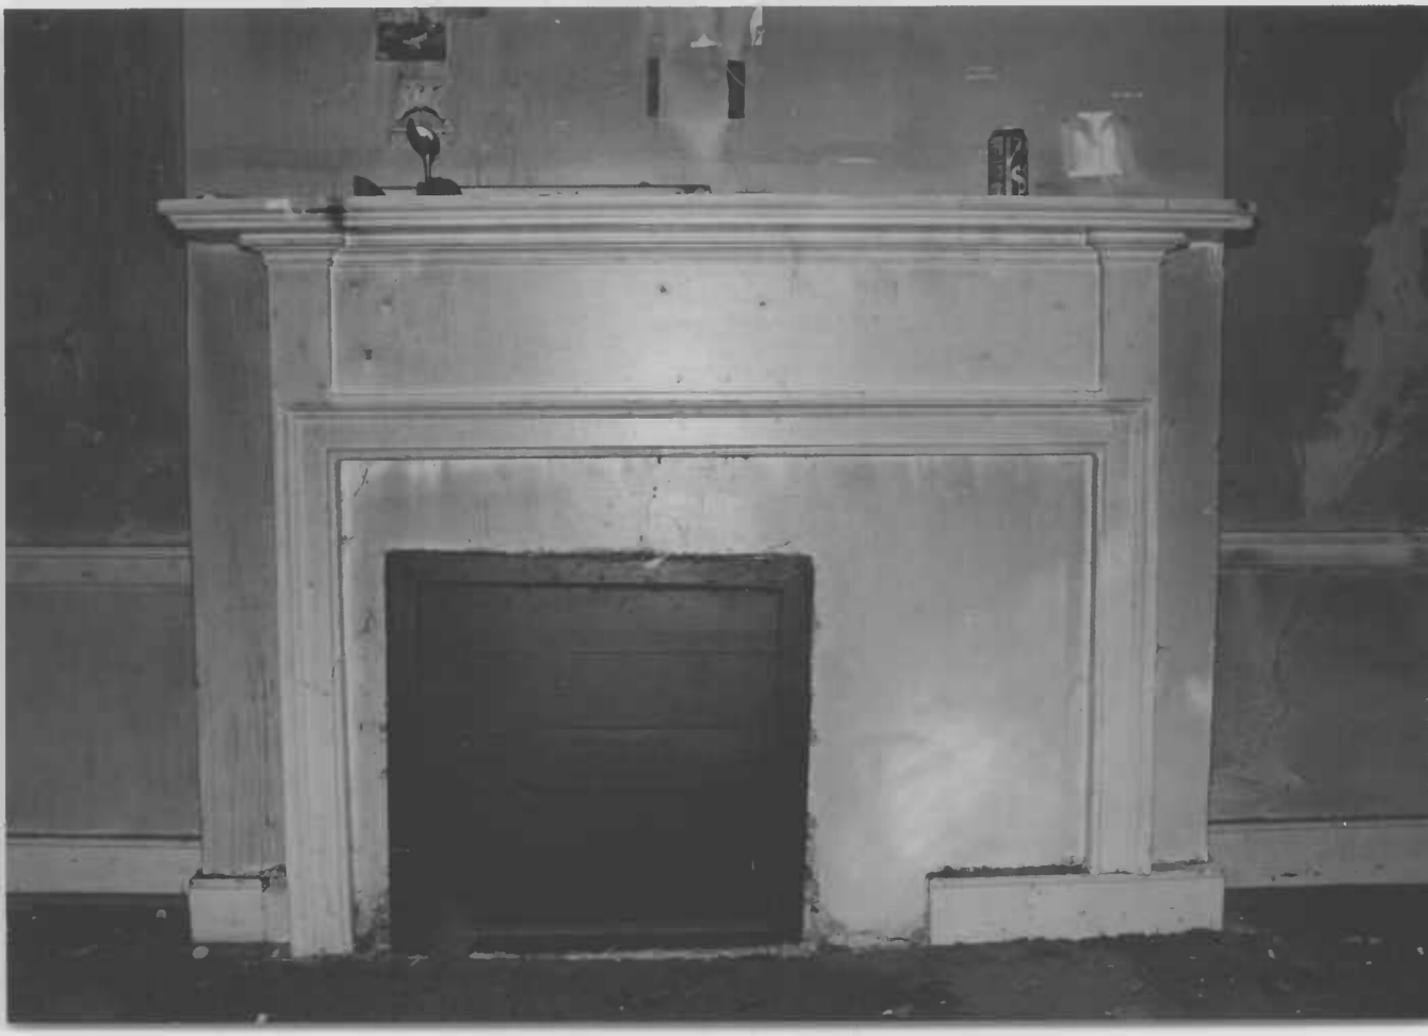
10 OF 16

Neg. Loc.: Maryland Historical Trust
E. Chamber Mantel

The east chamber has random width floor that runs east/west. There is chair rail in this room. The windows have quirked Greek ovolo and bead on the edge of the frames, and the door does too. There is a fireplace centered on the east elevation. It has a wood mantel with a back band the same as the rest of the room. The freeze has one sunk flat panel and the bed mold has a Greek covetto and bead. The edge of the mantel shelf is molded with a quirked Greek ovolo and bead. The fireplace is now closed off. The mantel appears to be moved from elsewhere, perhaps from the room below, as it is set on top of the plaster and there is a gap on the north side between the baseboard and the mantel. On the south side, the baseboard stops short of the opening and the mantel sits awkwardly on top of the baseboard. The south

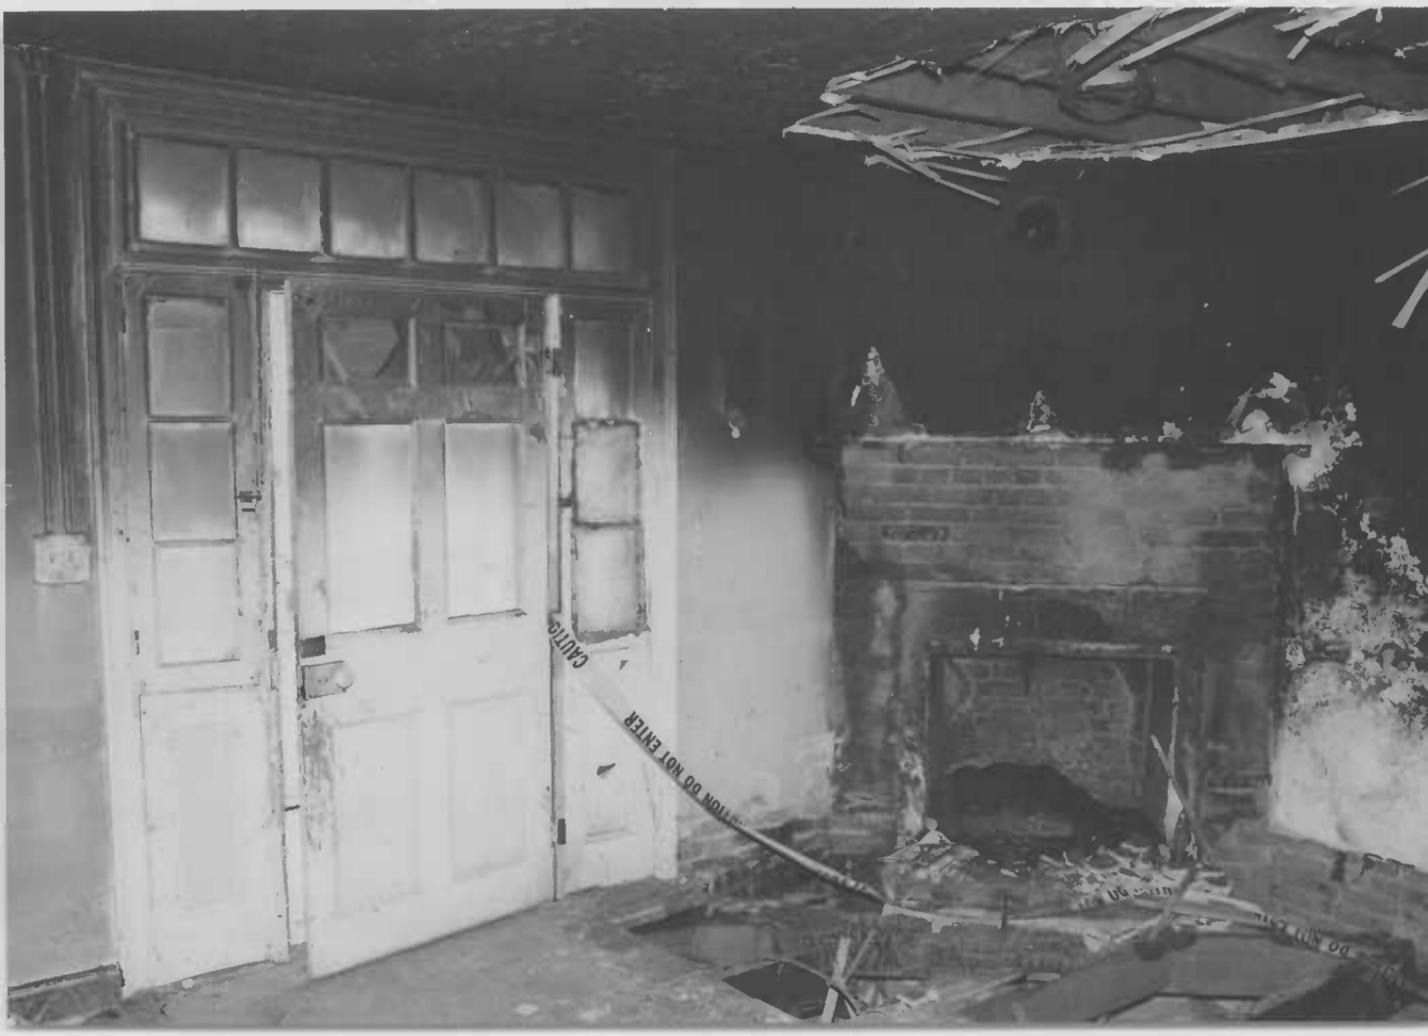
11 OF 16

Center Rm - VW-NW Elevations

The center room has a two run stair on the east wall with a landing at the north end. The south end of the stairway has been rebuilt and has oak treads; stair brackets that are wire nailed; turned tapered balusters and newel posts and a molded hand rail. These features appear to postdate World War II. The stairs to the north appear to have pine treads and they are considerably more worn. The stringer on the east side of the stairway is all of one piece. It appears that the stairway was originally in a passage that was divided from the center room, but the wall must have been removed and has been replaced by two large brackets. The self elevation of what must have originally been the passage has a six panel door with an architrave that has quirked Greek ovolo and bead back band. This door was grained at one time with darker margins on the panels. It has a cast iron rim lock with a mineral knob and the lock is marked "PAT'D DEC.14,1842 PAT'D FEB.15,1866". The strike plate is marked "PAT'D FEB.21,1861or7?" This is not the original lock, as there is a ghost of a larger rim lock on the east side of the door. The east wall is at least partially hollow and may be a frame wall set against the stone wall. The north wall where the passage was is now closed of with horizontal

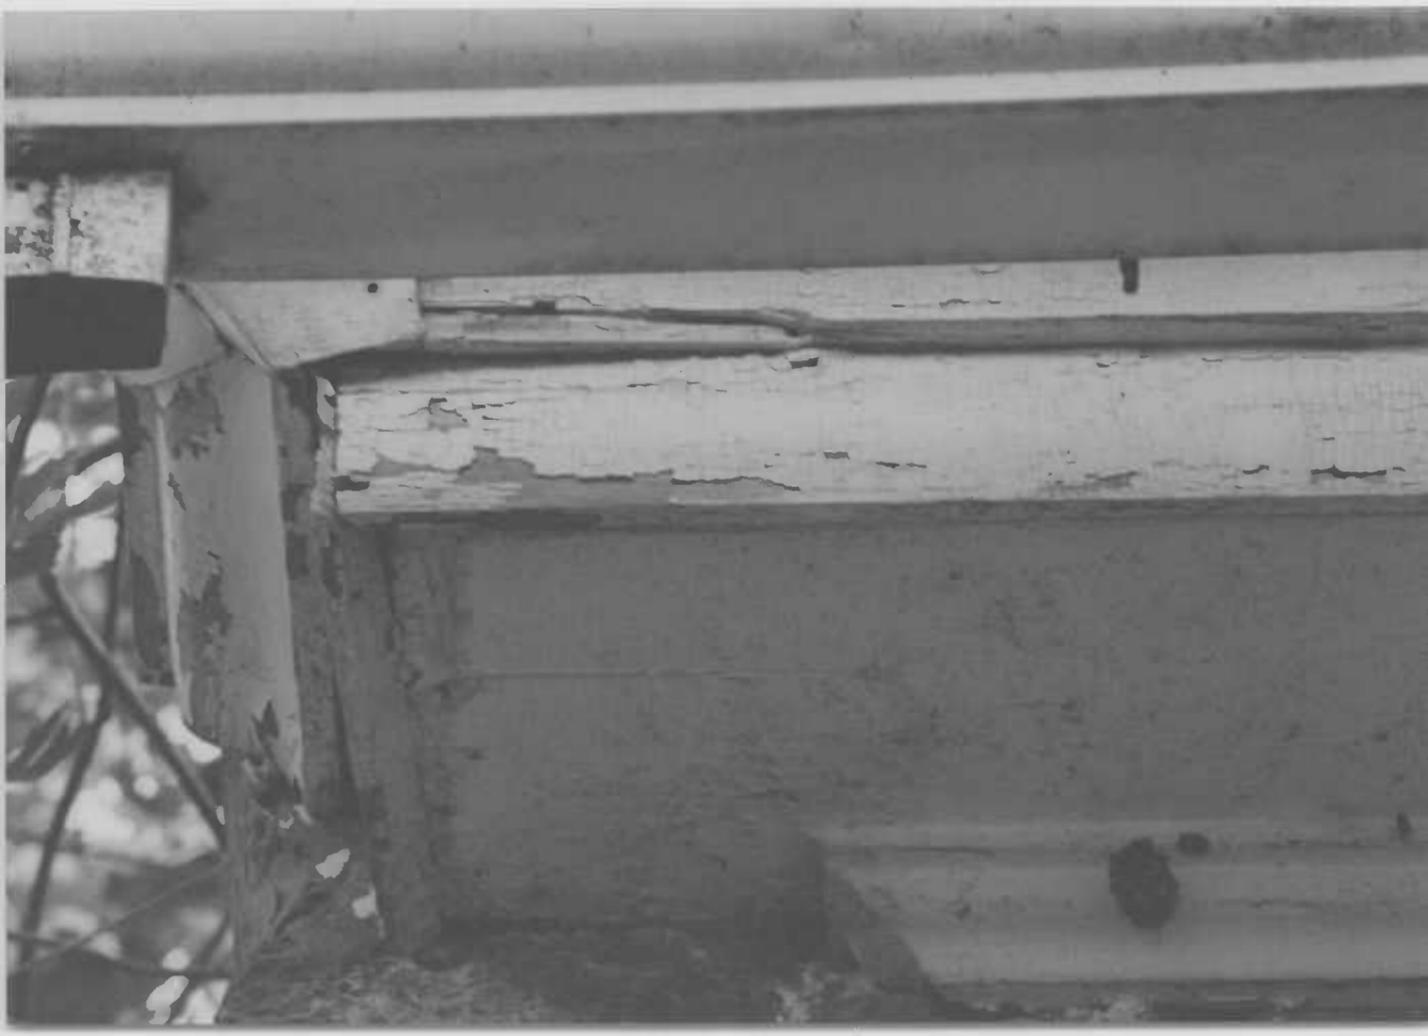
12 OF 16

House: Cornice - NE Corner
