CARR-1584

Wakefield Valley Rd., New Windsor Vicinity

Maryland Historical Trust
State Historic Sites Inventory Form

historic Bail-Repp Farm

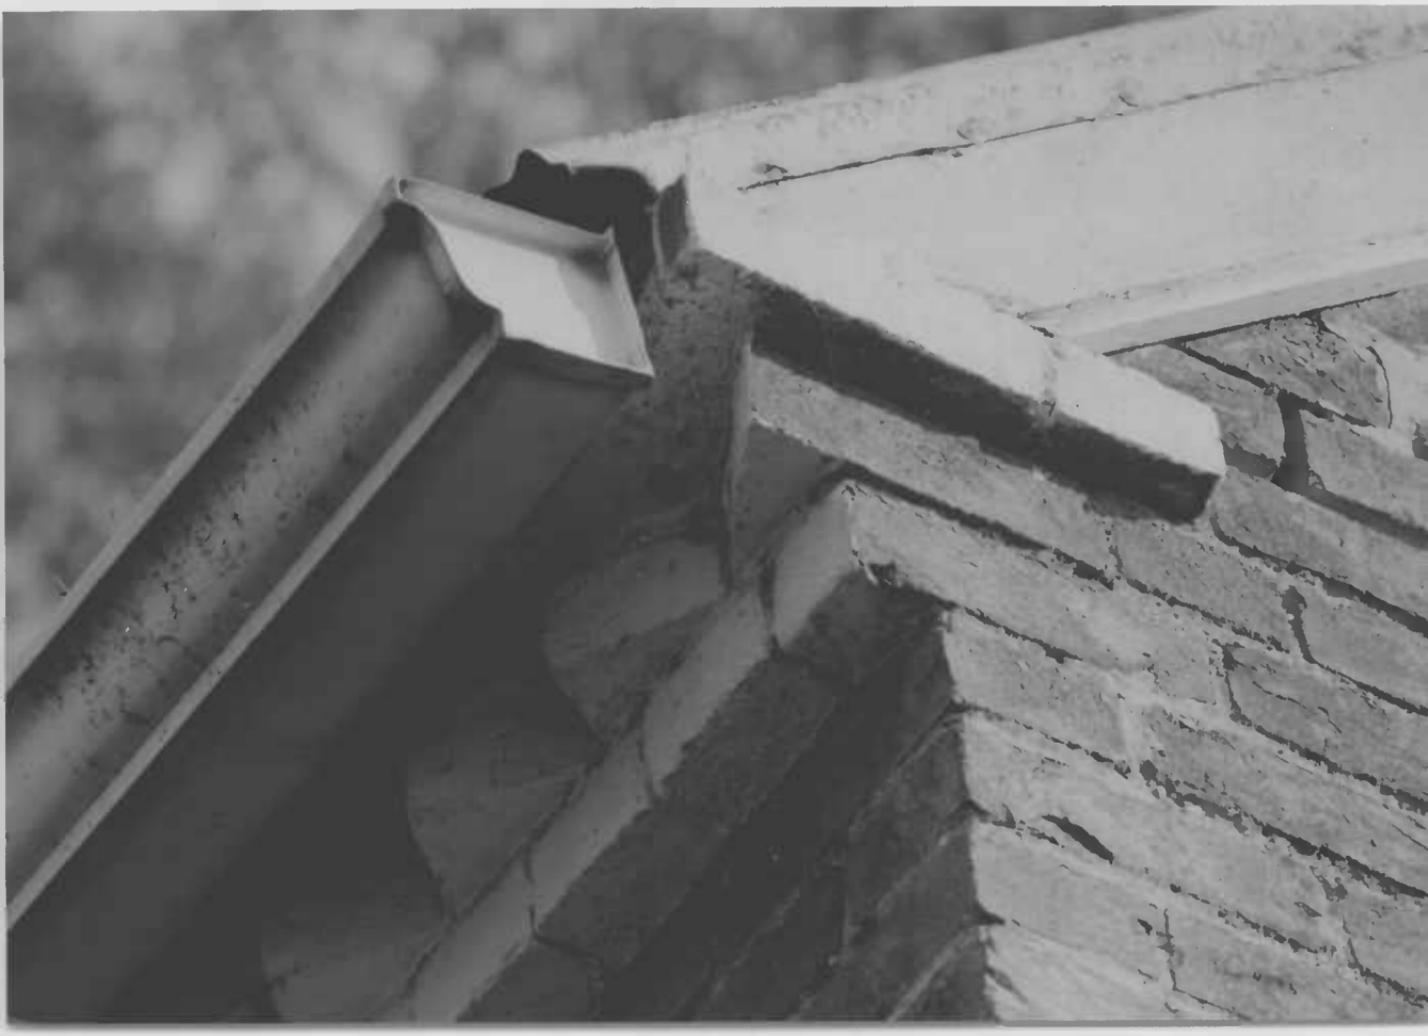
13 OF 16

Neg. Loc.: Maryland Historical Trust
House - Cornice - NW Corner

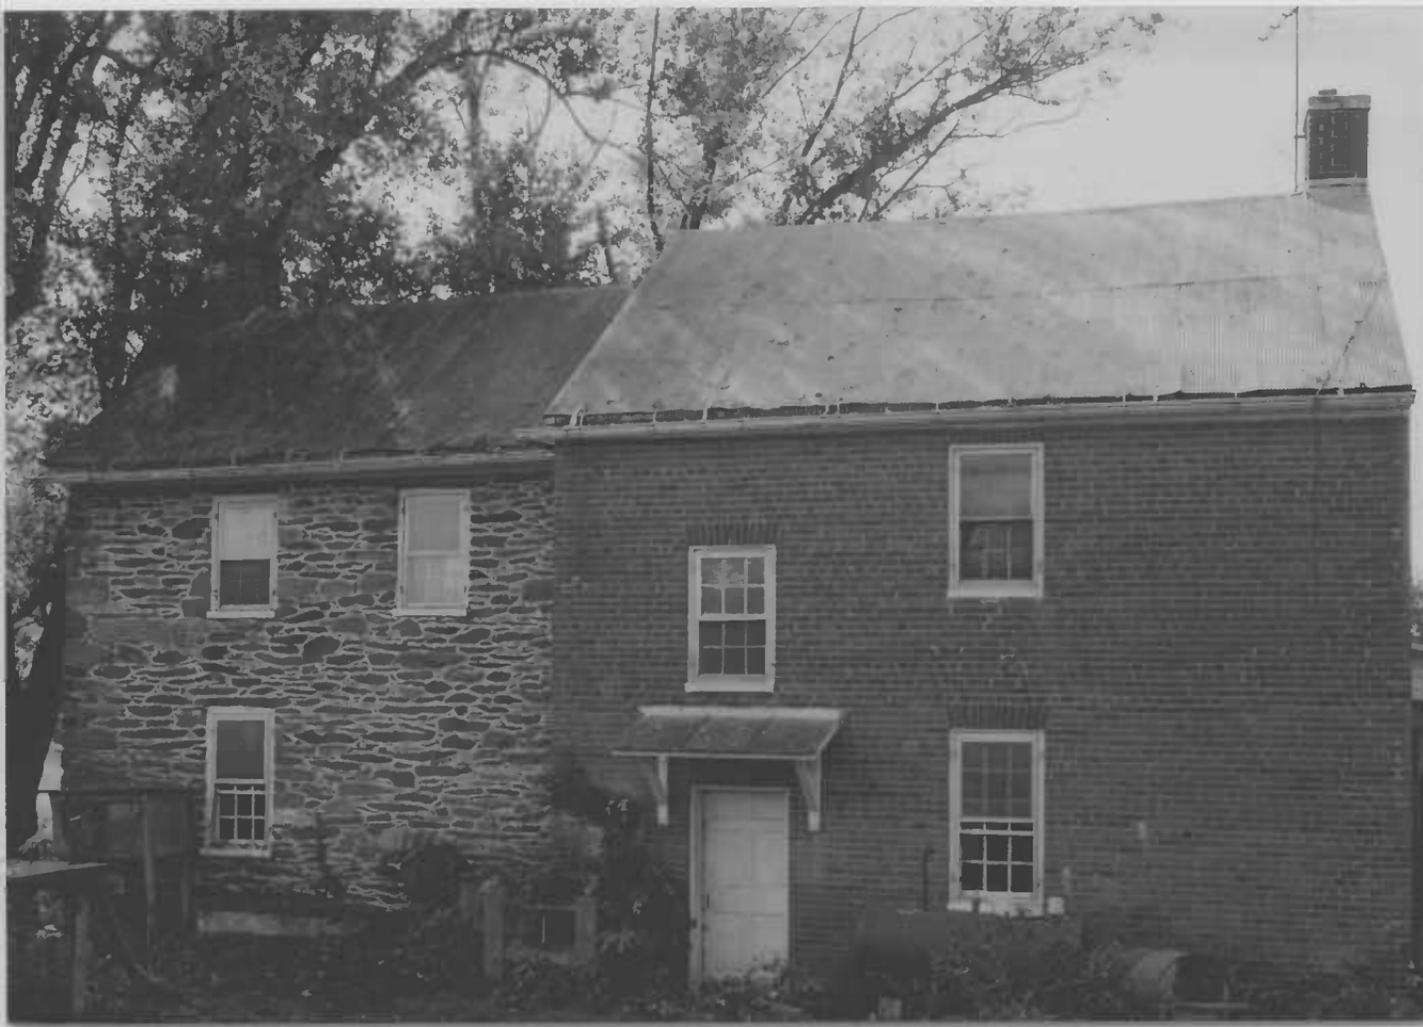
14 OF 16

Bail-Repp Farm
Wakefield Valley Road
Carroll County, MD
Photo: Kenneth M. Short
Date: Oct. 97
Neg. Loc.: Maryland Historical Trust
House - N. Elevation

The north elevation of the stone section has a 9/6 sash in the east bay of the first story and two 6/6 sash in the second story. There is a wood box cornice with an ogee bed mold and an interior brick chimney centered on the east gable end. The brick section to the west projects approximately four feet to the north of the north plain of the stone section. This has 4 to 1 common bond brick with traces of penciling. On the first story, the east bay of this section has a six panel door with a wrought Suffolk latch that has lima bean cusps. There is a stone sill and a splayed brick jack arch. There is a small pent roof above that has standing seam metal. It is supported by Champford brackets that are bolted to the wall. There is patched brick on either side of the pent roof that suggests an earlier porch or hood was here. The west bay has a 9/6 double hung sash with a wood sill and a splayed brick jack arch. On the second story, the east bay has a 6/6 double hung sash with a wood sill and splayed brick jack arch. This window is set low just above the pent roof. The west bay has an identical 6/6 sash set just below the eave with a straight brick jack arch. The cornice has dog tooth brick with a corbled header course both above and below. The brick work of the cornice is painted white. There is an interior brick chimney on the west gable end.

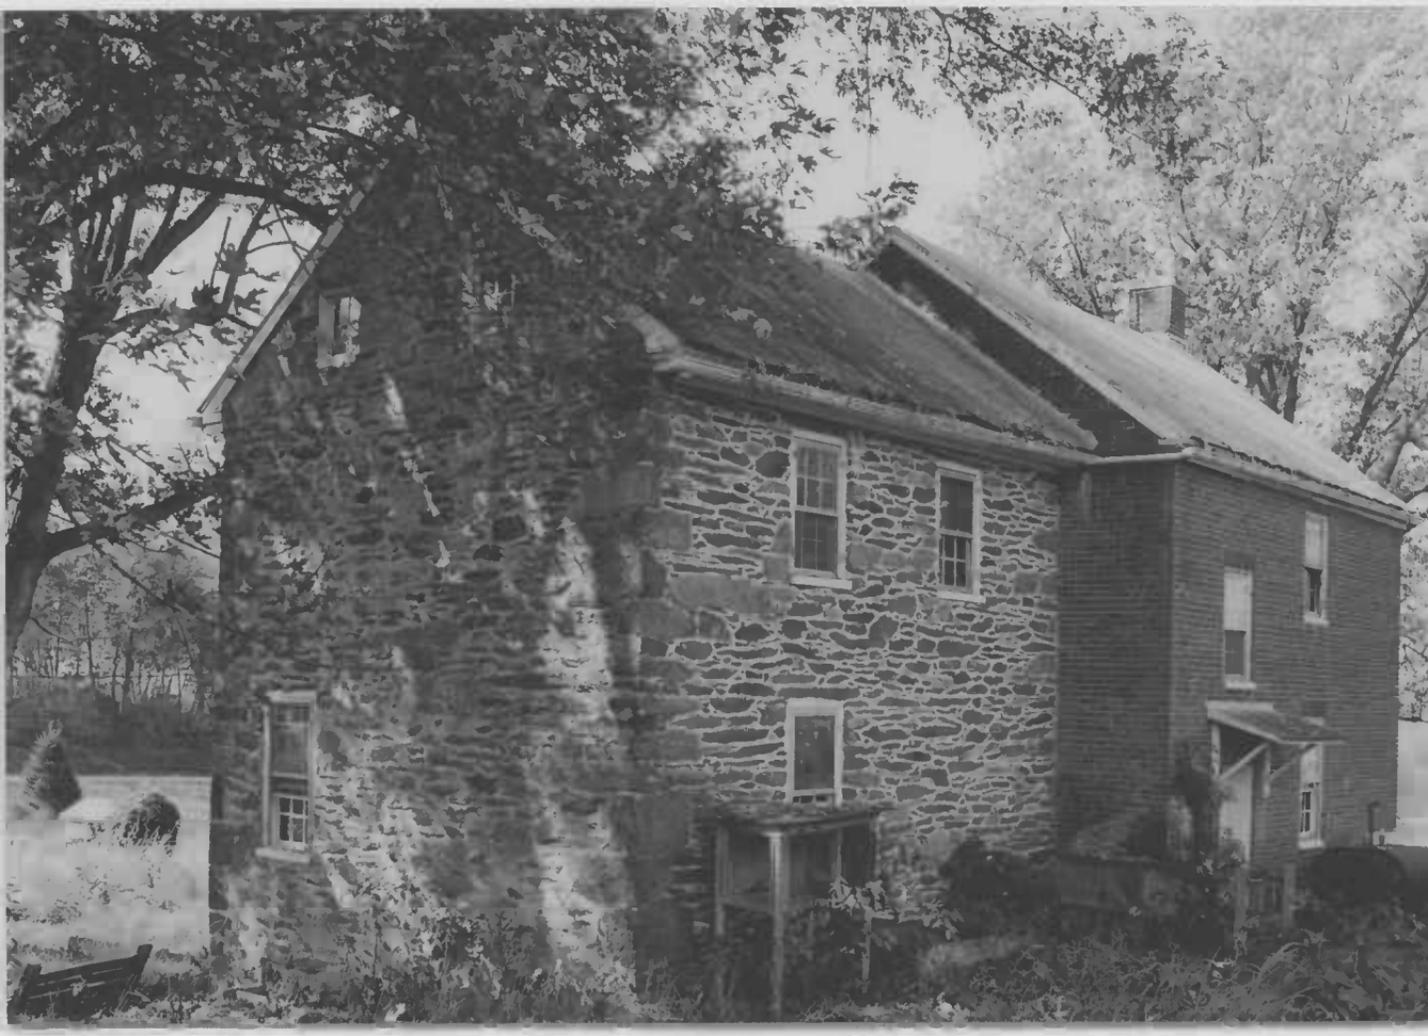
15 OF 16

House - E & N Elevations
