**MARYLAND HISTORICAL TRUST
NR-ELIGIBILITY REVIEW FORM**

QA-529

PROPERTY NAME: Pemberton Farm
ADDRESS: 113 Pemberton Farm Lane, Queen Anne, MD 21657
OWNER: William B. Messix, III
TAX PARCEL NUMBER: 30
PROJECT: MD 404 from US Route 50 to Denton Bypass
SITE VISIT BY: Archaeological and Historical Consultants, Inc.
NAME: Wendy Zug-Gilbert

Pemberton Farm Continuation Sheet

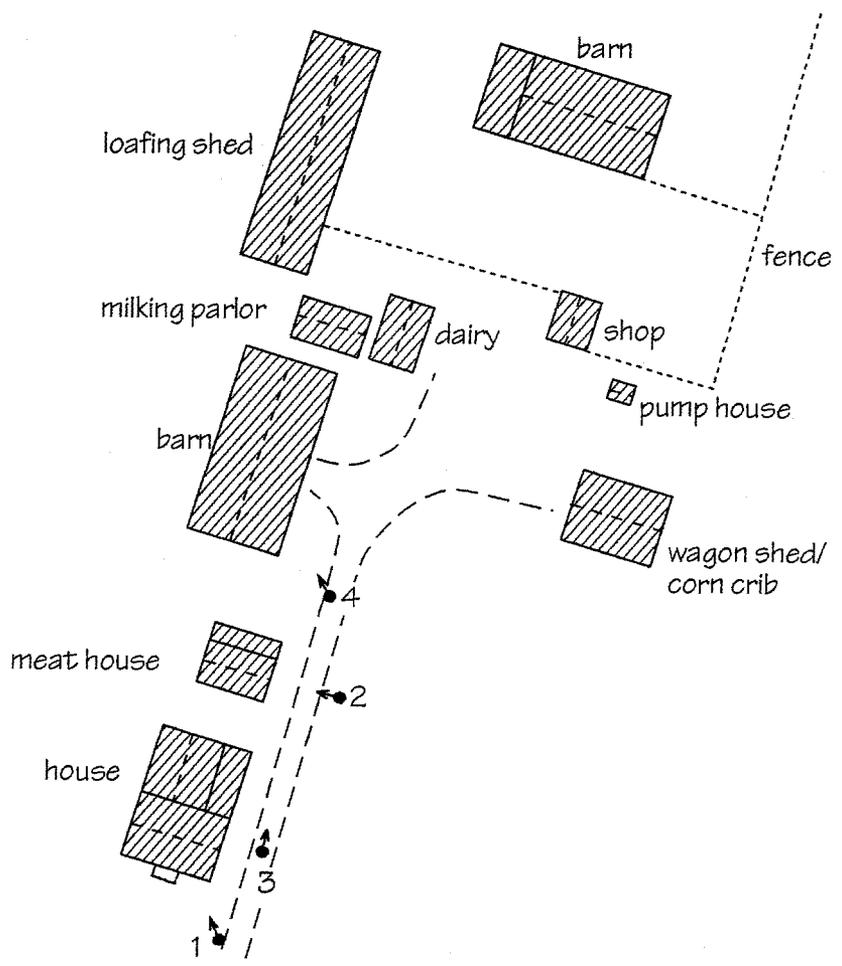
Willoughby Vicinity
Queen Annes County, Maryland
Resource Sketch Map

● = Photo Viewpoint
▨ = Historic Structure
not to scale

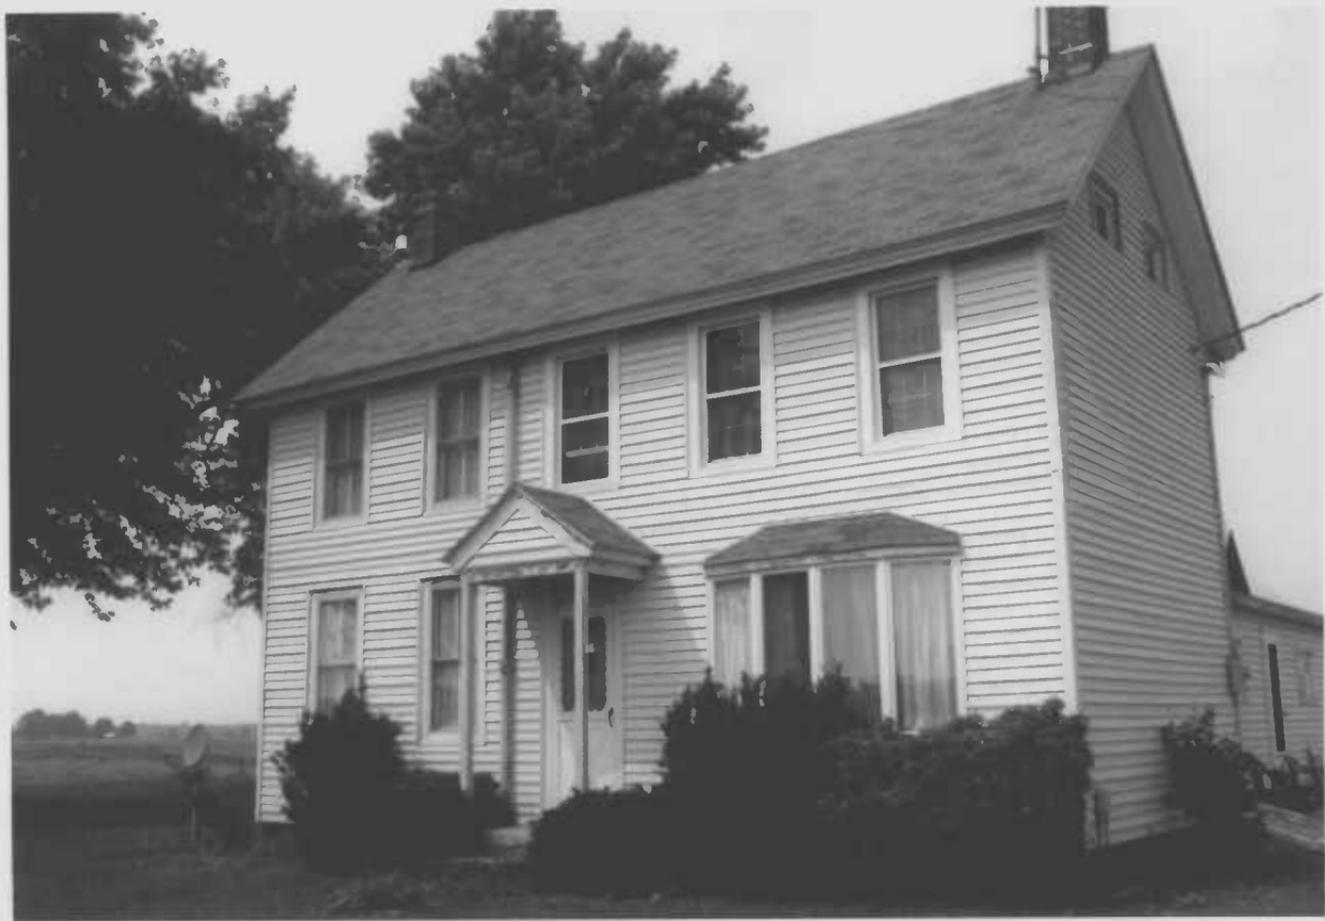
1 of 4

Farmhouse, facade (south elevation), facing north

The farmhouse is a two-and-a-half-story, L-shaped dwelling consisting of a five-bay main block with a rear kitchen wing of the same height. A one-story addition is located in the rear ell. At first glance, this residence appears to be a symmetrical late nineteenth-century farmhouse; however, upon closer inspection, it may have actually been constructed in two phases. The eastern three-bay portion of the structure has six-over-six sash windows consistently throughout. The western two-bay portion has two-over-two sash windows throughout. If this house were constructed in two phases, then the eastern section would be the older of the two and its plan would have originally been side-hall. The western two bays and the rear ell may have been added later, giving the appearance of a symmetrical façade. The interior brick end chimneys are also dissimilar, further suggesting multiple construction phases. The structure is covered with vinyl siding, has an asphalt-shingle roof, and sits on a brick foundation. A small gabled porch roof at the front entry is supported by squared posts. A bay window has replaced the two first-story windows on the eastern section of the façade.

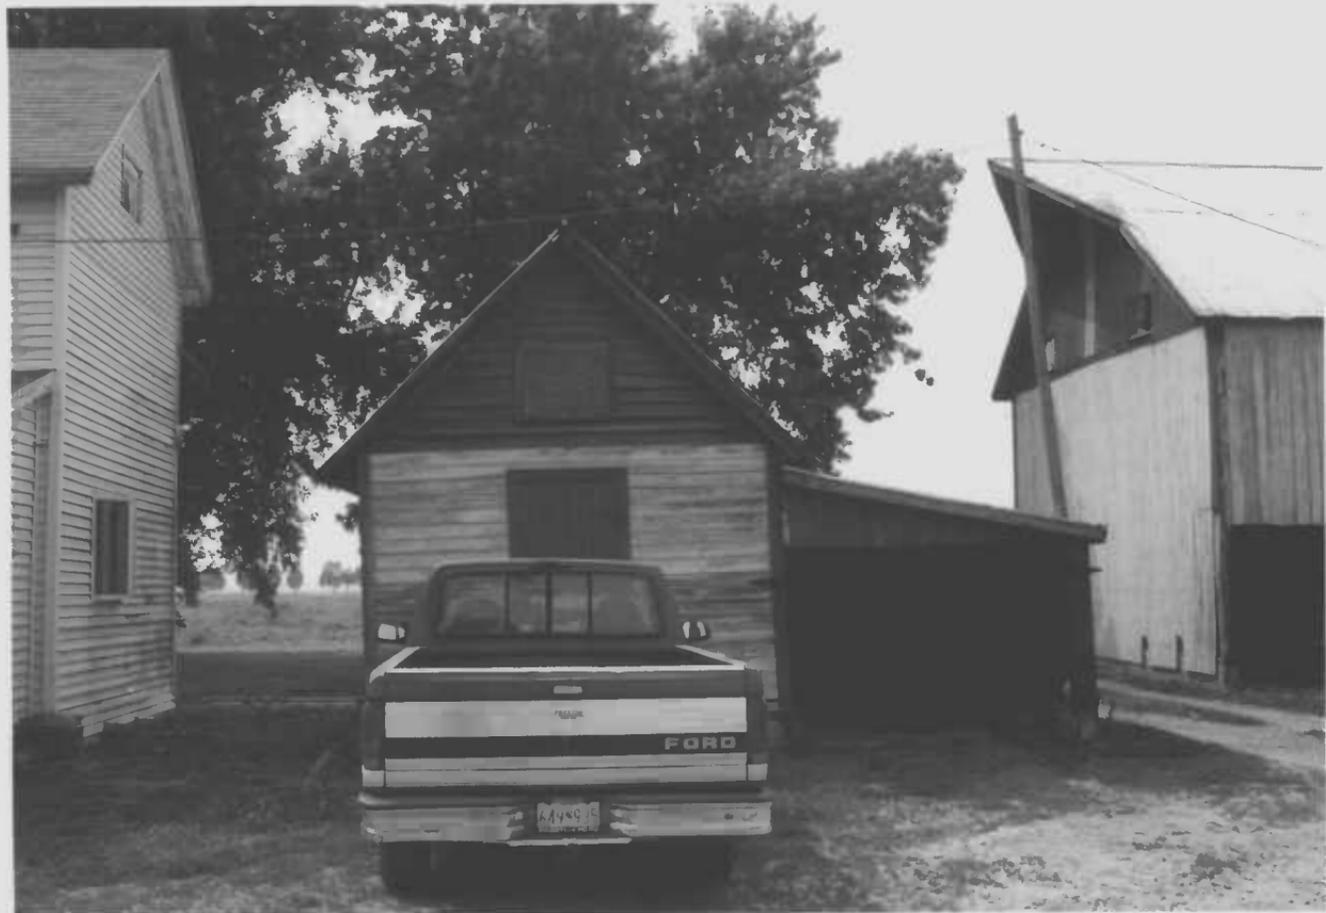
2 of 7

Meat house with addition east elevation, facing west

The property's outbuildings date to the late nineteenth/early twentieth-century. Directly behind the farmhouse is a frame gable-roof meat house with a shed-roof addition on its northern side wall. The agricultural buildings are located north of the farmhouse and are organized such that the larger buildings form the perimeter of the farmyard in which the smaller buildings are situated. The west side of the farmyard is framed by a large barn and a loafing shed, both of which were built in the 1930s. Both are frame with metal roofs. The gambrel-roofed barn is covered with vertical planks, has a hay hood on its south end, and has a large addition on its north end that substantially increases the size of the structure. The north end of the farmyard is formed by a smaller, more recent barn. Referred to as the 'colt barn,' the frame structure sits on a concrete-block foundation and has plank siding and a metal-covered gabled roof. Smaller outbuildings within the middle of the farmyard include the milking parlor, dairy (milkhouse), and shop, all of which were constructed during the first half of the twentieth century. The milking parlor is a concrete-block structure with a gabled metal roof. The dairy and shop are frame structures on concrete-block foundations and are covered with wood siding and have metal gable roofs. The dairy has a tall brick chimney with an arched hood on its eastern side wall. The east side of the farmyard is framed by a pumphouse and a corncrib/wagonshed. The pumphouse is a low concrete-block structure with a metal roof. The corncrib/wagonshed is a frame building with a gable-front metal roof.

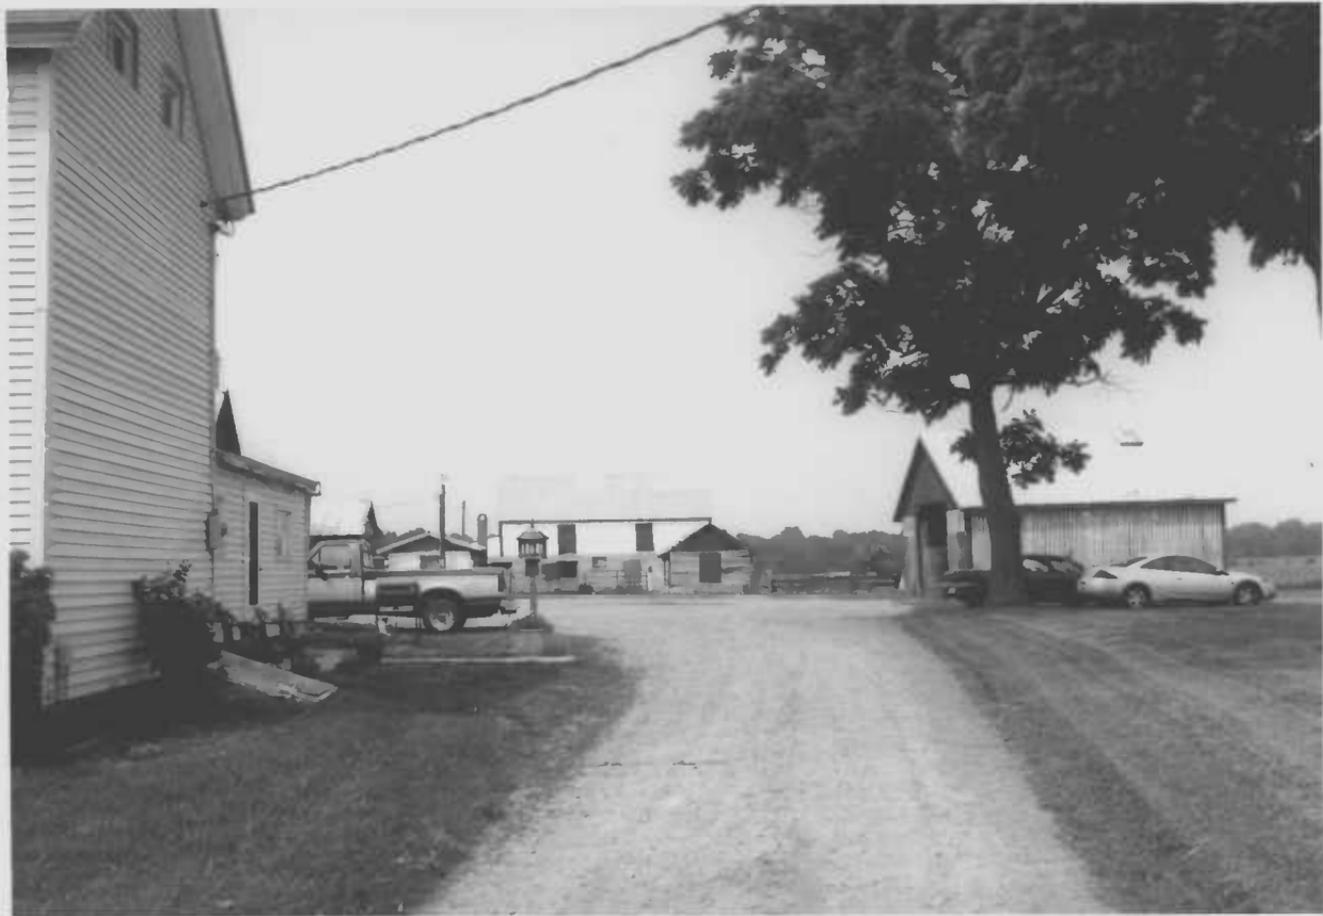
3 of 4

View of farmyard showing corner crib/wagon shed, shop, barn, and dairy,
facing north.

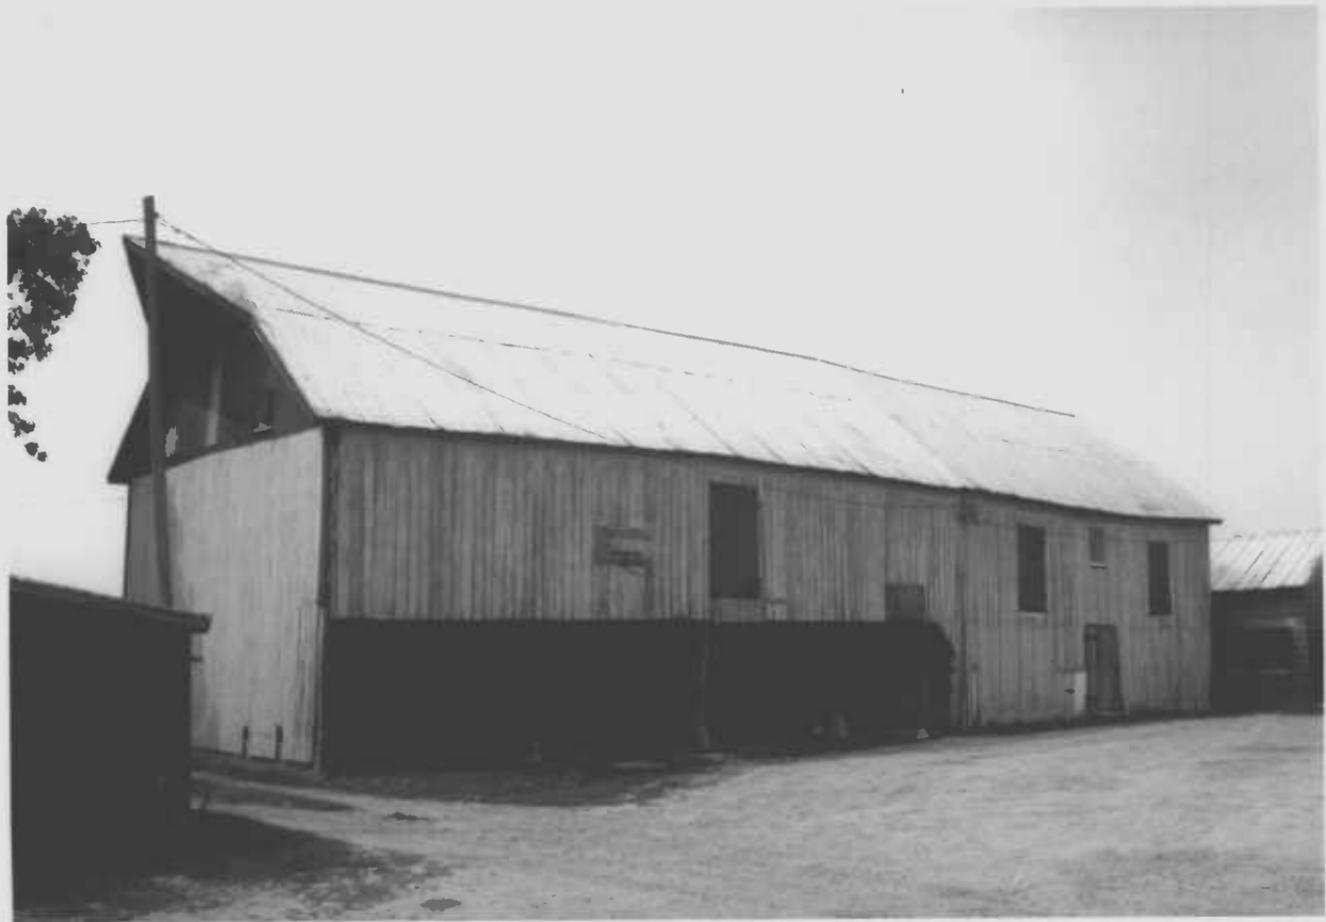
4 of 4

Barn with addition, east elevation, facing northwest.

Note milking parlor at far right
