**MARYLAND HISTORICAL TRUST
NR-ELIGIBILITY REVIEW FORM**

Property Name: Forthuber House Inventory Number: BA-2938

Address: 15920 York Road City: Sparks, MD Zip Code: 21152-9376

7. Description

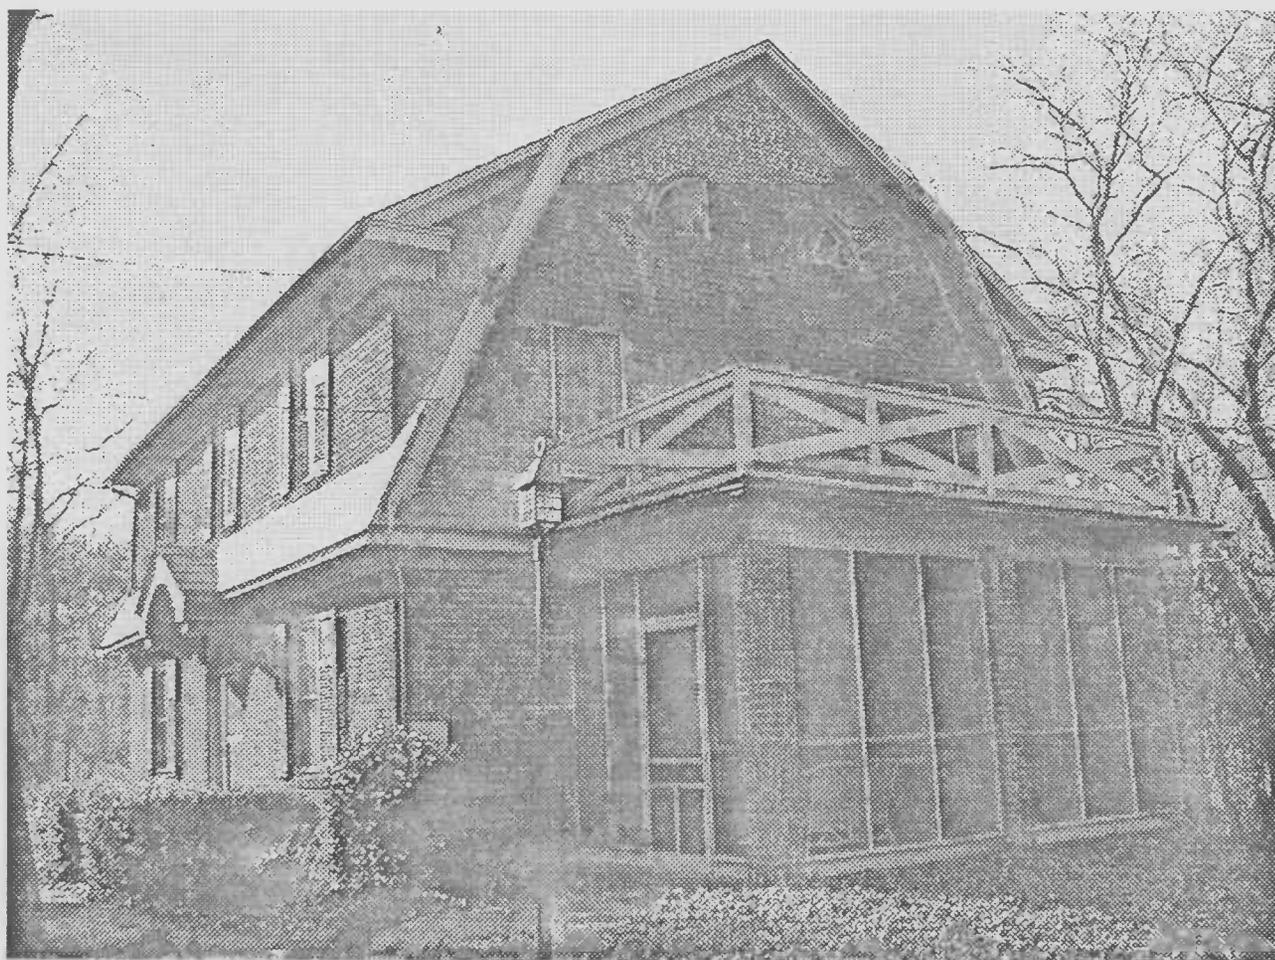
Figure 1. North and east (principal) façades of the 1931 Forthuber House.

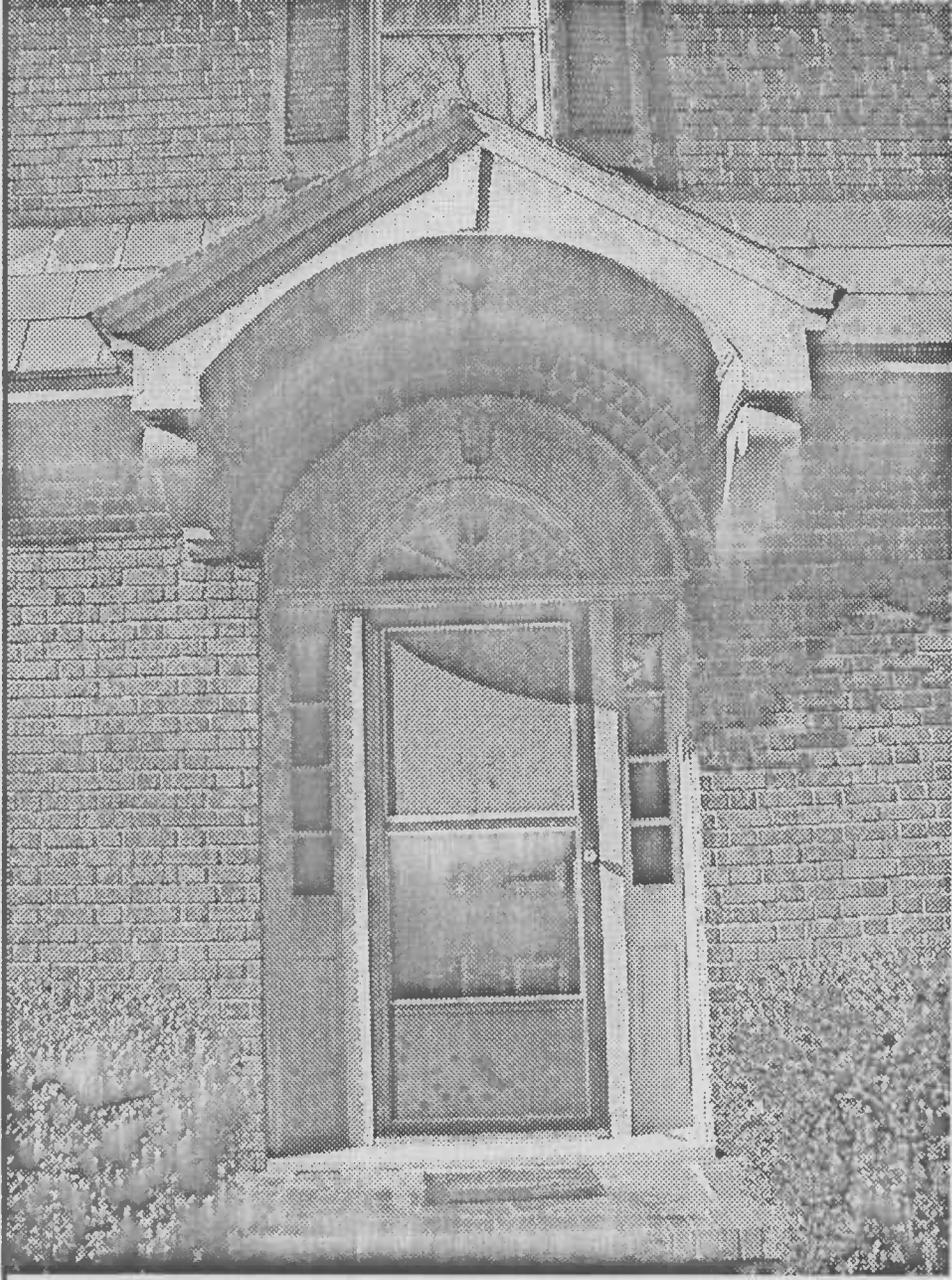
A gabled hood with a concave, beaded board soffit supported by heavy scroll sawn brackets shelters the centrally placed front entryway. A fanlight transom and sidelights further accentuate the entrance. Slate shingles survive on the roof and on the false eave that belts the building between the first and second floors, the shingle pattern being a plain offset arrangement designed to protect against seepage rather than to draw attention. The cornice and returns are pronounced and in apparent good shape. The diagonal board rails and deck moldings appear to be original, although the surveyors did not have direct access to ascertain their condition. The screening frames of the porch appear to be intact and original. The 9/1 light double-hung second floor windows and the 12/1 double-hung first floor windows appear to be original, as are the shutters and associated hardware, and the paired quarter-round attic lunettes on each gable end.

Figure 2. Principal entrance to the Forthuber House.

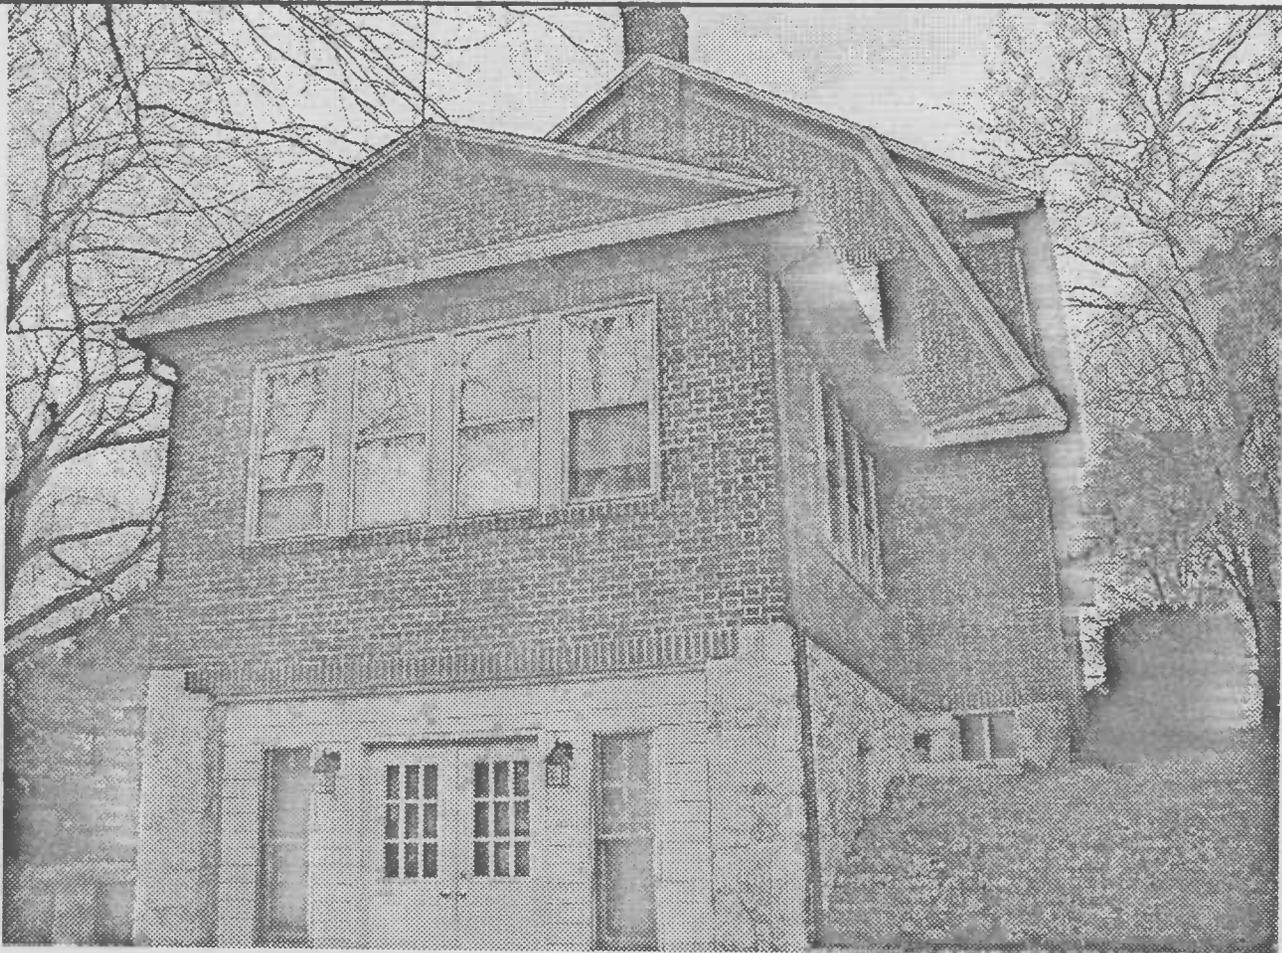
Significant changes include the conversion of a possible garage under the south end of the dwelling into an office or den. The frame infill has been adorned with vinyl siding and double exterior grade steel doors, all eminently removable and not visible from the front of the building. A shed utility room addition on the rear of the building has been removed, although the poured concrete foundations survive, as does a shadow along the west façade of the dwelling marking the location of the utility room's shed roof.

Figure 3. South façade of the Forthuber House.

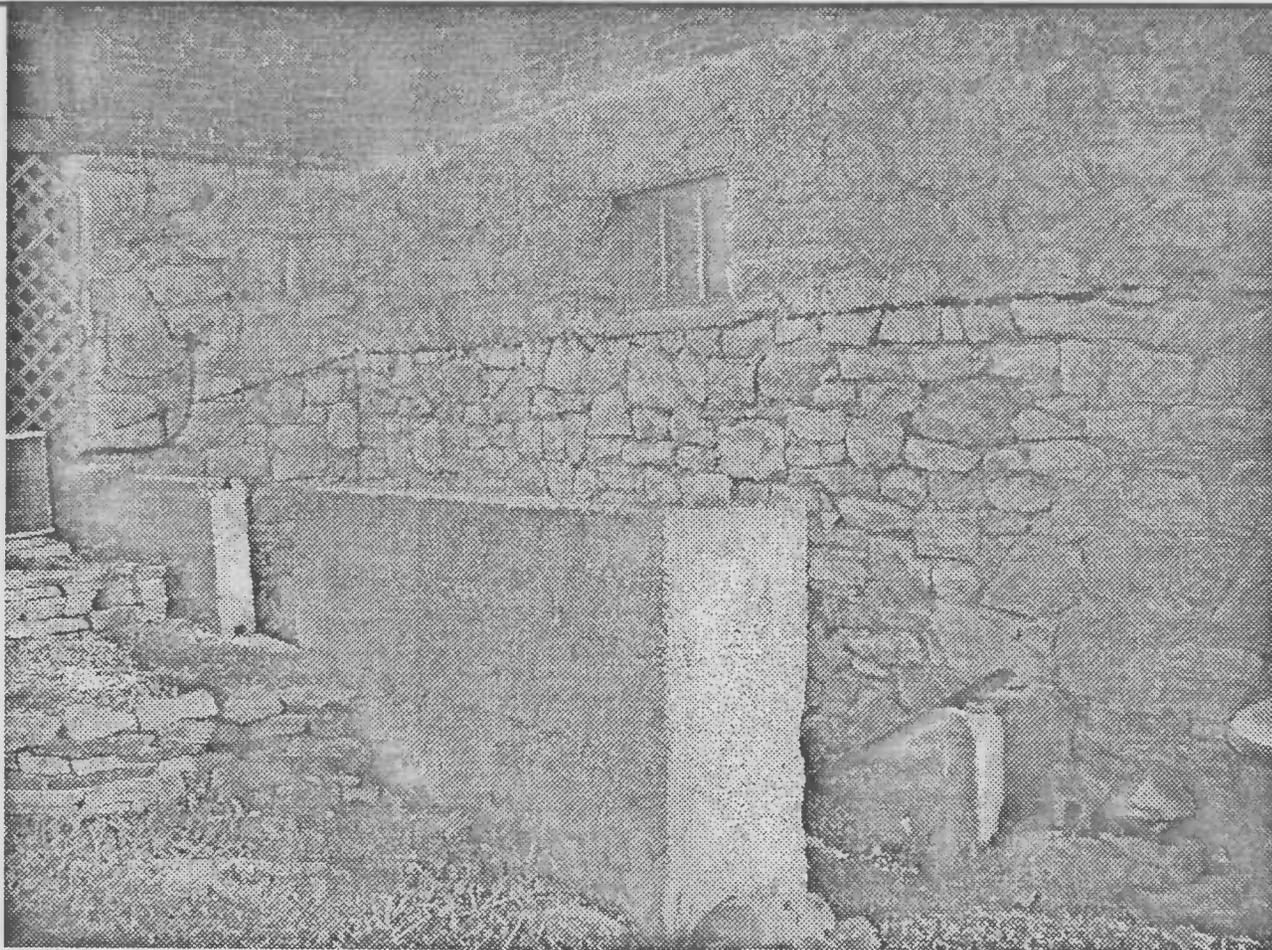
Figure 4. Southwest corner of the Forthuber House. Note remains of probable utility shed and shed roof shadow.

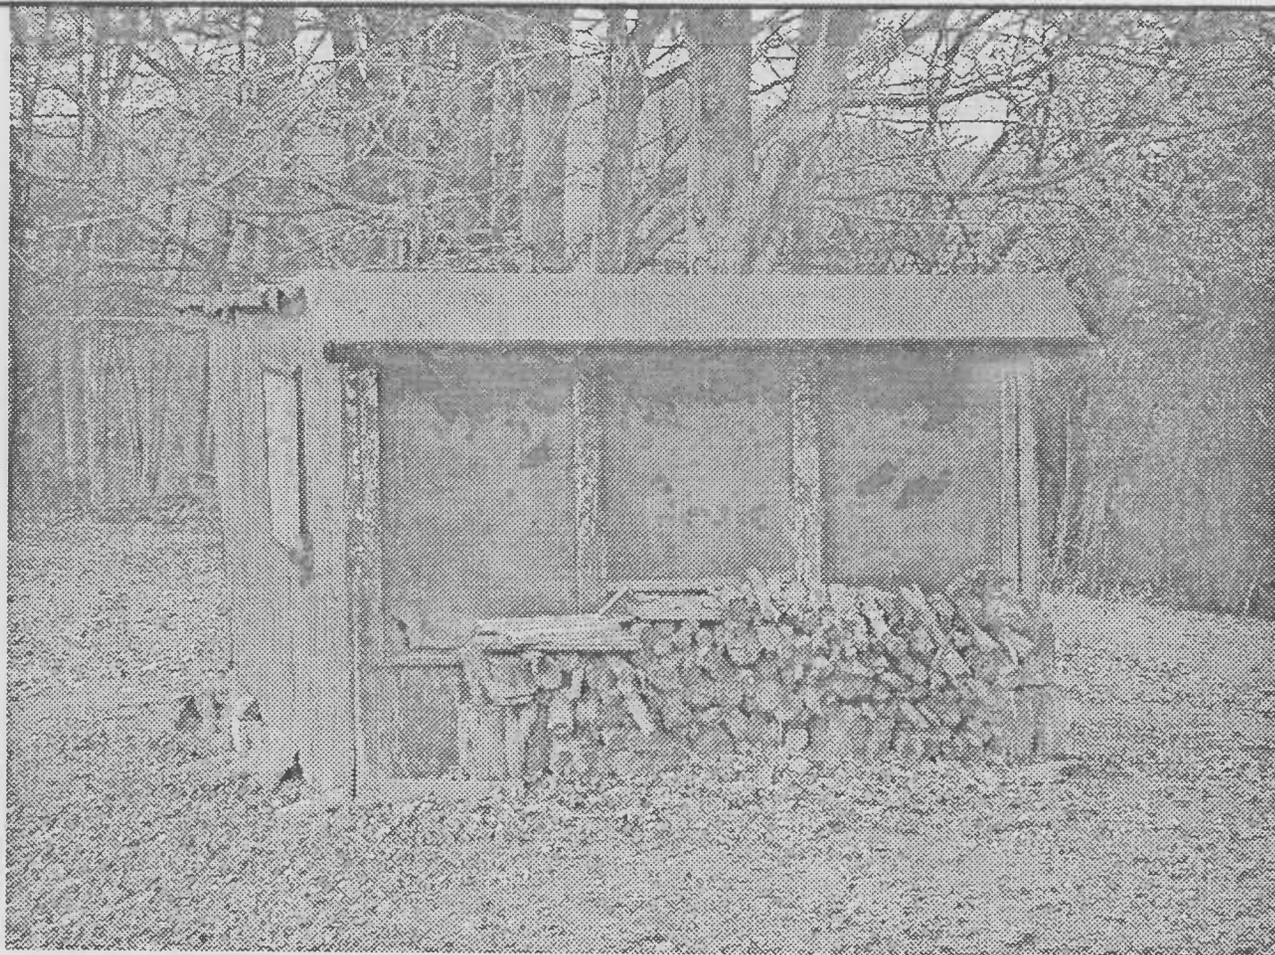
A rear garage, suggested by a small westward oriented earthen ramp, probably has been removed and the site now occupied by a frame tool shed and woodshed. The shed is in poor condition, sits awkwardly on a deteriorated block and concrete foundation, and is constructed of vertical boards of uniform width on a frame of milled dimension lumber. The shed is roofed with tarpaper and its principal façade consists of three boarded windows suggestive of a roadside stand rather than a domestic storage or wood shed. There is a prefabricated metal storage shed south of the house.

Figure 5. Framed shed with tarpaper roofing in rear yard of the Forthuber House.
