BA-3063  
Old Rider Post Office  
8013 Bellona Avenue  
Riderwood  
Private  
c. 1885-1898

## Maryland Historical Trust Maryland Inventory of Historic Properties Form

historic Old Rider Post Office  
other

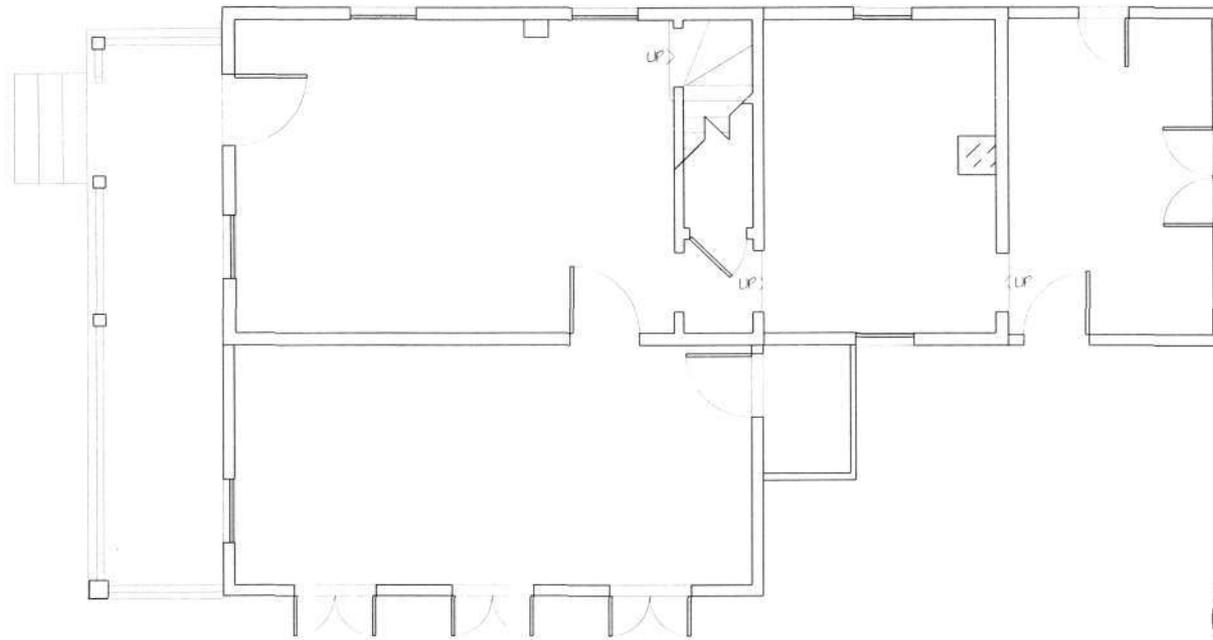
FIRST FLOOR PLAN MEASURED AND DRAWN BY KEN SHORT JANUARY 2002

The northwest room has carpet on the floor and new baseboard. The architrave has a sunken field and is mitered at the corners. The sash are hung on weights. The southeast elevation has a doorway set to the east that leads to an enclosed winder stair. There was never a door in this opening. There is also a doorway on this wall that is set to the south and leads to a small vestibule. It also never had a door. The southwest elevation has a doorway to the south with the same architrave. The door has four lights over two panels, with sunken fields and ovolo panel moulds. It has a mortise lock and butt hinges with loose joints. In the vestibule, the architrave is symmetrical, and is pulvinated in the center with two beads on each side, a field outside of the beads, and a beaded interior edge. There are bull's-eye corner blocks. On the southwest side of the vestibule is a new shallow closet. On the northeast is a four-panel door with sunk double fields and ogee panel moulds. It has a mortise lock and butt hinges with loose joints. There is a closet beneath the steps, inside this door. The flooring here has linoleum over what appears to be pine, and the floor runs northwest-southeast. The baseboard here has an ogee and bevel on top. On the southeast side of the vestibule is a doorway to the center room. There is no evidence of a door ever being in this location, and there is one step up to the floor level of the center room.

The center room has 3 ½-inch-wide pine flooring that runs northwest-southeast and has new baseboard. The architrave has a sunken field with an ogee on each side of the field and a small bead on the inner edge. There are bull's-eye corner blocks. The

walls and ceiling are an early sheetrock, and the ceiling has narrow wood strips over the joints. The sash are hung on weights. This room is now a kitchen. The doorway on the northwest elevation, to the vestibule, has architrave with a bead on the outer edge. The southeast room has a concrete floor that had tile on it, but the tile has been taken up. There is access in the floor of this room to the cellar. The openings have plain mitered architrave. There is a cornice with an ogee above the cavetto. On the southwest elevation is a door with six lights over two panels. The panels have sunken fields and ovolo panel moulds, and the door has a mortise lock and butt hinges with ball finials.

The southwest room also has carpeting and new baseboard. There is plain mitered architrave and a small cornice moulding with an ogee above a cavetto. The southeast elevation has a door with four lights over two panels, and the door is identical to the door on the northeast elevation that leads to this room, but has butt hinges with ball finials. The glass has been painted. The door leads to a closet that is one step up from the floor level of the southwest room.

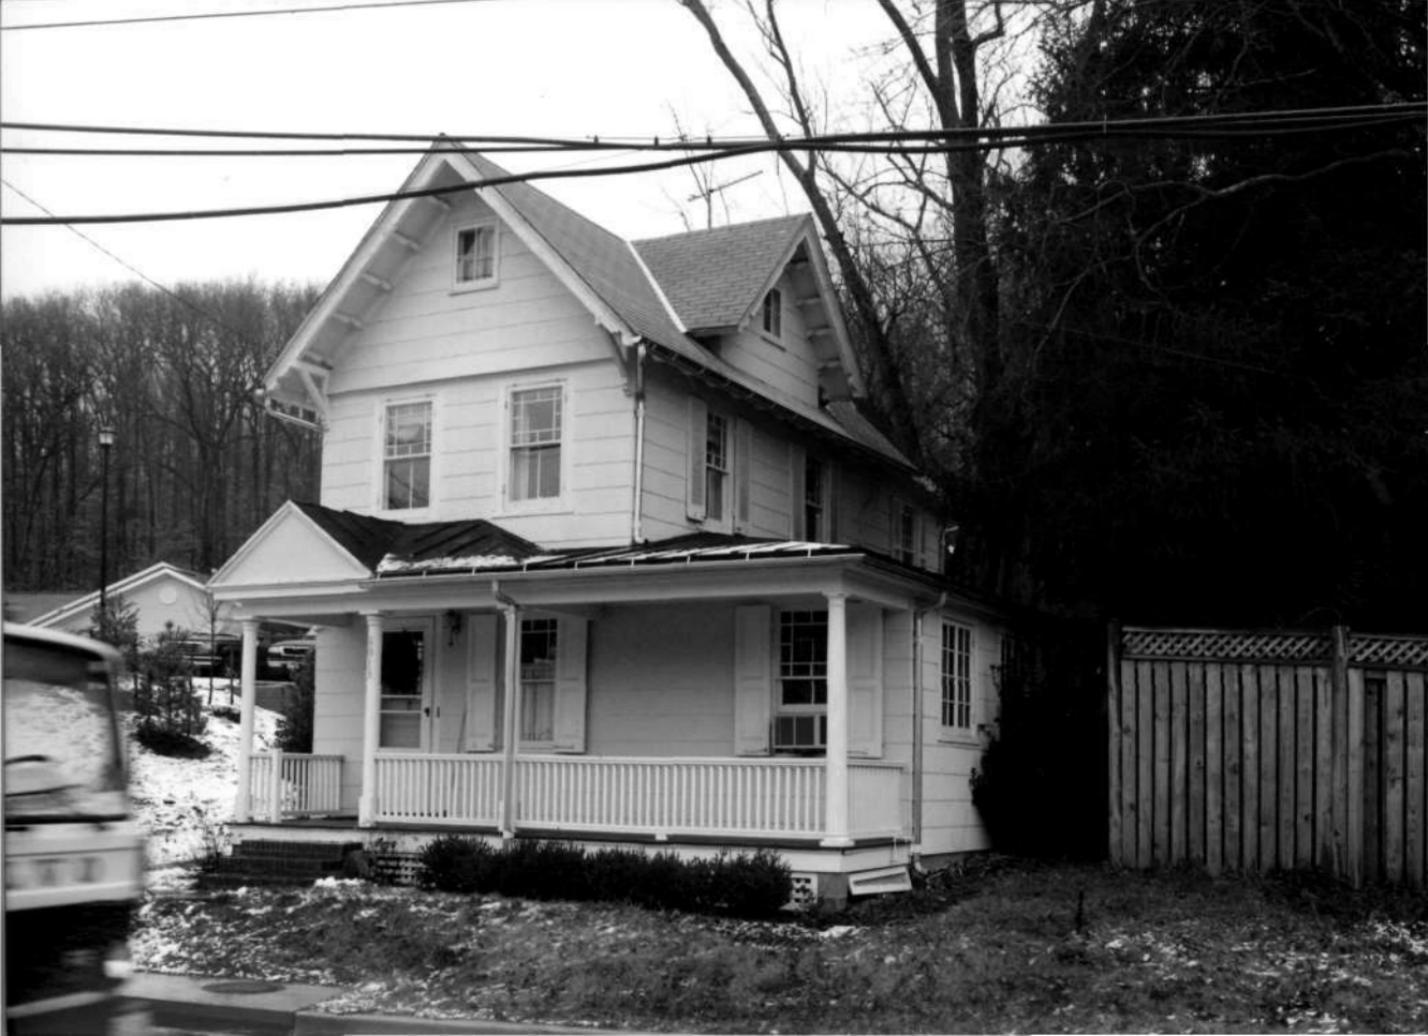
1/4

On the northwest elevation, the first story has a door in the north bay with Queen Anne sash and three lying panels that have quirked ogee and bevel panel moulds. The head cut trim has a beaded interior edge. To the west are two double hung sash with a Queen Anne sash above a two-light sash. They have the same head cut trim, and wood sills. Each window has a pair of two-panel shutters with sunk, flat panels and quirked ogee and bevel panel moulds. The back side of the shutters have bead and butt work. There is a one-story, three-bay porch supported by four Doric columns, and it has a pediment over the north bay. There is a wood deck, beaded-edge-and-center board soffit, and square vertical balusters. The second story has two sash identical to the first story. The gable end is set to the street, and has a four-light sash with no trim. There are wide, overhanging eaves with brackets.

On the southwest elevation, the southwest addition to the main block has three pair of eight-light casements with plain head cut trim and wood sills on the first story. The second story of the main block has two typical Queen Anne sash with blinds, and the rafters and dormer are identical to that on the northeast elevation. The first story of the center wing had a porch that wrapped around on the southeast. This porch has been extended on the southwest end and enclosed on the southeast to make the wing. The first story of the center wing has a typical two-over-two sash with no shutters or blinds, as does the second story.

Northwest & southwest elevs

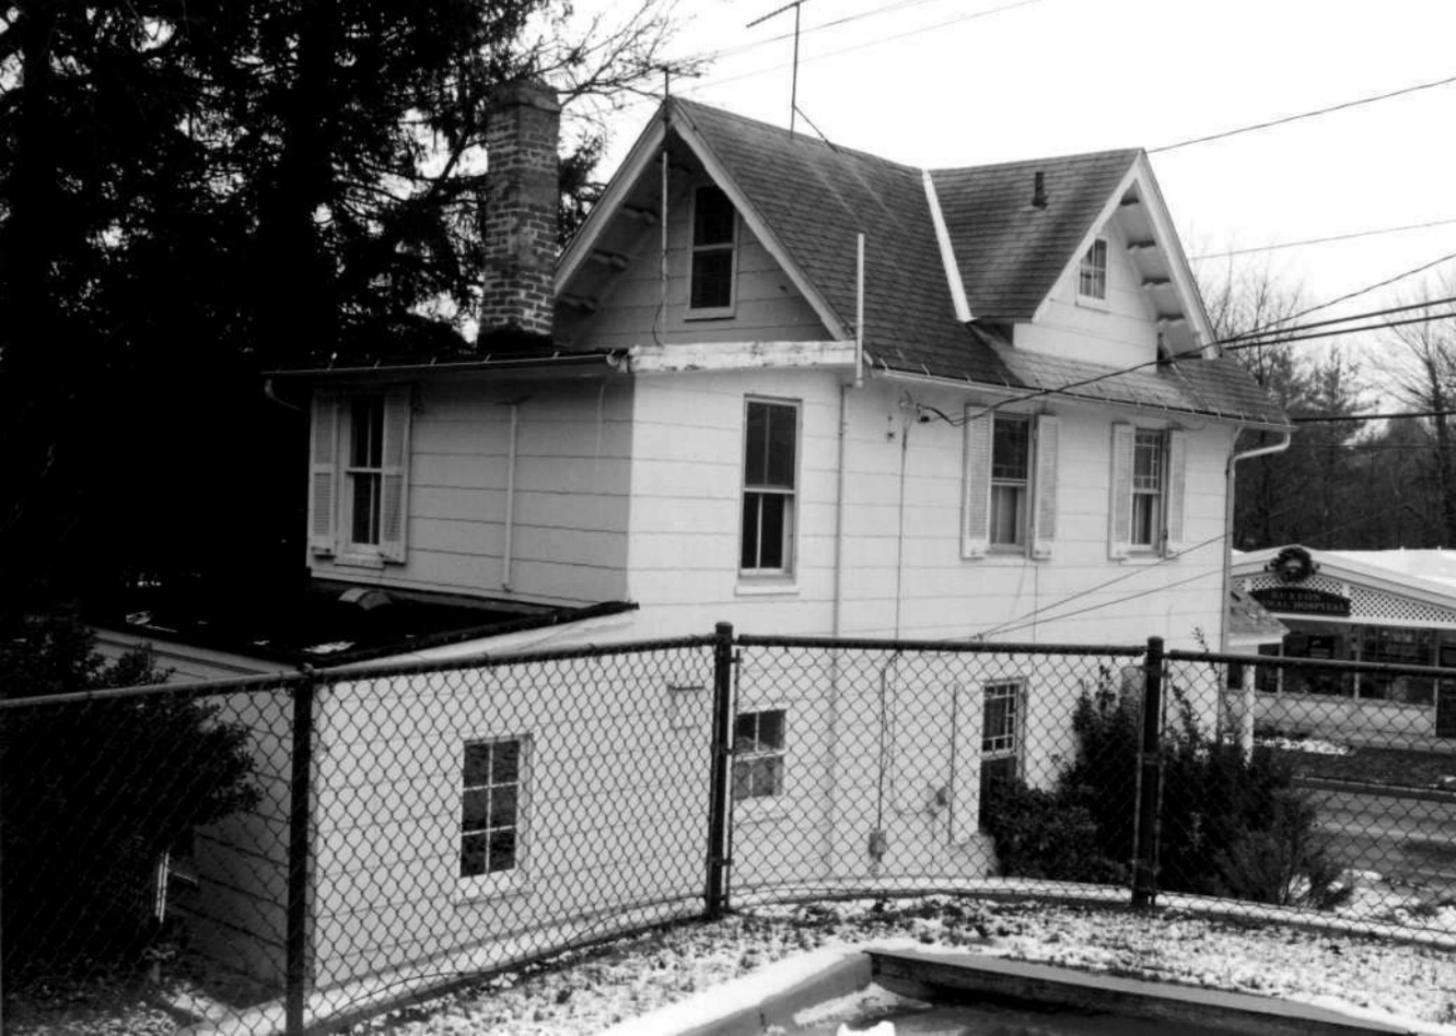
2/4

On the northeast elevation, the first story of the southeast wing has a six-light casement. The center wing has a two-over-two sash with a beaded-interior-edge frame. The main block of the house has two typical Queen Anne sash with shutters. On the second story, the center wing has a two-over-two sash with a beaded-interior-edge frame and the main block has two typical Queen Anne sash with blinds. There are exposed rafter ends that are decoratively cut. There is a gabled wall dormer with a bracketed cornice and a small four-light sash. The southeast elevation has a pair of six-light casements in the center of the first story. The second story has a typical two-over-two sash with blinds in the south bay and an interior brick chimney set east of center. The gable end has a bracketed cornice and a four-light sash.

Southeast & northeast elevs

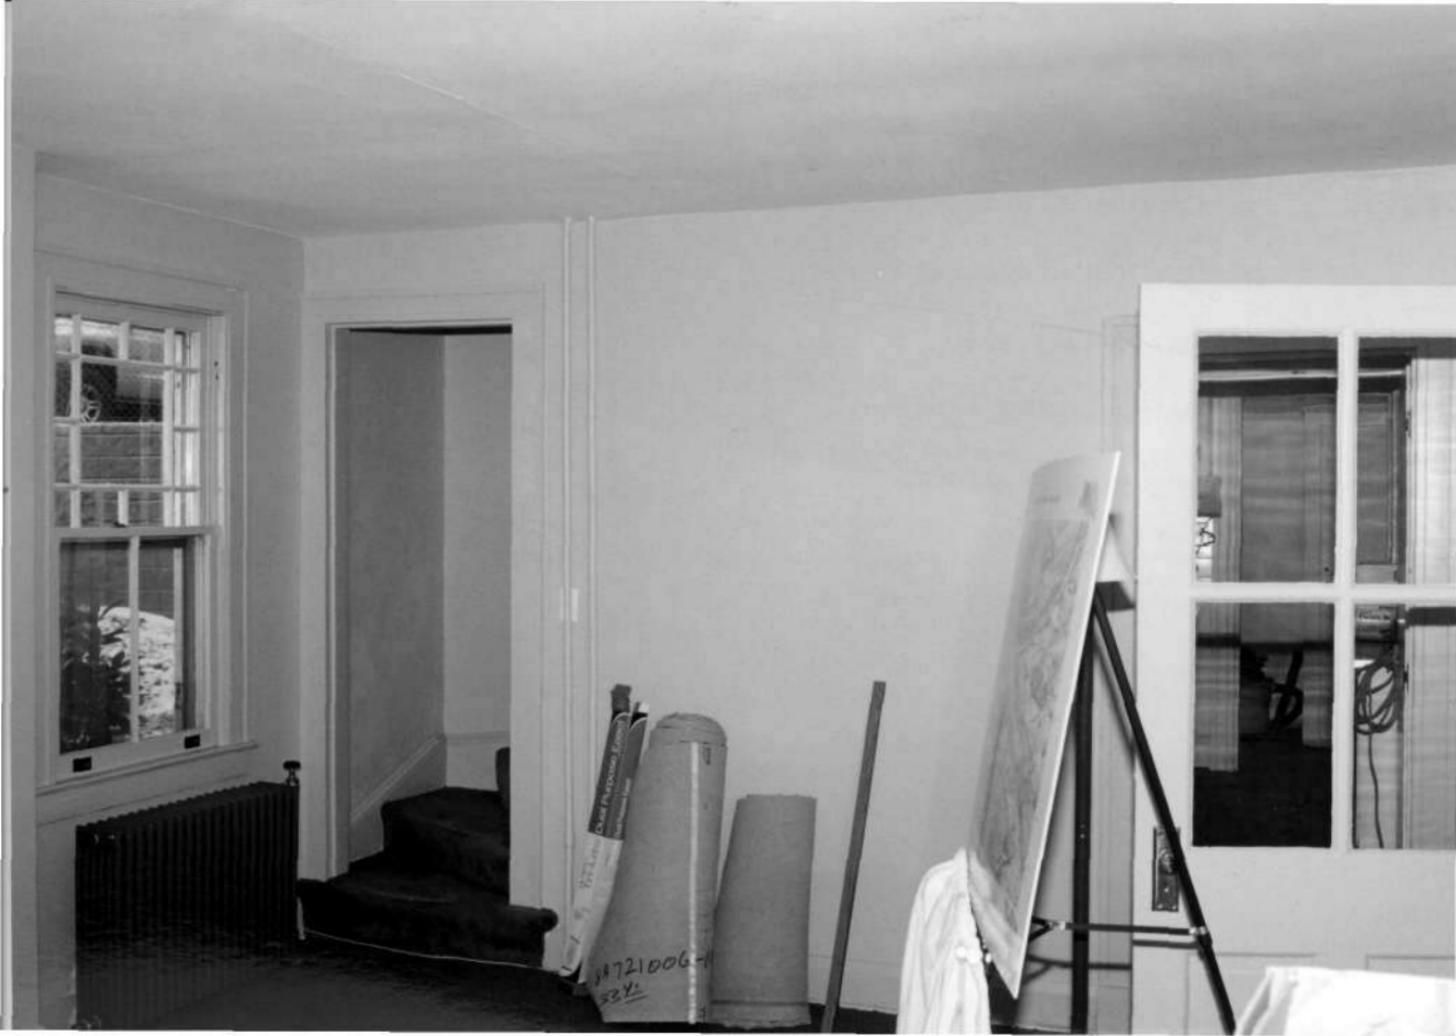
3/4

Northwest rm, vw east
