COUNTIES (MD/PA) HARFORD/YORK
M&D milestone no. 29 (31)
MHT-HSI no. HA-1022
MAGI 1310223234
PROTECTED/ENDANGERED/MISSING

FIELD SHEET: MASON & DIXON LINE, MARYLAND-PENNSYLVANIA BOUNDARY MARKER SURVEY

MASON & DIXON WEST LINE: MILESTONE 29 (31)

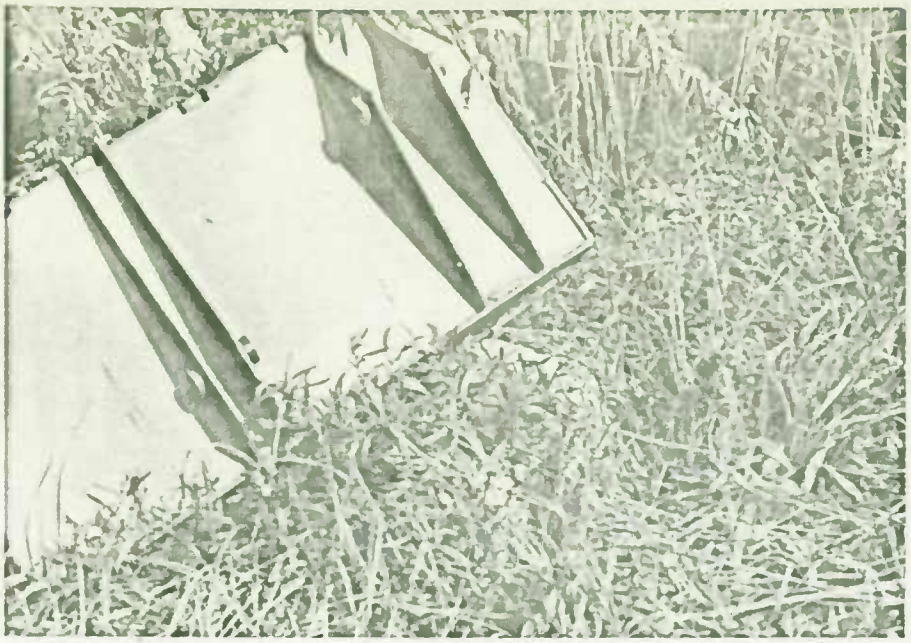
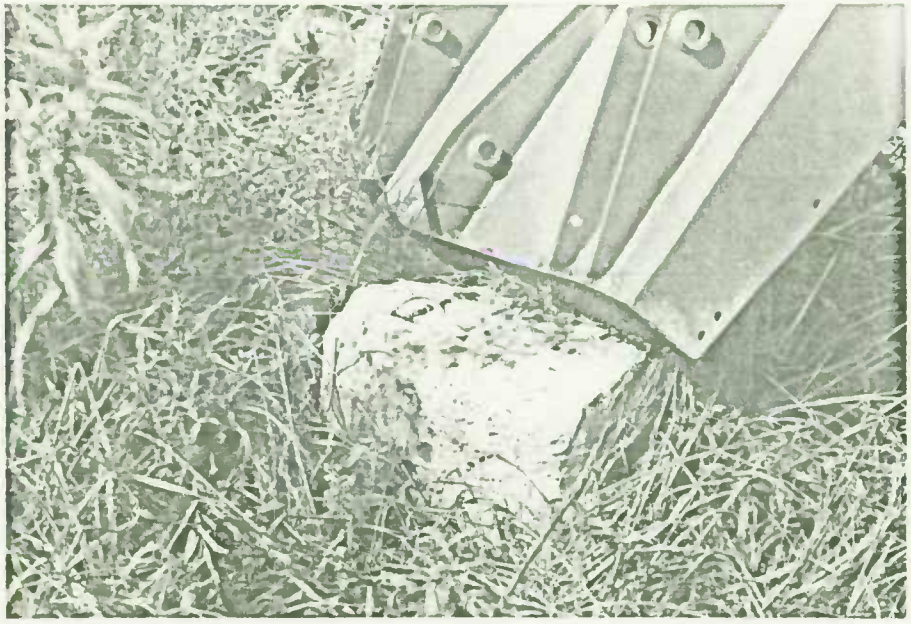
MASON & DIXON
WEST LINE;
MILESTONE NO. 29

PHOTS: JEAN EDWINI c. 1970
FOR MHT HISTORIC SITES INVENTORY
