COUNTIES (MD/PA) BALTIMORE/YORK
M&D milestone no. 53 (56)
MHT-HSI no. BA-1572
MHT MAGI no.
PROTECTED/~~ENDANGERED/MISSING~~

FIELD SHEET: MASON & DIXON LINE, MARYLAND-PENNSYLVANIA BOUNDARY MARKER SURVEY

MASON & DIXON WEST LINE: MILESTONE 53 (56)

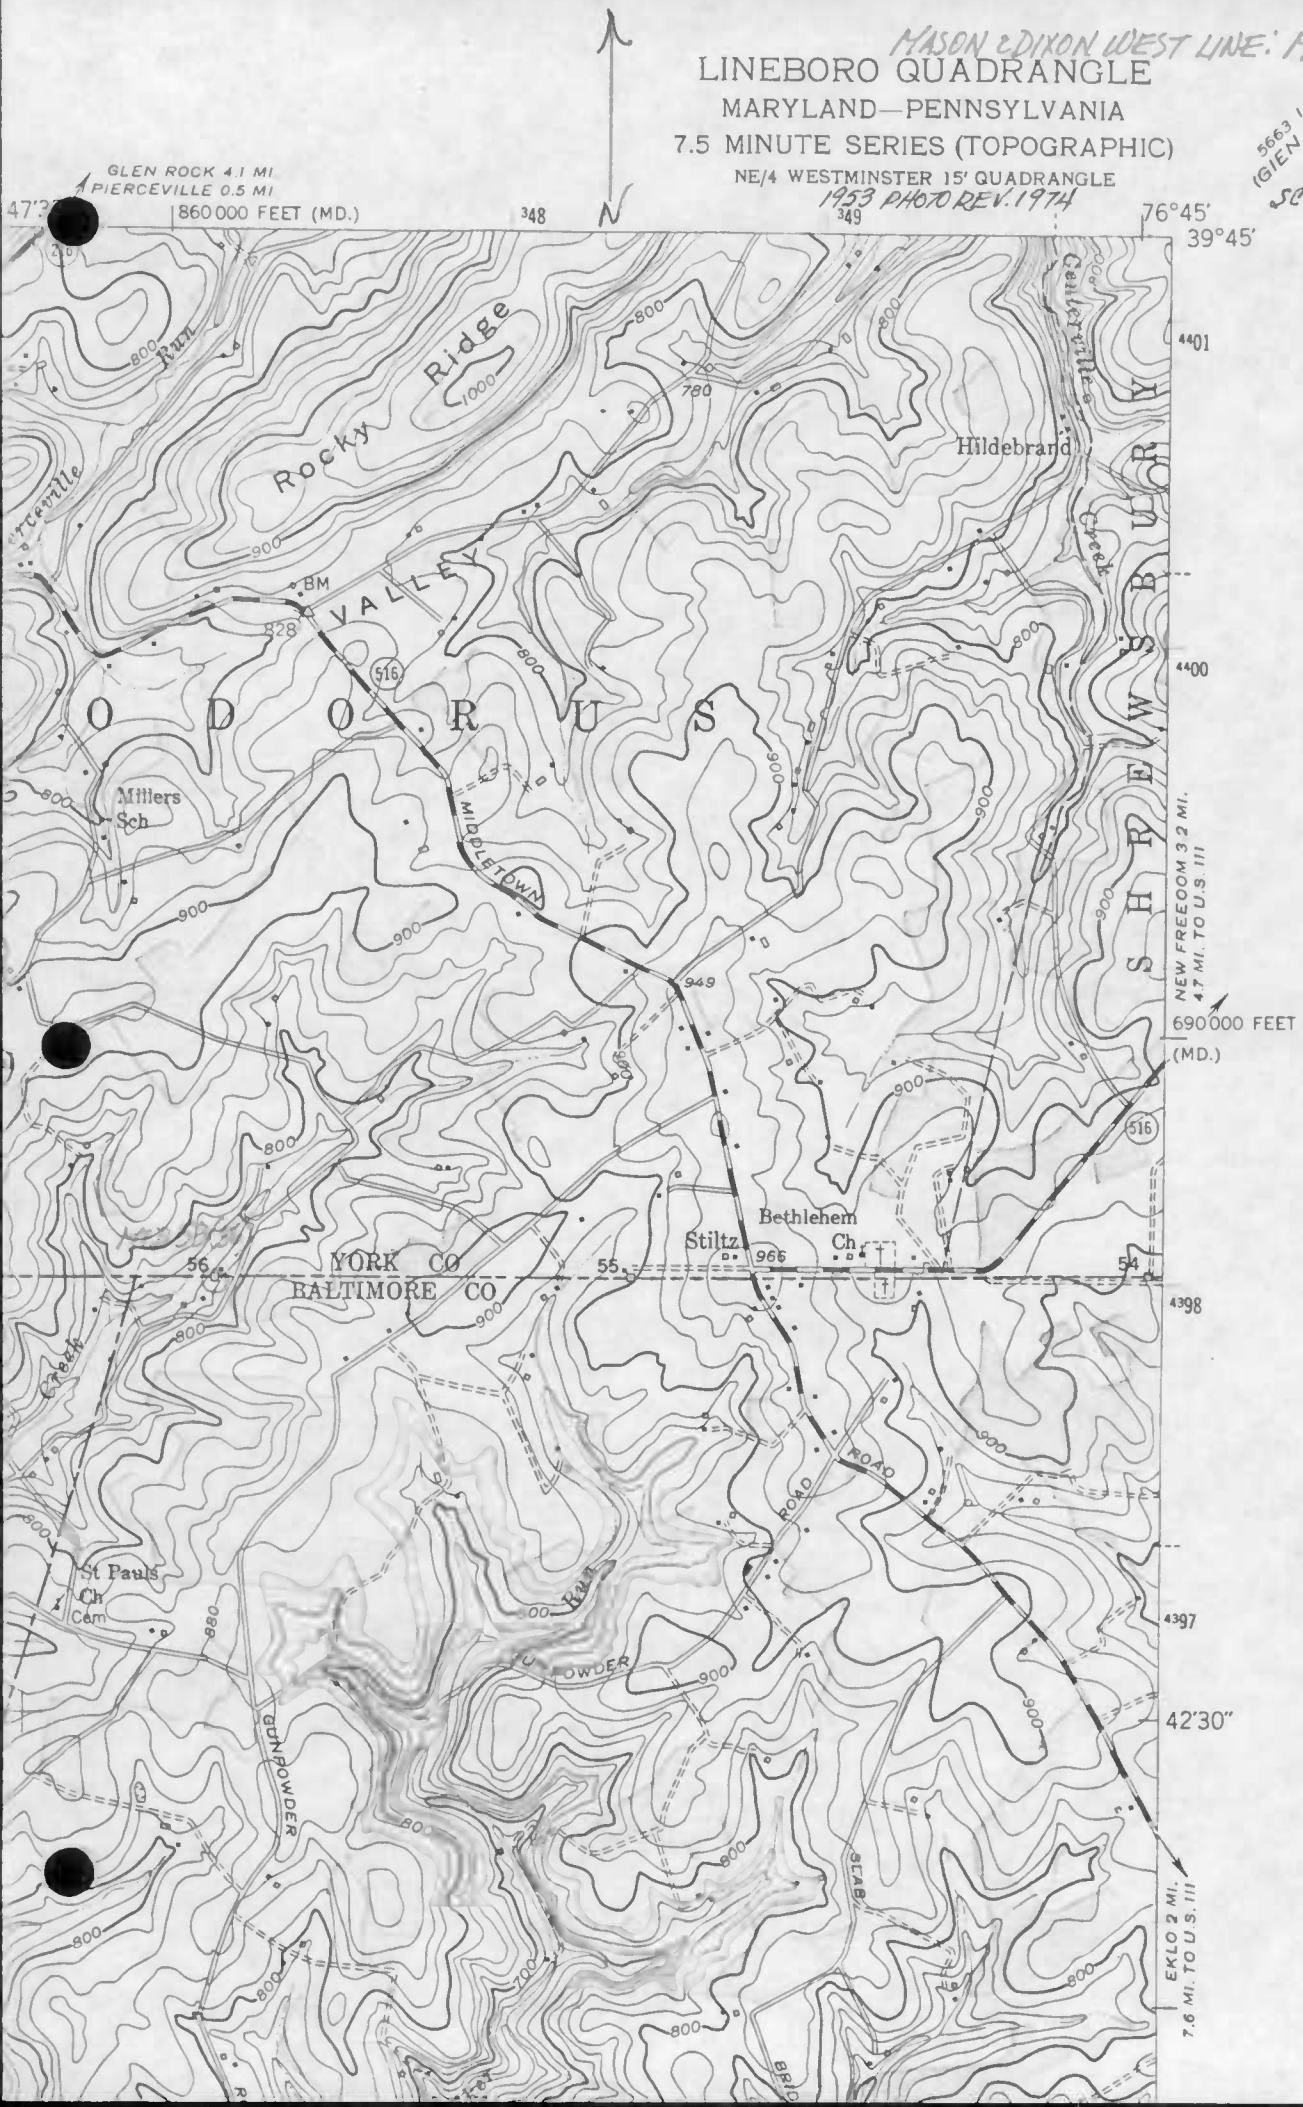
LINEBORO QUADRANGLE
