COUNTIES (MD/PA) GARRETT/SOMERSET
M&D milestone no. --- (194)
MHT-HSI no. G-IA-192

FIELD SHEET: MASON & DIXON LINE, MARYLAND-PENNSYLVANIA BOUNDARY MARKER SURVEY

MASON & DIXON WEST LINE (MD-PA) BOUNDARY MARKERS;
MILESTONE NO. --- (194)

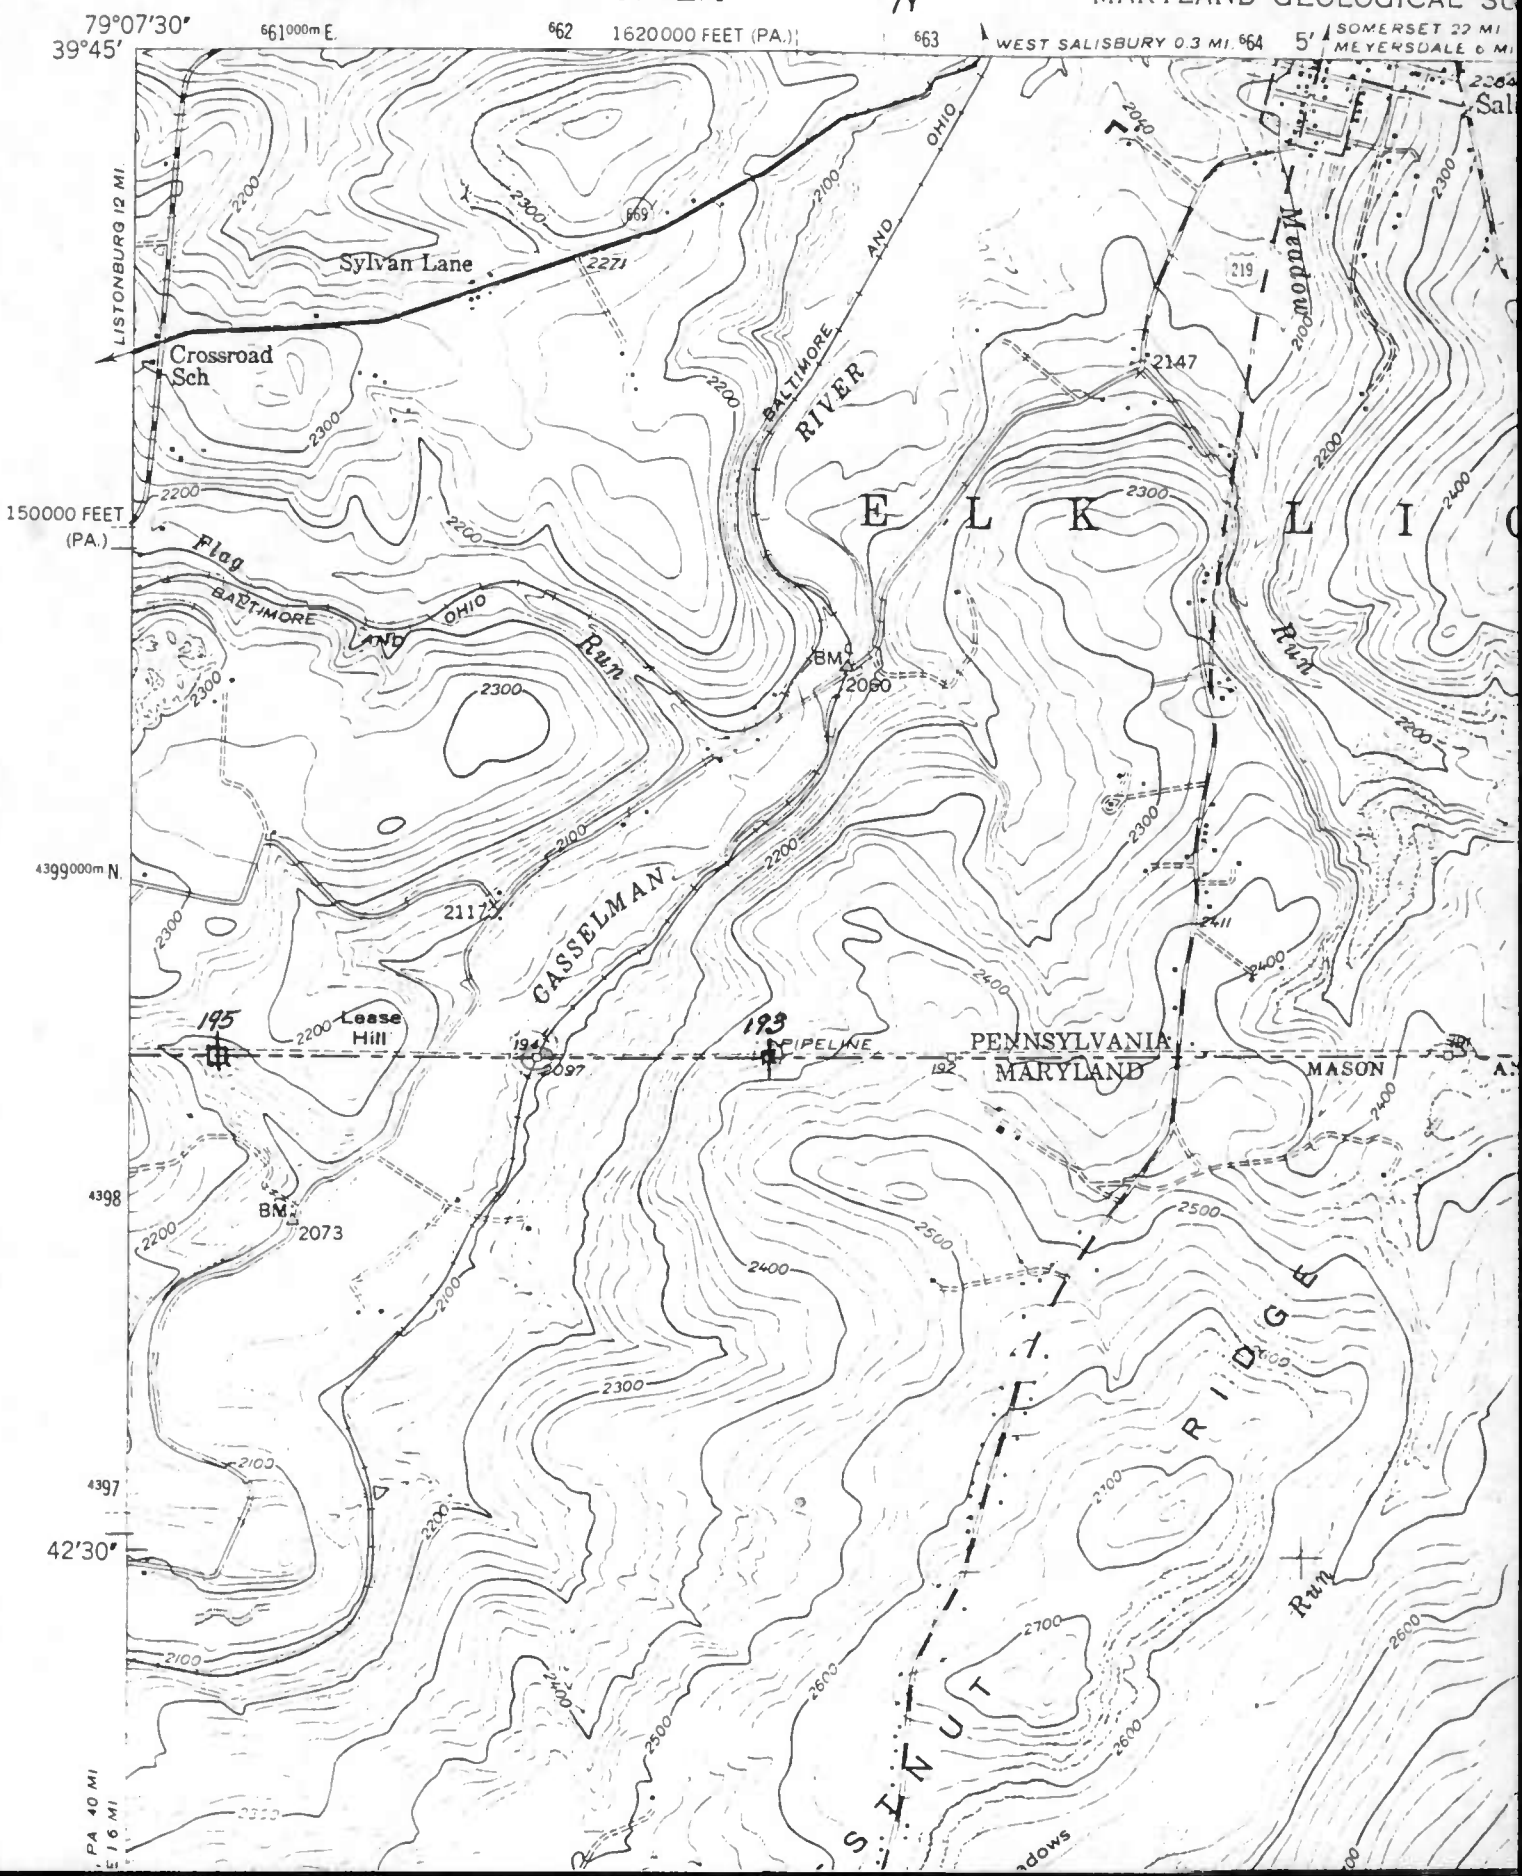
1979-81 Inspection notes: order no. --- (194); photos/negatives/slides no.---(194) --- (194). New stone monument addition to the Line (1902); in place; in excellent condition; firmly set. Stands about 1½' above ground; chip in letter P, M and dates clear and intact. Protected by site and fencepost.
