HA-766 - HA-769

MARYLAND HISTORICAL TRUST

INVENTORY FORM FOR STATE HISTORIC SITES SURVEY

HISTORIC: Constant Friendship

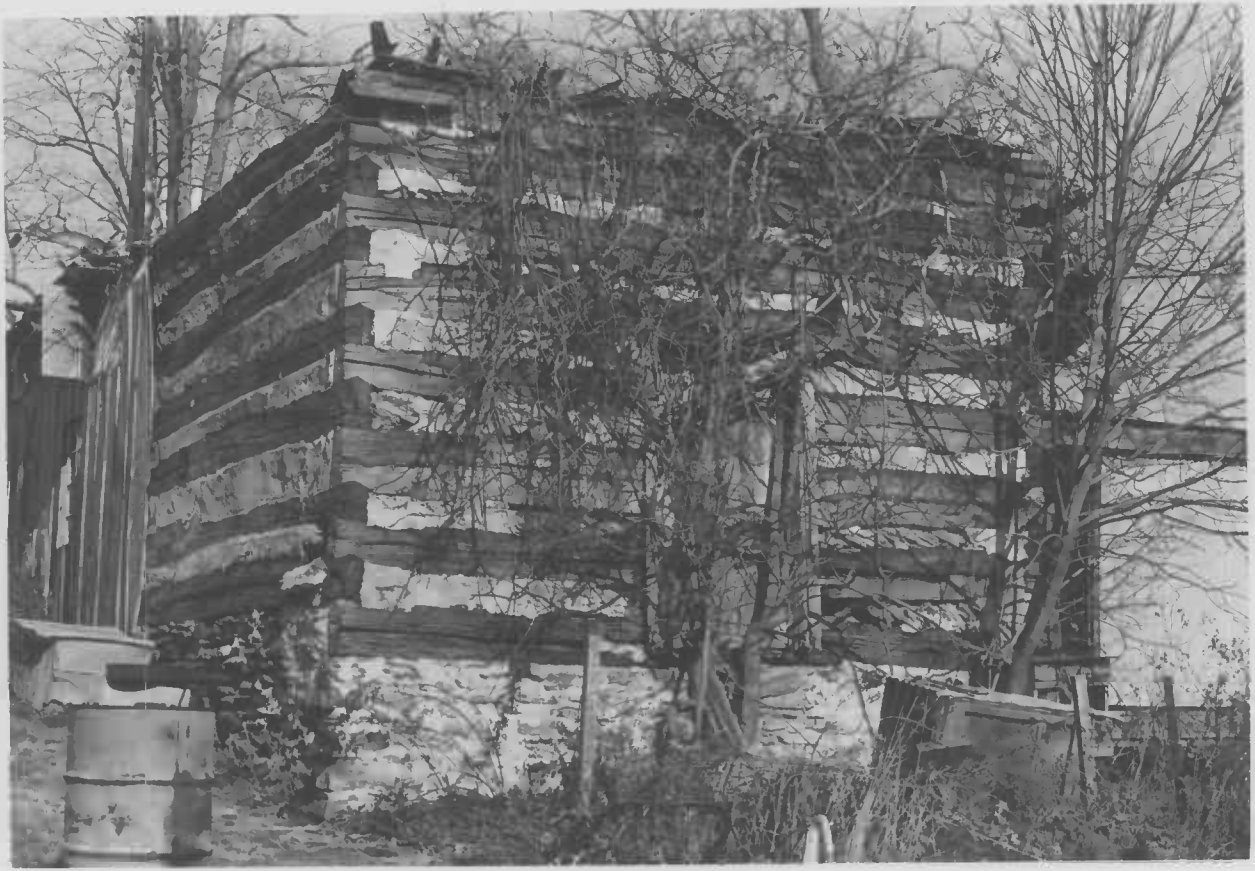
Constant Friendship HA-767
Log Out Building
Bel Air/Emmorton
Susan M. Deeney
November, 1976
South

The actual construction of this log smokehouse is sturdy-its interlocking log frame is plastered and chinked with stone. The slate roof of this building has fallen in, though, due to its weakening by extreme vine growth. This structure is approximately 8-10 feet square, one story, and it is built onto 3-4 feet high rubble stone foundations. A door is located on the south facade.
