PG 85-B-6
85-B-7
85-B-8
MAGI # 17015433635

MARYLAND HISTORICAL TRUST

INVENTORY FORM FOR STATE HISTORIC SITES SURVEY

AND/OR COMMON
Cedarville Natural Resources Management Area

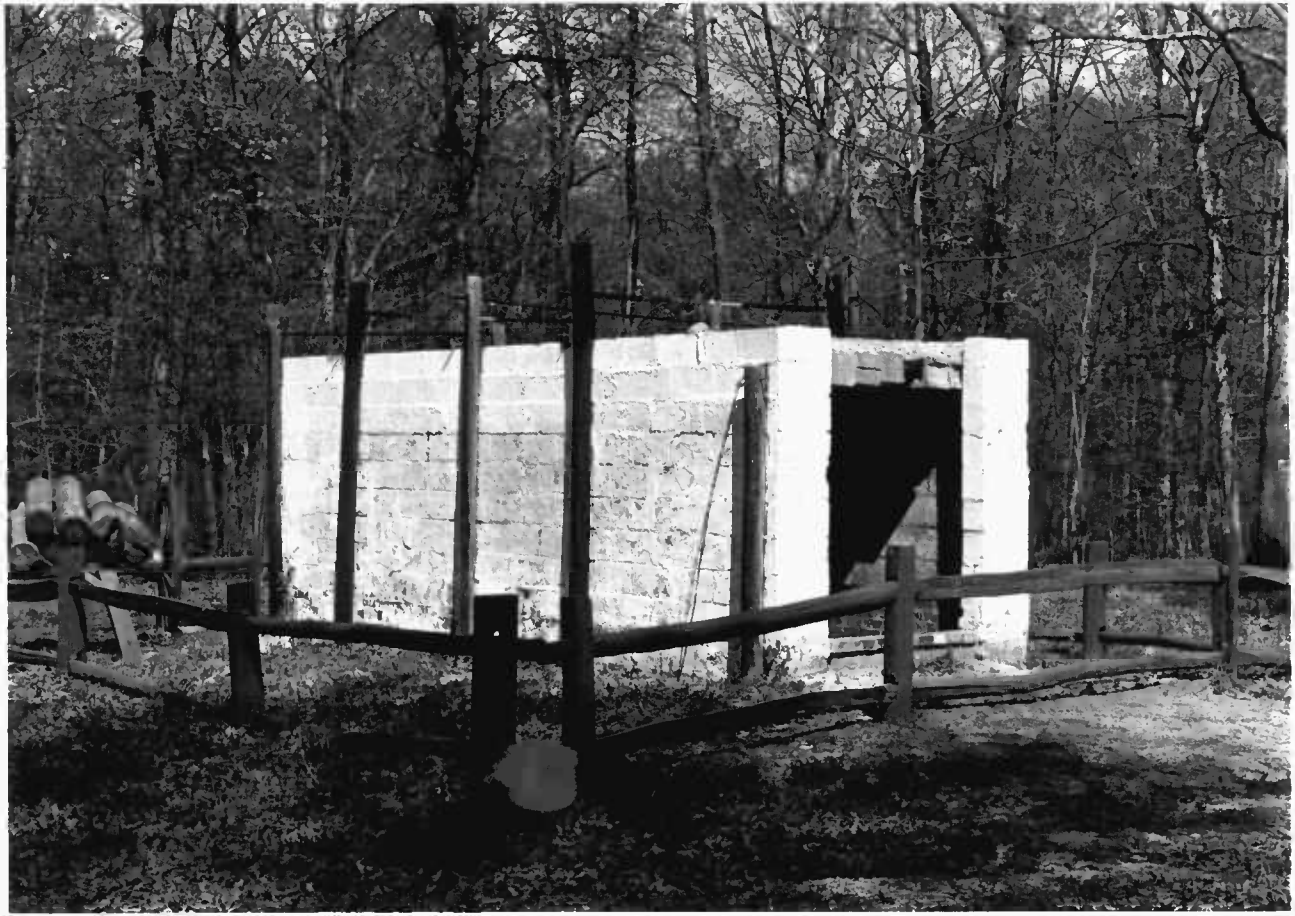
HG: 85B-8

Charcoal Kiln - DNR-19. A charcoal kiln constructed in the late 1940s/ early 1950s to demonstrate the production of charcoal in a masonry block is located south of the farmhouse on the west side of Cecarville State Forest Road. An identical kiln once operated adjacent to it. The following description of the kiln and its operation was authorized in May 1975 by Frederick R. Schutt, a Cedarville NRMA park technician.

CEDARVILLE CHARCOAL KILN
CEDARVILLE, MARYLAND
CEDARVILLE NRMA
