MARYLAND HISTORICAL TRUST
NR-ELIGIBILITY REVIEW FORM

Property Name: Small Structure No. 13166XO Inventory Number: HO-753

Project: MD 983 over Tributary of Patuxent River Agency: SHA

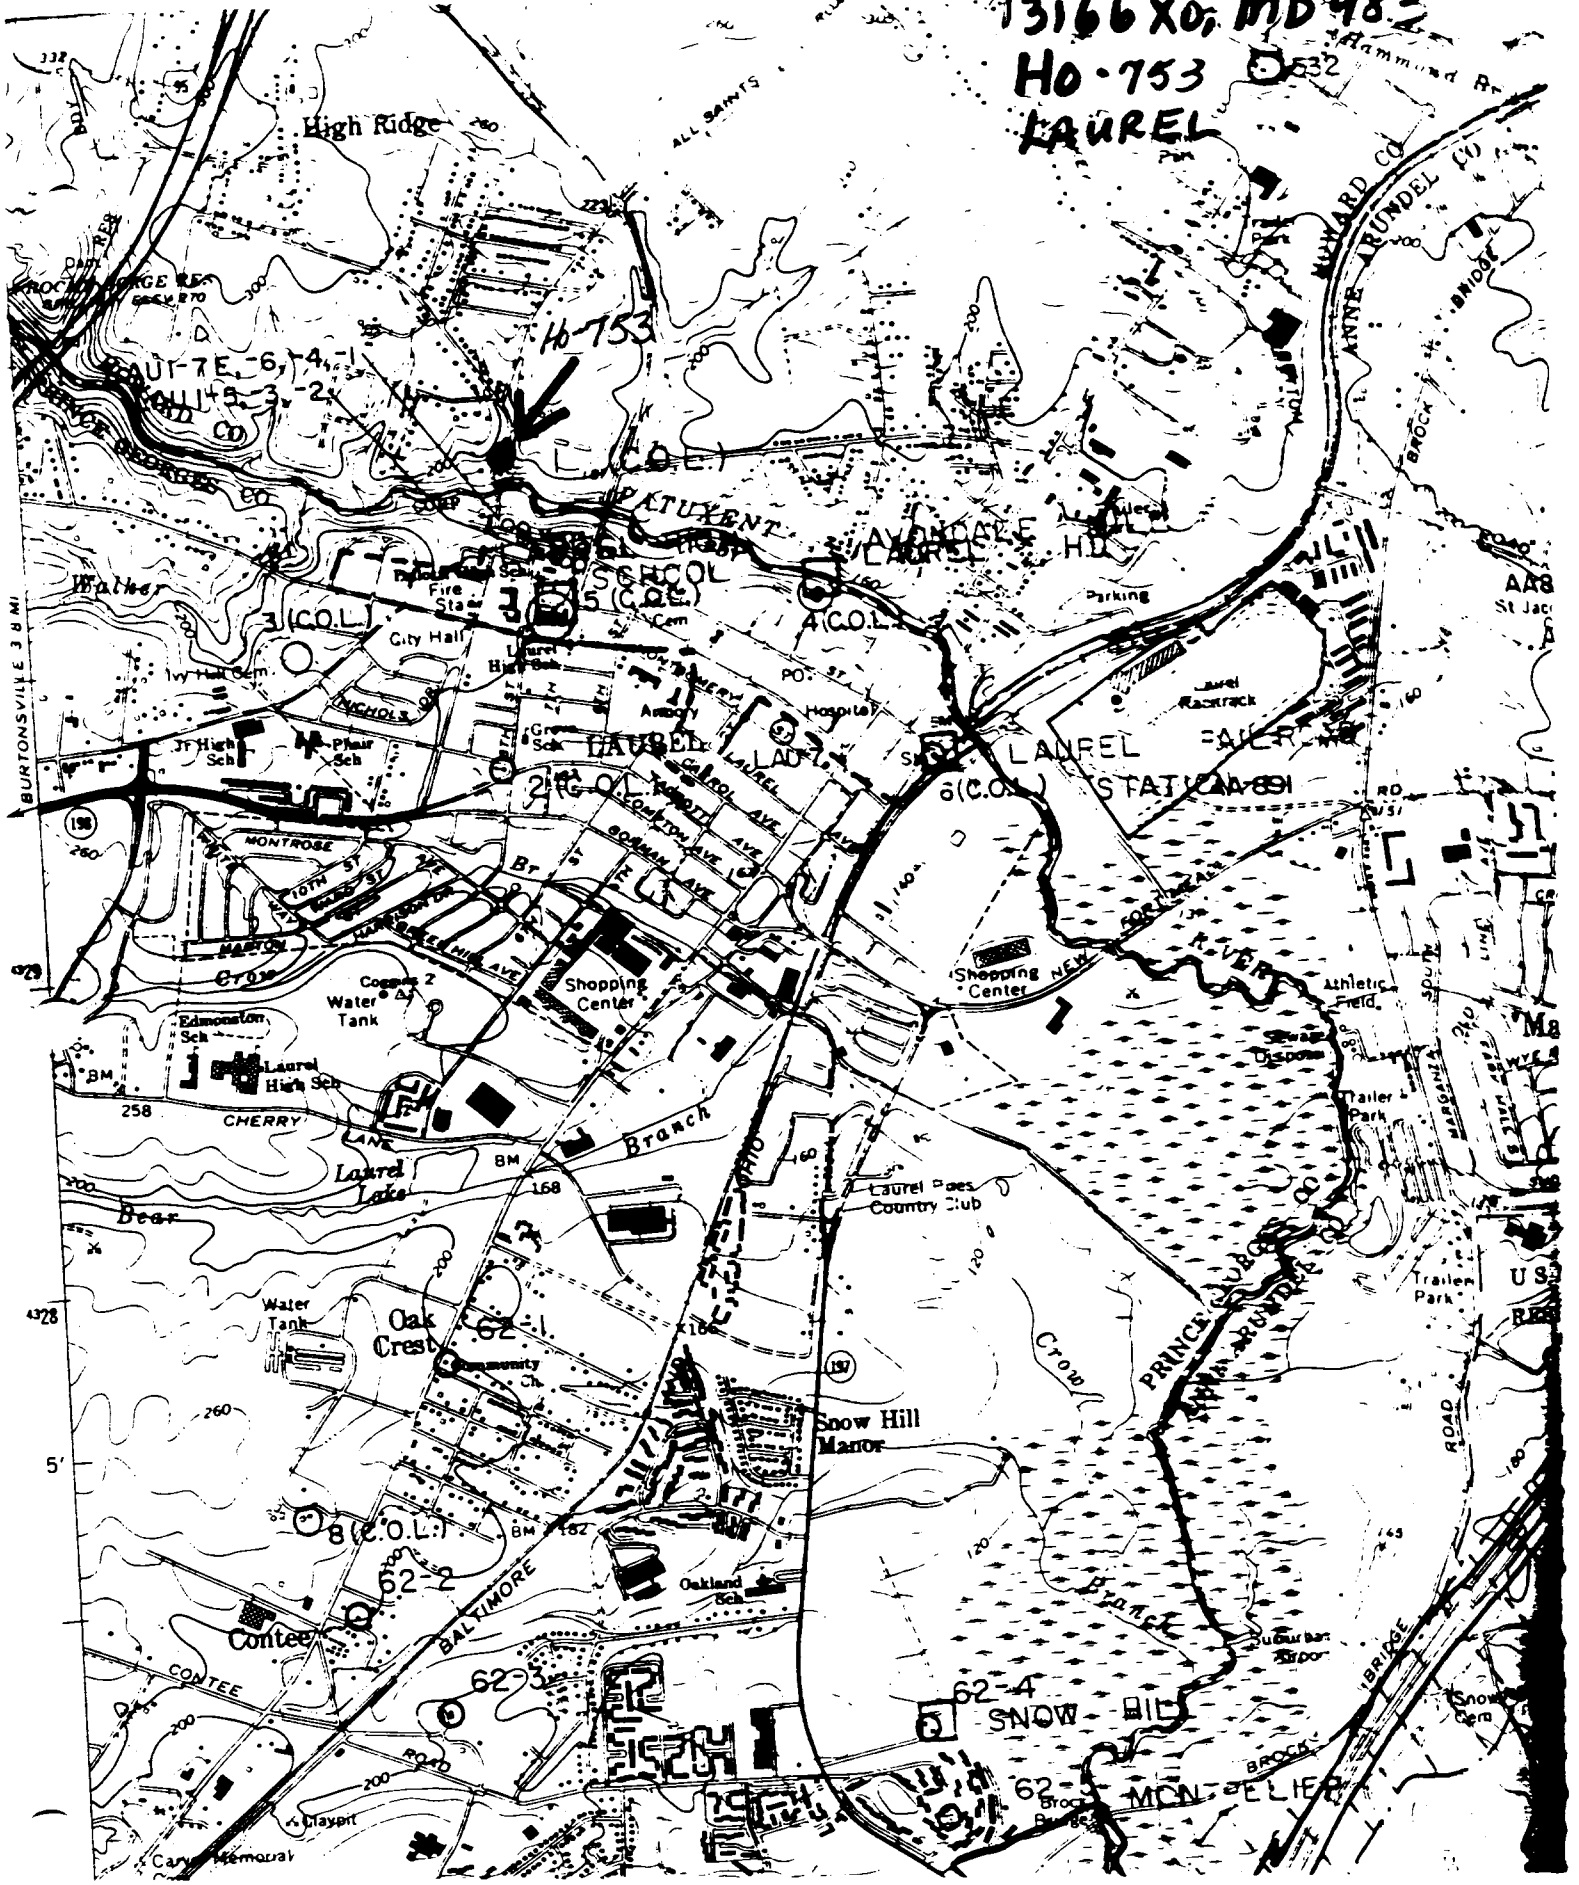
13166 XO; MD 98
HO-753
LAUREL

Small Structure No. 13166X0 is a concrete slab small structure, with three-foot, seven-inch span, built at an unknown date, which has been repaired repeatedly to address structural deficiencies. The structure is on a pronounced skew, with the short slab on the west elevation, supported on highly deteriorated rubble stone abutments, lacking a parapet. The east elevation is characterized by a long spandrel wall, with a concrete parapet, which is lacking wingwalls. The slopes are supported by riprap. The rubble abutments have deteriorated, voids have appeared in the road, and wall, and portions of the concrete parapet/wingwalls have failed. There is undermining of the footings of abutments.
