# Appendix A

## Facility Overviews

This appendix profiles 21 existing State-owned and -operated facilities in detail and also describes the proposed Baltimore County Juvenile Detention Center. Our recommendations for each of these facilities can be summarized, briefly, as follows:

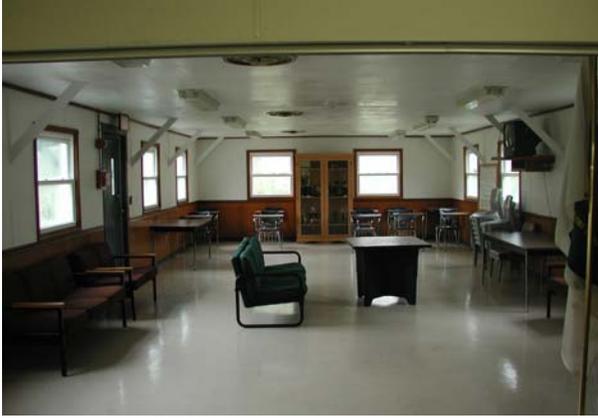
The dormitory is a wood-framed building built over a crawlspace. The toilet, shower, and laundry areas are in an adjoining building area several steps lower, of concrete masonry construction on a concrete slab. There are moisture problems at the base of this building. The dining area had a significant interior humidity problem when the facility was visited in late spring, possibly caused by inadequate ventilation of moisture from cooking operations. The school is a leased modular building

A diligent maintenance staff keeps things running, but replacement of older buildings such as the kitchen/dining facility and the dormitory building will likely be required in the next decade or so. One modular classroom should also be added to this facility.

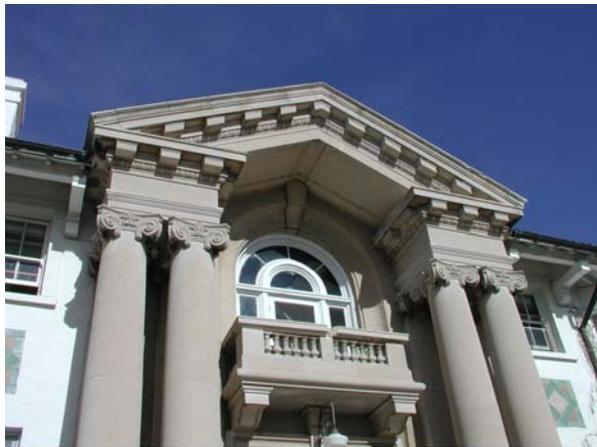
## **OTHER BUILDINGS**

The remaining buildings on the Pratt campus include the main Administration building for the entire Hickey facility, the food service facility, the intake/infirmery building (Master Control), a school, and a gymnasium. The administration building was constructed in 1923. This structure contains some 13,000 square feet in two stories plus a basement, and is similar in style to the old residential buildings on the Pratt campus. A chapel adjoins this building. Similar to the other older buildings, systems are antiquated. Only the second floor has a central heating-ventilation-and-air-conditioning system.

The Barrett Building on the Pratt campus houses food service facilities for the entire campus. Built in 1958, it suffers from outdated systems and a serious mold problem in the basement. The dining facility in this building served youths housed on the Pratt campus. Meals prepared here are still delivered to a satellite dining facility on the Fletcher campus.

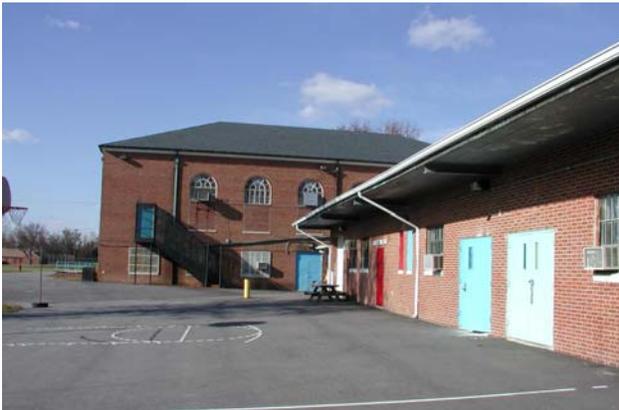
The gymnasium connects to the school, constructed in 1960. The 24,000-sq.-ft. school is also on two levels, situated on a slope, with vocational shop areas accessed at grade from the West and its classrooms arranged along a double-loaded corridor. The structure consists of masonry exterior walls with concrete “dox”-plank floor and roof structures.

Meals are prepared and served in the Lane Building, constructed in 1951. This two-level building contains the kitchen and dining room on the upper level, with a central laundry on the lower level. The laundry’s dryers are fueled by propane. This structure has masonry walls and a concrete waffle slab floor system. There is evidence of corrosion of reinforcing steel, attributable to the serious humidity and moisture problems, particularly on the lower level.

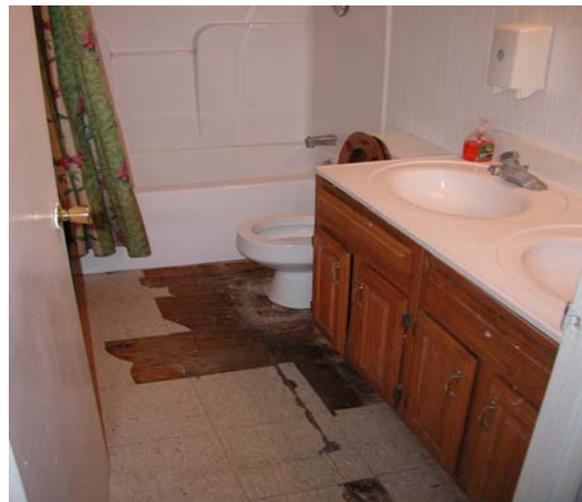
There is an ongoing problem with the basement flooding, which appears to be due to the ineffective stairwell drain and storm drain line. In addition, vinyl sheet and tile flooring in the kitchen and the two resident bathrooms has deteriorated to the point where moisture has damaged the subfloor. Subfloor in these areas should be replaced, and new flooring installed.

The building overall is in fair to good condition, but the level of wear imposed on this building by 8 to 10 boys requires diligent maintenance. The storm drain leading from the basement drain should be investigated, and flooring repairs should be made to the kitchen and bathrooms.

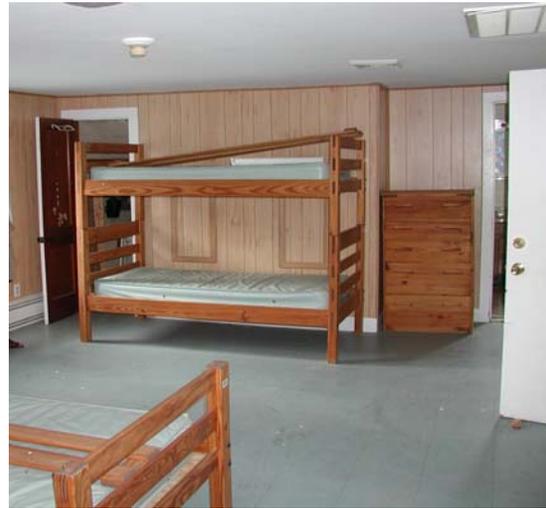
The building is in generally good condition. There is water damage to the second floor ceiling at the rear of the house from an apparent roof leak. There is also damage to the first floor bedroom closet ceiling from a second floor bathroom-plumbing leak. The exterior stair contains some damaged and rotting wood. No code deficiencies were observed. With classification as a residential occupancy

To accommodate both boys and girls, modifications should be made to the first floor bathroom to add at least a shower. This would allow one gender to occupy the larger area on the second floor, while providing one bedroom that could house two youths on the first floor. Repairs should be made to the damaged roof and ceilings and the egress stair.

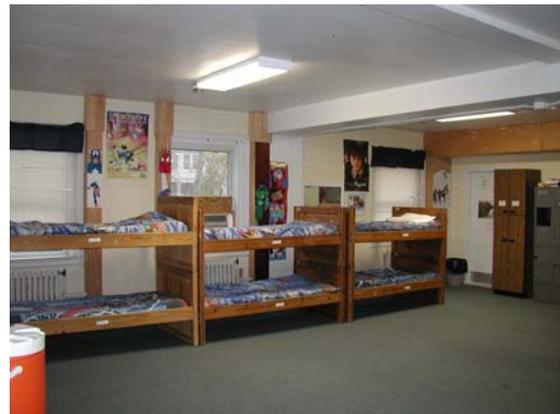
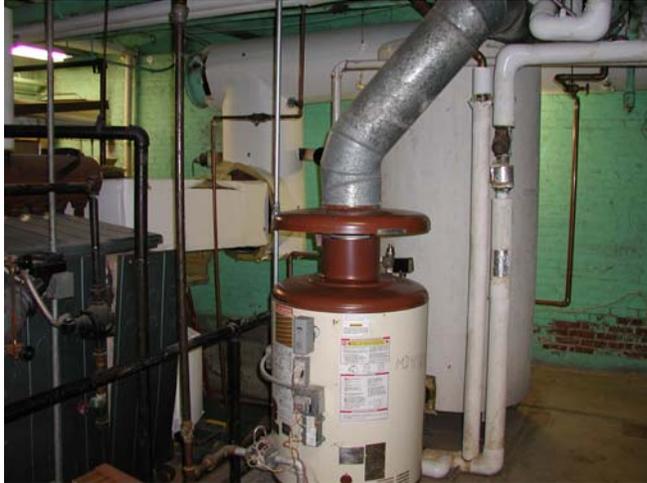
Although the sleeping rooms are clean and fairly well maintained, the dorm-style bathrooms are in poor condition, owing mostly to continuing leaks in the plumbing system. Building systems, including heating and plumbing piping, are for the most part original to the building and obsolete.

A central boiler provides steam heat to the building; there is no central air conditioning. Window units in the offices and bedrooms provide cooling. All windows are vinyl replacement units. There are security screens as the interior of the windows. The elevator is ancient and likely original to the building. There has been some abatement of asbestos.

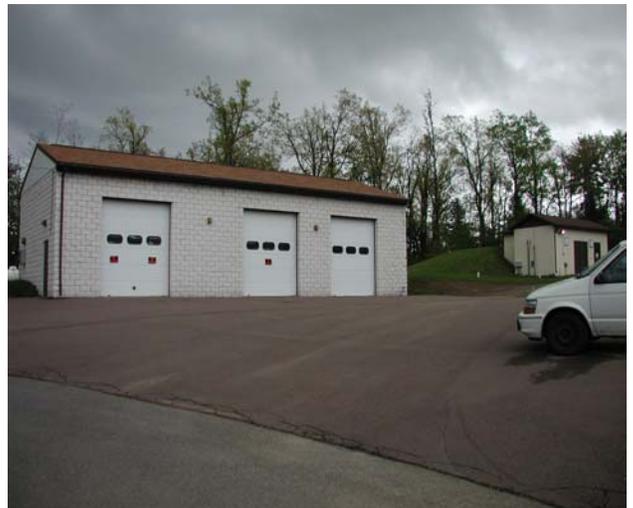
Most of the buildings are in good condition, except for the modular school building, whose concrete masonry foundation shows cracking. Harsh winter conditions make continued diligent maintenance necessary.

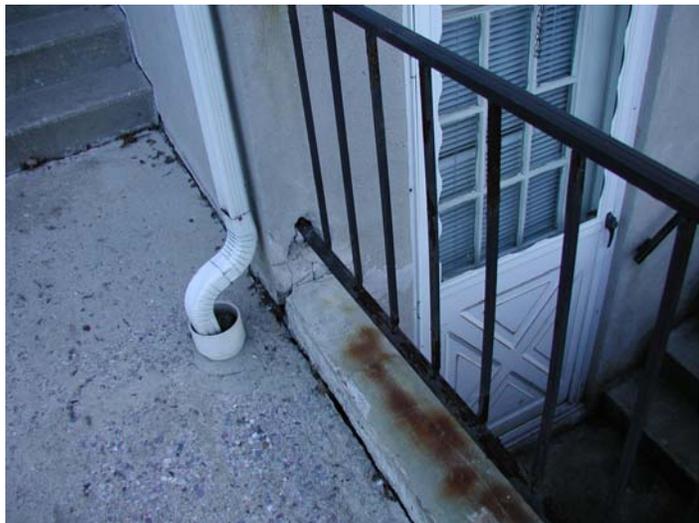
There are moisture problems in the basement. Drainage from an adjacent property is directed toward the Shelter. The sewage system

relies on an ejector pump. When power fails, toilets and showers are unusable. There is some spalling on the foundation concrete and at the paving.

The building is overall in fair to good condition, but the level of wear imposed on this building requires diligent maintenance. The basement moisture problems should be addressed after an examination of the foundation drainage problem.

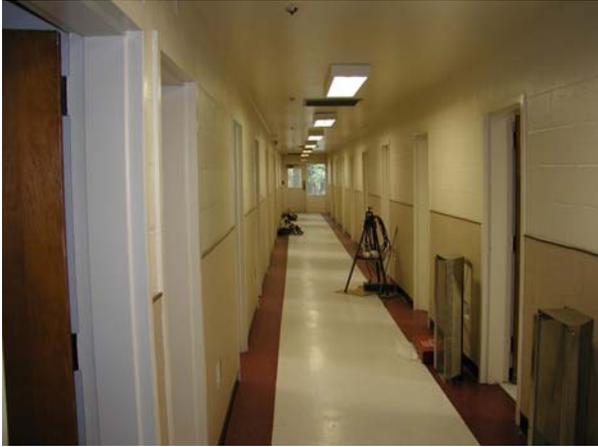
## RESIDENTIAL BUILDINGS

The five residential cottages were constructed in 1972. They are identical one-story buildings of about 5,800 square feet, with concrete masonry unit exterior walls and precast concrete plank sloped roofs. Each cottage contains 18 single bedrooms, dorm-style bathrooms, and common lounge and classroom areas. The cottages are heated with individual hot-water boilers. There is no central air conditioning. One building has been recently renovated on the interior and is in excellent condition, with a new fire alarm, emergency and exit lighting, and sprinkler system. All cottages need roofs replaced. The

roofs are a low slope, and the current shingle roofs were installed with no ventilation beneath the shingles, leading to the deterioration of the material.

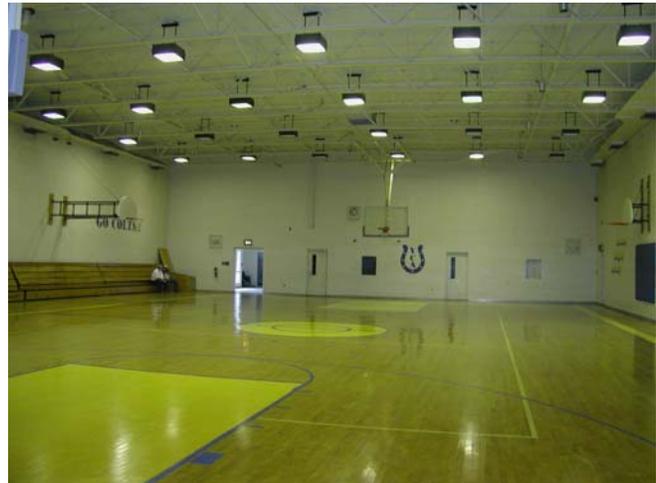
## GYMNASIUM

The gymnasium, built in 1972, is in good condition, although the building is unsprinklered and has an outdated fire alarm. Exterior walls are concrete masonry units faced with brick. The roof structure is steel bar joists and metal deck. The toilet and locker rooms are in fair condition. The 13,000-sq.-ft. gym provides a full-size basketball court and has an elevated stage at one end. The building is handicapped accessible, although there is not handicapped access to the stage. The gym is used by local schools.

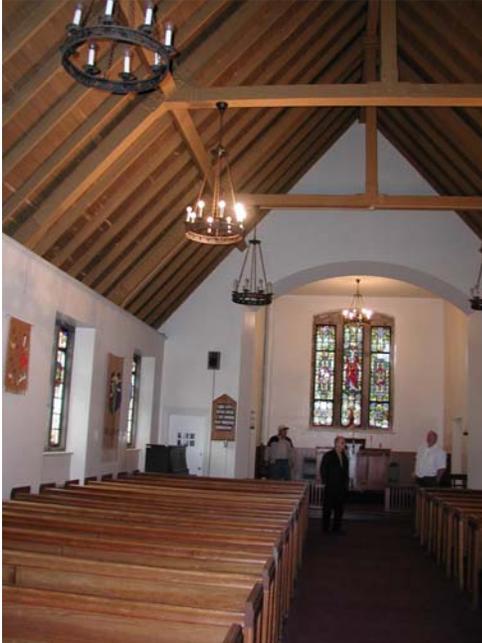
The remaining buildings on the campus include a modular school building, which is in poor condition and nearing the end of its useful life. There is a serious mold problem in this building. A one-story library building, constructed in 1993, is in good condition, although in need of a new roof. An attractive stone chapel sits just outside the security fence. It was constructed in 1933 and is in good

condition. Near the chapel on the outside of the security fence is the superintendent's residence, a two-story stone and shingled house built in 1932. Its condition is good. The adjacent staff apartments, constructed a few years later, are in poor condition. Small storage and maintenance buildings were not investigated.

The Cullen campus is an excellent resource for DJS. The existing buildings, within a secure fence, contain valuable space that could be used to house youths needing a secure facility. The school building should be removed. Residential functions should be removed from the Cullen Building, which could be better used to house educational functions, along with the administrative and dining functions. Information technology infrastructure, i.e., cabling, should be added. Three cottages still require renovation and all cottage roofs require replacement

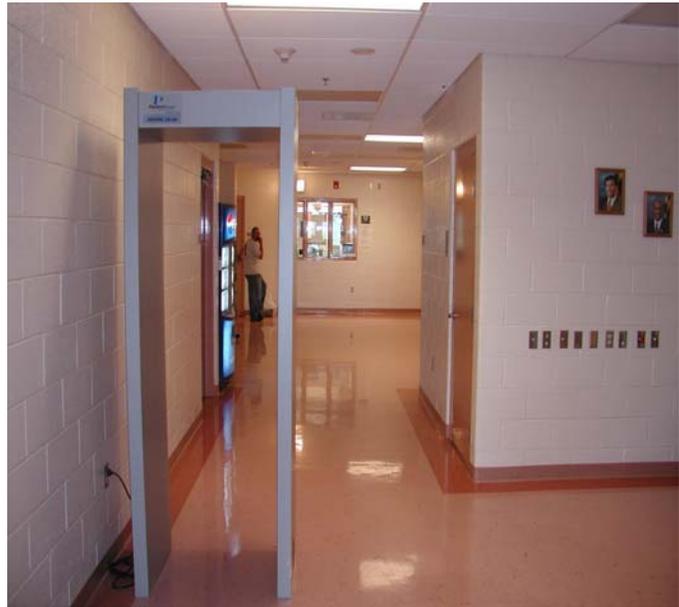
The recently constructed building exhibits no areas of code noncompliance, but there have been problems with construction deficiencies, including heating-ventilation-and-air-conditioning problems, noninstitutional grade plumbing fixtures, and malfunctions of drains, locks, and other items. The facility has been subjected to an outside engineering review.

As at BCJJC and Carter, metal beds present a suicide hazard.

With resolution of construction-related problems, the facility should function well.

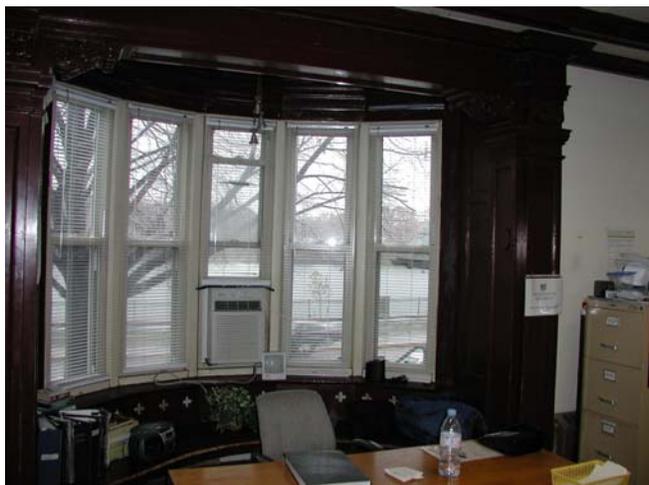
The eastern building, at 907, contains areas used by the residents. The building has been a boys' group home since 1992. The first floor includes a dayroom and meeting areas in the original living and dining rooms, administrative offices, and a dining room and kitchen in a rear addition. There is a full commercial kitchen, but it is not used for meal preparation—instead meals are prepared at the Maryland Youth Residence Center. The central hall has an open stair leading to the second floor, which contains additional office space, plus four dormitory-style bedrooms and bathrooms. The basement includes a boiler and a hot-water heater, as well as an indoor recreation area. The building is a Tudor-style structure, with much of its elaborate woodwork and detailing intact. There is a shortage of program and common spaces for the residents.
