Interim Report on Archival and Architectural Evidence
Old Senate Chamber at the Maryland State House

09/17/2008

Report by the John Greenwalt Lee Company

Lead Investigator: Charles A. Phillips, AIA, AIC
with John Lee, Ellen Hagsten, and Lisa Wilkerson (CAD)

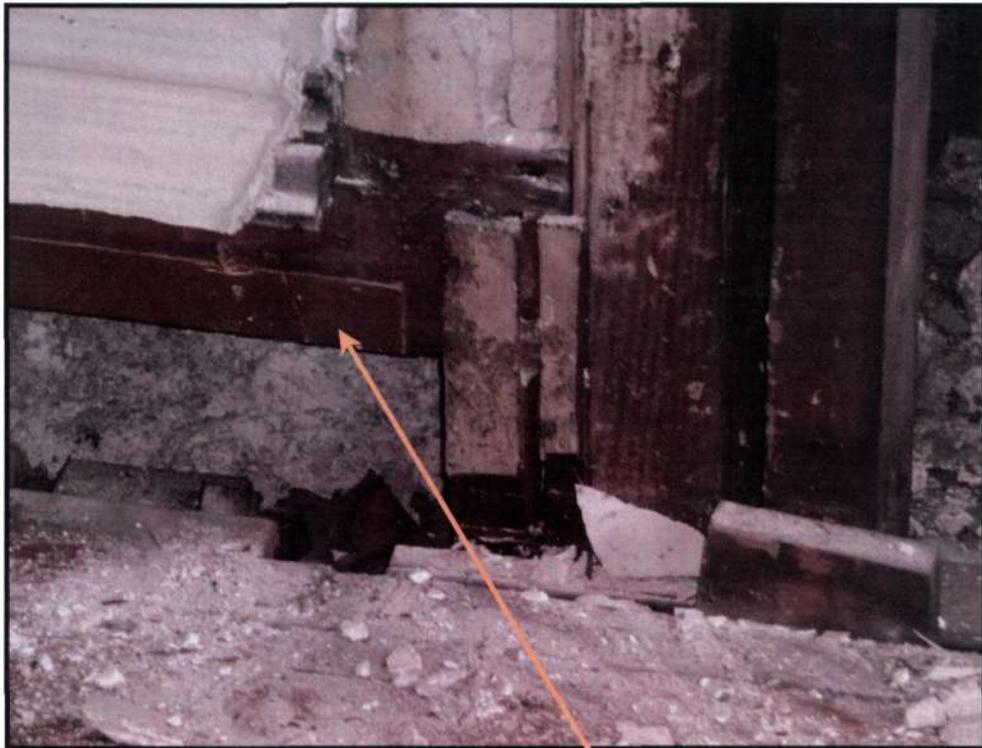
Reused board with 1878 maple graining

Annotation: Grounds for the 1905 baseboard just to the right of the dais included a reused piece of the 1878 trim, thus providing an example of the light wood with two-toned graining used throughout the building in 1878.

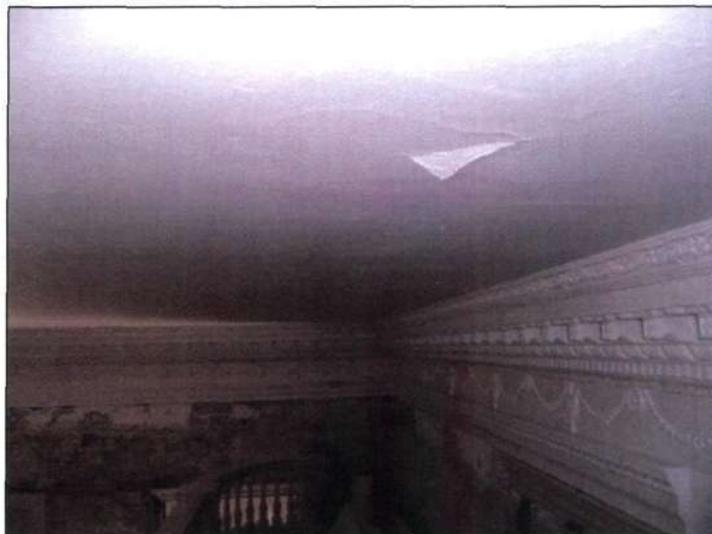
1905 ceiling plaster looks fine from the floor, however it is experiencing the same failure symptoms as the wall plaster – just not yet as pronounced. Recommend replacement as with the wall plaster as it will need to be replaced within the next decade with considerable mess and damage to lower work. Removal may assist current re-piping project

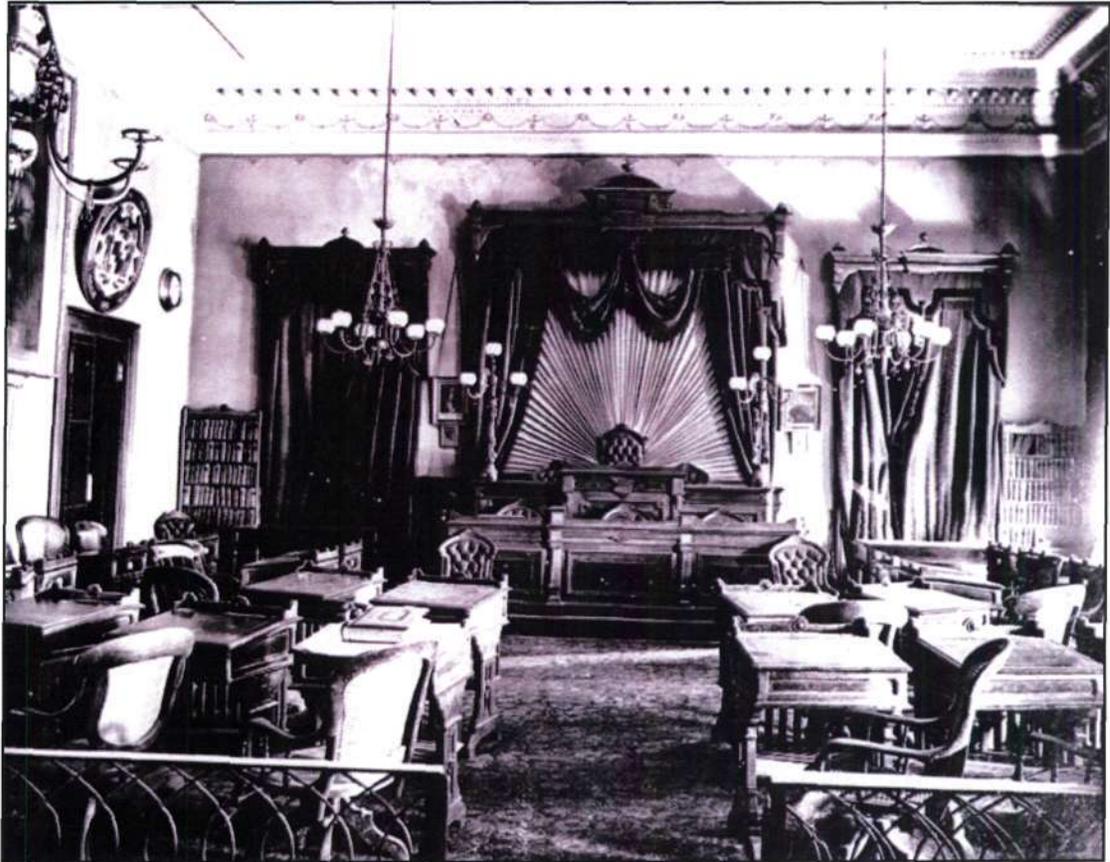
This is the cornice as recreated in 1878.

None of the individual parts match the photograph from 1868 that shows the previous cornice, although they are generically similar. There is an additional step in the plaster between the cornice and the field of the ceiling. This transition is decorated with a cast decorative band. As a quick reference, look at urns and the position and shape of the swag.

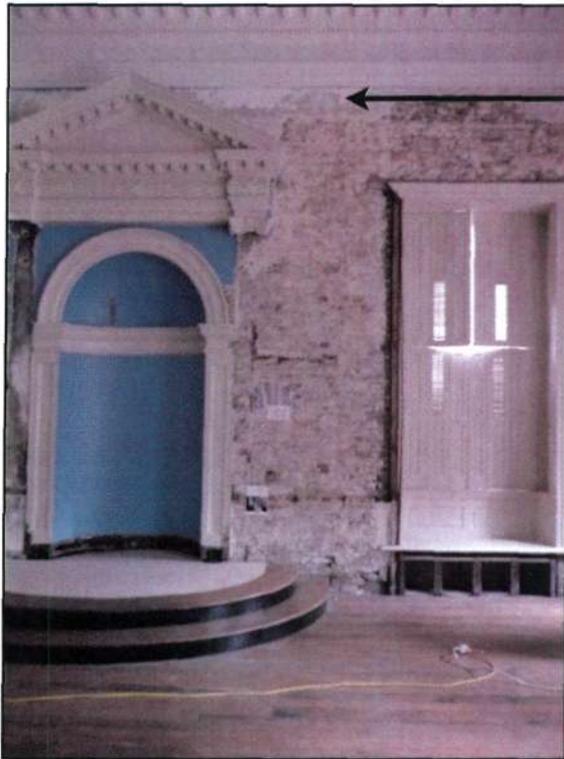
J.A. Wilson notes that the 1905 ceiling is about 3" lower than the 1878. This was verified in 2008 by removing the bottom band (architrave) of the cornice and finding 1878 wall plaster running 3-1/2" up behind it.

With 1905 blue wall plaster removed, note the 1878 wall plaster with intact finishes extends below and behind the 1905. The 1878 plaster is intact on the walls behind the current cornice and down about 3-1/2" onto the wall below.

According to J. Appleton Wilson, the ceiling was lowered by 3" in 1905. Why was an approximately two foot band of 1878 plaster retained around the room before re-plastering in 1905?

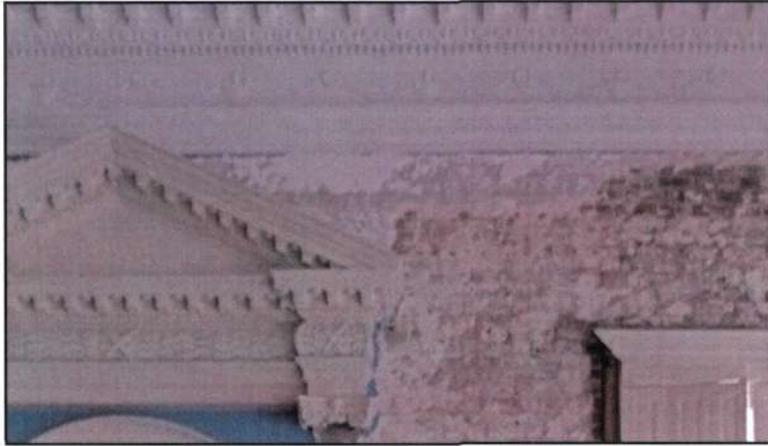
1905 rendition Nothing is centered over the niche, but a rosette is nearest. Urns are sharply conical, sitting on a narrow base. Large rosettes high than urn, creating asymmetrical swag drape. Draped swags do not touch bottom of band.

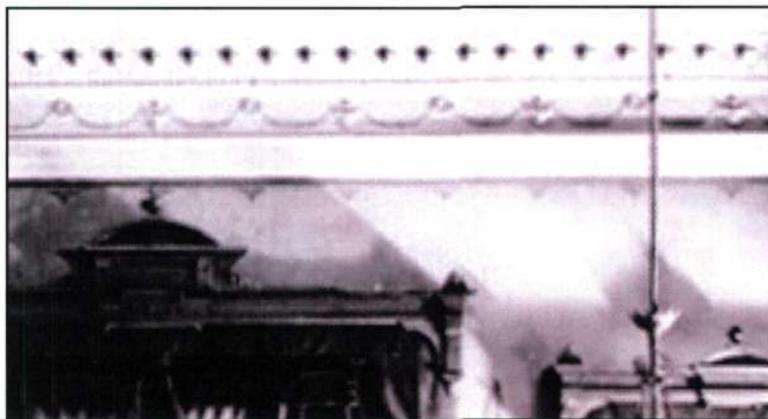
1878 cornice: An urn is centered over the niche, swags are considerably more flattened, nearly resting on the bottom of the band and rising higher on urn with a wider spacing between elements.

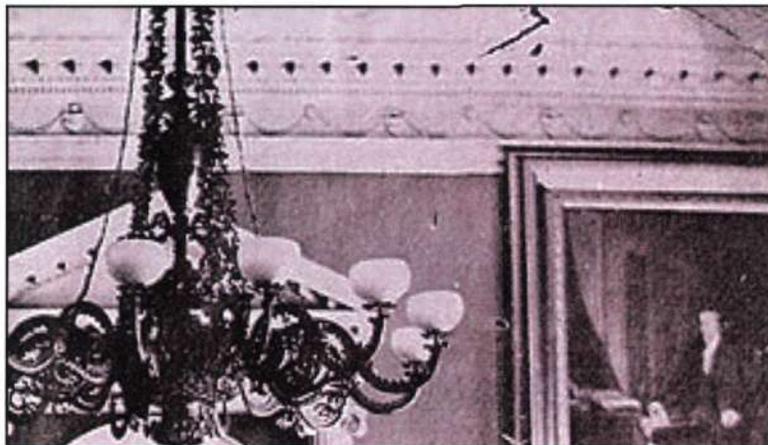
1868 view: Urns are much stouter and very rounded swags touch the bottom of band before rising to mid-point on urns.

Annotation: Details are not consistent from one era of cornice reconstruction to the next.

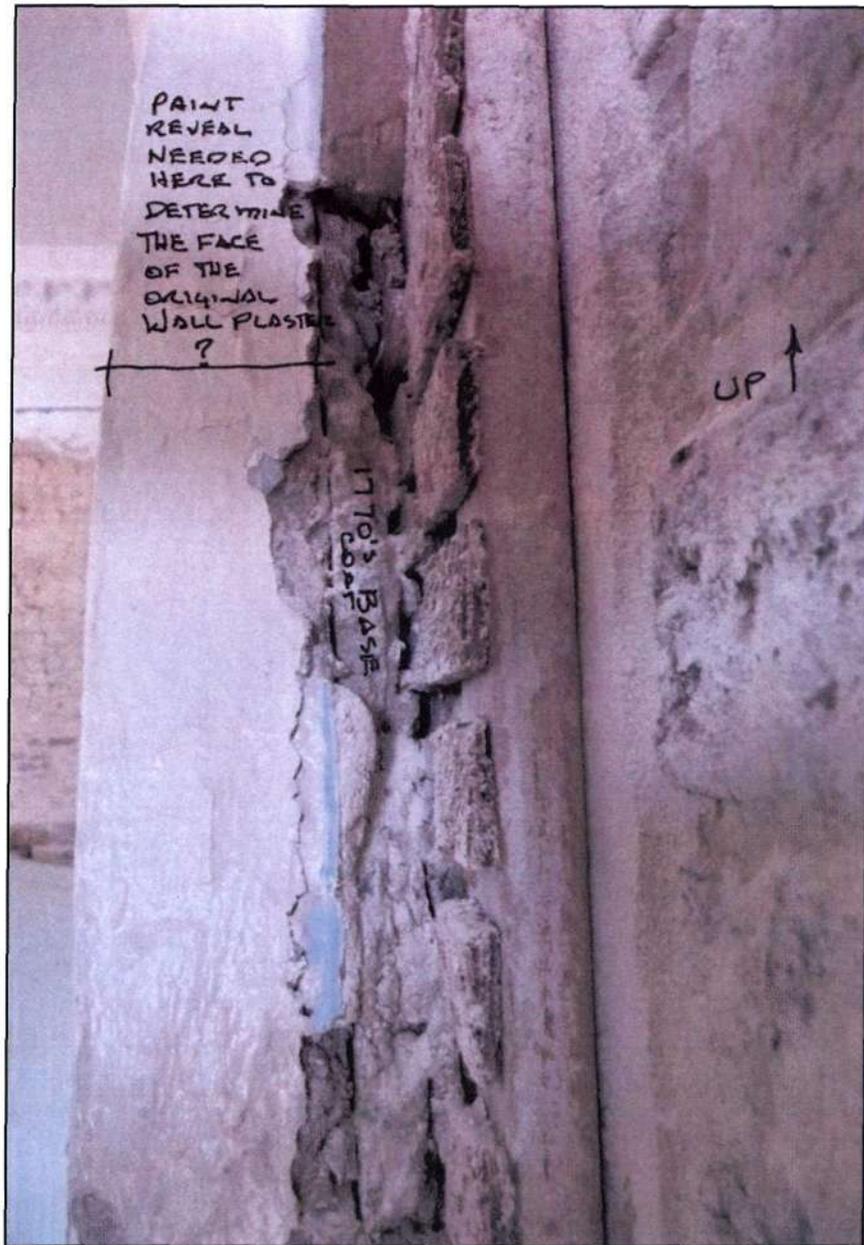
The right edge of the niche revealed in section showing the original construction with the lath running behind wooden pilasters.

Careful removal of the paint on the edge of the woodwork here may provide additional information about the original thickness of the plaster adjoining the niche and the paint treatment on the woodwork.

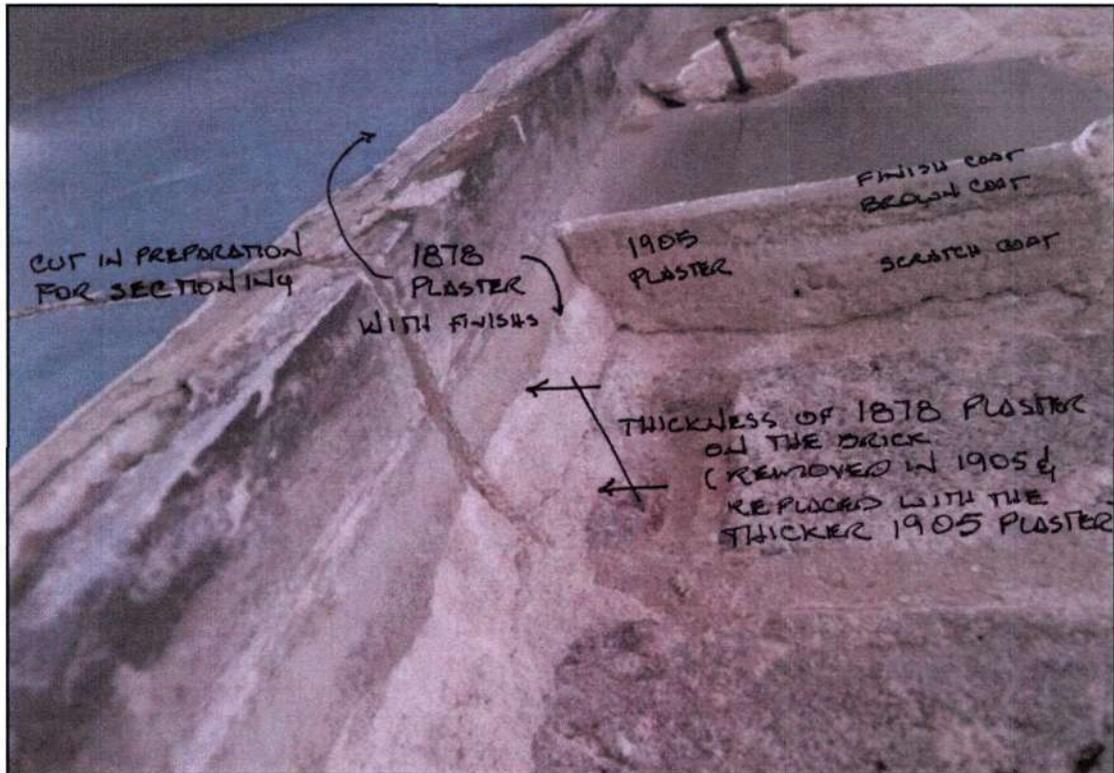
The right edge of the niche with 1878 plaster sectioned and partially removed up to the original 1770's plaster of the arched architrave.

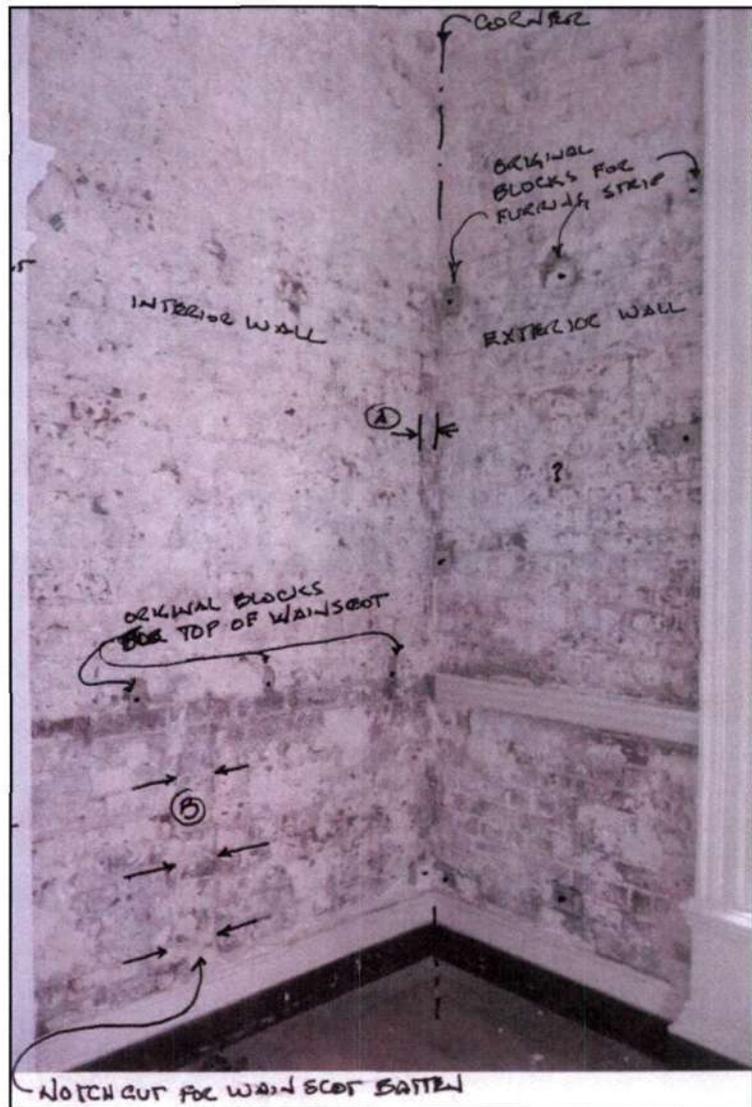
Since the wall plaster on exterior walls was not in contact with the brick and the wainscot was made of wood, there was no plaster contact either above or below chair rail height and the basic background color (below the 1878 and 1905 plaster haze) is the same shade.

Note that the walls above arms reach have not been as well cleaned as below at the time of this picture and are much whiter with plaster haze from the weak 1905 plaster.

At the corner, a darker vertical stripe (A) on the interior wall was protected from plaster by the adjoining corner furring strip from the exterior wall.

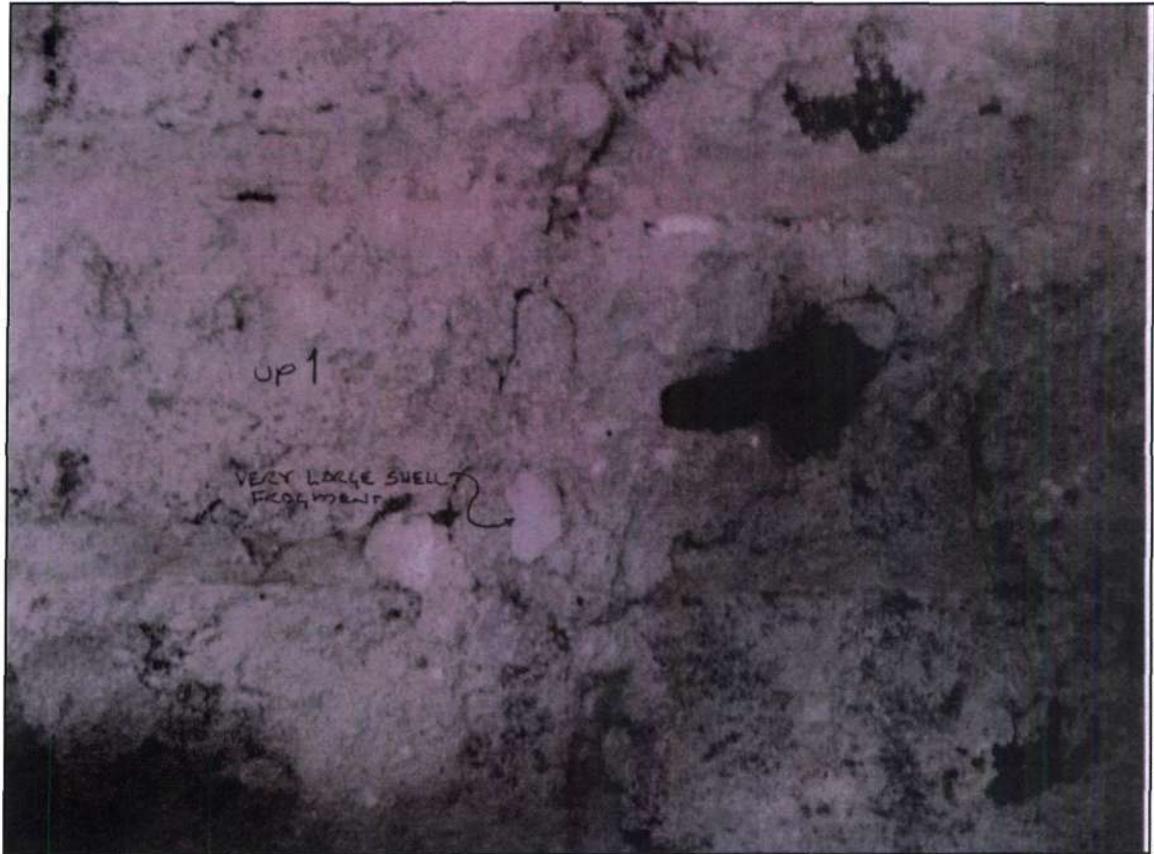
On the interior walls once the 1905 plaster was removed, numerous locations have bits of what appears to be original base coat with sizable chunks of shell flecks remaining. These obviously do not occur on the exterior furred out walls.

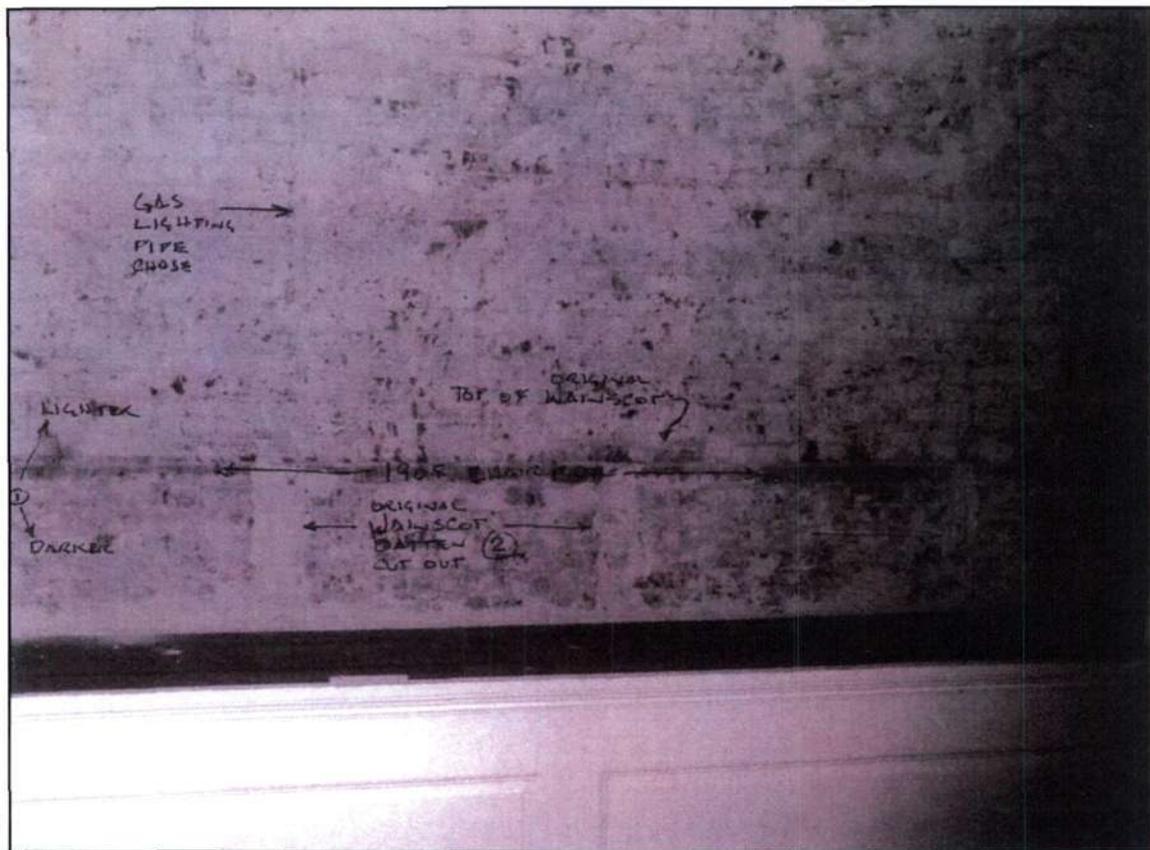
View of the back wall of the gallery shows the original wainscot was taller.

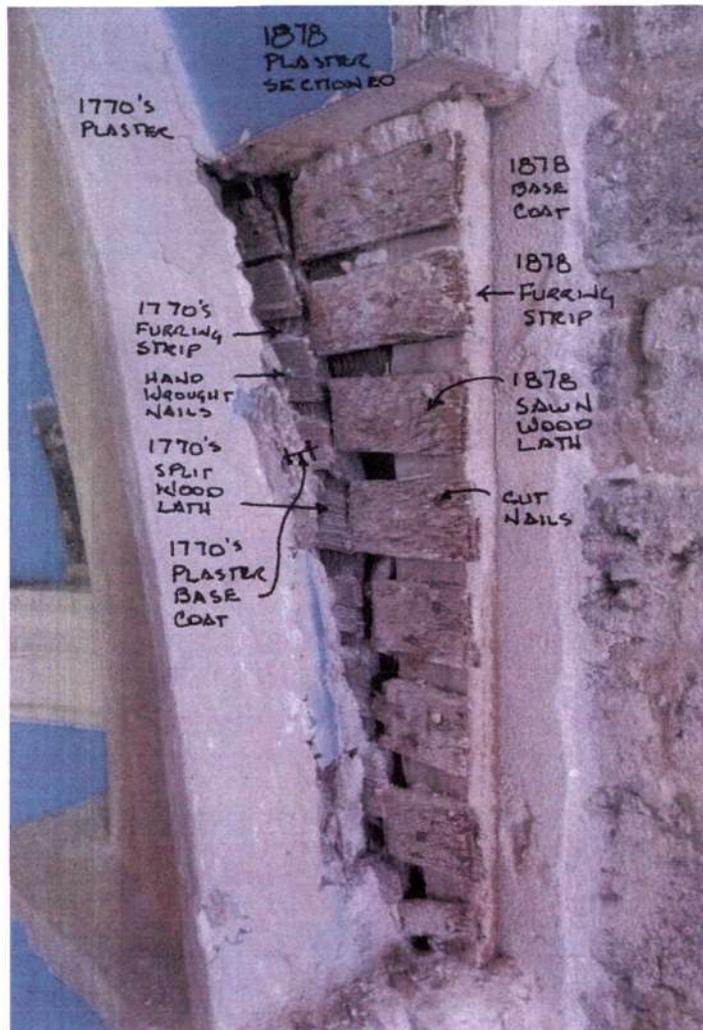
The 1905 and 1878 wall plasters on this exterior wall were applied directly on the brickwork. The 1878 plaster was furred out only at the spandrels of the niche.

All of the 1770's plaster was furred out on the exterior walls. Thus the furring strip, lath, and base coat of the 1770's plaster at the niche is indicative of the wall plaster used for the room originally - it just happened to be protected by the decorative plaster of the architrave at the niche which was not removed in 1878.

Where decorative plaster elements were added, they would most likely have occurred on top of the standard base (or scratch) coat of plaster with adjoining brown and finish coats of wall plaster abutting the decorative work. This means it is unlikely there will be any trace of the decorative plaster elements both on the furred walls and those that were directly plastered.

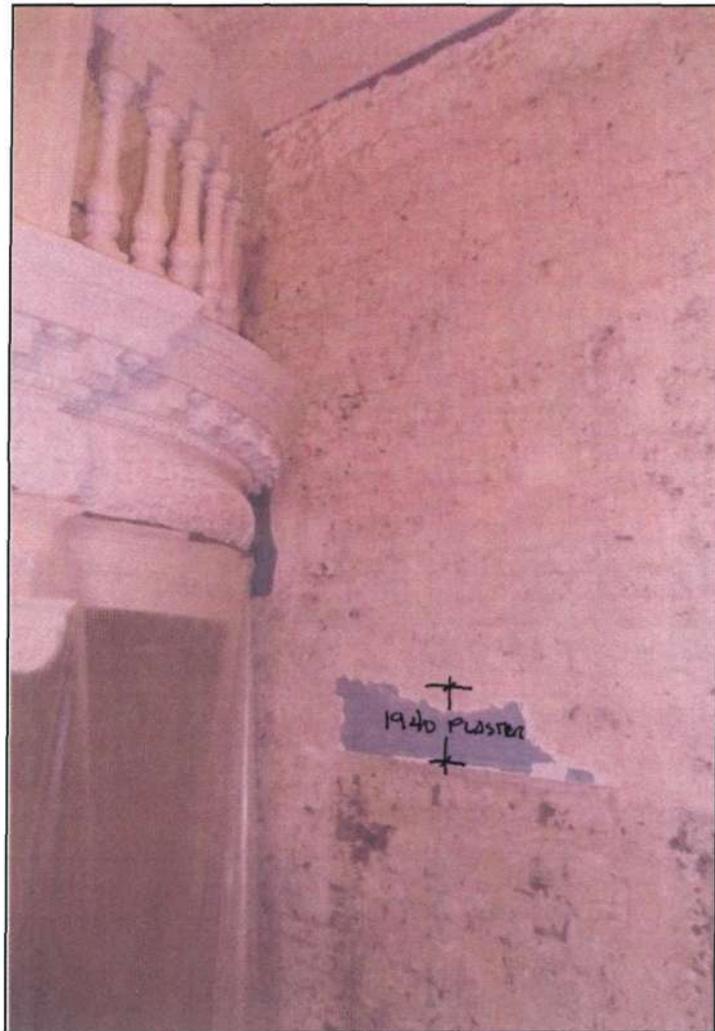
Infill plaster from the 1940s above the false door indicates removal of the 1905 overdoor. Because the design of the 1905 overdoor was not balanced by wider trim (or pilasters) below, it appeared top-heavy and so was removed in the 1940s as part of a reinterpretation of the restoration.

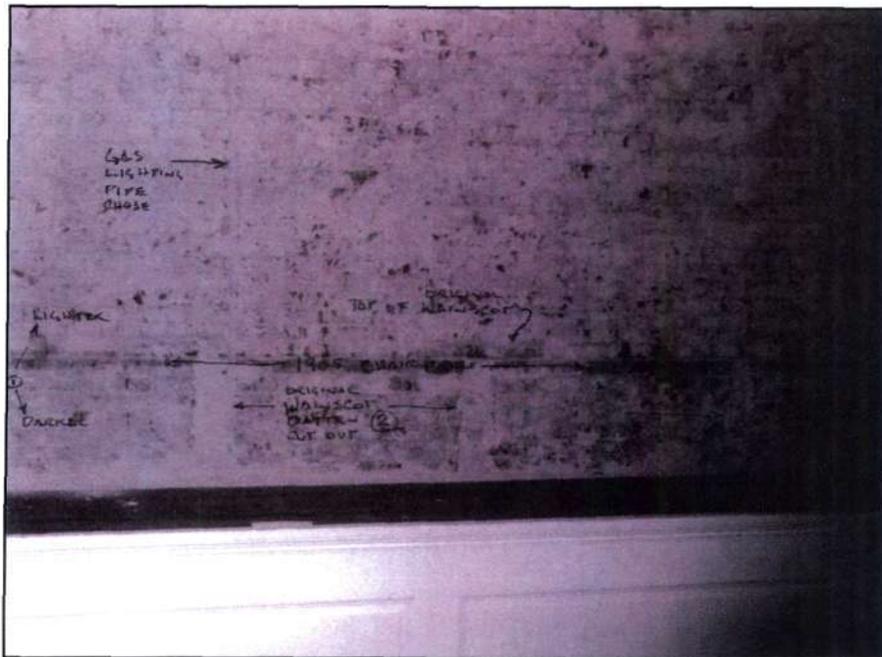
With the pre-1878 treatment of the room having plaster directly on the interior walls and wood wainscot below, the area below the original chair rail height is still markedly darker - in spite of the lime haze from the 1905 plaster coating everything. Note the difference in wainscot height down several inches with the 1905 restoration from its taller 1770s arrangement when the panels of the “plain dado” wainscot were originally attached with battens on the backside. The battens were chopped into the brickwork (see filled patches) to keep the face of the wainscot in the same plane as the plastered wall above.

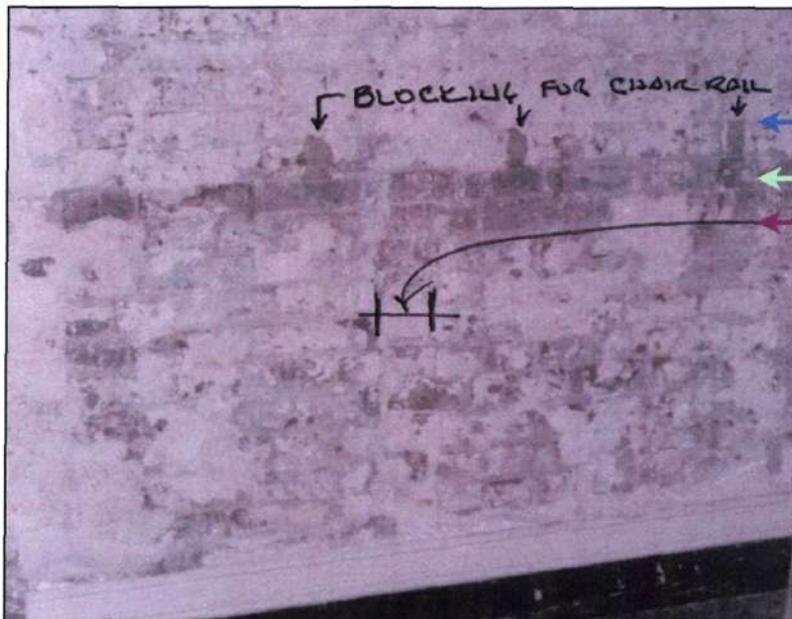
- ← Blocking for original chair rail higher than dark line
- ← denoting 1905 chair rail
- ← Brick relieved for batten

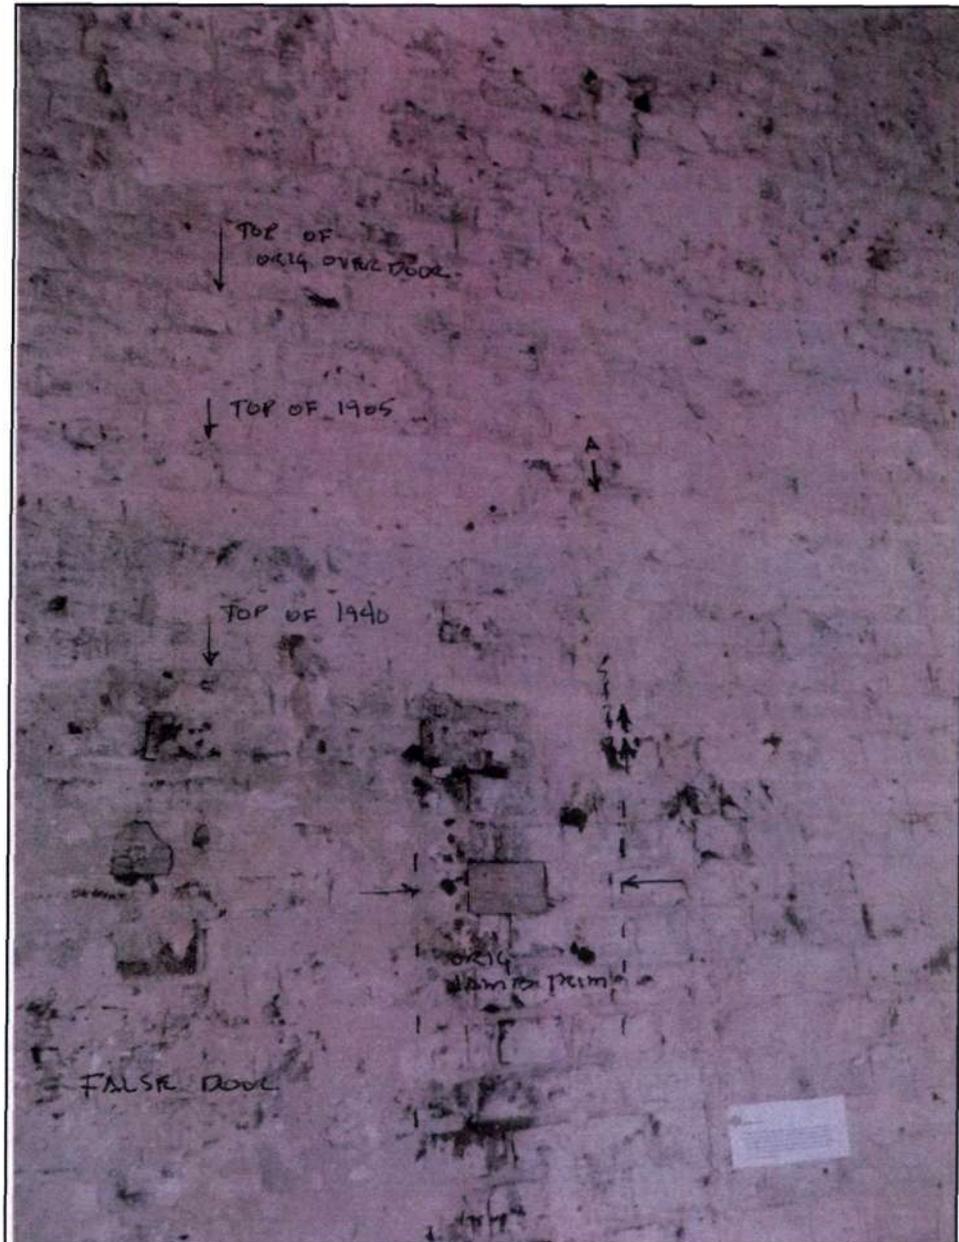
In this photo of the false door, both the 1905 and the 1940 plaster has been removed, along with the 1905 false door and trim (1905 overdoor removed in 1940). The top of the 1940 trim is approximately the top of the original pilaster capital and the top of the 1905 trim is about the top of the original frieze (A-A' is the vertical imprint line for frieze bracket).

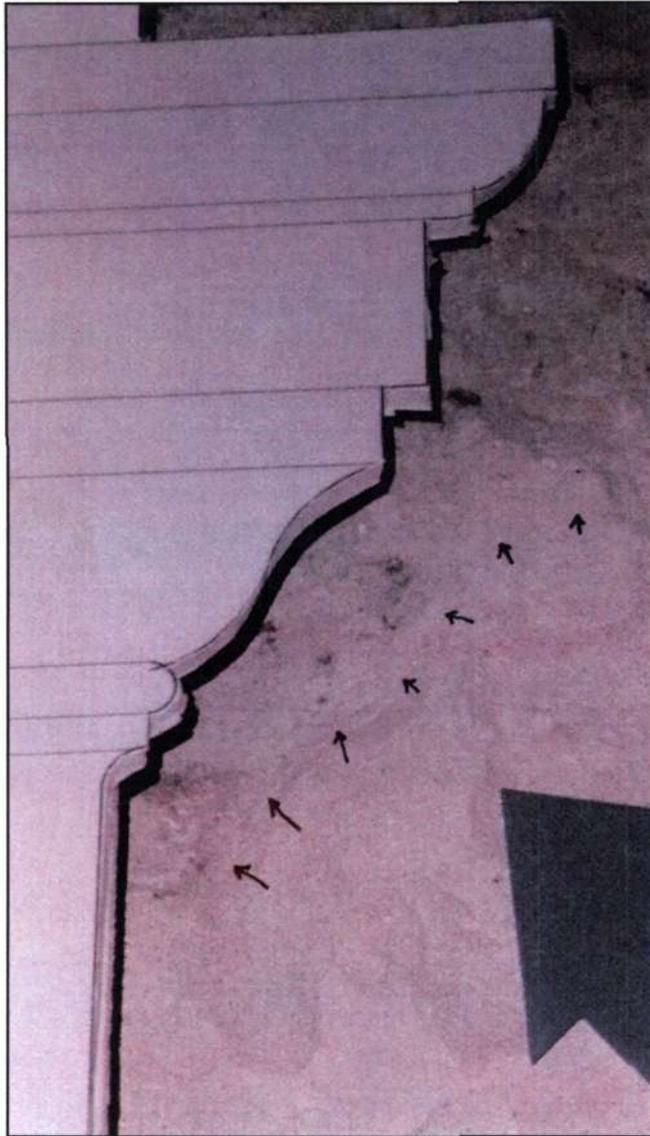
Also noticeable with IR is the edge of ridges in original plaster remaining on the wall at an intersection with the edge of the early entablature. The apparent straight edge at the height of the oak leaf frieze band suggests it was capped with brackets. The use of a bracket is suggested by Trumbull's paintings and sketches, but the configuration he sketches appears to differ with these ghosts.

[If there was not a bracket at the edge, the pulvinate (pillow-shaped) bulge of the frieze would end in curvature where it turns back to wall, not a straight line.]

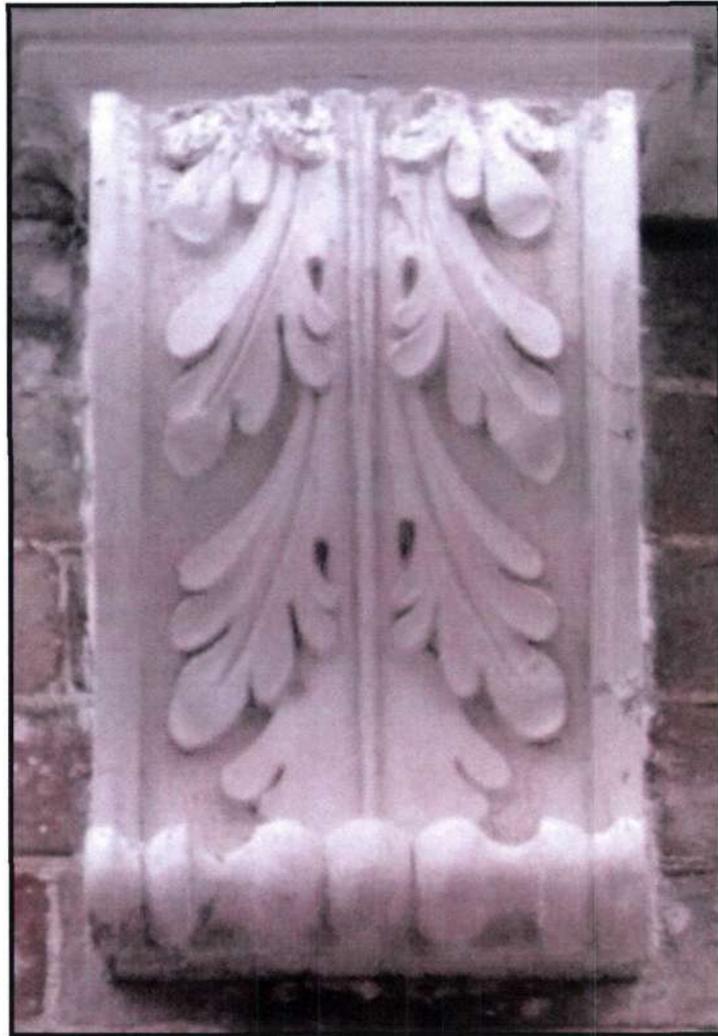
Photograph by the John Greenwalt Lee Company, 2008

The wooden pilaster with plaster capital at the niche matches very closely with the evidence for the door trim (seen with IR photography, plaster ridges, and ghosting).

Again, with the addition of brackets centered over the pilaster capital, the overdoor can have Trumbull's brackets while creating the straight vertical line at the edge of the frieze band that the ghosting suggests.

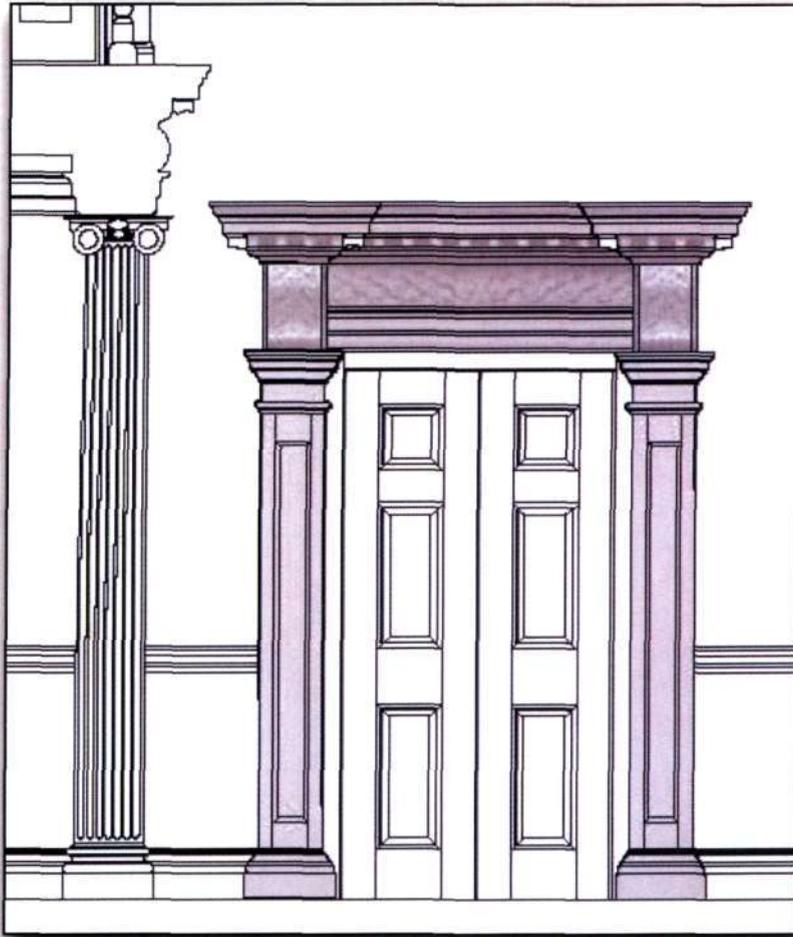
Historic American Building Survey (HABS Va-141) of a doorway at Gunston Hall, near Lorton, Virginia. This is an excellent example of a fully dressed Georgian doorway. (In this photograph, however, it is missing a number of applied carved decorations such as: the double lotus in the frieze over the pilaster, the rosettes in the interlocking circles, and the rosettes on the neck of the pilaster capital that have subsequently been replaced).

Note the bold relief of the door panels and the carving around each panel.

The HL hinges are 20th century; the original were decorative brass barrels with the leaves set in hidden mortises.

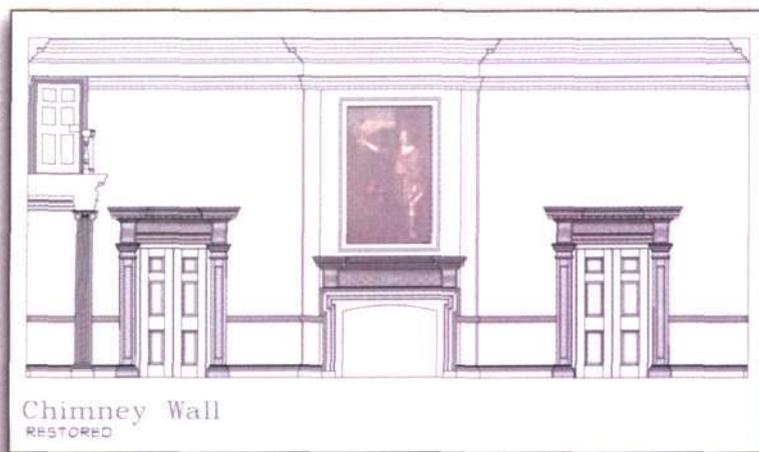
The evidence for doorways in the Old Senate Chamber indicates a wooden element about 14+ inches wide at the jambs. On the wall there is still the imprint of a molded element 90 inches from the floor that corresponds to the capital over the niche pilaster .

If the paneled pilaster of the niche that is 11 inches wide were also at the doors and a 3" backband was added on the inside edge (to allow doors to open wide in spite of the capital), then this would achieve 14" wide trim.

At the false door there is a clear outline of straight line rising vertically above the capital aligned with the outside edge of the pilaster shaft. The plaster area tends to then move horizontally a few inches then generally out at a 45 degree angle implying a plaster overdoor entablature at rests on brackets sitting atop the pilaster capitals.

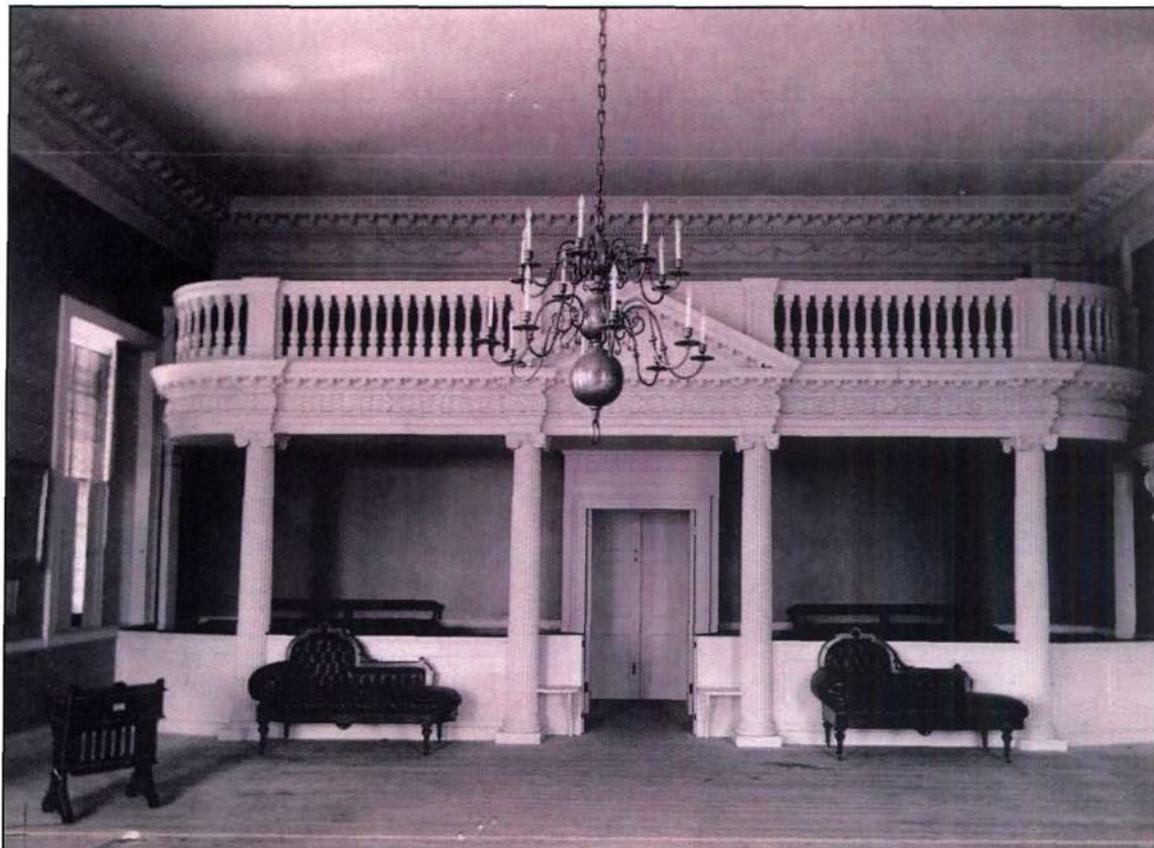
1905- casing architrave

As with most early Colonial Revival “restorations”, Georgian, Federal, Neo-Classical, and even Greek Revival styles get blended into “Colonial”. The window trim, especially the casing architraves and the shutters, are now very delicate and definitely not the bold Georgian of the original architrave over the niche.

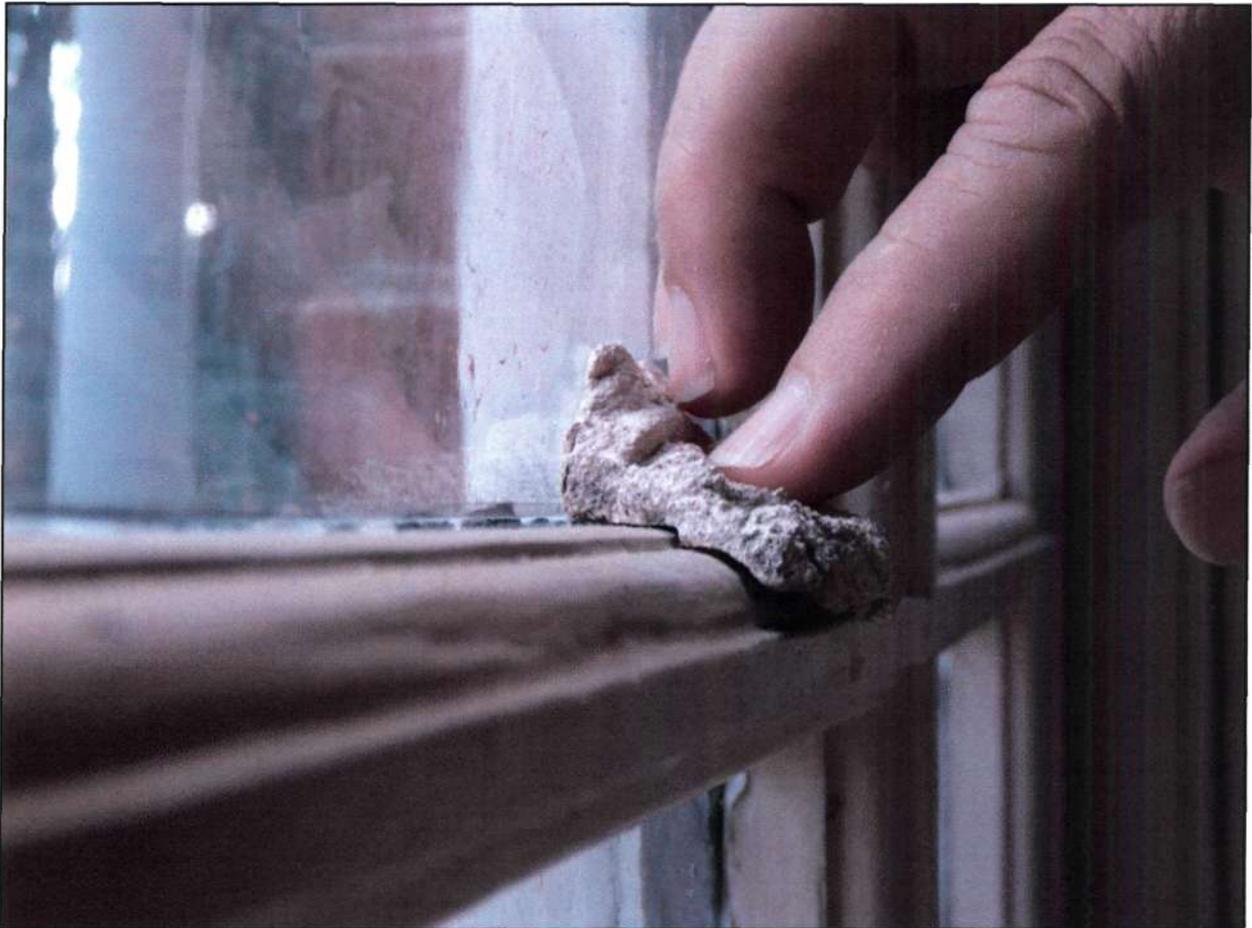
Evidence uncovered within window recesses with 1905 window seat removed:

A= early floor line probably from the original floor; indicates not originally built with window seats

This fragment of plaster found in the space beneath the window recess closed up in 1905 where the gallery wainscot intersects the fourth window. It appears to be mortar that was dropped during plastering of the room onto a window muntin where it cured before being swept away.

It does not match the current window profile.

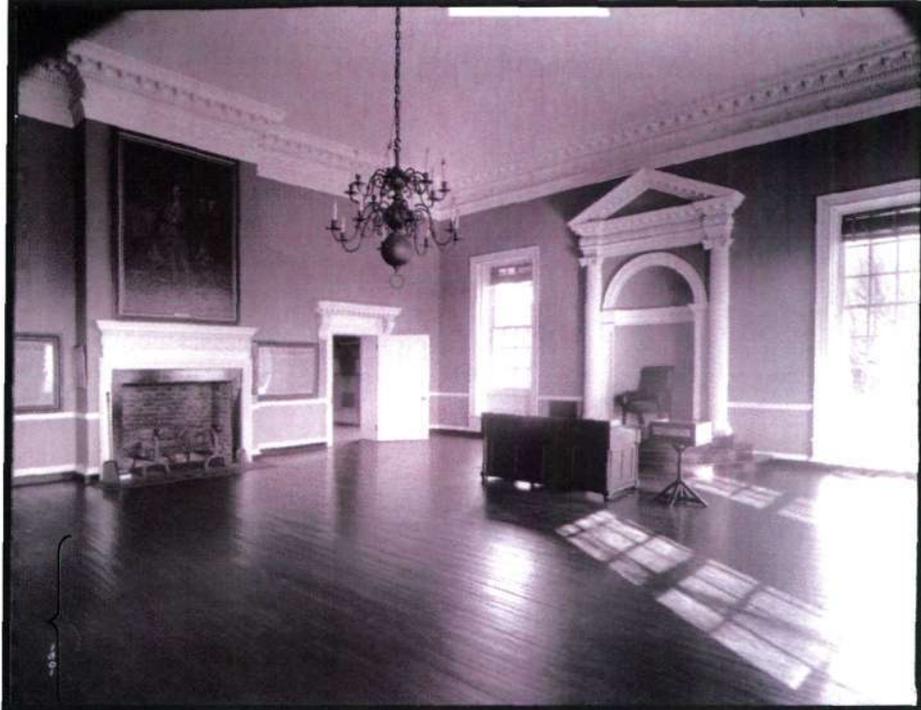
- **Dais with three steps per *Columbian Magazine* of 1789;**
- **Engaged columns and pediment as per circa 1868 photograph;**
- **1878 plaster between columns and outside of niche architrave;**
- **1770s niche, niche architrave, necking band in plaster & paneled pilasters in wood.**

Physical evidence shows the dais was only two steps high and a foot larger in radius. The 1905 engaged columns and pediment are anemic and do not project sufficiently out of the wall. The columns should start out a step lower and be almost full round and just touching the wall. The cornice of the pediment should not break forward at the columns (continuing fully projected forward the full length as in the 1868 photograph) and the leaves should be oak in an overlapping or wave pattern as opposed to bay leaves laid one-dimensionally.

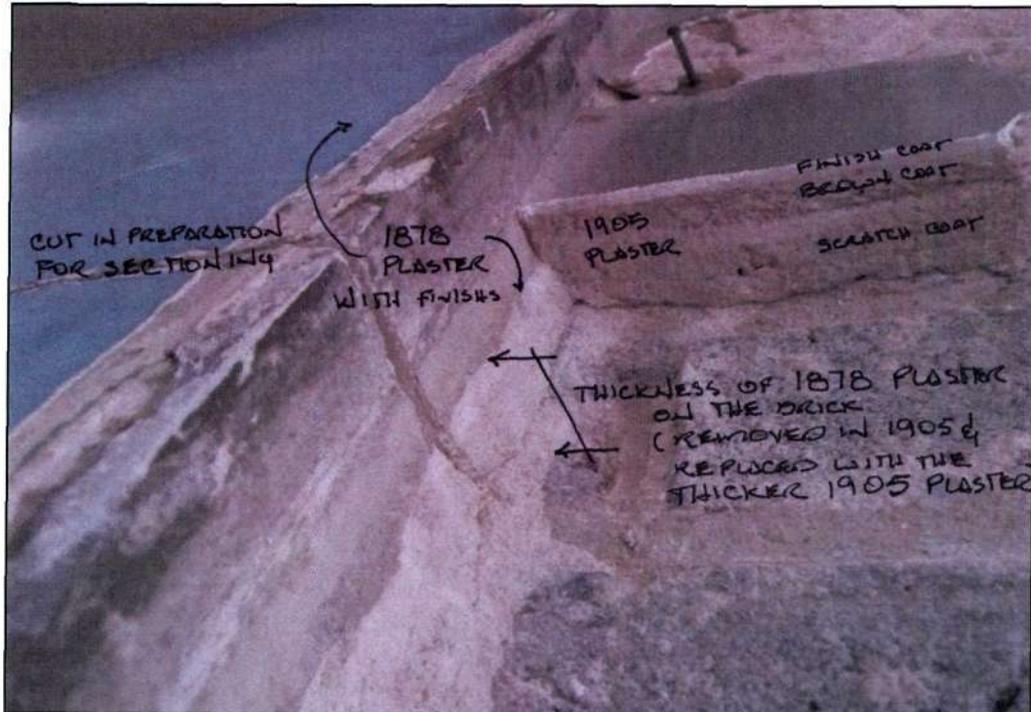
Looking up at the intersection between 1878 plaster in the spandrel over the niche with the 1905 plaster directly on the adjacent brick wall. The blue-painted area was generally exposed while the rest of the photograph to the right was covered by the engaged column. These plasters are typical of the wall plasters used during their respective periods.

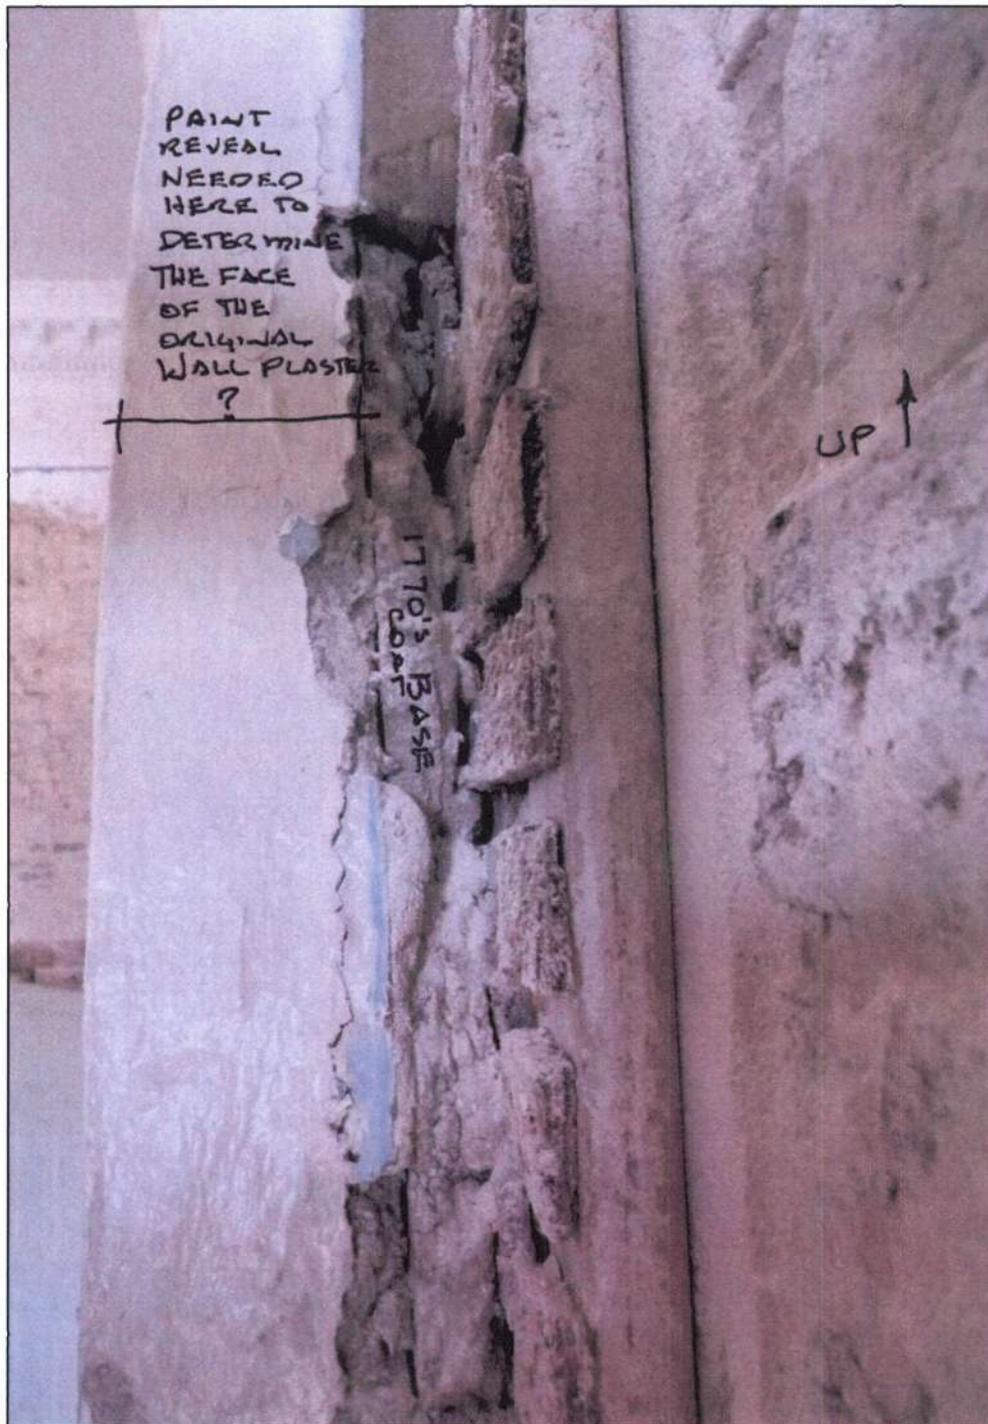
Right edge of niche detail

The 1878 lath almost obscures the original lath. The line between the 1770s original basecoat is clear. Not only is the thickness of the original plaster of interest, but often wall paints lap over onto the edges of projecting decorative work. The spandrel may not be treated the same as the field of the wall, but it may have been. Either way, knowing what interleaves the trim finishes will be of great interest.
