Interim Report on Archival and Architectural Evidence
Old Senate Chamber at the Maryland State House

09/17/2008

Report by the John Greenwalt Lee Company

Lead Investigator: Charles A. Phillips, AIA, AIC
with John Lee, Ellen Hagsten, and Lisa Wilkerson (CAD)

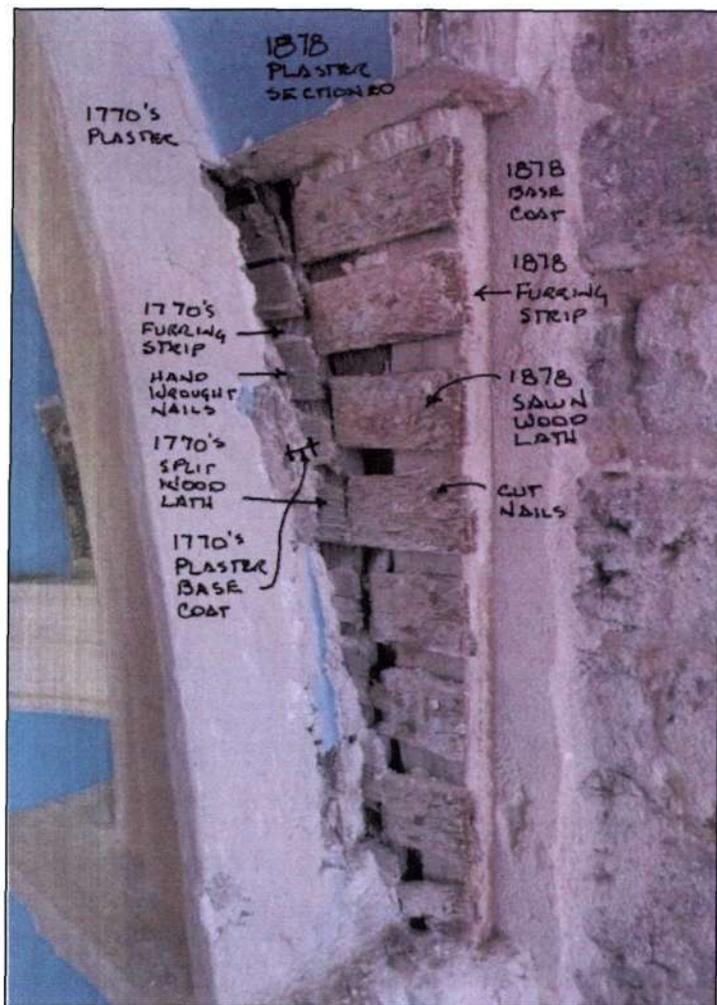
Right edge of niche with 1878 plaster sectioned and partially removed up to the original 1770s plaster of the niche's arched architrave.

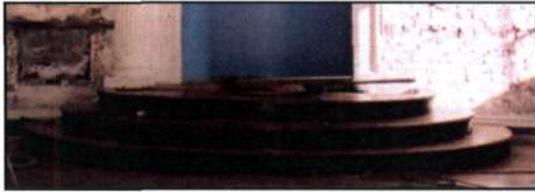
from three to two risers

The top of the 1905 dais has now been lowered by one riser to approximate the original dais height. The unplastered space above the new landing implies a baseboard of approximately that height. There should be a paint line to correspond with the actual top edge of the base.

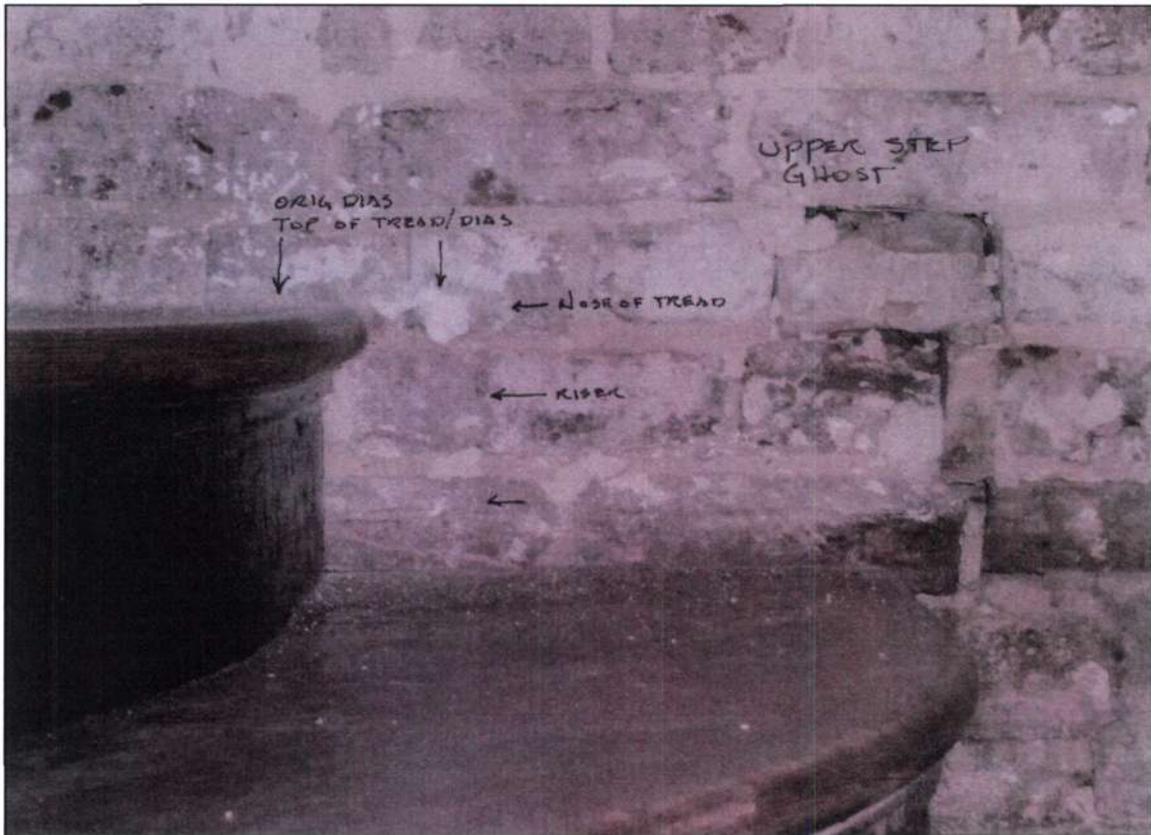
With 1905 plaster removed and the 1905 dais bottom two risers returned to their 1905 position, the original top riser location is most readily seen.

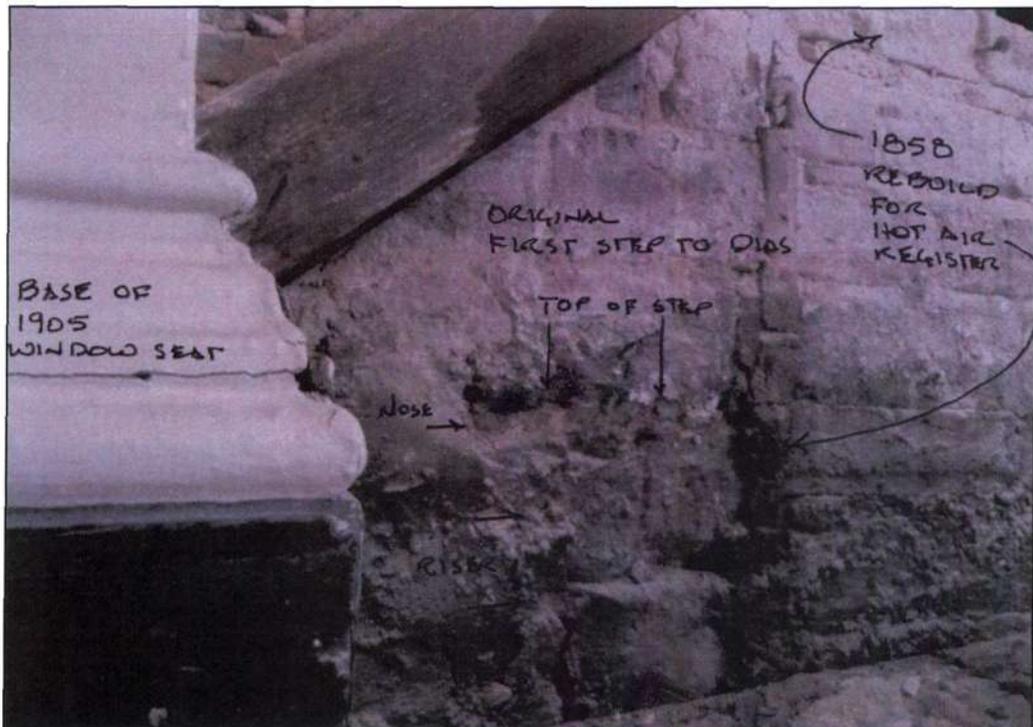
The position of the ghosts for the original first or bottom step makes a broad base (about 24") to the two-riser dais. This would allow those speaking to rise up one step from the floor, but not occupy the top of the dais that was reserved for the Senate President.

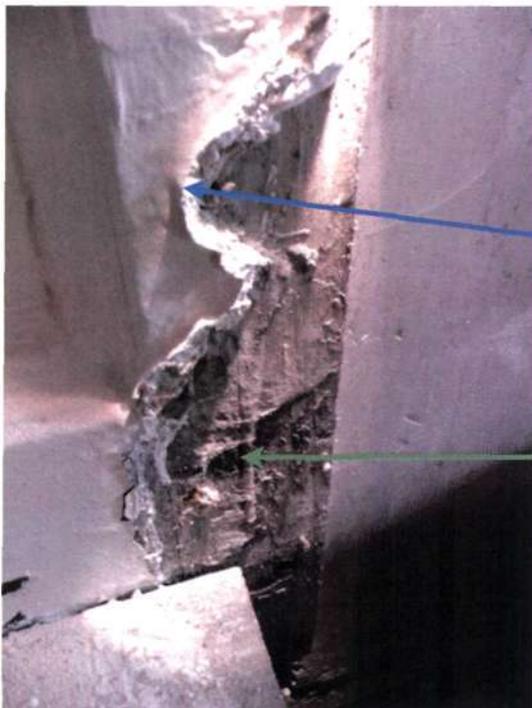
While the pilaster was stripped in 1905 after the column was installed, it retains early finishes beneath the 1905 column base.

Paint line of the 1905 base to the engaged column

Paint line of the original base to the free-standing column that only touched the pilaster at the base

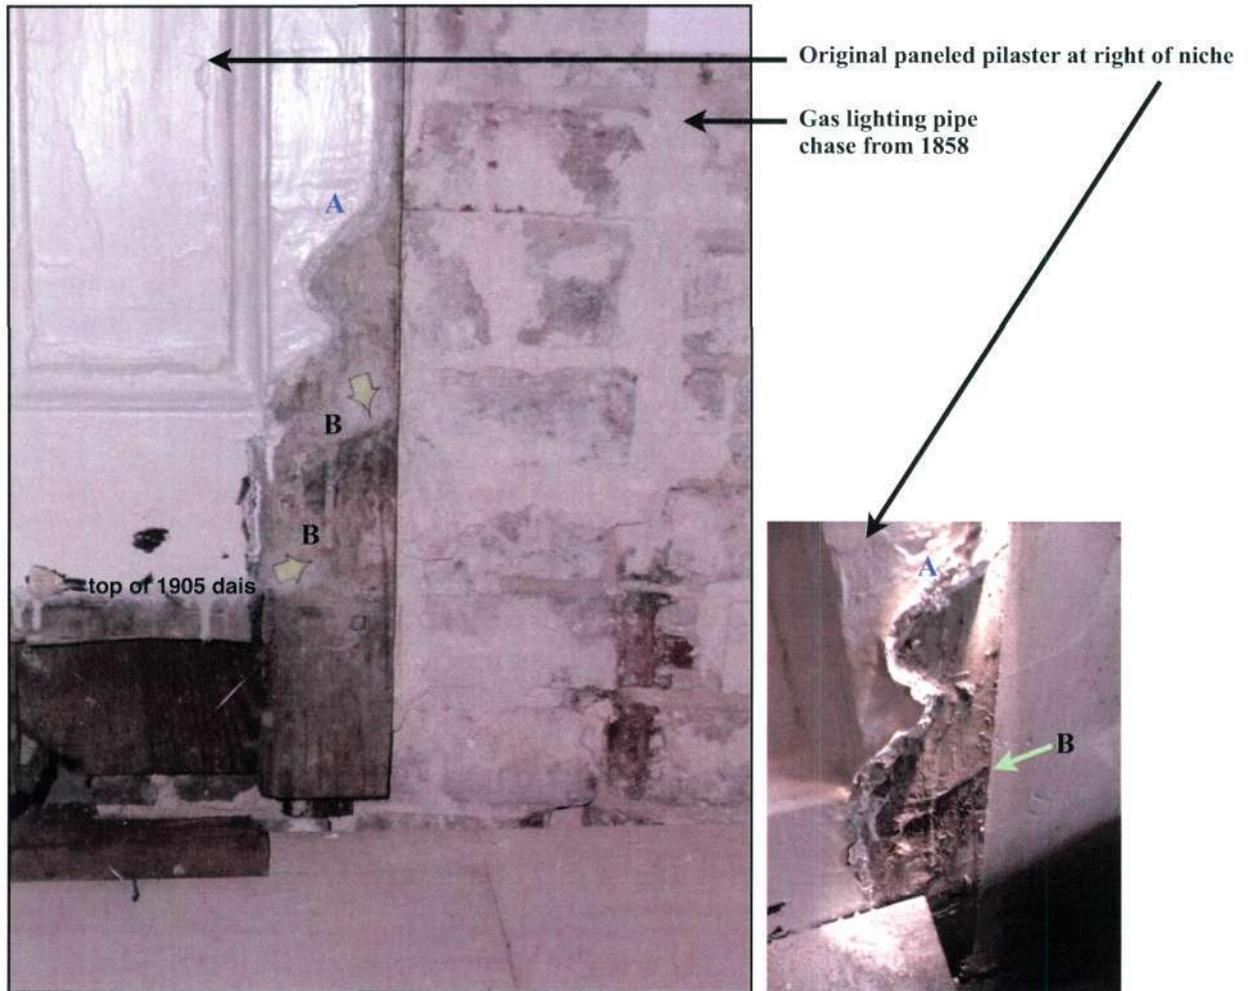
After the top 1905 step had been removed lowering the dais

Before dais lowering

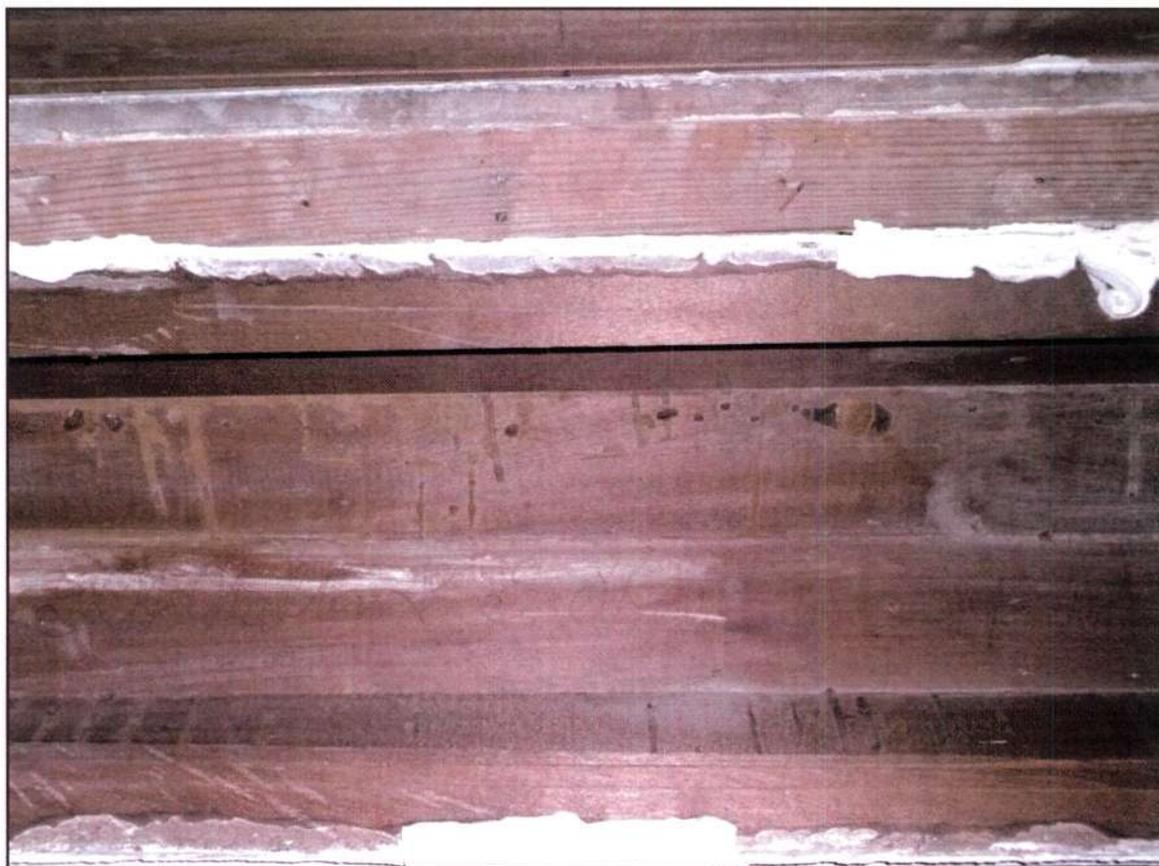
Signed and dated interior of right hand engaged column at niche: Sept 14th 1905.

Although the curved plaster of the niche, the banding, and the pilasters appear to be original, the rest of the surrounding details of the niche are 1905 recreations. This was further confirmed with discovery of the signature and 1905 dating found inside the right-hand column. It is interesting to note that the September date of installation is less than a month after the Restoration Committee began a statewide appeal for more information and photographs that might guide their restoration efforts.

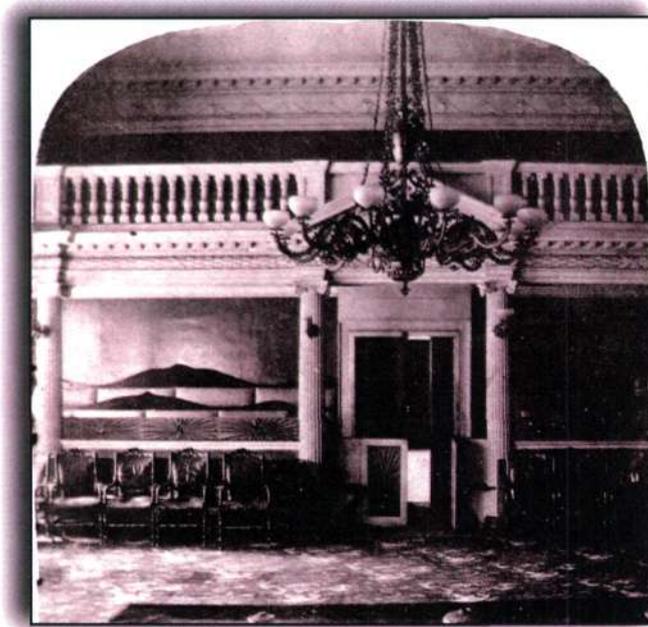
Annotation: The committee that reviewed the constructed building expressed the opinion that the Senate Room, president's seat and gallery were more elegant than required.

This group was certainly aware of the competition between communities and especially between state capitols at Annapolis, Philadelphia and New York to become the national capitol. In particular, the competition between this new State [Stadt] House at Annapolis and Independence Hall in Philadelphia would have been foremost in their thinking.

While the 1905 restoration created an elegant president's seat and gallery, the room as a whole did not rise to elegance.

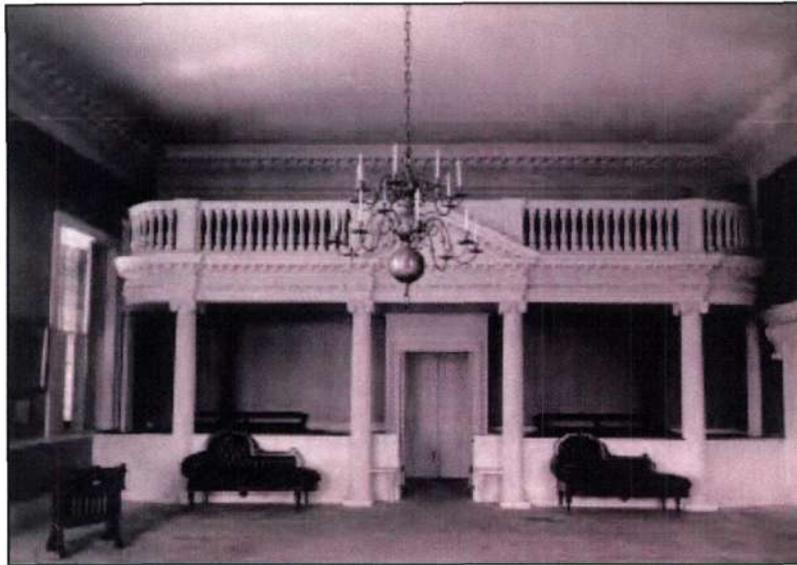
Annotation: It appears that all of the carved elements were made of plaster in the original construction. Mr. Frederic considered this of low quality and incapable of being repaired and reused. It should be noted that ten years early the Corps of Engineers recommended that Mount Vernon be re-created in marble due to the insubstantial nature of wood (perceptions of durability among architects of the era may therefore be suspect).

made by Mr. W. M. Chase, 941 W. Franklin St. On writing to him he said he could find no negatives of the old Chamber but sent me a small photograph of the wall opposite the gallery which was he had discovered, in an old sample book. Of course this was exactly what we lacked, and gave us the columns, and entablature about the niche. I then wrote for a photo of Trumbull's picture in the rotunda of the Capitol at Washington, and Mr. Elliott Woods, the Architect in charge, sent me a very clear print. This picture was painted in 1814 and from it we were able to reproduce the hoods and consoles above the two small doors, one of which is false. The photographs had been taken about 1868 before any changes had been made in the room except that the chimney breast had been removed. As Mr. Frederick has stated that he had prepared careful drawings of the gallery so that it might easily be reproduced, I asked him that we might have the advantage of these. He replied, under date of June 16, 1905, that he had given up his office, and such papers as he had retained were packed away, and he was about to leave the City for some months and could not comply with my request.

The small photograph of the South wall also showed the main doorway and the enclosure below the gallery for spectators. This had small swing doors with panels of gathered silk, and on each side, a small bracketed seat for a door keeper. These were reproduced as accurately as a minute examination of the photograph admitted. In my constant search for authorities I found a copy of the *Columbian Magazine* published in Philadelphia, February, 1789, which contained a short notice of the State House, and more important still, a plan of the main floor. This plan showed the gallery columns on the floor, the location of fireplace and doors in West wall. These were merely confirmatory, but the "Throne" for the Speaker was all important and was shown as three risers above floor and of an oval shape, somewhat flatter than a half circle. This was carefully followed. It also gave the original staircases, one on either side of the building, from a landing of one of

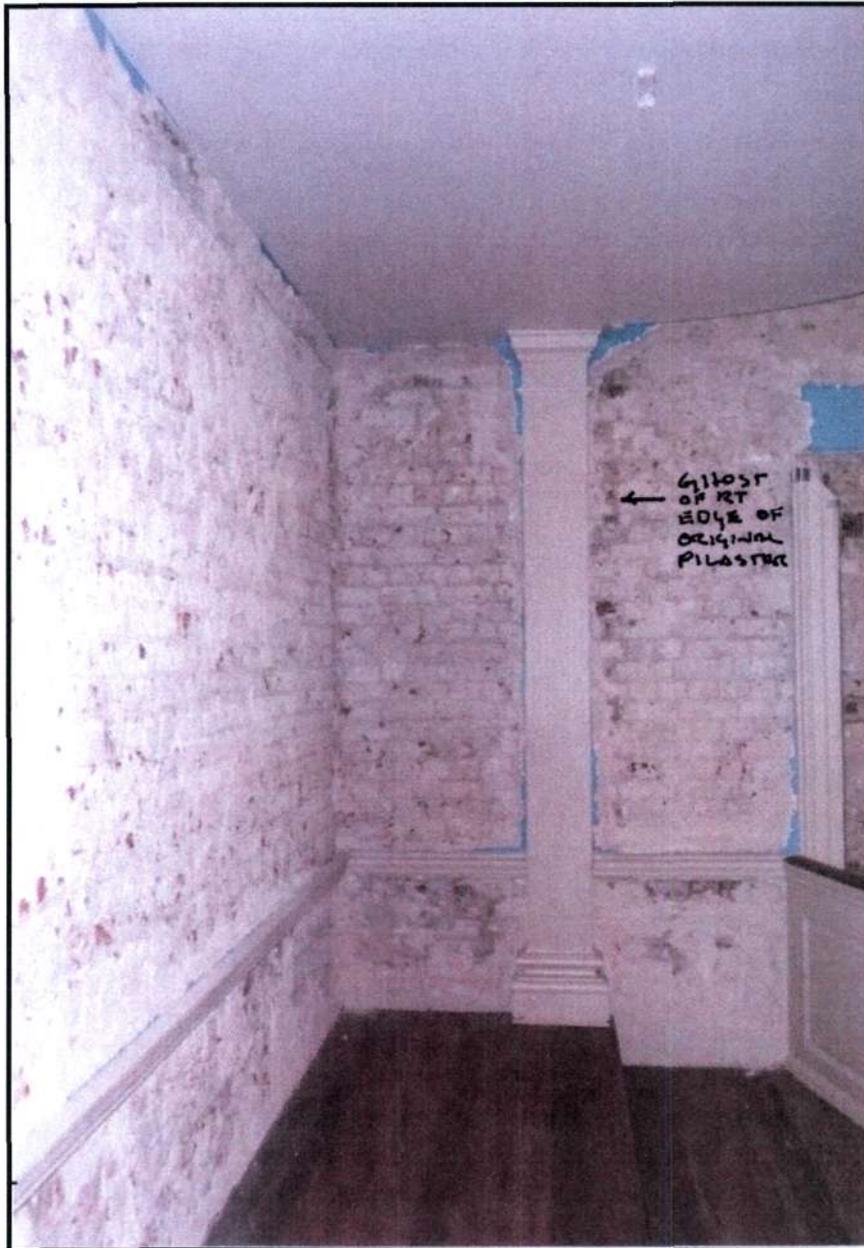
Annotation: 1870s Architect George Frederick was unable or unwilling to provide his drawings of the gallery to the 1905 restoration committee.

RESTORATION OF THE SENATE CHAMBER.

59

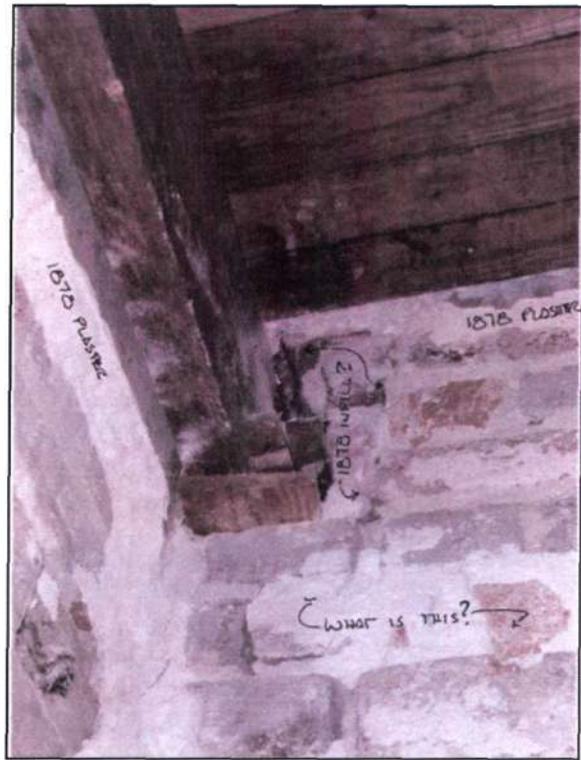
As the annotations show, the room underwent the usual slow progression of alterations with the first significant work being done in 1792 and 1798. These changes were largely associated with the lower level of the gallery and replacement of the ceiling and cornice due to structural problems above the Old Senate Chamber.

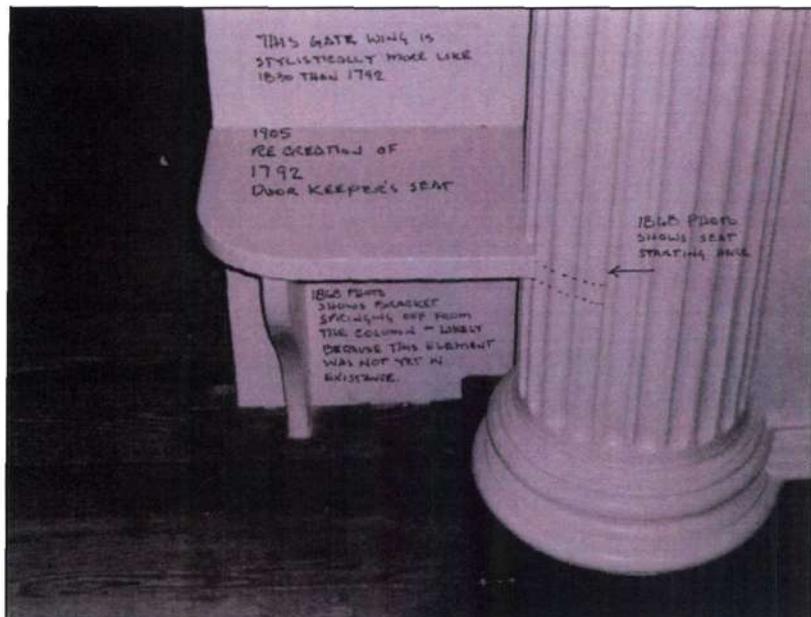
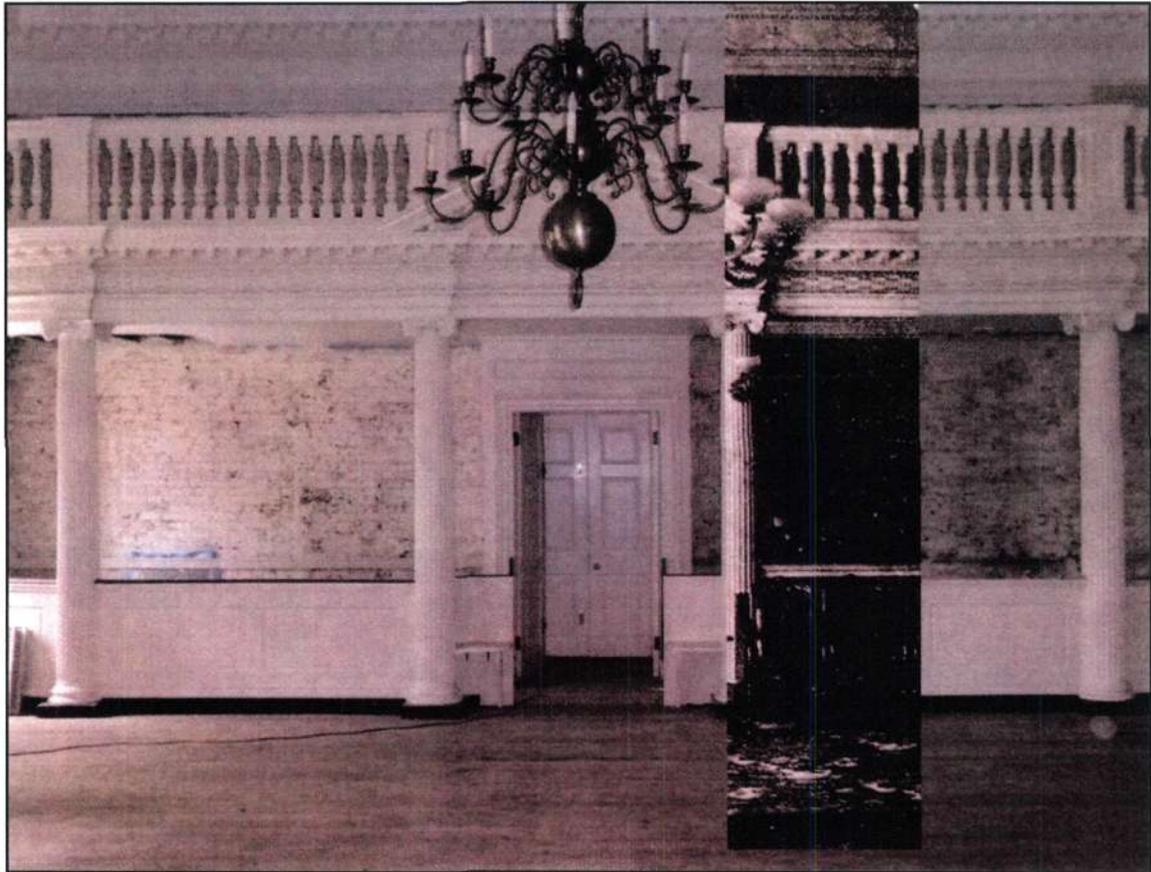
Edwin White's painting in 1856 provides our next view of the room and probably renders the chandelier and the niche/dais most accurately, although he sheds no light on the question of door or window trim and, like the previous views, shows no windows on the niche wall.

The 1868 stereocards are the first photographic views and, since photos are relatively unbiased, we can trust what they show within the frame. The stereoviews show the 1792 alterations are in place on the gallery, but unfortunately the frame does not include the gallery ends and the central pediment is largely obscured by the very large 1858 gas chandelier and its globes, while the niche is pretty well shown where it is not also obscured by the chandelier. The niche wall also shows paintings covering the previous locations of windows.

In the 1830's several additional large paintings are ordered for the room and apparently with insufficient wall space windows are sacrificed. Does this also explain the three rather than four windows on Lossing's window wall? And if so, which window was obscured? Close examination of the windows when they are all uncovered may answer that question. Unfortunately these two 1868 views show no unaltered doors or windows.

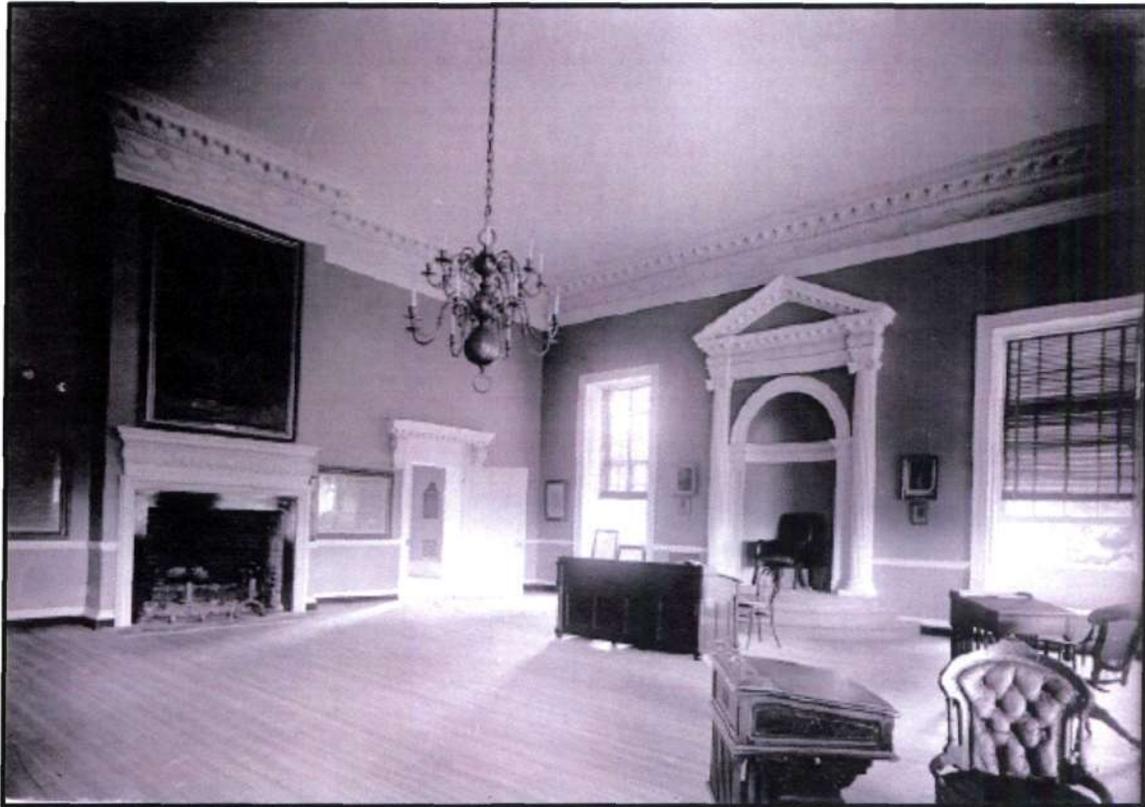
The question of what the ceiling was like in 1783 is not easily answered. The installation of a ceiling medallion as part of the 1798 ceiling repair, rather than as a separate project, makes it seem there had always been one and it was being replaced “in-kind.” Yet this is not conclusive and the ceiling may have been simply flat plaster throughout – likely whitewashed.

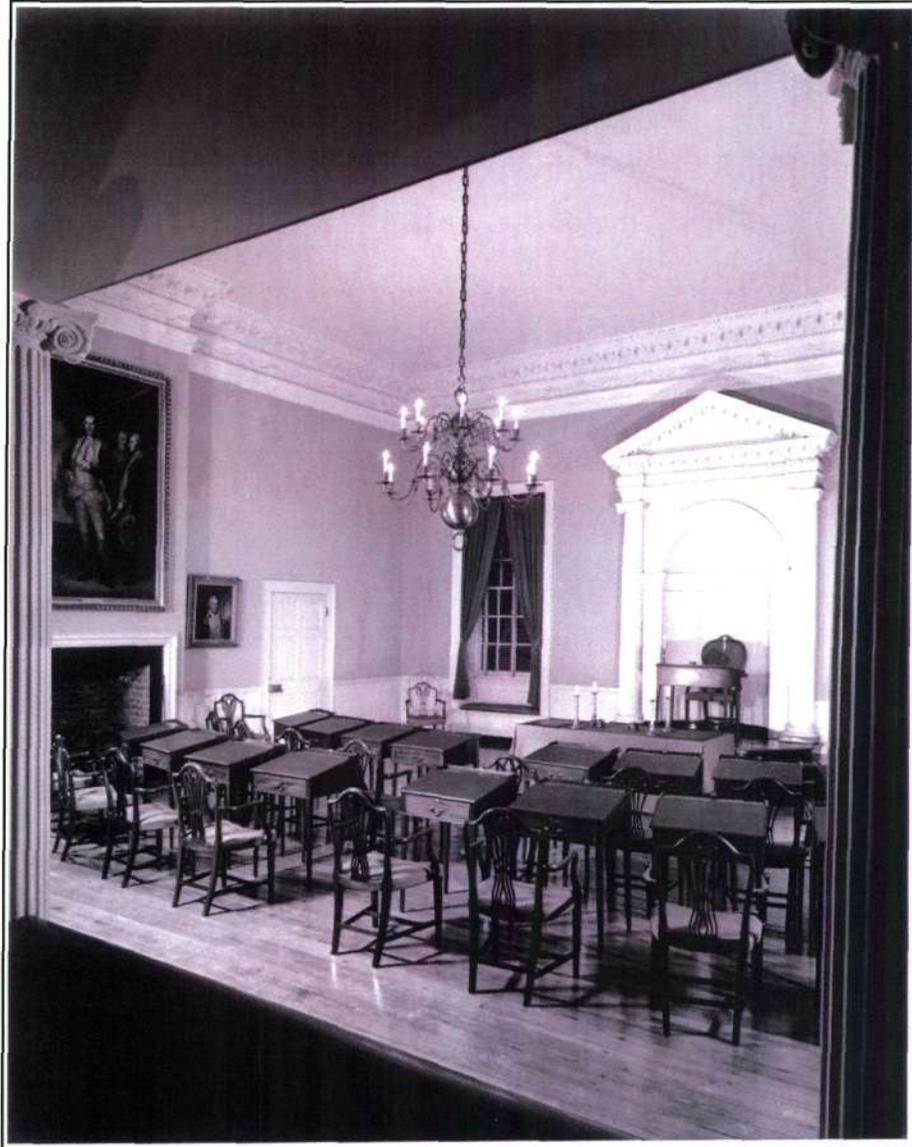
Current floor was installed during the 1940 restoration, it is a random-width southern yellow pine salvaged from a source not associated with the State House. It has a nail pattern completely disassociated from its original context and does not relate to an historic floor framing arrangement.

Annotation: Newly-installed salvaged pine floor. (This is still in place in 2008)

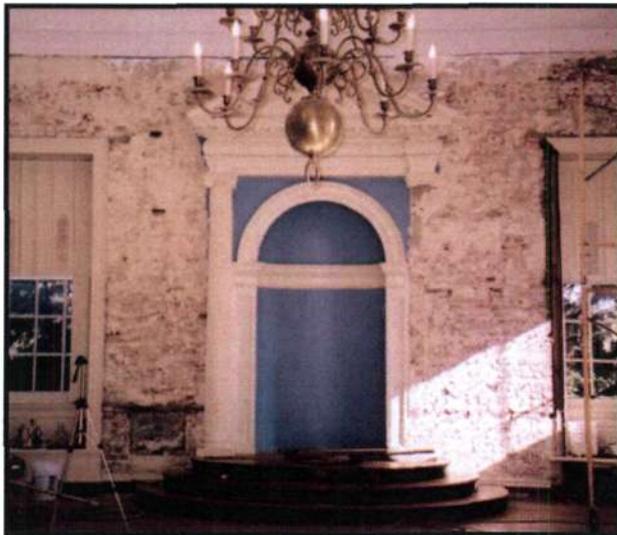
During the archaeological investigation of 2008, the landing of the 1905 dais was removed and the top lowered by one riser to approximate the original dais in height (as shown by physical evidence). The unplastered area at the base of the niche implies a baseboard of approximately that height.

Before: 1905 dais created a diminutive landing

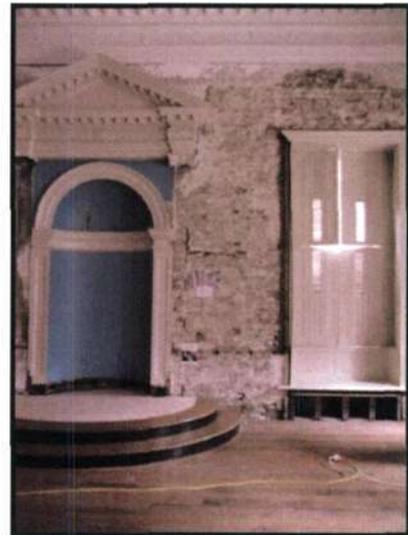
After: 2008 removal of top riser achieves a dais closer to original proportions, including a broader landing

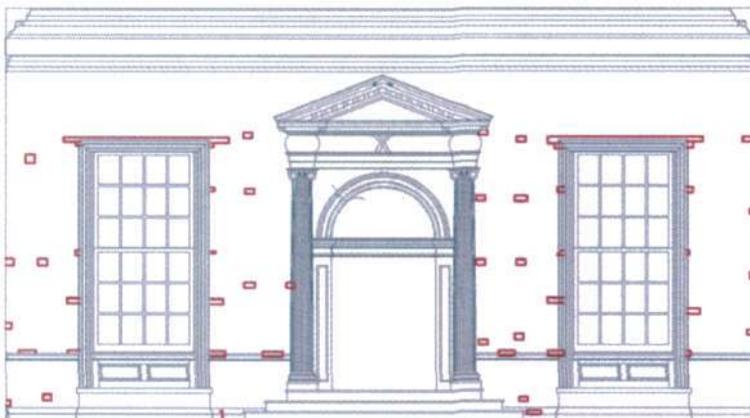
Niche Wall
AS IT APPEARED IN 2007
WITH ORIGINAL EVIDENCE SUPERIMPOSED

2007 appearance with orphaned blocking shown

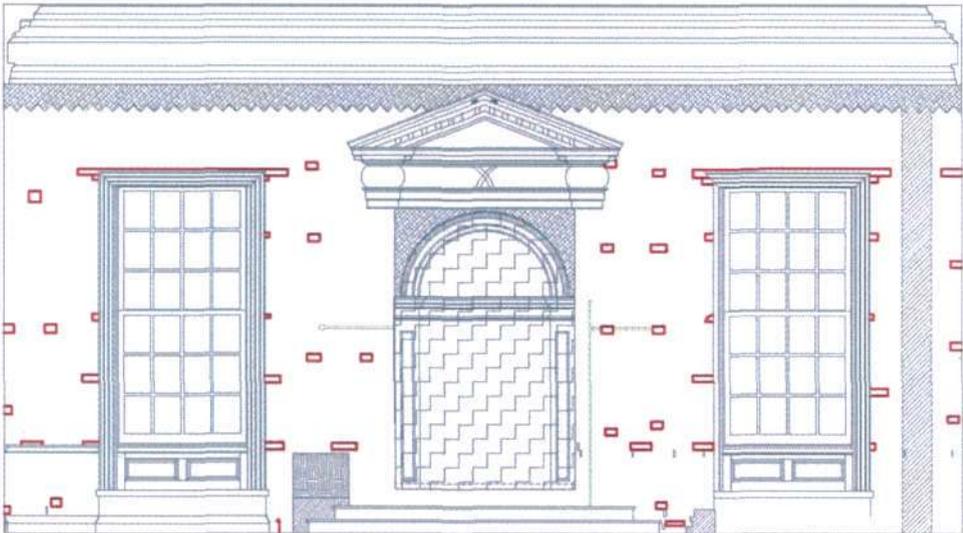
Niche Wall
 SHOWING EVIDENCE AND AREAS
 OPENED FOR INSPECTION

Whereas the blocking does not mate with the 1905 trim:

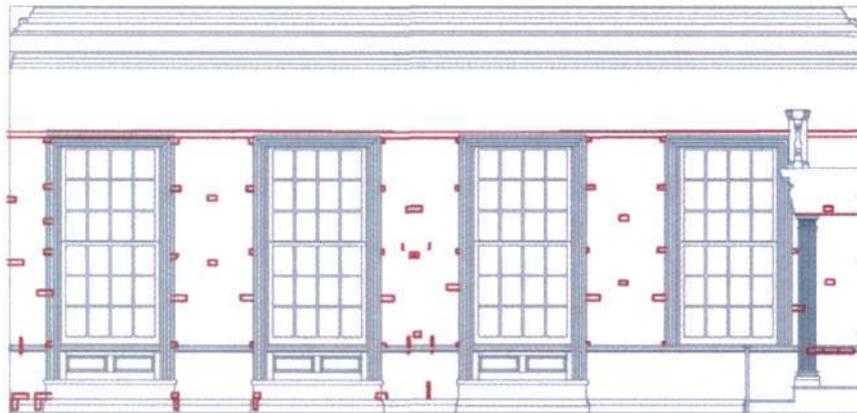
Window Wall
AS IT APPEARED IN 2007
WITH ORIGINAL EVIDENCE SUPERIMPOSED

Window wall with exposed areas and unearthed blocks

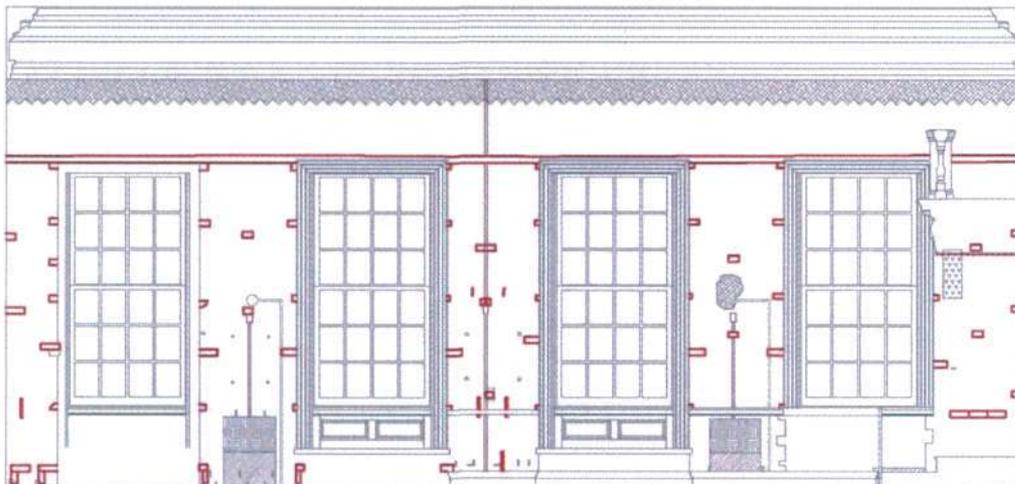
Window Wall
 SHOWING EVIDENCE AND AREAS
 OPENED FOR INSPECTION

Whereas nailing blocks do not correspond to 1905 restoration:

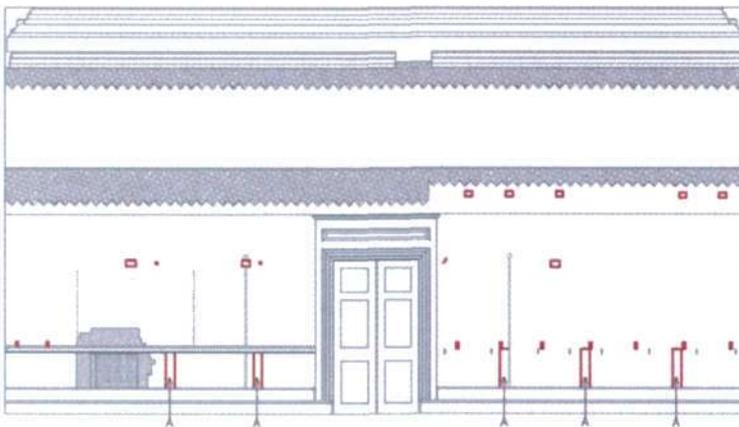
Gallery Wall
SHOWING EVIDENCE AND AREAS OPENED FOR INSPECTION

Gallery end wall showing exposed evidence from investigations

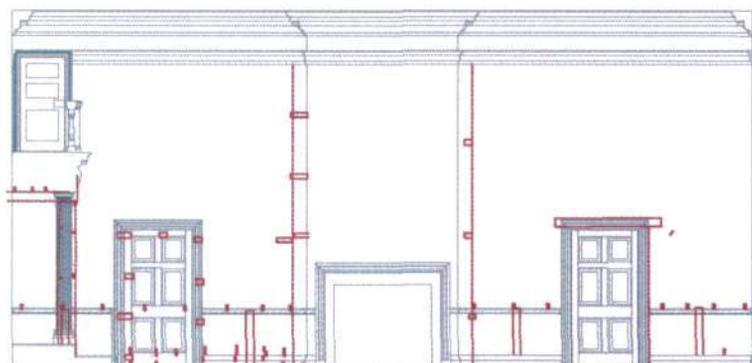
Chimney Wall
AS IT APPEARED IN 2001
WITH ORIGINAL EVIDENCE SUPERIMPOSED

Locations of blocking uncovered in study

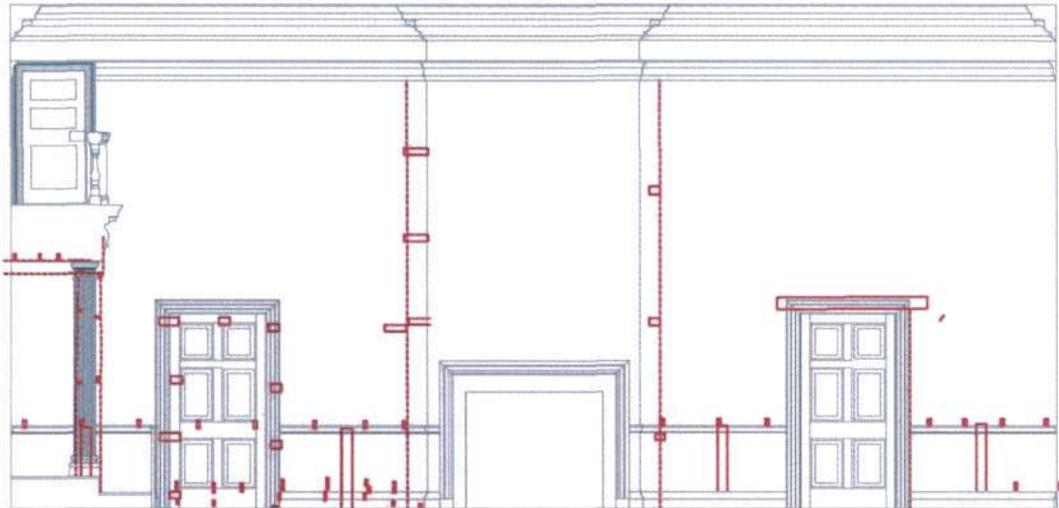
Chimney Wall

In contrast, the 1905 restoration left many original blocks orphaned.

AS IT APPEARED IN 2007
WITH ORIGINAL EVIDENCE SUPERIMPOSED
