COASTAL AND ESTUARINE GEOLOGY

FILE REPORT NO. 02-05

**Evaluation of Potential for Sedimentation
on Natural Oyster Bar 8-11
from Dike Construction at the
Poplar Island Environmental Restoration Project**

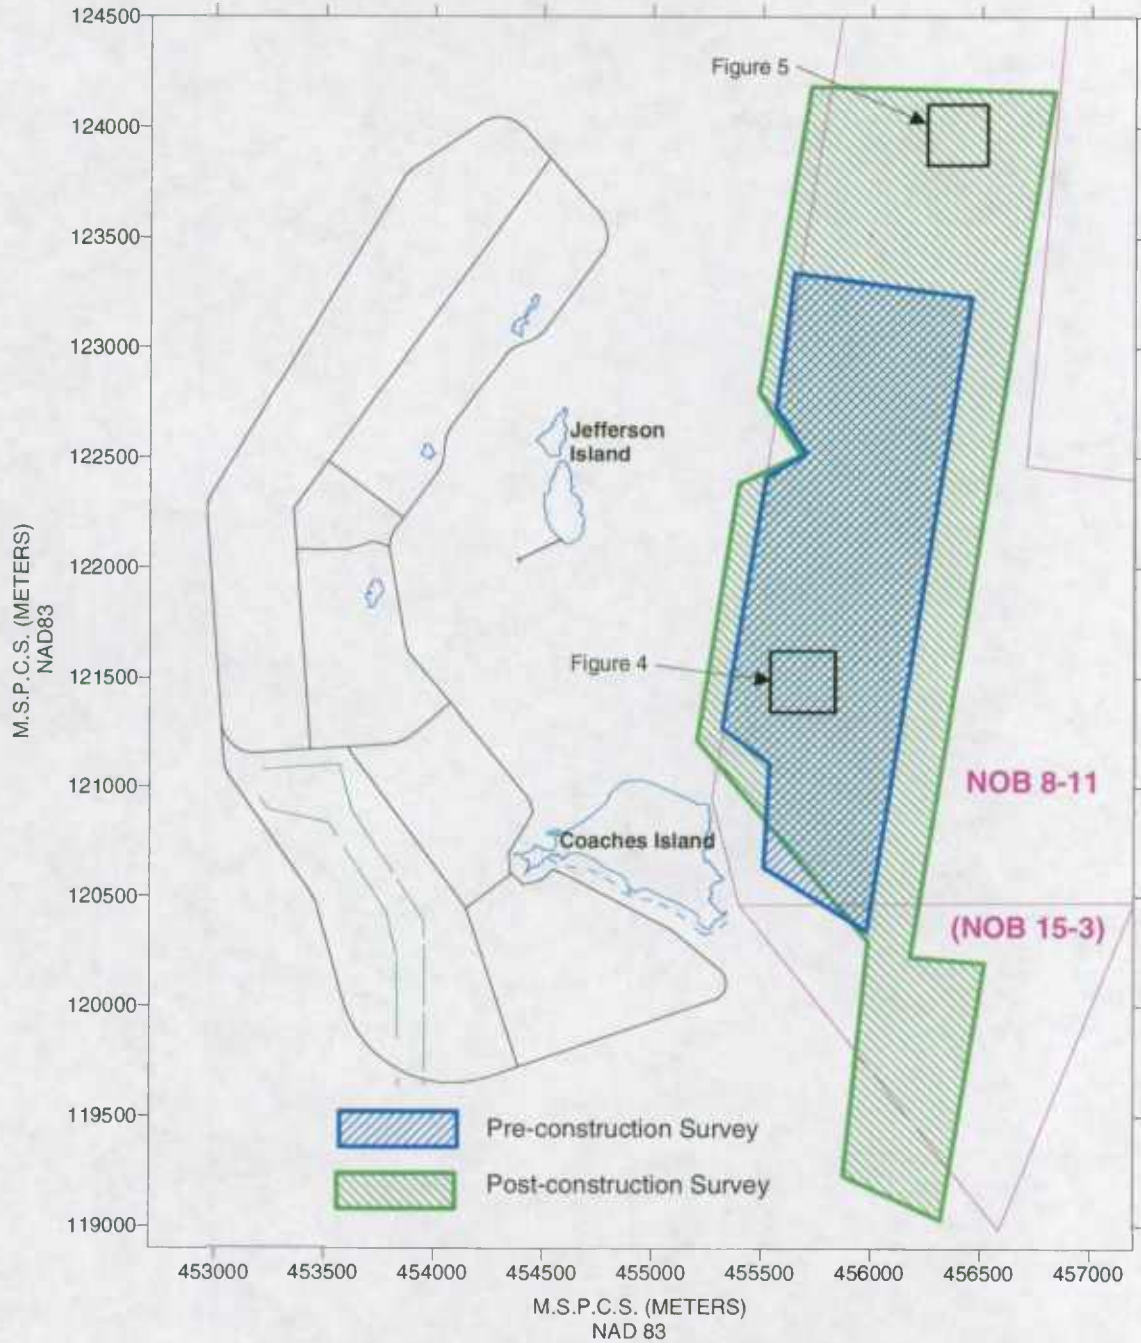
Poplar Island Environmental Restoration Project Sidescan Study Areas in NOB 8-11

Figure 1: Location Map of study area showing location of Coaches and Jefferson Islands, PIERP dike locations and the location of NOB 8-11 and 15-3. The pre- and post- construction side scan surveys are shown by the hachured areas and identified in the legend. Locations of Figures 4 and 5 are also indicated.

An initial side-scan sonar survey was conducted on August 15, 2000. The area of coverage is indicated by the blue cross hachured area on Figure 1. This survey utilized a Klein 2000 side-scan unit operating at a frequency of 100 kHz and interfaced with a DGPS for navigation. The system was rented from a vendor in Annapolis. A full digital mosaic of the results was prepared by Enviroscan, Inc using GeoDAS software marketed by Oceanic Imaging Consultants, Inc. Unfortunately, weather conditions and system settings produced results that were only fair on this date. Water column turbidity and surface waves resulted in acoustic data that were of less than ideal quality.

The initial side-scan sonar survey of NOB 8-10 was conducted in August 2000 to establish bottom acoustic reflectance characteristics prior to any construction activity at the PIERP site. Although the system settings and weather conditions resulted in side scan data that was only of fair quality, results were sufficient to determine that there were few, if any, oysters in the bar area that was surveyed. The surveyed area is shown by the diagonal blue colored hachure on Figure 1.

The post construction survey, conducted on August 8, 2001 covered slightly more of the bottom area of NOB 8-11, and extended beyond the limits of the initial survey. The limits of this survey are shown as the green hachure on Figure 1. The bottom characteristics within the surveyed area were the same as shown on the pre-construction
