CARR-1404

4101 Alesia to Lineboro Road  
Alesia (vicinity)

# Maryland Historical Trust State Historic Sites Inventory Form

historic Miller-Hoffacker Farm

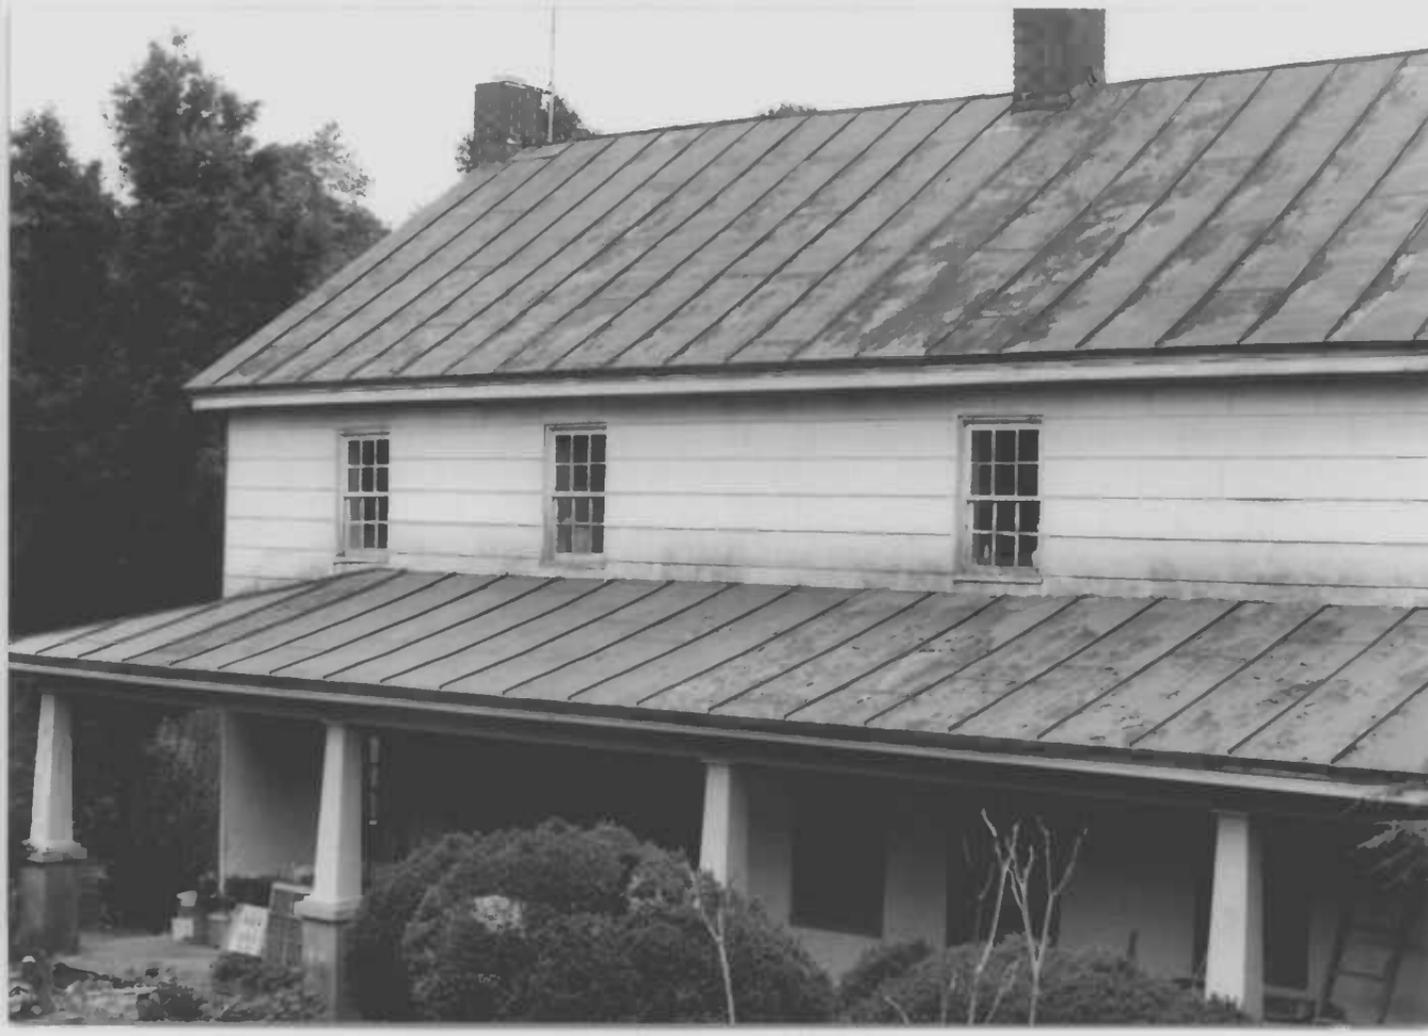
House - southwest elevation

The house currently faces southwest toward the road and is a two-story, five-bay by two-bay structure with a rubble stone foundation and a gable roof of standing-seam metal with a northwest-to-southeast running ridge. The house is banked on the southwest with an exposed foundation wall on the northeast elevation. There is an exterior brick chimney centered on the northwest and an interior brick chimney between the west-center and center bays. The house is built in two sections, but apparently was built all at one time, as there was no obvious break in the foundations. The southeast half has V-notch cornered logs with stone chinking laid in mortar. The northwest half has logs with a vertical post at the south corner. The logs appear to be whitewashed, but only a small portion is exposed to view. The first story of the southwest elevation has horizontal, hand-split lath attached with cut

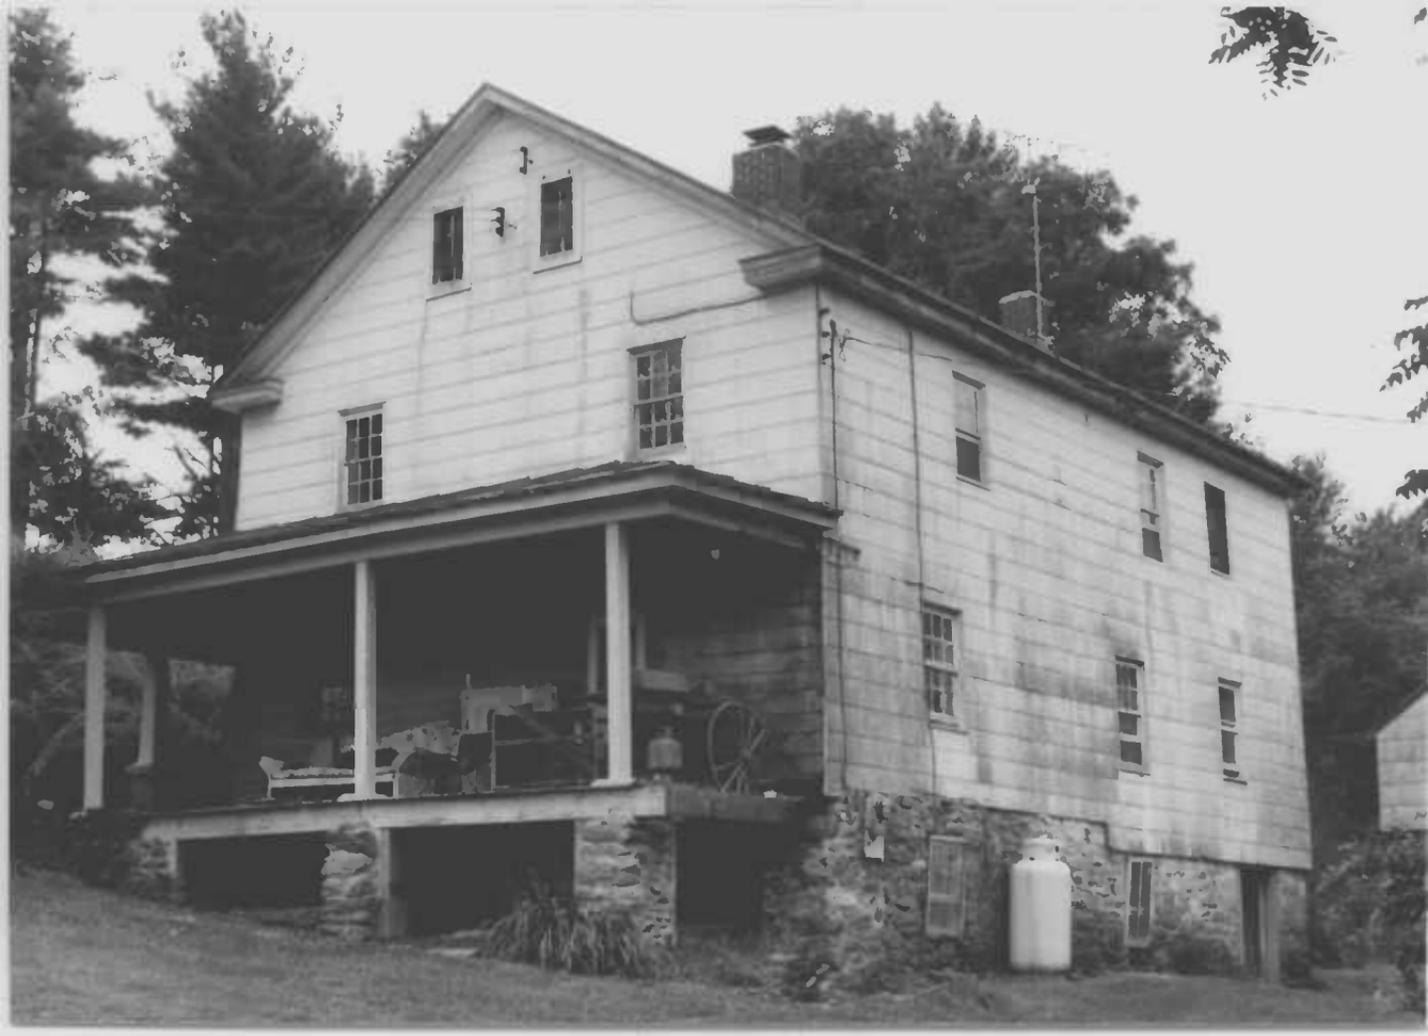
House - southeast and northeast  
elevations

On the northeast elevation the foundation retains traces of whitewash. In the east bay of the foundation there is a 6/3 sash with a wood sill and a plain surround. The north-center bay has an identical window. In the north bay is a new vertical-board door constructed with wire nails. The north corner of the foundation has quoins. The first story has, from east to north, a typical 6/6 sash, no opening, no opening in the center bay, a typical 6/6 sash, and a typical 1/1 sash in the north bay. The second story has a typical 6/6 sash set north of the east bay, no openings in the east-center or center bays, a typical 6/6 sash set north of the north-center bay, and a typical 6/6 sash in the north bay. There is a wood box cornice.

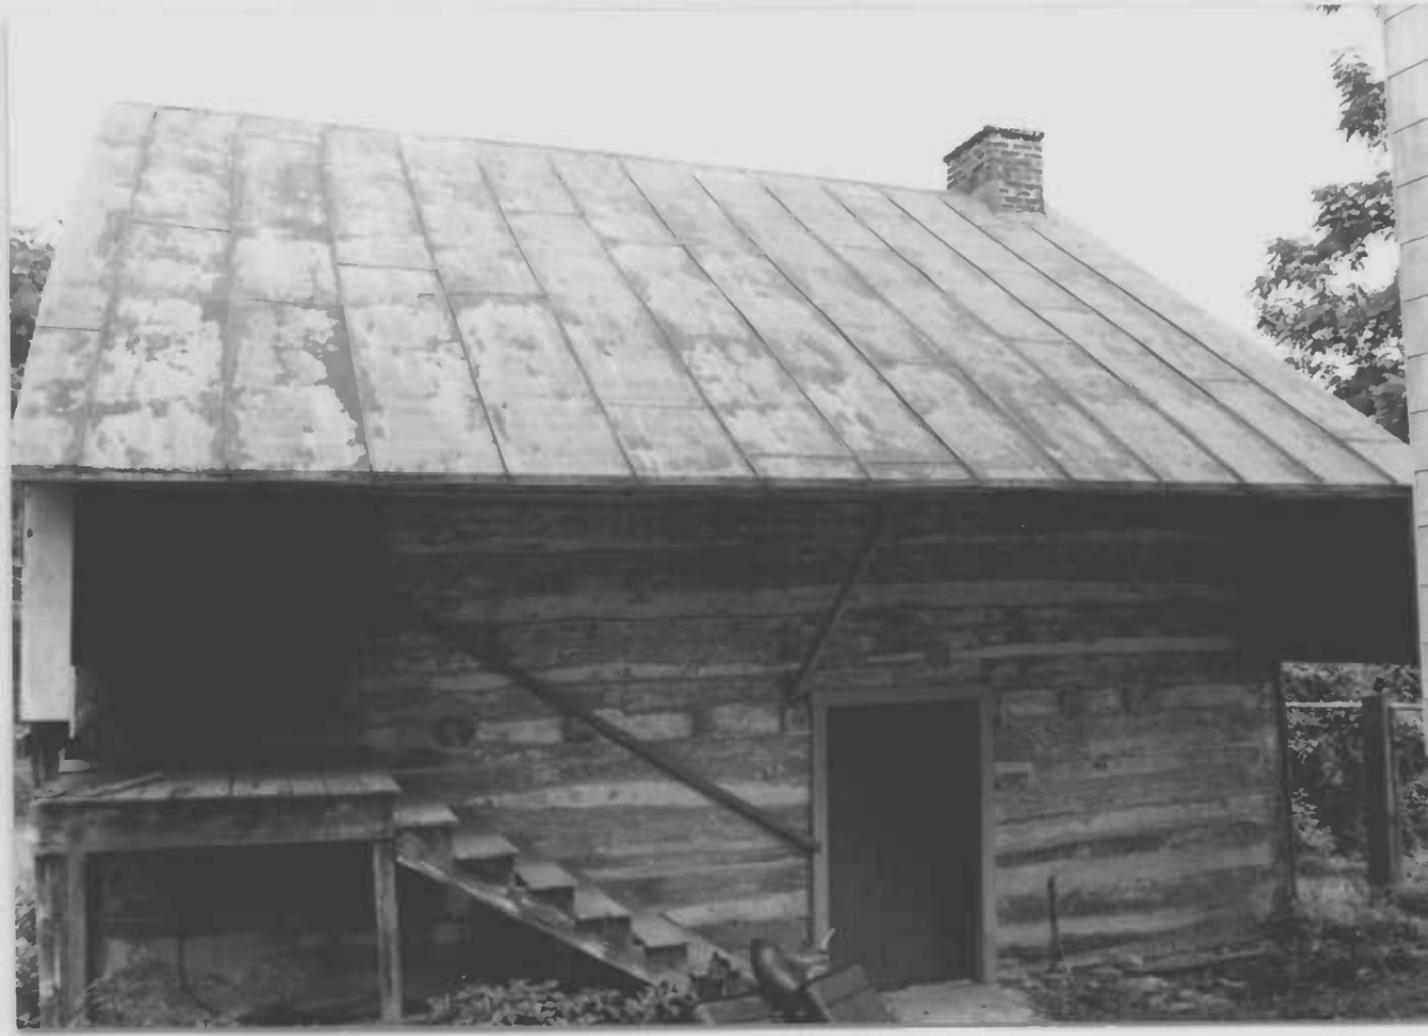
Summer Kitchen - southwest elevation

The summer house is located about 10 feet north-northeast of the house. It is a two-story, two-bay by one-bay hewn log structure with V-notch cornering, a rubble stone foundation and a gable roof of standing-seam metal with a northwest to southeast running ridge. It has an interior brick chimney on the southeast. On the southwest elevation the logs are exposed and have been re-chinked and whitewashed. The first-story south bay has a beaded-edge vertical-board door that has been added onto on the top. The original opening was very short. The architrave has a beaded interior edge. The door is hung on interior strap hinges that are tapered and have round ends. To the west are circular-sawn exterior

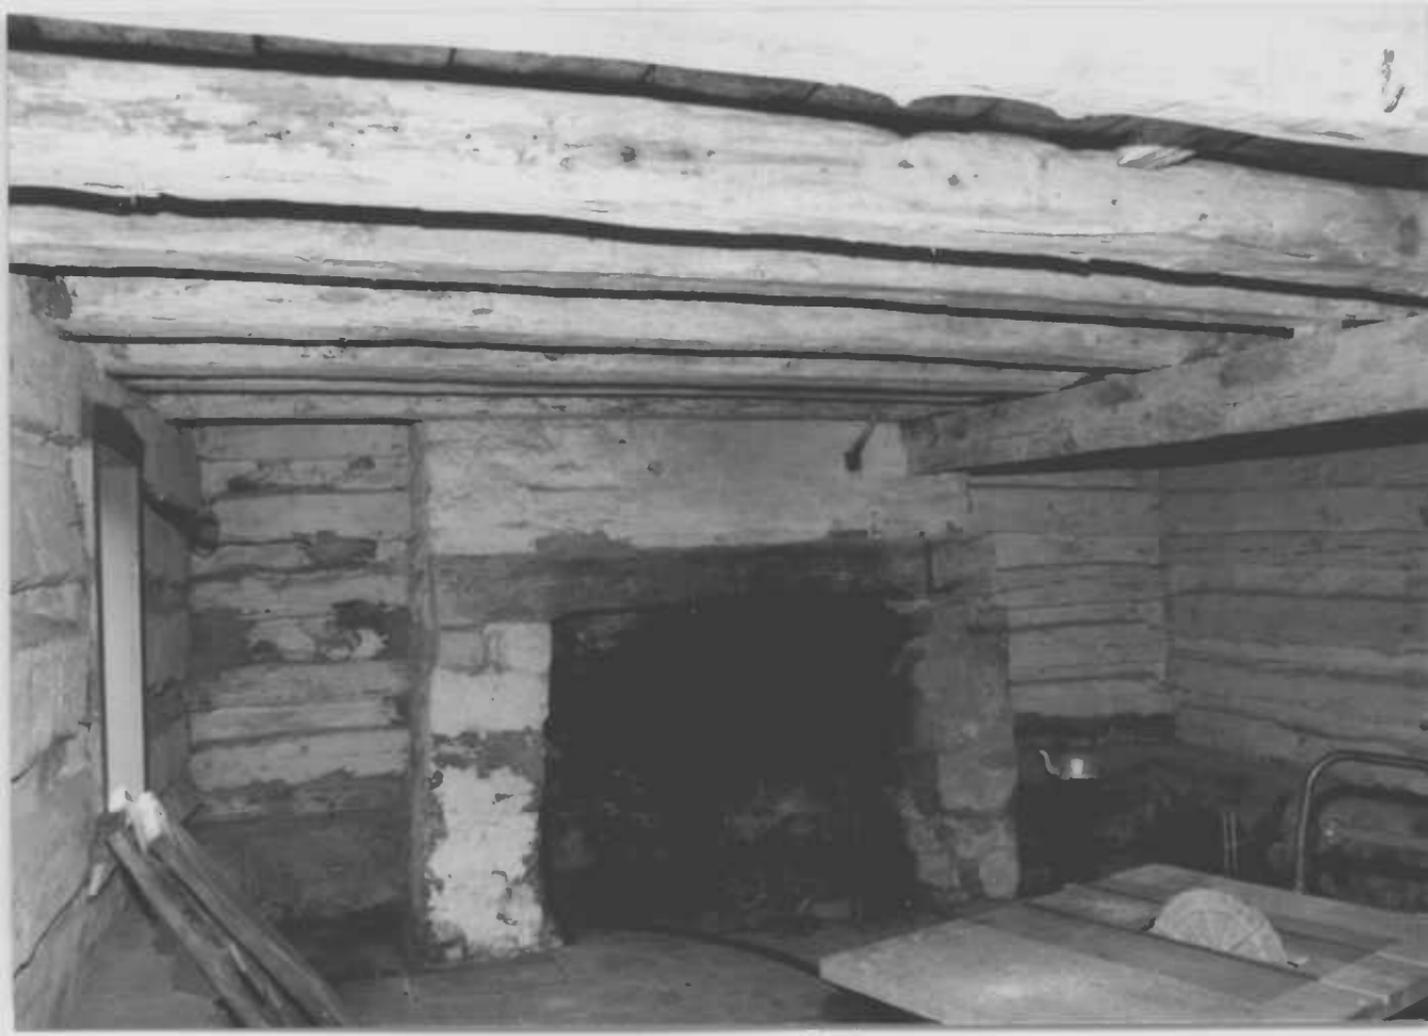
Summer Kitchen interior - 1st story  
view southeast

There are two steps down to the first story, which is one room with a concrete floor covered with roofing slates. The rubble stone foundation wall is exposed in the room. There is a large stone fireplace centered on the southeast end. It has straight jambs and a hewn wood mantle tree. On the outer ends of the southwest and northeast sides of the fireplace are hewn horizontal beams set in the stone work, and the mantle tree rests on these beams. Above the mantle tree the fireplace is stone on the outer sides with brick in the middle. There is a hole on the southwest side of the front of the fireplace with an iron bar set in it that is not attached to anything. It is not clear if this bar is original or later. The openings have plain surrounds with pediments above them. This trim work is wire-nailed. There is a summer beam that runs northwest to southeast. It is hewn on all four sides and is 8½ to 9 inches square. The joists run northeast to southwest. Most of them are hewn on top and bottom. They rest on top of one of the outer log walls and the log above the joist ends is notched on the bottom of the interior of the building only. These joists are 7 to 10 inches wide by 6 to 7 inches deep and are spaced 22½ to 29½ inches on centers. One log that was used in the wall to fill a wide gap between other logs is not structural and has notches in it that make it appear to be re-used plate. Another log similarly used has an end with a notch in it, either to hold a rafter foot or a tilted false plate. The logs are whitewashed on the interior. There is a concrete trough in the northeast end of the room. The flooring above is random-width, mill-sawn, tongue-and-groove boards.
