QA-12

Leager Farm or "Woodridge Corrected"
Millington vicinity
Private

c. 1790 & 1810

INVENTORY FORM FOR STATE HISTORIC SITES SURVEY

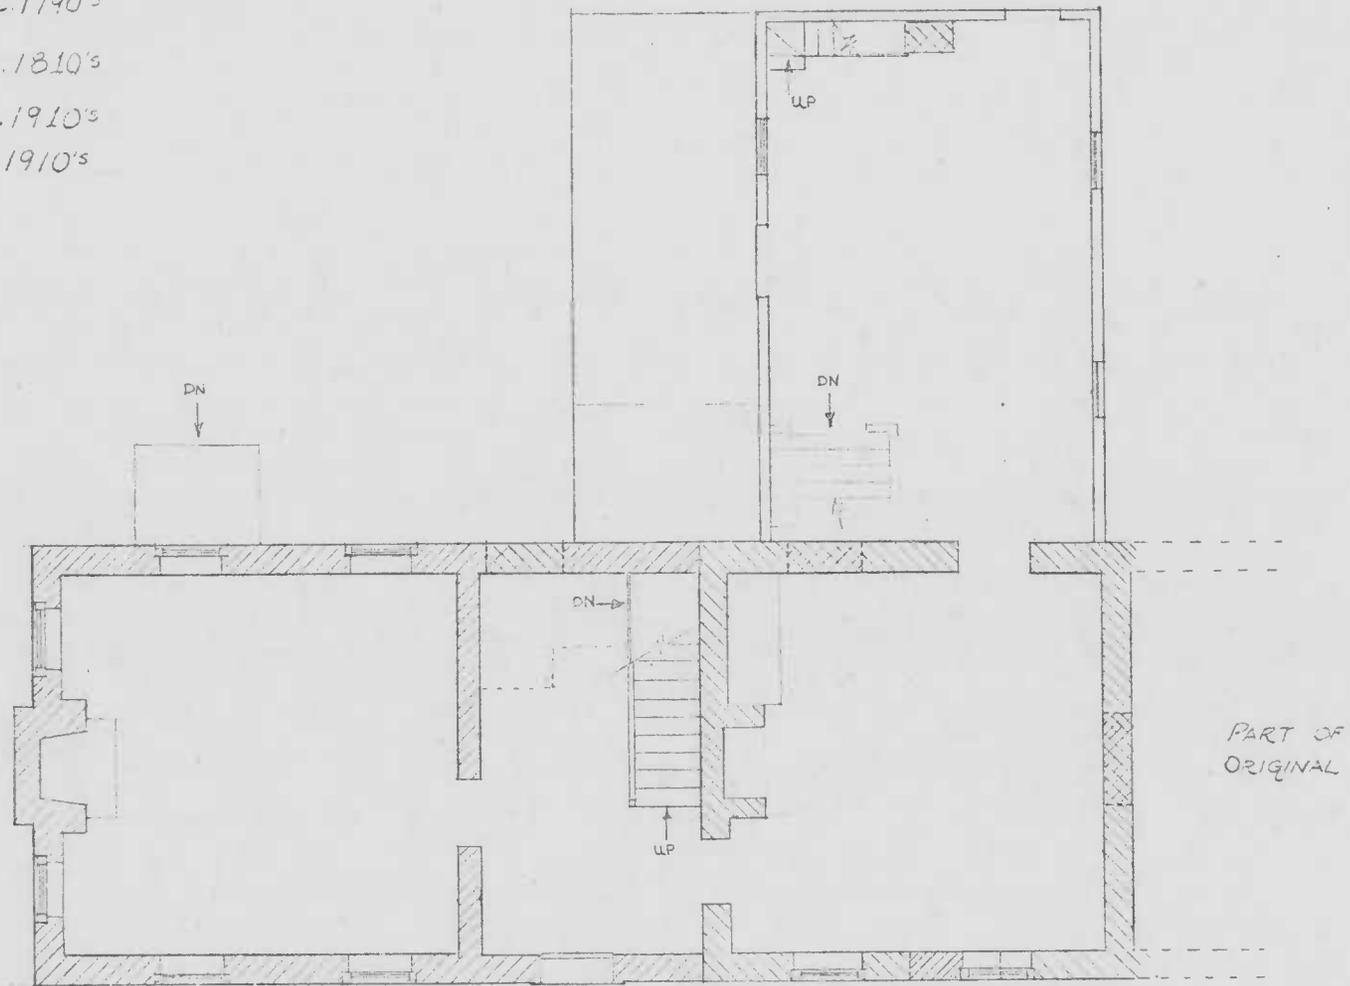
ORIGINAL DOOR

PART OF ORIGINAL

LEAGER FARM HOUSE
FIRST DISTRICT, Q.A. CO.
FIRST FLOOR PLAN
SCALE - 1/8" = 1'-0"
M. BOURNE, JAN, 1933

The house faces southeast and is composed of two brick sections on this facade and a frame wing on the back. The earliest part of the house is the present dining room, on the northeast end, which was constructed around 1790. Twenty to thirty years later, the taller brick structure was added to the southwest gable of the original. Around 1910, a frame two story section with porch was built behind the dining room. From that period very little has happened to the building, with the result that the house has a feeling of antiquity found in few houses of the period.

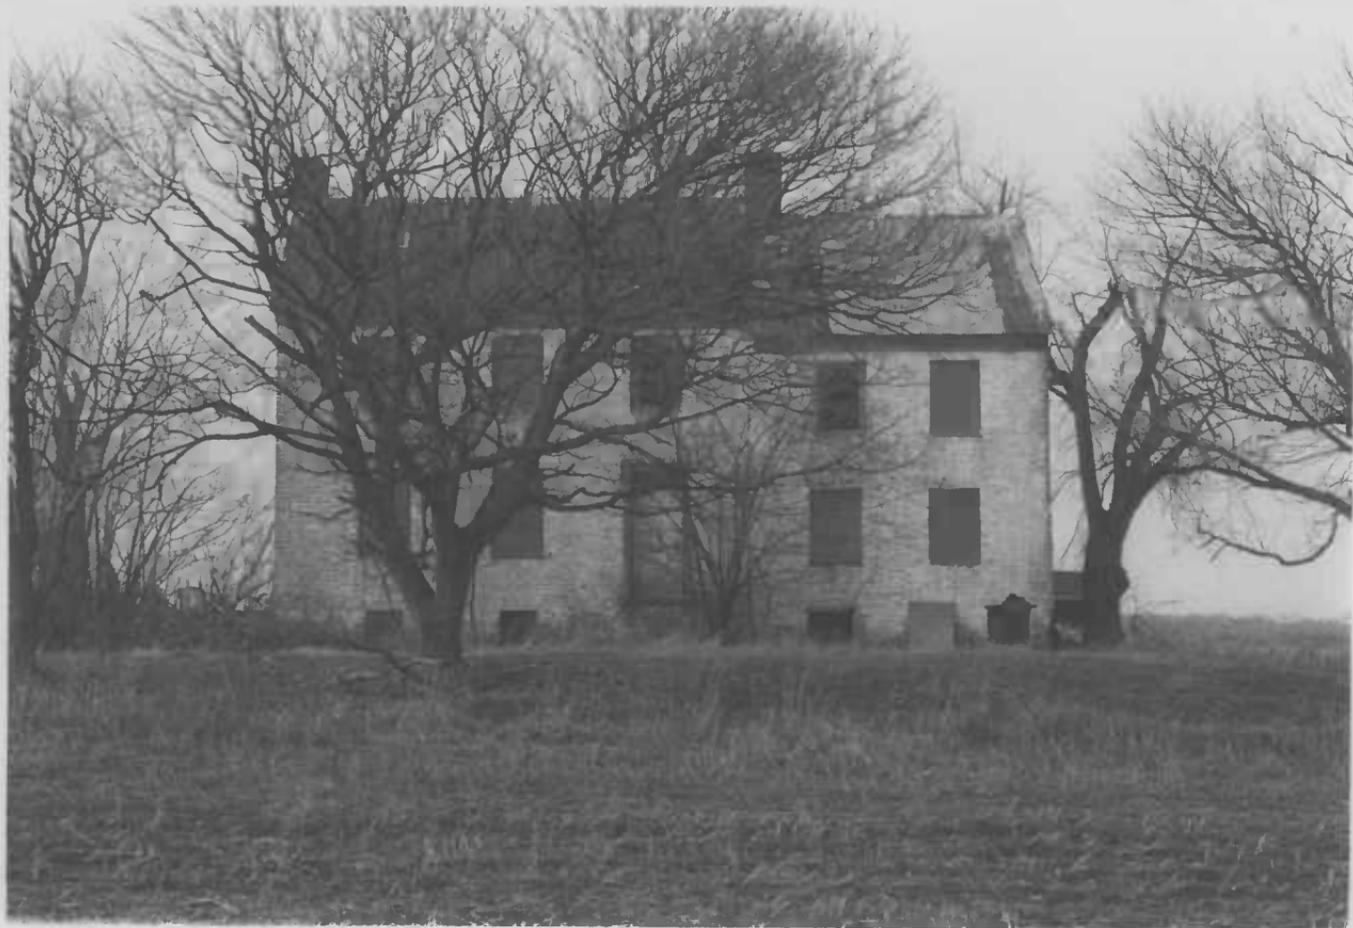
QA-12

Southeast elevation

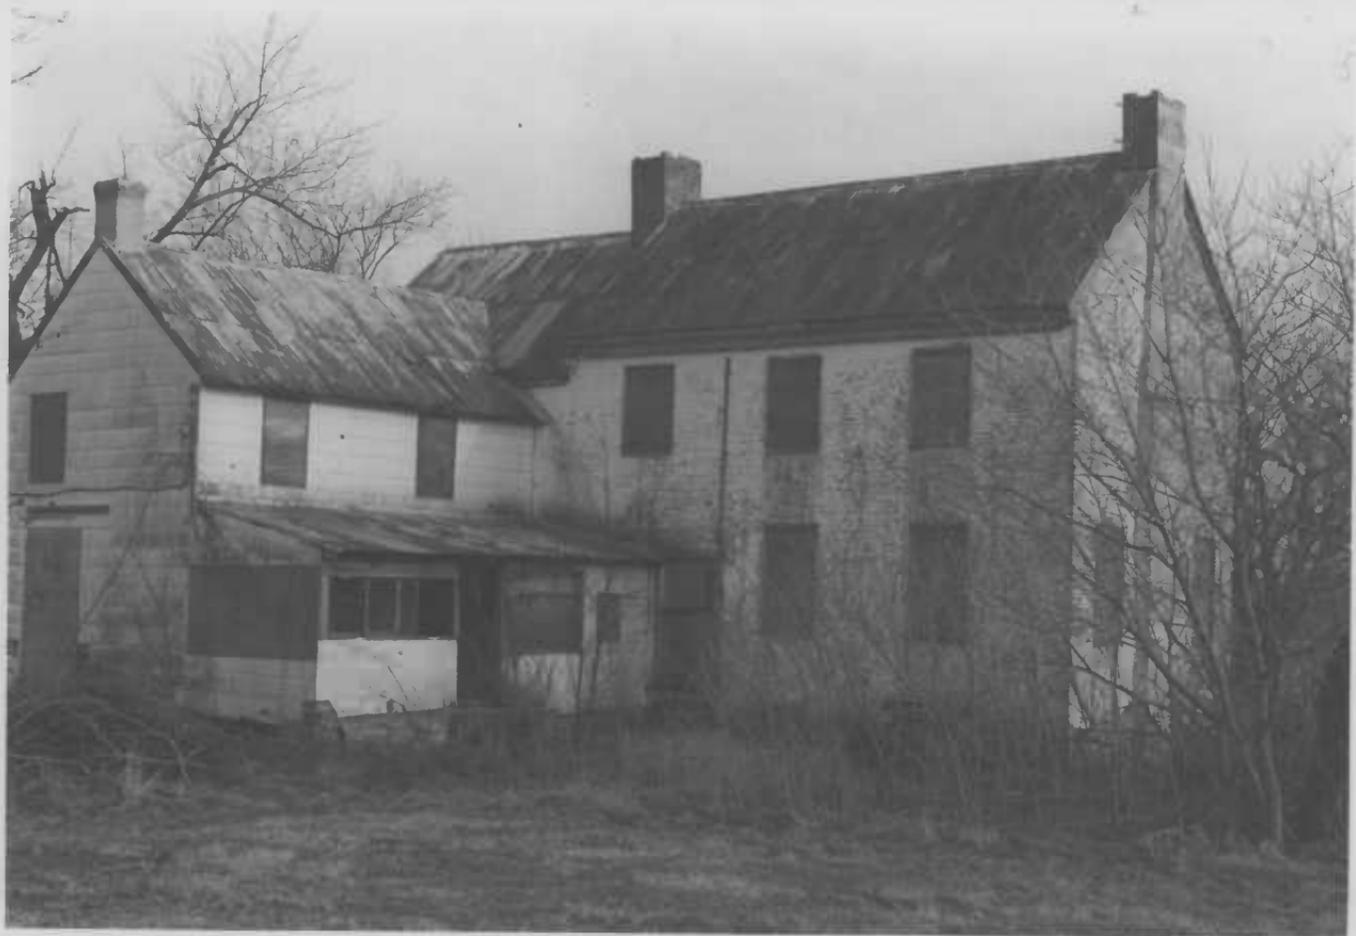
QA-12

West

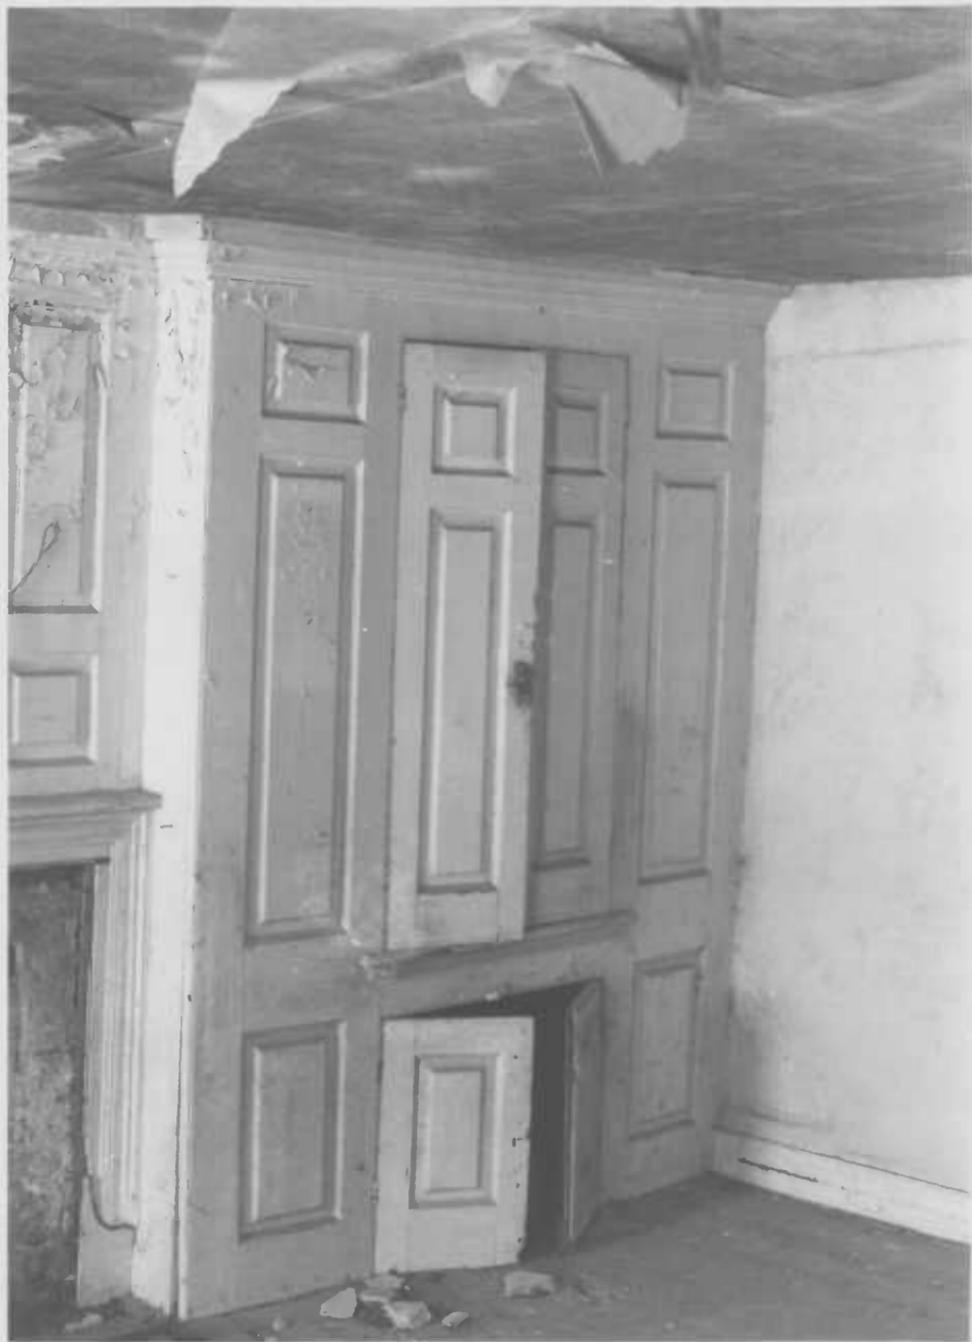
QA-12 Julian Leager Farm
Sudlersville vicinity
Michael O. Bourne
Interior, paneled cupboard

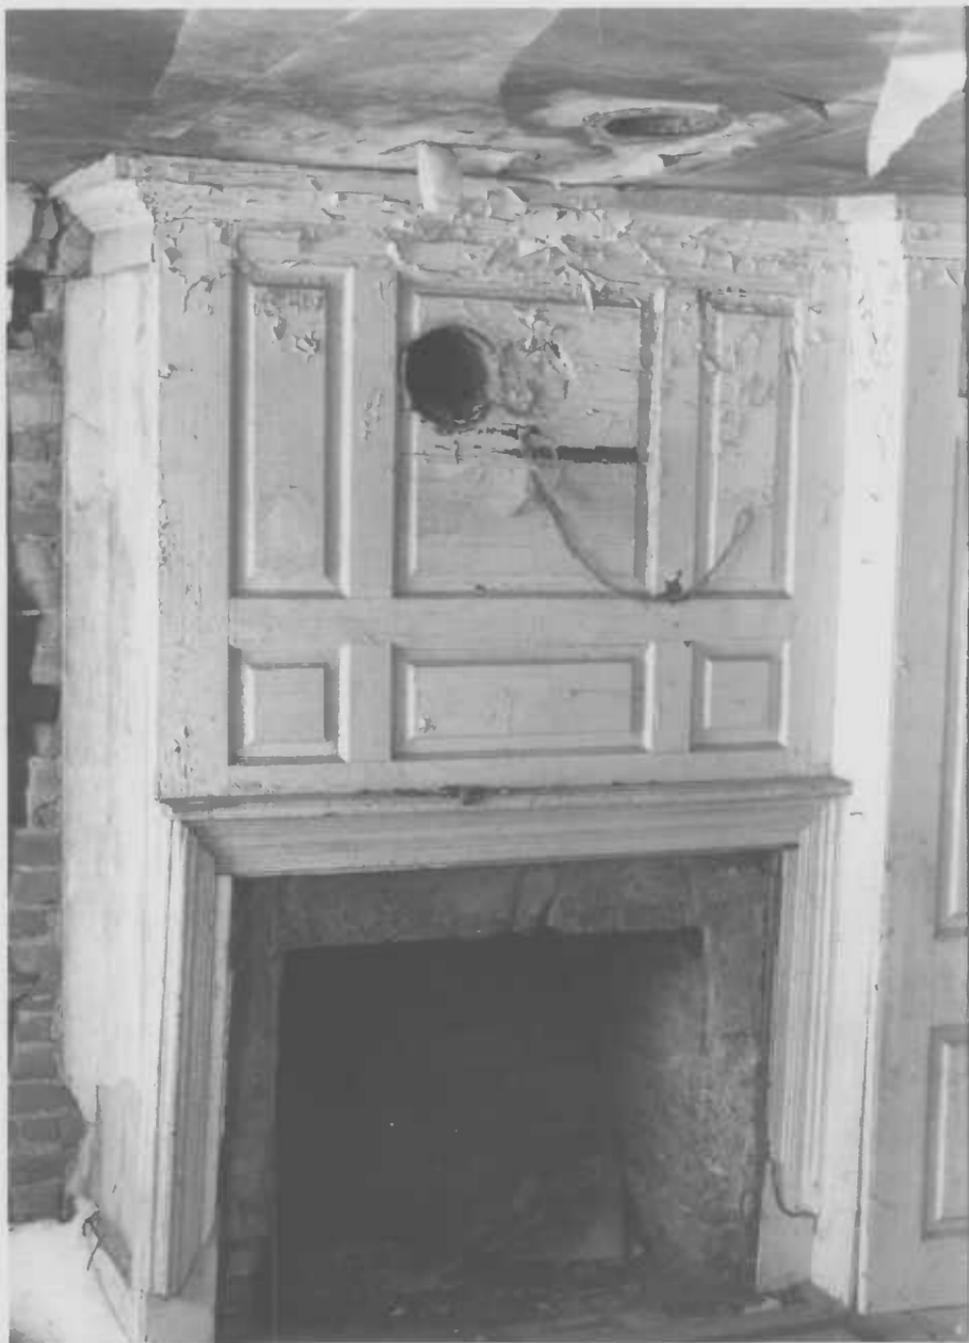
QA-12

Julian Leager Farm
Sudlersville vicinity
Michael O. Bourne
Interior, paneled chimney
breast
