QA-48

James Clements Farm
Sudlersville
Private

circa 1760-1790

INVENTORY FORM FOR STATE HISTORIC SITES SURVEY

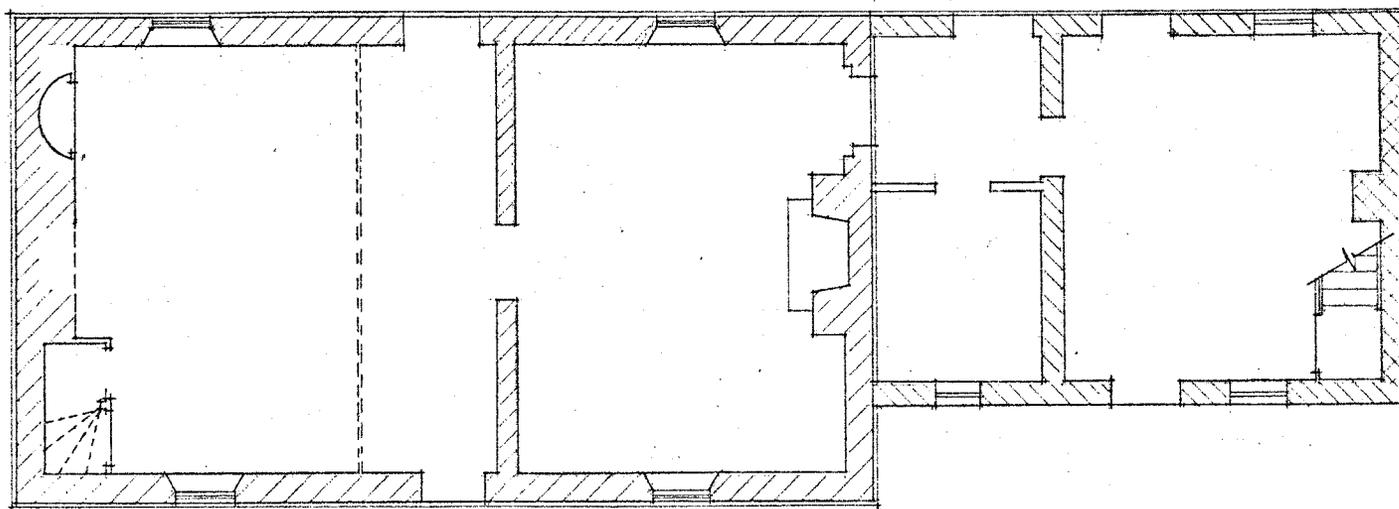
- ▨ PERIOD I: C. 1780
- ▩ PERIOD II: C. 1800
- ▧ PERIOD III: 20th C. REPAIR

JAMES CLEMENTS FARM
SUDLERSVILLE, MARYLAND

SEPT. 27, 1978

Evidence found concealed below the modern stairway suggests that the present hall-parlour plan is a modification of an earlier, though not necessarily original center hall plan. A scar remains in the plaster below the stair from a one-inch board partition which formed a hallway approximately $5\frac{1}{2}$ feet wide. The early baseboard and chairrail remain on this section of wall, and the outline of the board partition is clearly outlined on the trim. Although the trim does cross the line of the wall, there is no paint where the partition and the corresponding trim butted against it, and a pair of carefully cut notches in the baseboard show where the partition baseboard was mitred into place. The seam in the plaster also indicates that the partition was put in before the wall was plastered, and not as an afterthought.
