QA-64

C. P. Merrick Farm
Ingleside vicinity
Private

early 19th century

INVENTORY FORM FOR STATE HISTORIC SITES SURVEY

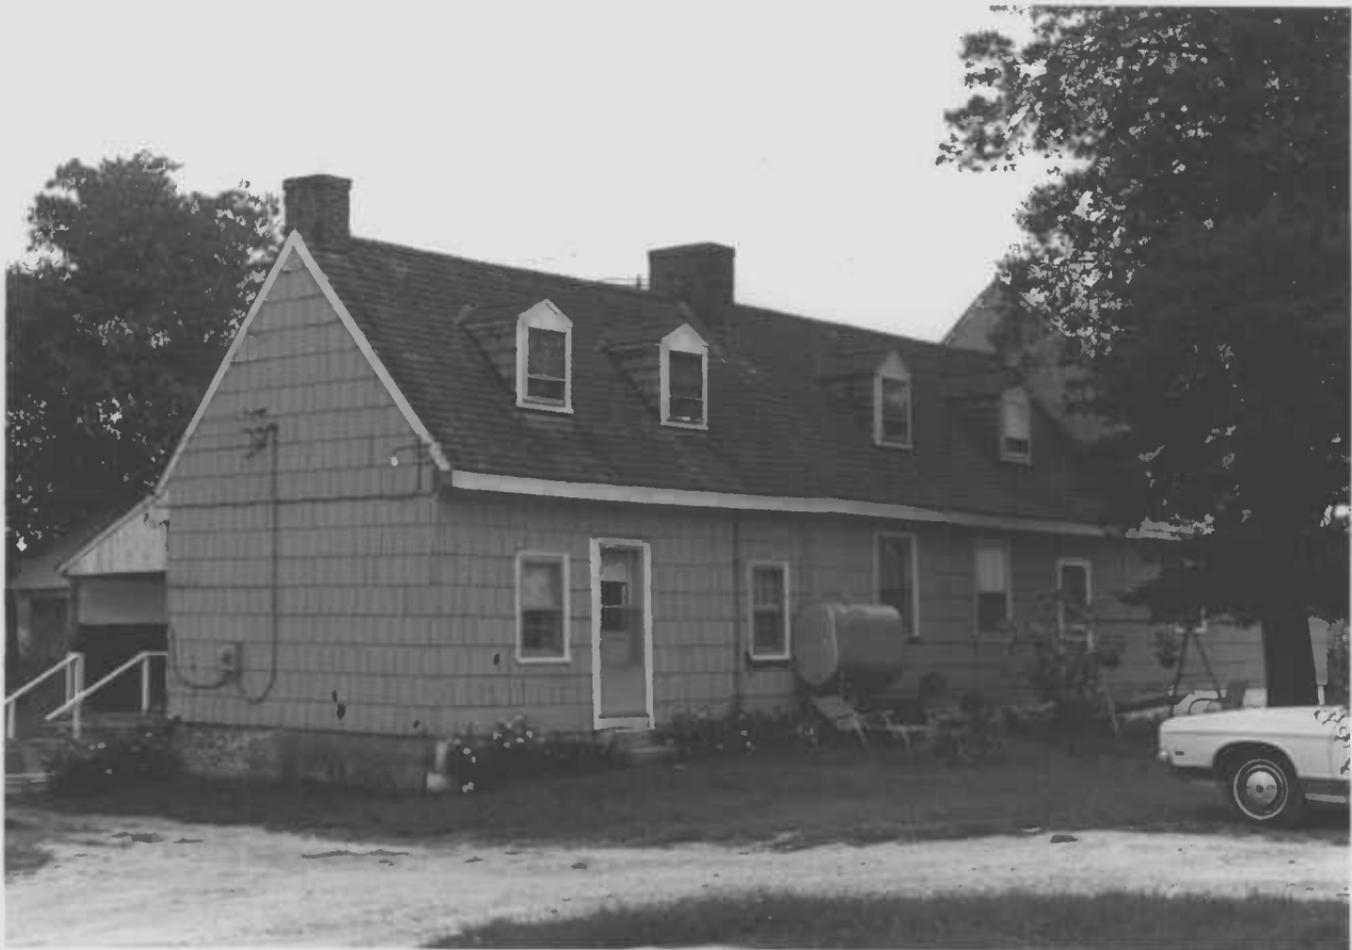
QA-64

Merrick Farm
Brierly Mill Road
Ingleside vicinity
Orlando Ridout V 1979
House from Northwest

The house is of frame construction, built in three stages. The original section is 1 1/2 stories high, two bays wide, and one room deep, with a single flush brick chimney centered on the south gable of the gambrel roof. This part of the enlarged house rests on a random bond foundation, with asphalt shingle siding and a tin roof. There are two 6/6 windows on the first floor and two 6/6 shed roof dormers on each facade. There are no openings on the exposed south gable; the north gable is covered by an early addition. No evidence survives of an original exterior door, but it seems likely that a single door was originally located in the center bay of each facade, opening into a hall-parlor plan. Early surviving exterior detail includes molded window frames, tapered and beaded rakeboards, and a beaded fascia board on the box cornice.

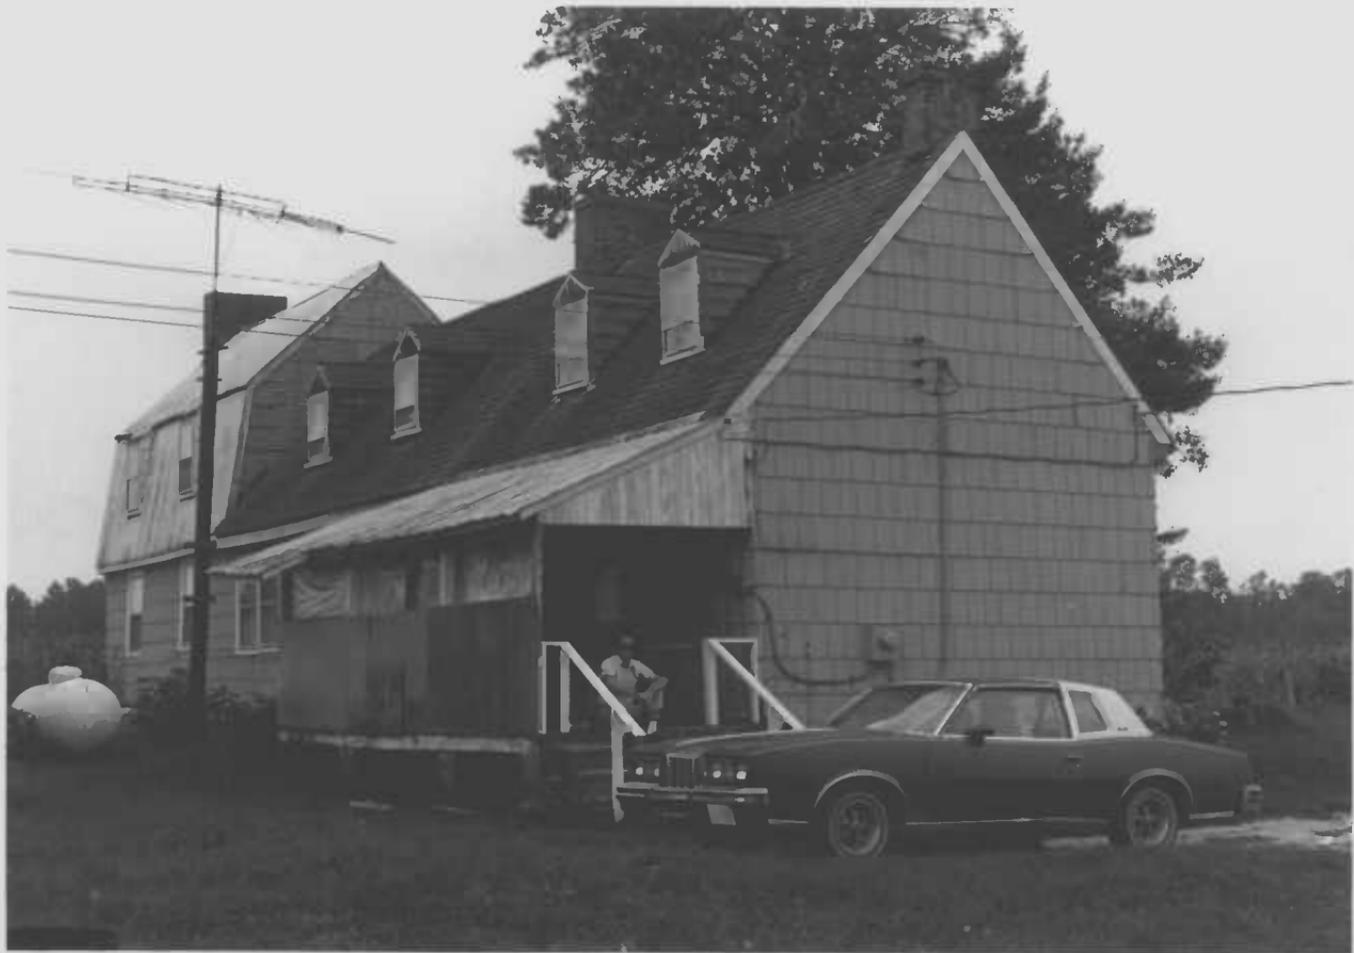
QA-64

Merrick Farm
Brierly Mill Road
Ingleside vicinity
Orlando Ridout V 1979
Main house from Northeast

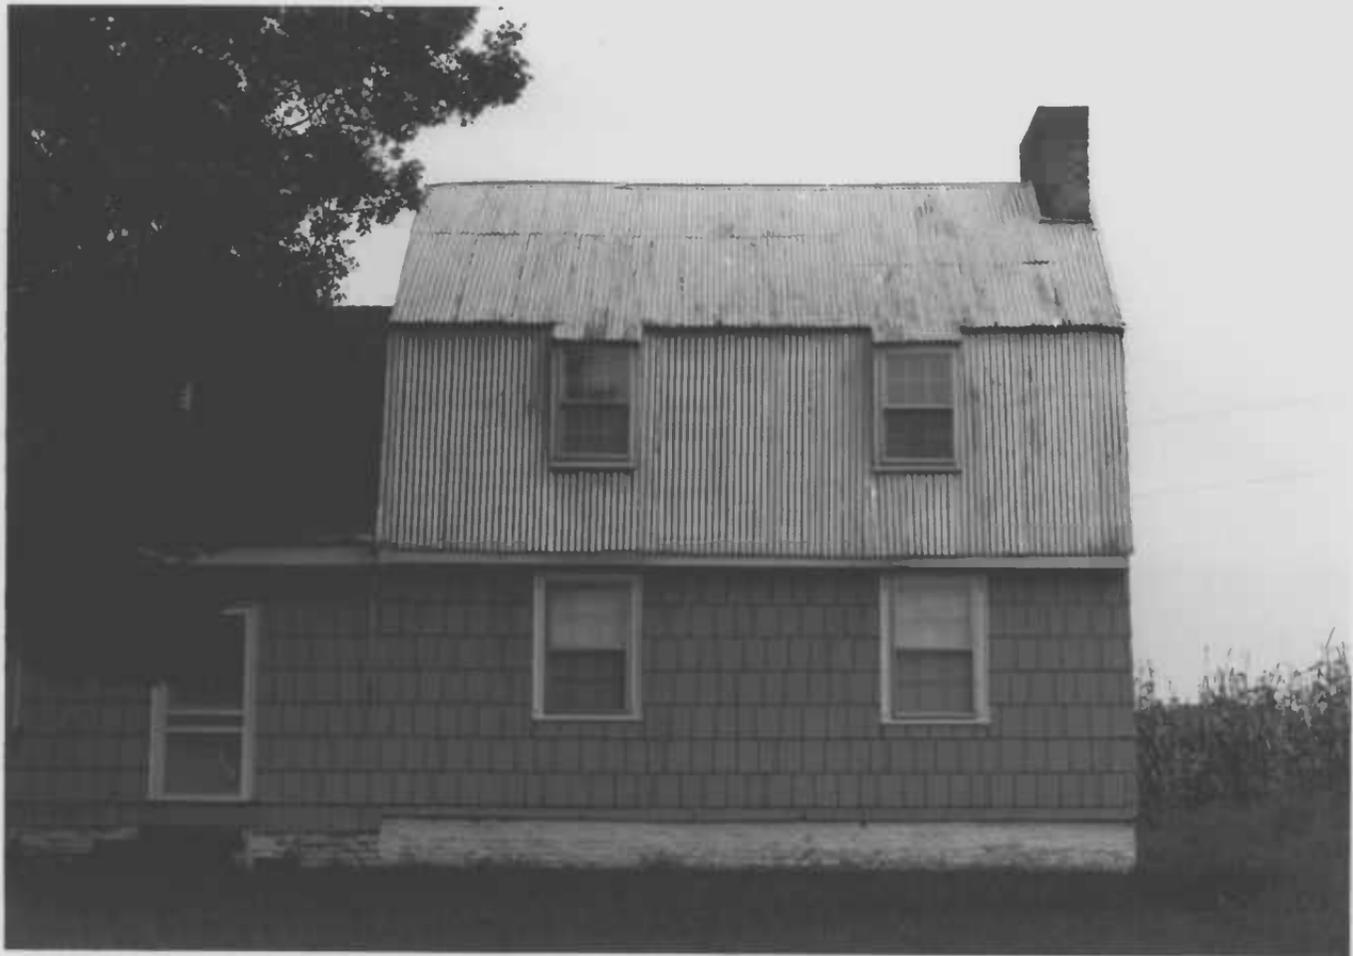
QA-64

Merrick Farm
Brierly Mill Road
Ingleside vicinity
Orlando Ridout V 1979
House from West

there are now four 6/6 windows on the first floor and two 6/3 dormers. The second window from the south (on the first floor) is modern and apparently replaces a door. This addition rests on a three-course bond foundation about 6 inches lower than the original house. Window frames and cornice match the earlier building. This addition probably dates to the second quarter of the 19th century.

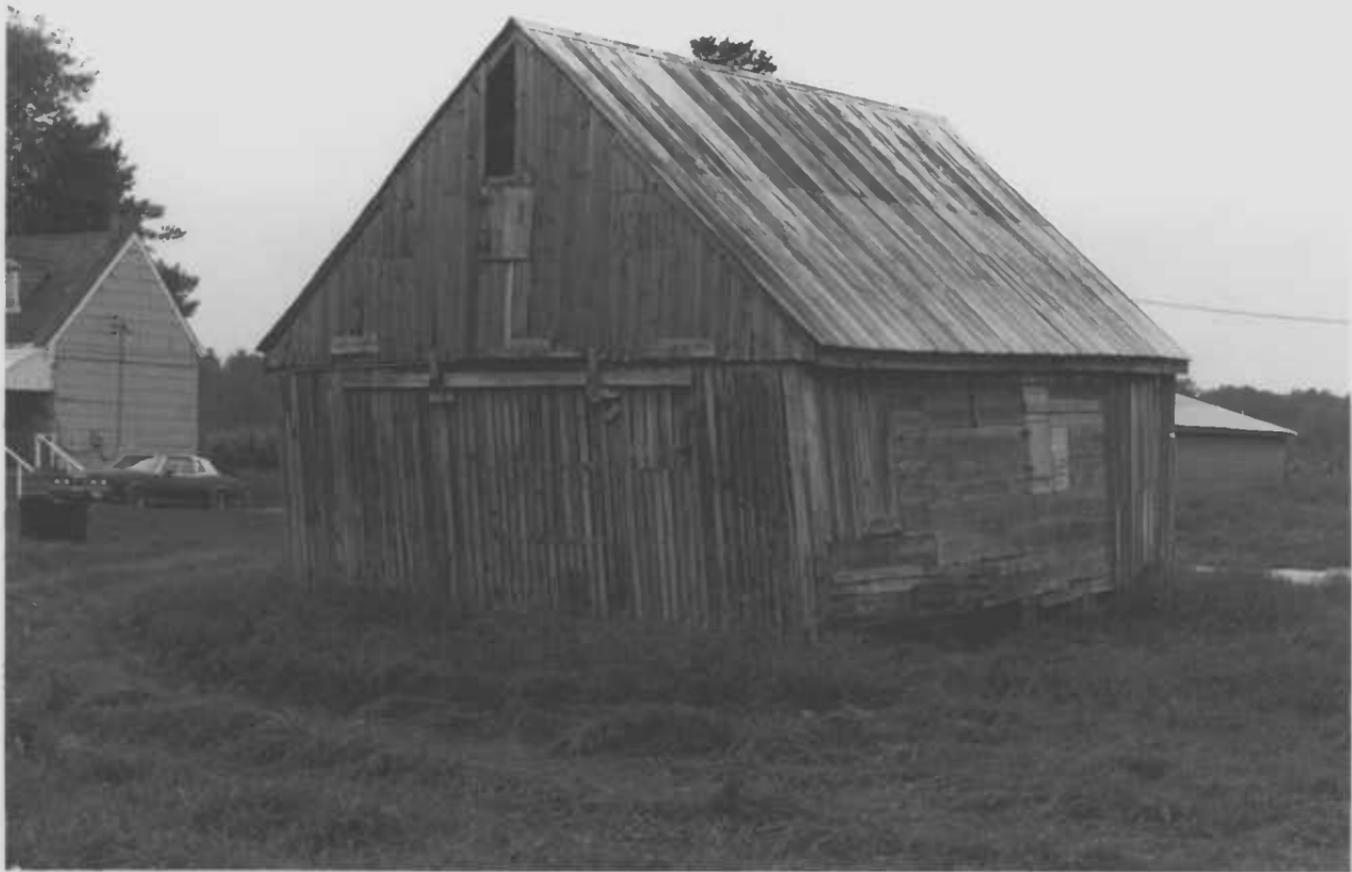
QA-64

Merrick Farm
Brierly Mill Road
Ingleside vicinity
Orlando Ridout V 1979
Granary

Of perhaps greater significance is the combined granary/crib to the northeast of the house. This heavy timber frame building may be an early tobacco house renovated to store grain and corn. The overall dimensions of 24 feet by 32 are typical of small tobacco houses and divide into the four foot bays necessary to hang tobacco. Framing evidence, particularly in the roof, reinforces this conclusion. The presence of wrought nails suggests an 18th century building, a rare survival among farm buildings on the Eastern Shore.

To the northeast of the house is a large granary with flanking cribs. The pitched gable roof is oriented on an east-west axis with the cribs in the east and west gable bays. This is an unusual arrangement, and combined with framing evidence suggests that the building has been adapted for its present use. The building is constructed of a combination of hewn and gang-sawn timbers, and it is clear that an early hewn timber building has been extensively repaired and reworked. Of particular interest are a series of early rafter pairs reused to support the west end of the roof. The rafters are hand-hewn and originally formed a roof steeper than the present 43 degree pitch. They have been reduced in length and the upper ends mitred, butted and nailed at the ridge. The most interesting feature is a series of collar notches on these rafters, with as many as seven collar beams or similar cross pieces on each rafter pair. The purpose of these collars is unclear, but the most obvious explanation is that they were used
