QA-88  
Emerson Farm  
Roe vicinity  
Private

circa 1800-1815

INVENTORY FORM FOR STATE HISTORIC SITES SURVEY

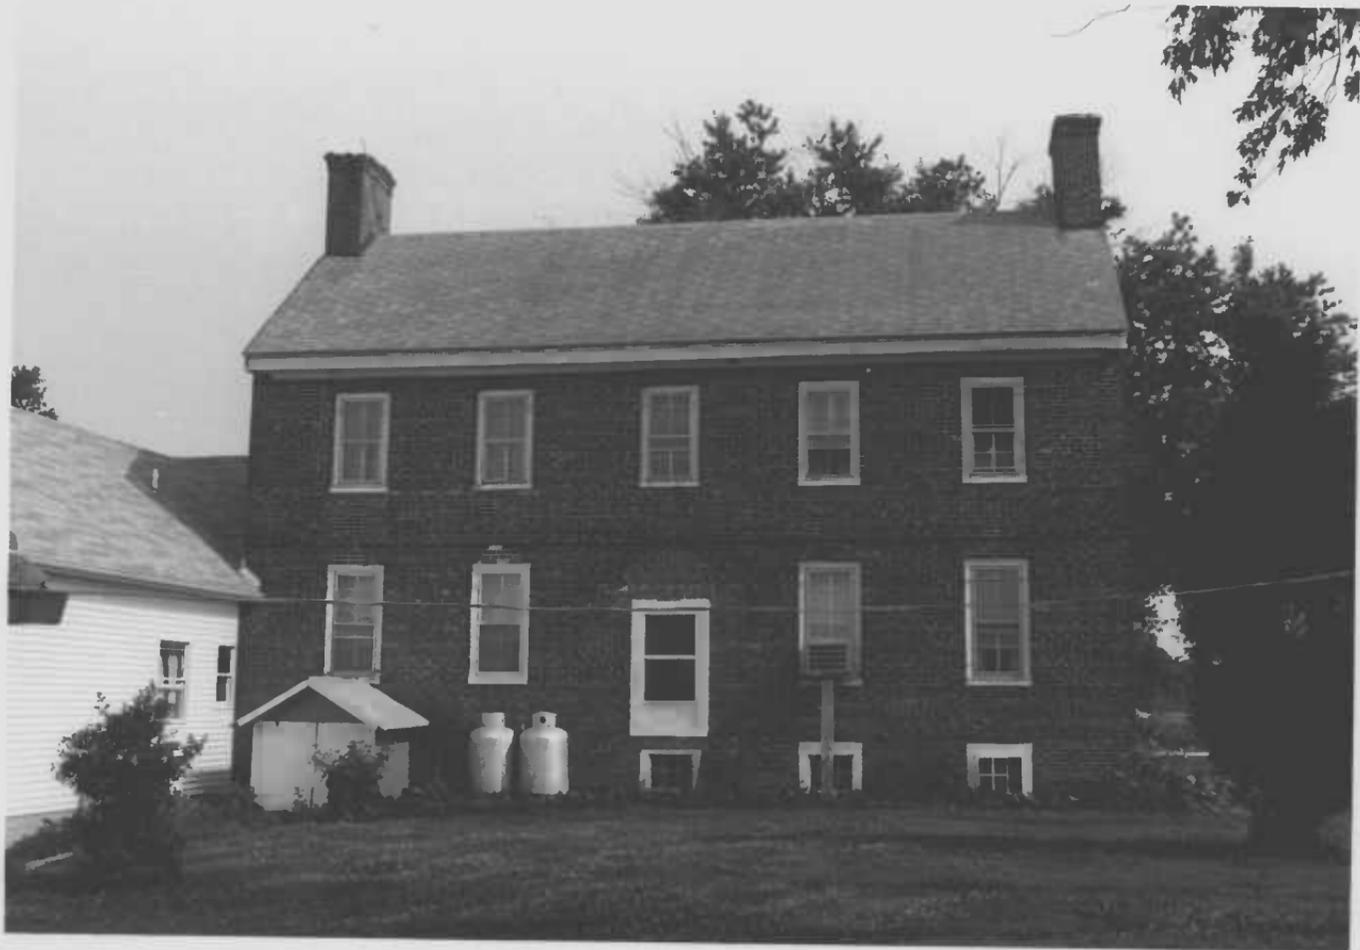
QA-88

Rear facade
