**MARYLAND HISTORICAL TRUST
DETERMINATION OF ELIGIBILITY FORM**

Property Name: Woodbury (Cloverfields, Marion Leaverton Farm) Inventory Number: QA-227
 Address: Wye Mills Centreville Road (MD 213) (west side) Historic district: yes no
 City: Wye Mills/Queenstown Zip Code: _____ County: Queen Annes
 USGS Quadrangle(s): Wye Mills
 Property Owner: _____ Tax Account ID Number: _____
 Tax Map Parcel Number(s): _____ Tax Map Number: _____
 Project: _____ Agency: _____
 Agency Prepared By: DOT/FHWA/E.Elinsky
 Preparer's Name: _____ Date Prepared: 12/3/1979
 Documentation is presented in: _____
 Preparer's Eligibility Recommendation: Eligibility recommended Eligibility not recommended
 Criteria: A B C D Considerations: A B C D E F G
Complete if the property is a contributing or non-contributing resource to a NR district/property:
 Name of the District/Property: _____
 Inventory Number: _____ Eligible: yes Listed: yes
 Site visit by MHT Staff yes no Name: _____ Date: _____

QA-227

Marion Leaverton Farm

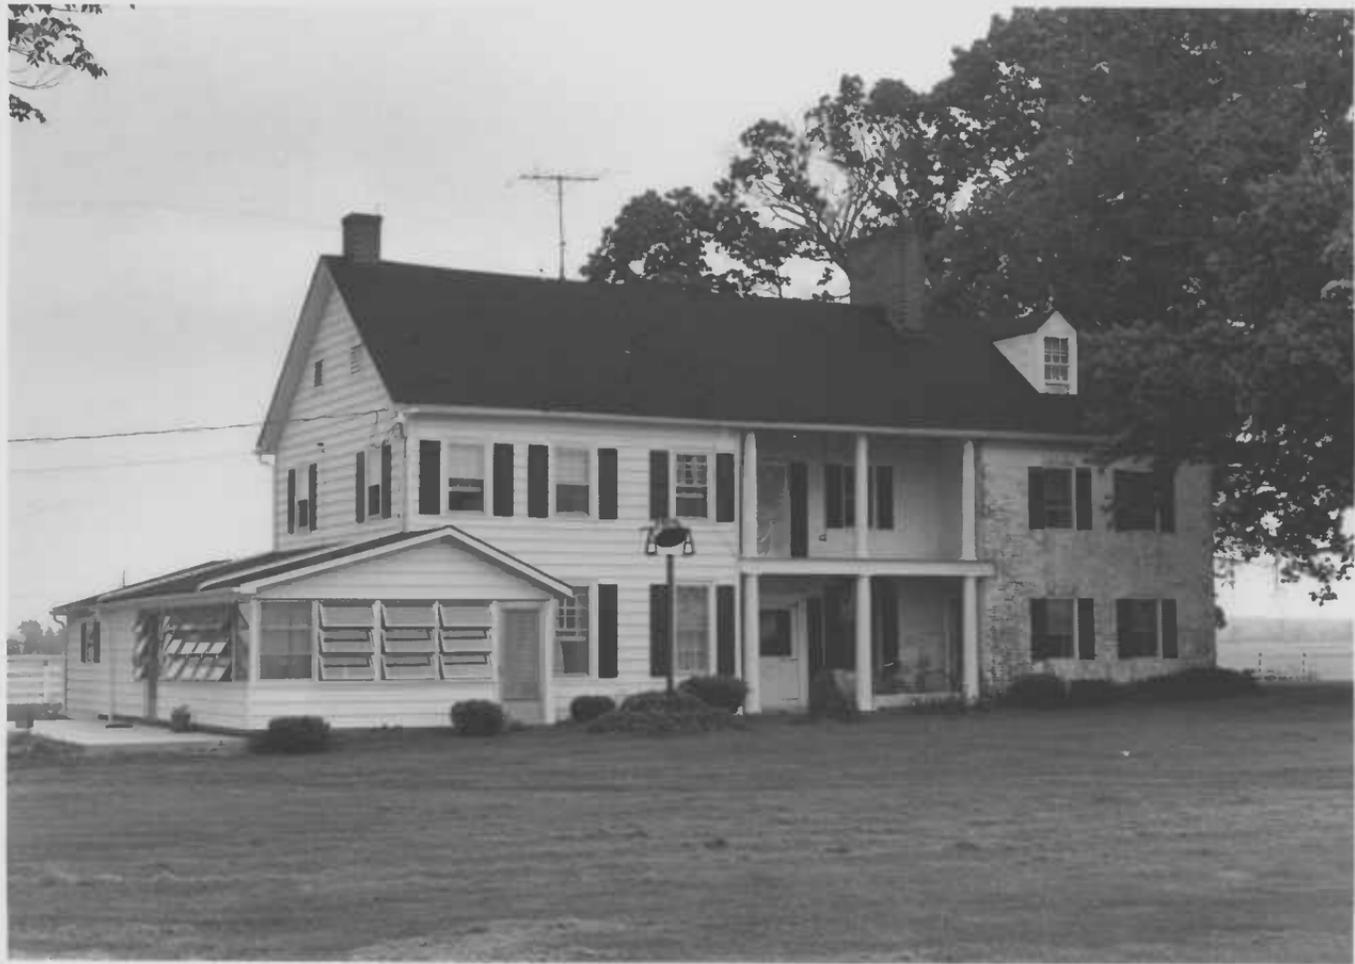
QA-227 Marion Leaverton Farm
Wye Mills vicinity
Orlando Ridout V 1979
View from Southeast

larger six-over-nine in the center of the west section. There are four six-over-six windows ranged across the second floor and a single six-over-six pitched roof dormer in the center of the east section of the roof. The brickwork is Flemish bond, with a corbeled brick cornice. There is no seam between the east and west portions of the building so the west or "rear" section is clearly original. It is worth noting that the six-over-nine window on the first floor has a jack arch that differs from those found on the other windows, suggesting it may have been altered or added at a later date, but unfortunately the jambs are concealed behind fixed shutters, and the opening cannot be examined in detail. There are no seams below the opening, thus ruling out an earlier door location.

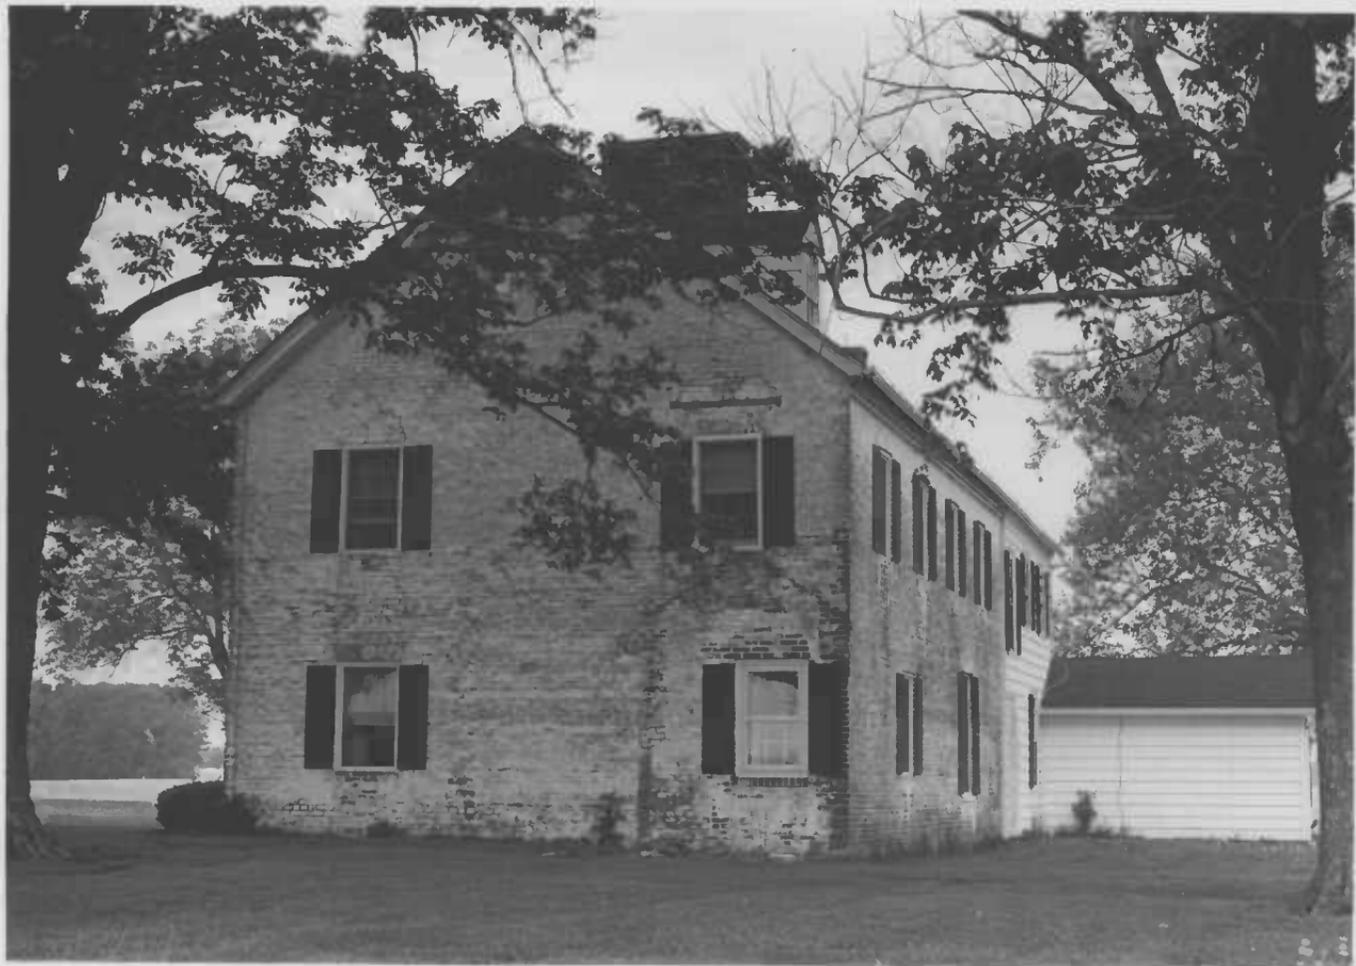
QA-227

Marion Leaverton Farm
Wye Mills vicinity
Orlando Ridout V 1979
View from Northeast
