QA-228

Benjamin Lee Farm  
Church Hill vicinity  
Private

INVENTORY FORM FOR STATE HISTORIC SITES SURVEY

Benjamin Lee Farm

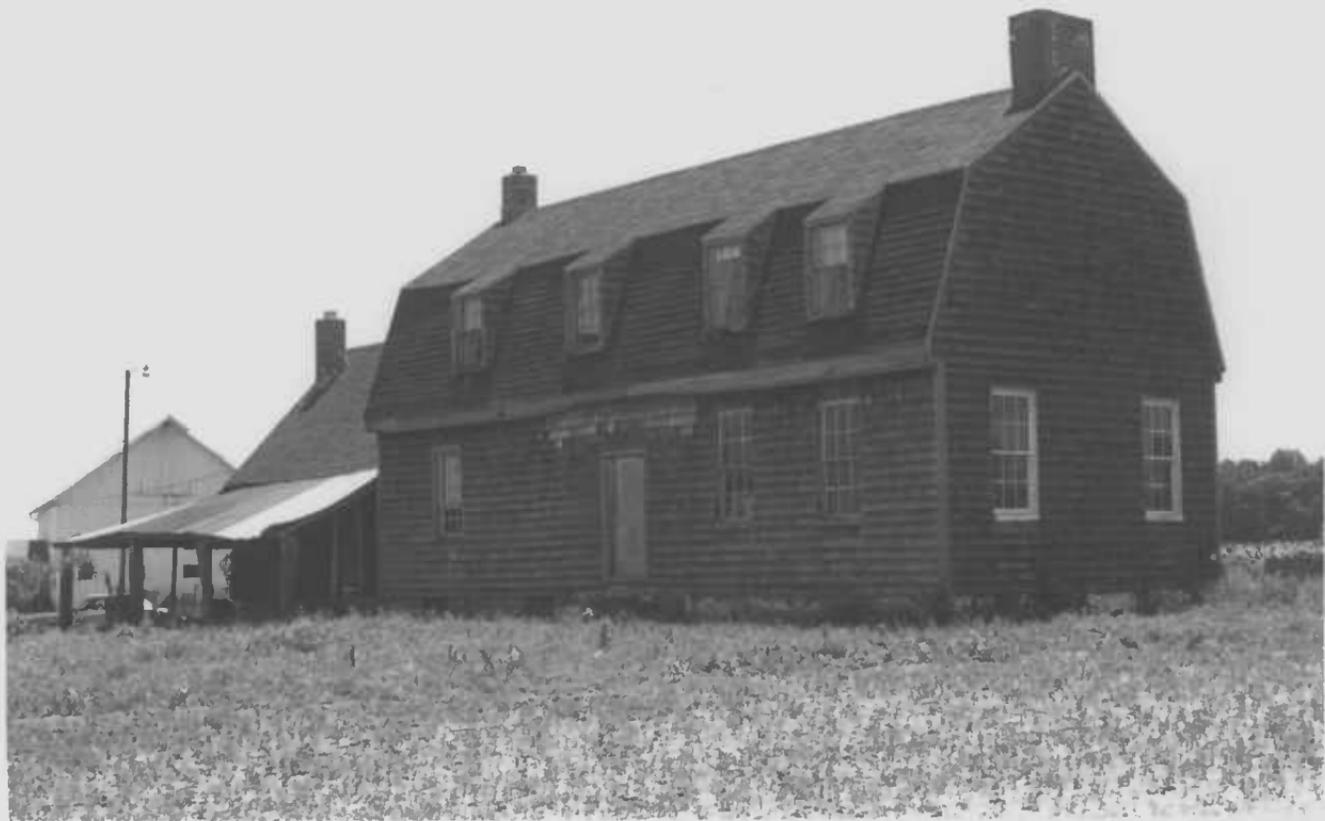
QA-228

Rear facade from north

On the rear facade, the door is offset slightly to west of center due to the interior stair, with two large 6/6 windows to the west and a single 9/6 window in the far east bay. There are four 6/6 shed roof dormer windows on the second floor. The slightly asymmetrical spacing of the windows, the 9/6 sash in the east bay, and a seam in the brickwork to the west of the rear door suggest that the house originally consisted of the three bays to the east and was enlarged by two bays circa 1830 to 1850. The foundation below the three east bays has been reworked and two modern cellar windows have been installed. The siding, cornice, and roof match the front facade.

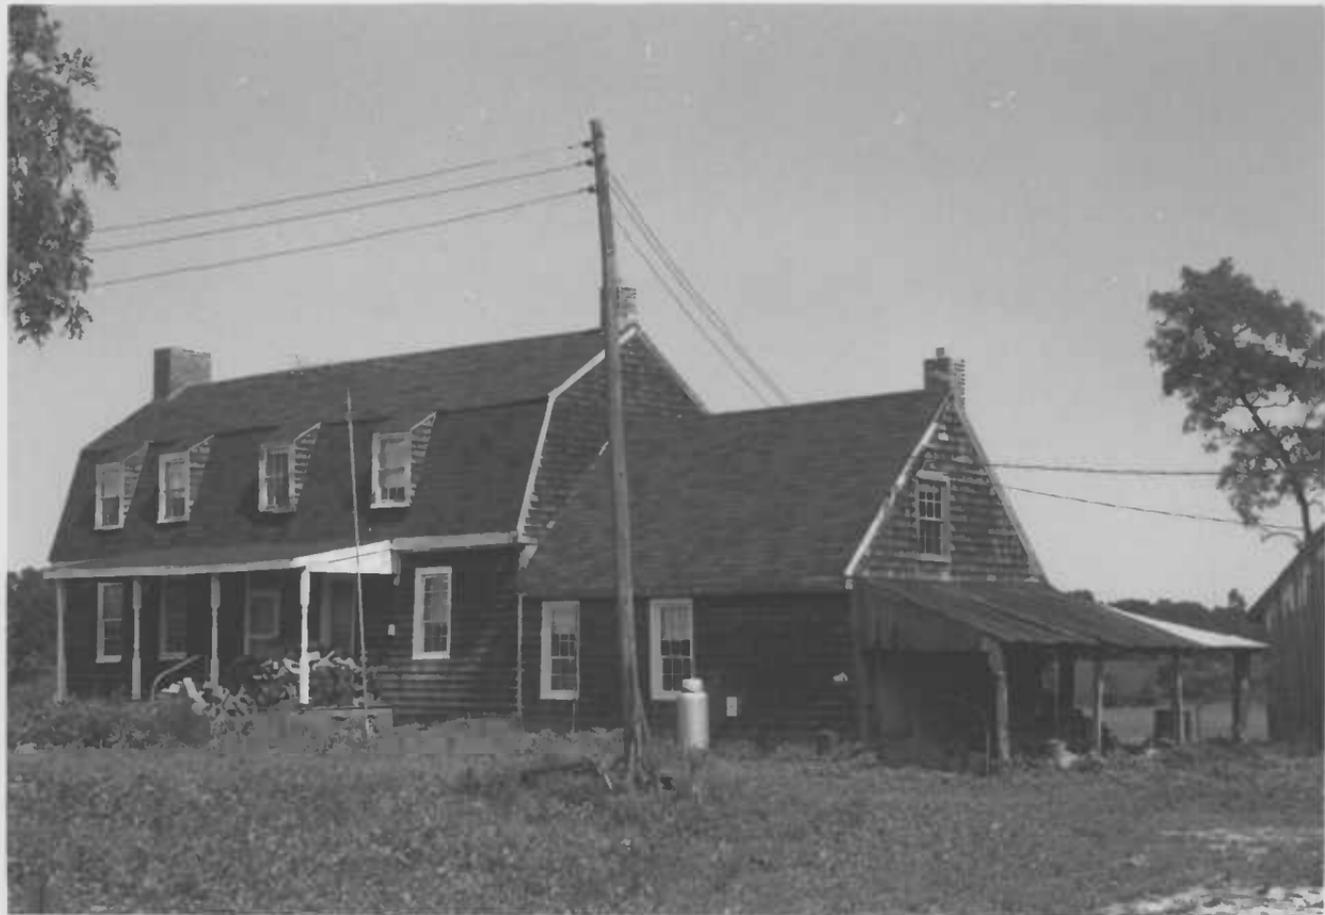
QA-228 Benjamin Lee Farm  
Church Hill vicinity  
Orlando Ridout V 1981  
Front facade from south

The principal facade of the house faces south. The door with four-light transom is located in the center bay, flanked by two large 6/6 windows to the west and two 9/6 windows to the east. Four 6/6 shed roof dormers are asymmetrically ranged across the second story. The building rests on a continuous brick foundation and is now covered with wood shingle siding. The eaves are boxed in, the roof is covered with asphalt shingle siding.
