QA-304

Florence Mason Bank Barn
Ruthsburg vicinity
Private

late 19th century

INVENTORY FORM FOR STATE HISTORIC SITES SURVEY

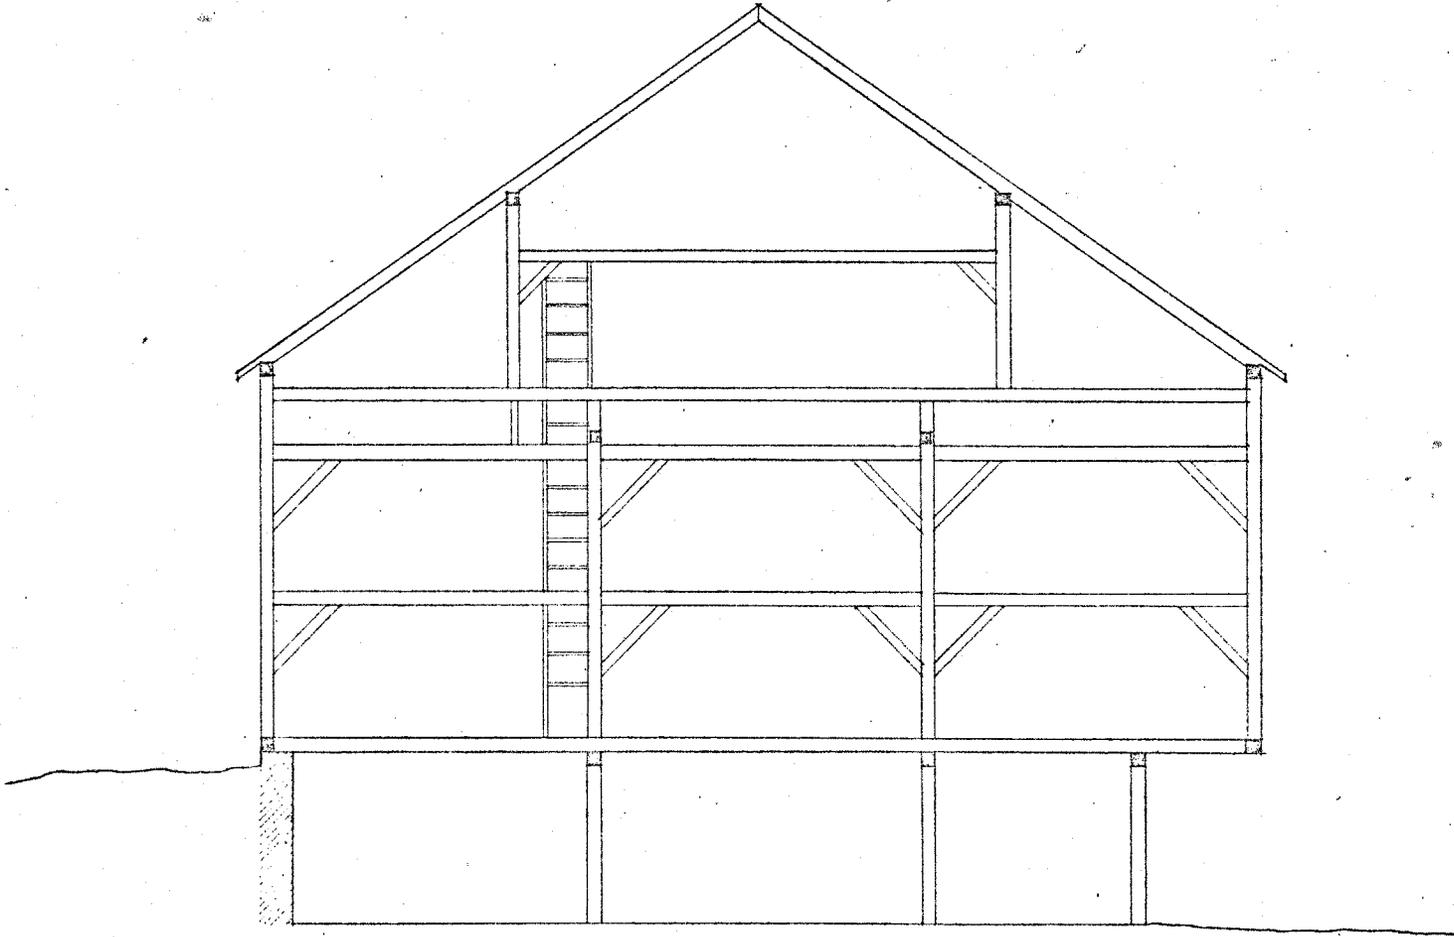
FRAMING SECTION

SCALE: 1/8" = 1'-0"

The barn rests on a brick foundation laid in common bond. The sills are laid directly on top of the masonry walls. Joists are let into the facade sills, and run parallel to the gables. The joists are supported by three girts running parallel to the ridge of the roof, which are in turn supported by heavy posts. The sill on the south facade is supported by the joists, which are cantilevered from a girt, supported by posts, which are also used to frame the exterior wall of the forebay.

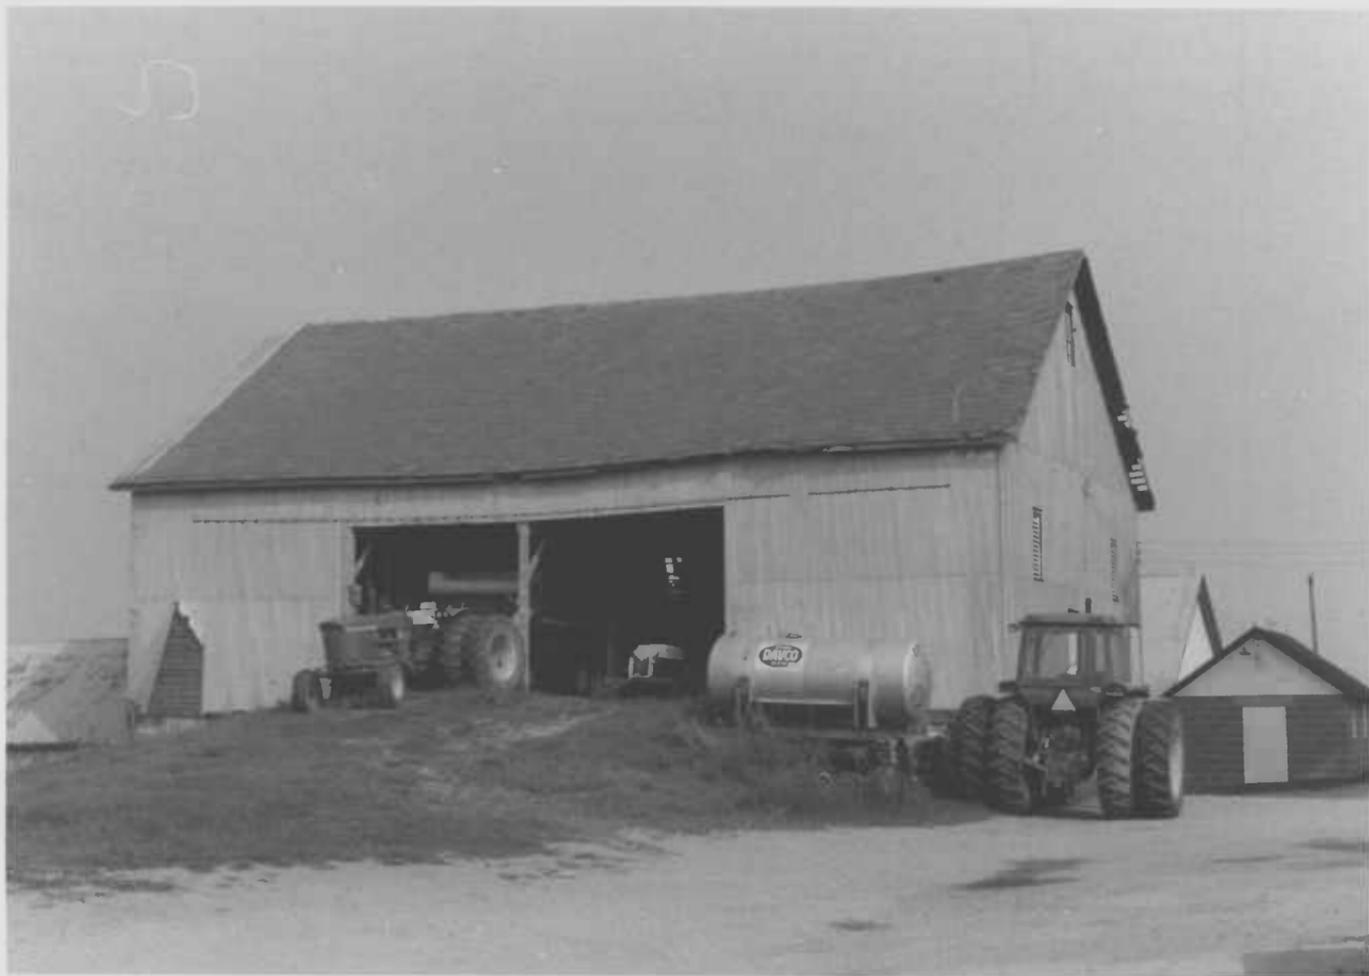
QA-304 Florence Mason Bank Barn
Ruthsburg, Md.
Orlando Ridout V, 1978 (MHT)
NW facade, camera facing SE

This seemingly innocuous looking barn is, on closer examination, one of the few known examples of a Pennsylvania bank barn surviving on the central and lower Eastern Shore. Sited on relatively flat ground, the "bank" is man-made, and consists of a wide earth ramp on the north side of the barn, allowing wagons and machinery to be driven up the ramp and through huge sliding doors into the mow. The south facade has the overshot bay typical of this type of barn, with a series of "dutch" stable doors allowing access to stalls on the ground floor. The brick foundation is laid in common bond, and is carried out the full extent of the overshot bay, but is not carried across the south facade.

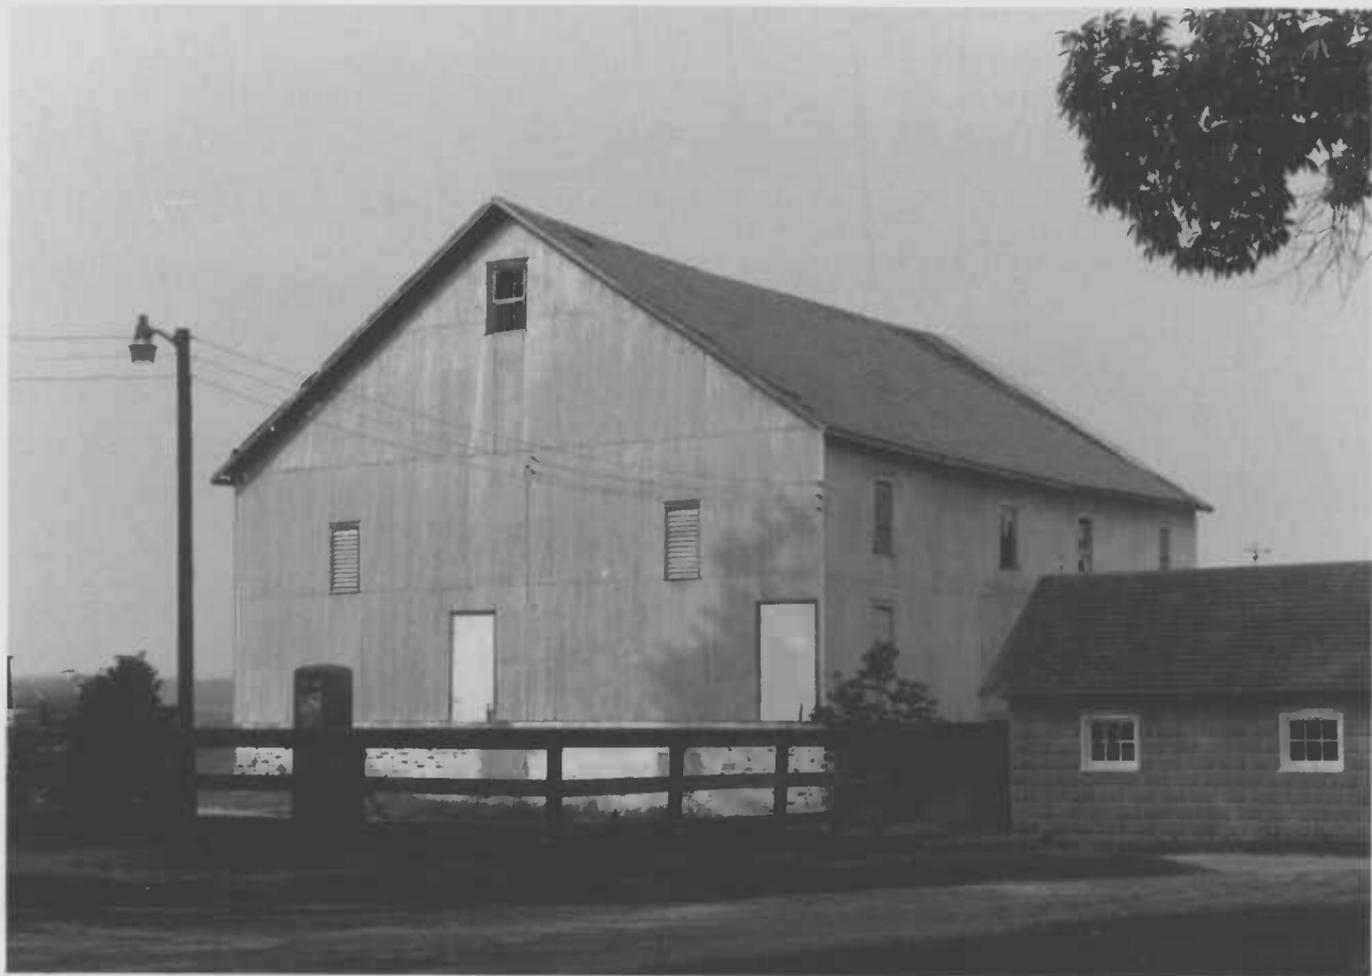
QA-304 Florence Mason Bank Barn
Ruthsbury, Md.
Orlando Ridout V, 1978 (MHT)
SW gable, camera facing NE

There are no other openings on this facade. The west gable has three small window openings in the brick foundation wall. Two of these have been closed up, but the third remains open. On the main floor level, there are two doors, and on the upper level there are two window openings with louvered vents. There is a single six-over-six window in the upper gable.

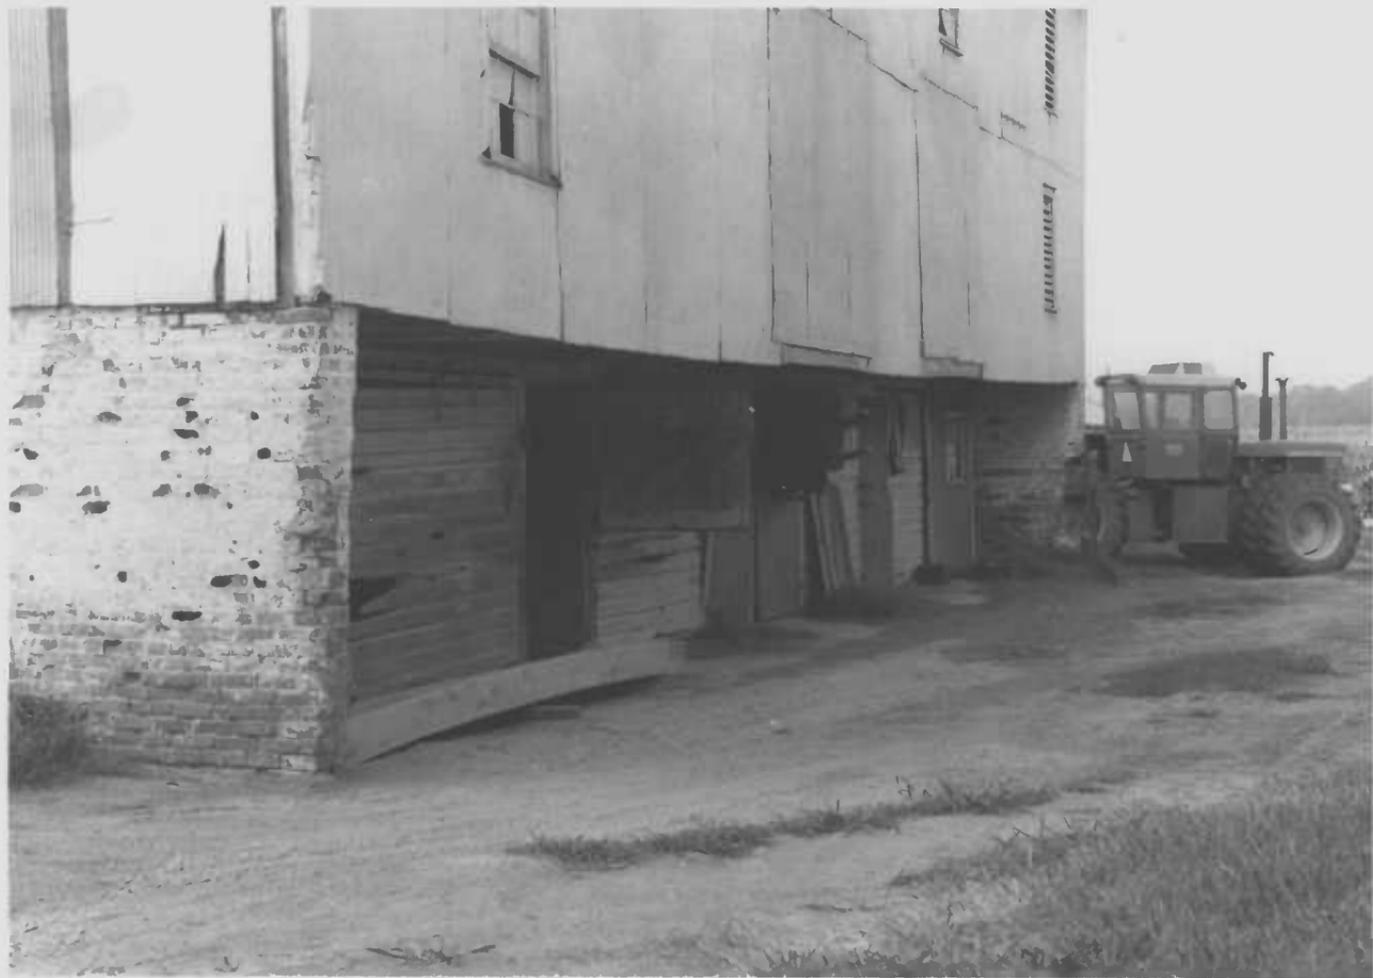
QA-304 Florence Mason Bank Barn
Ruthsburg, MD
Orlando Ridout V, 1978 (MHT)
Detail of forebay, camera facing NE

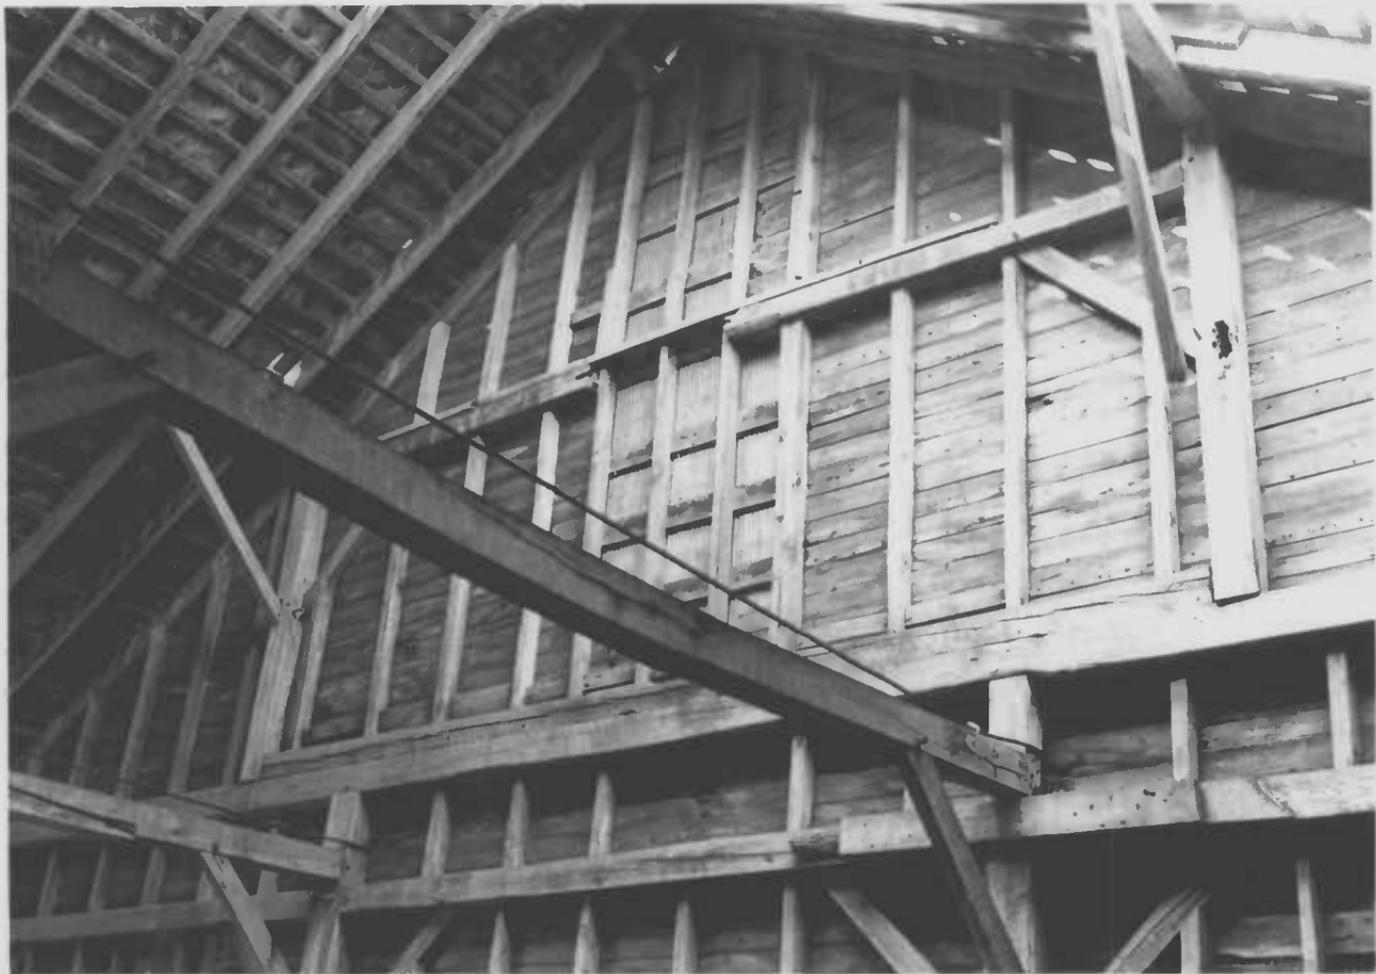
interior of loft

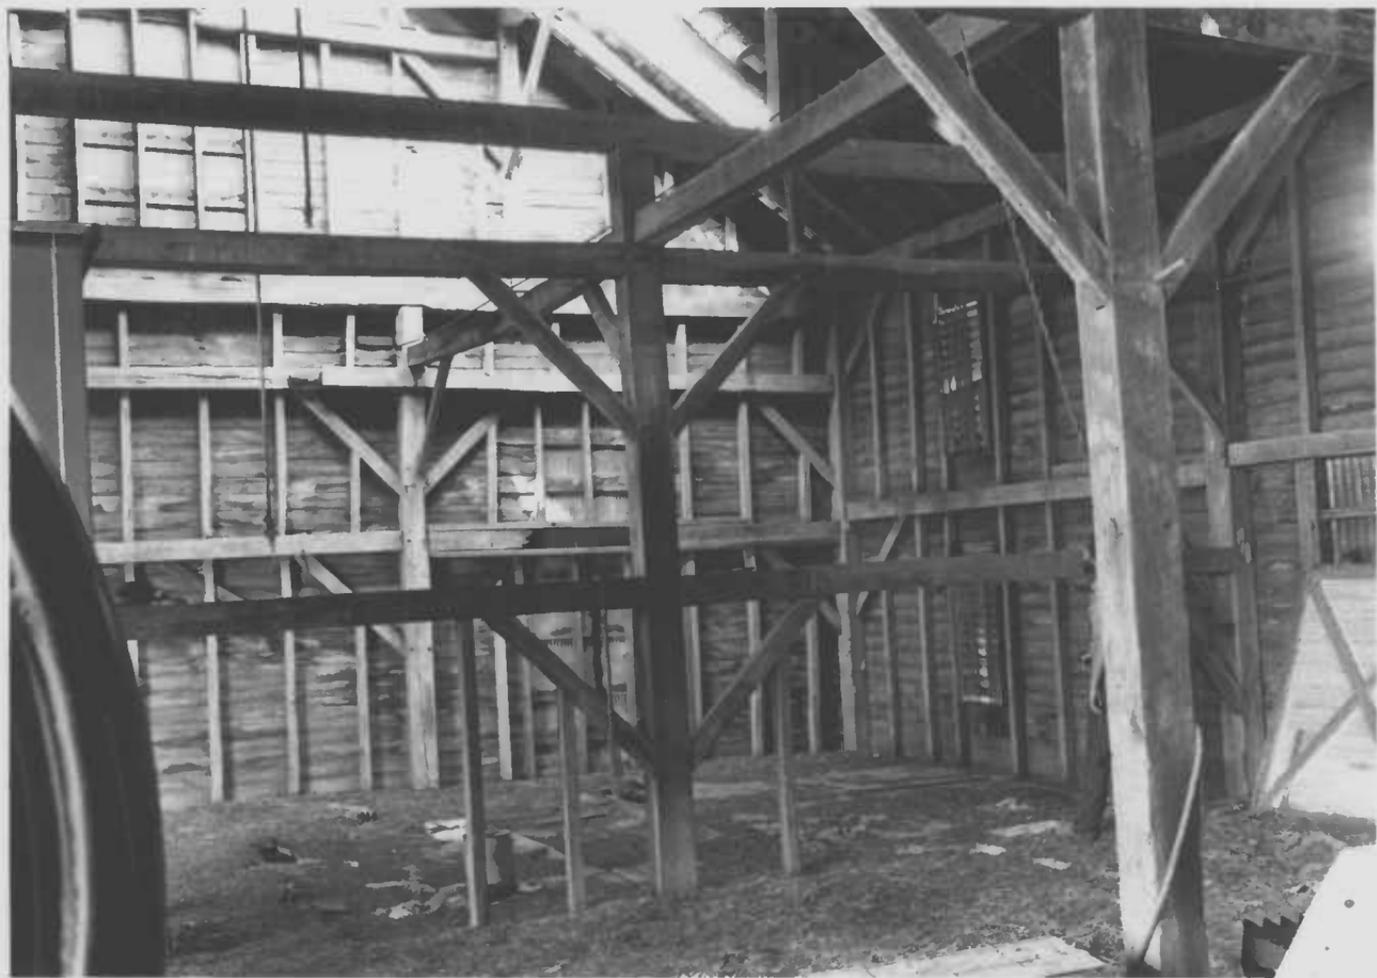
QA-304 Florence Mason Bank Barn
interior framing
Ruthsburg, Md
Mark Edwards 1978
