INVENTORY FORM FOR STATE HISTORIC SITES SURVEY

Gunther Farm

North side Back Starr Road

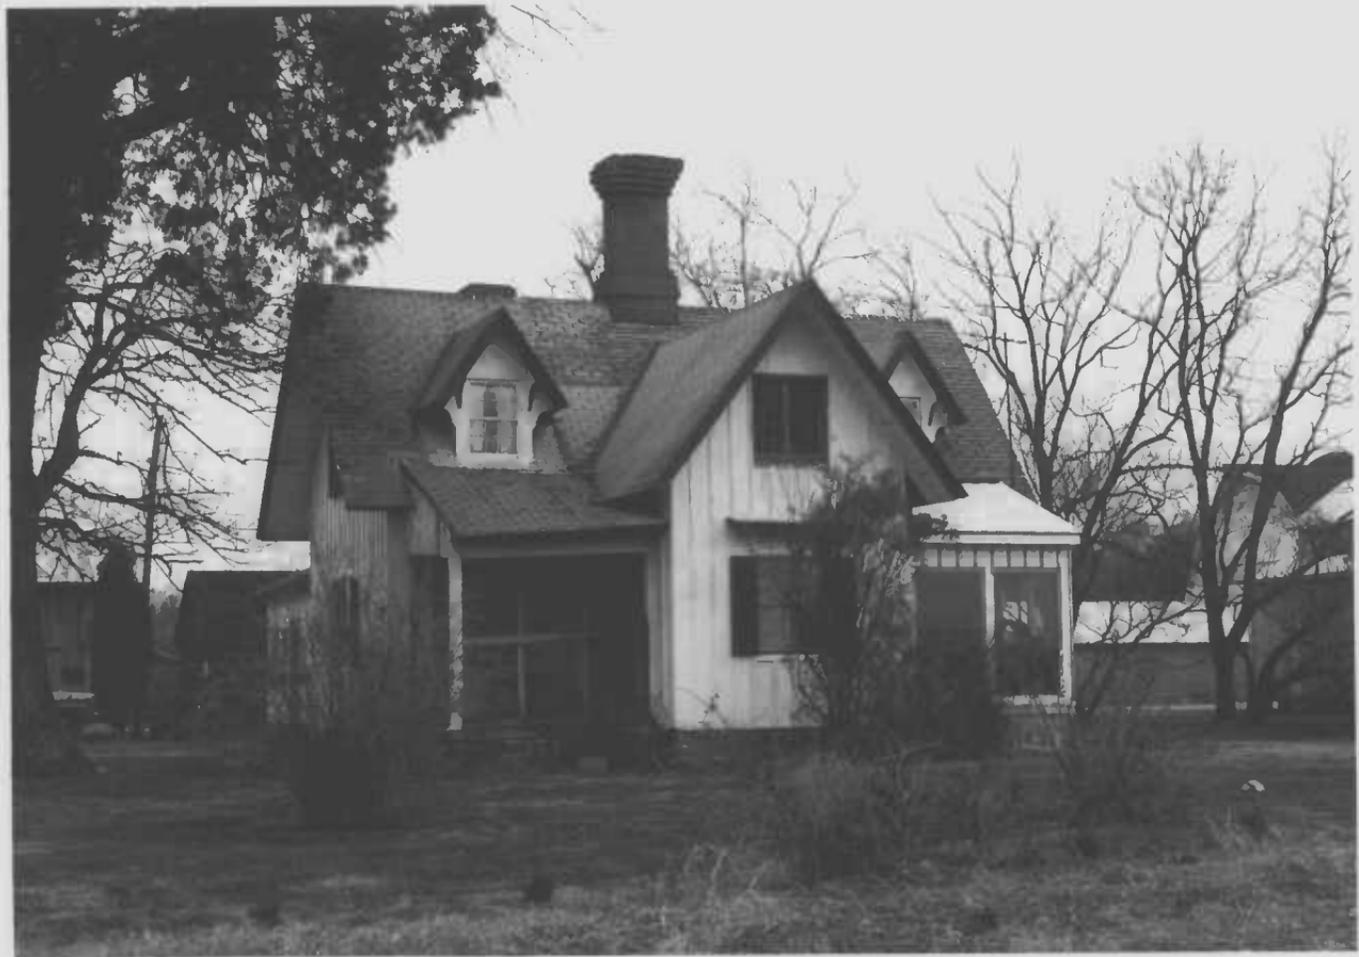
QA-423 Gunther Farm  
Back Starr Road  
Starr vicinity  
Orlando Ridout V Dec. 1980  
View from southwest

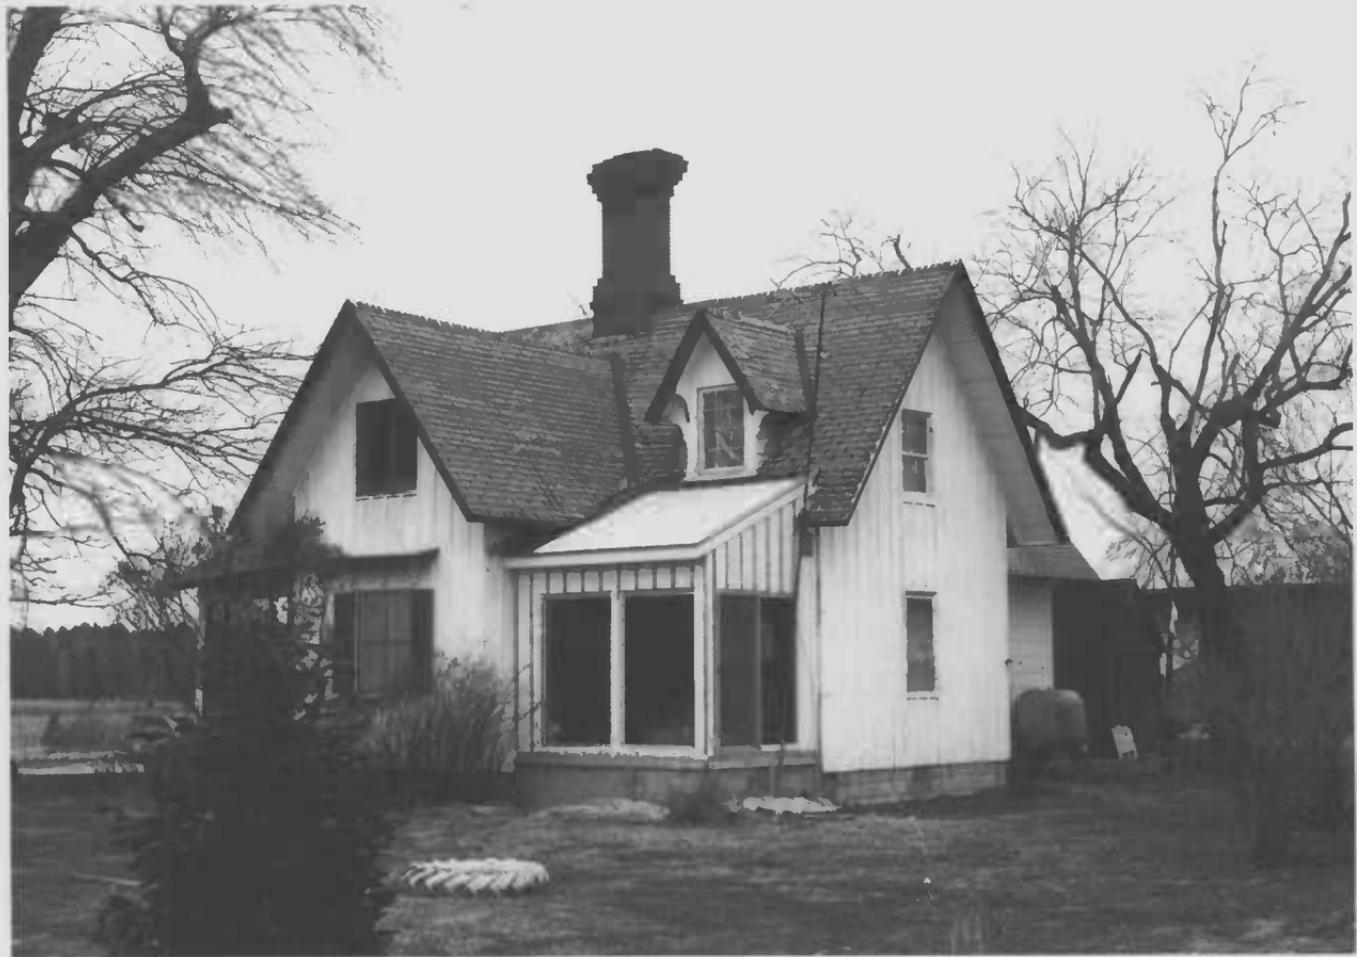
QA-423 Gunther Farm  
Back Starr Road  
Starr vicinity  
Orlando Ridout V Dec. 1980  
View from south
