COUNTIES (MD/PA) WASHINGTON/FRANKLIN
M&D milestone no. 112 (116)
MHT-HSI no. WA-V-213

FIELD SHEET: MASON & DIXON LINE, MARYLAND-PENNSYLVANIA BOUNDARY MARKER SURVEY

MASON & DIXON WEST LINE: MILESTONE NO. 112 (116)
CLEAR SPRING QUADRANGLE

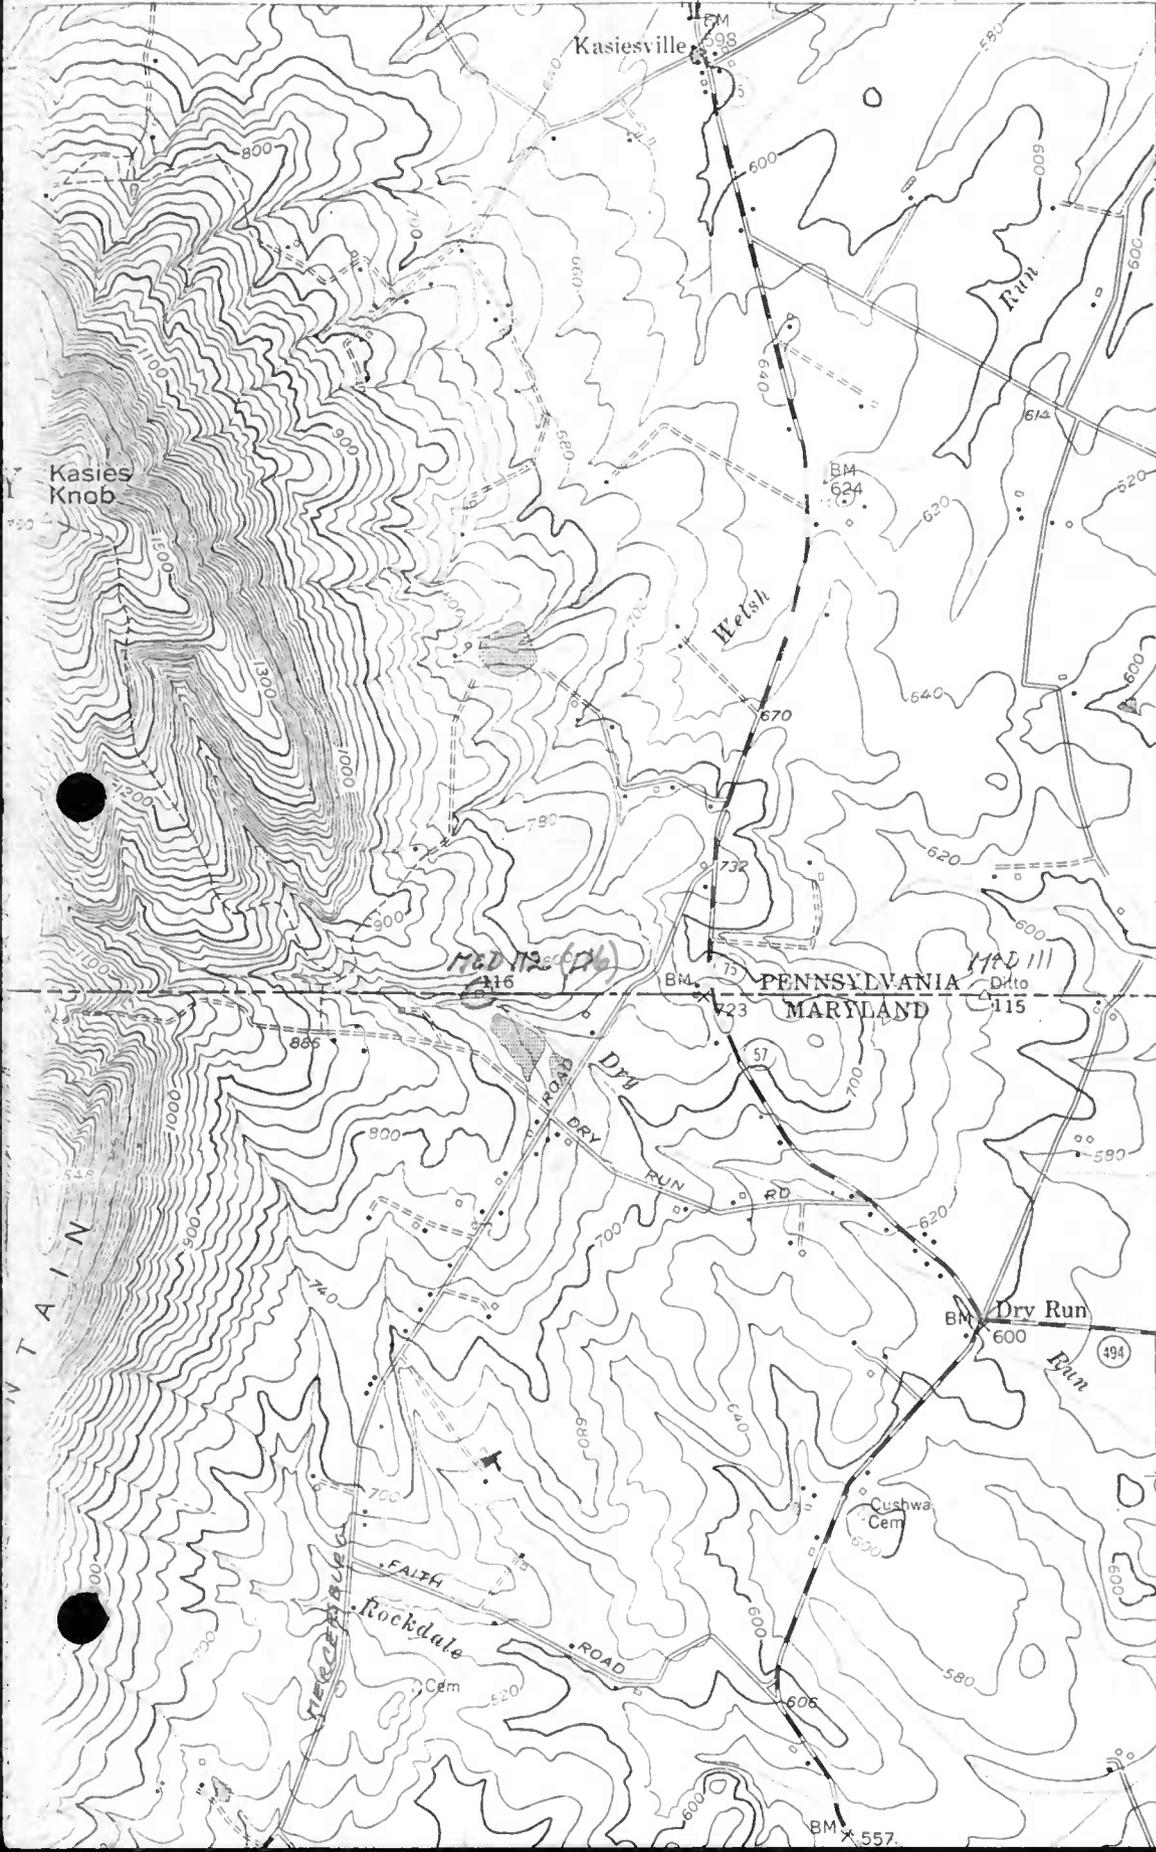
116. Original monument in solid foundation; in good condition; chipped on all corners; northeast corner especially. Lettering good.

1979-81 Inspection notes: order no. 112 (116); photos/negatives/slides no. 112 (116) 112 (116). Original M&D milestone of 1767 in place, standing about 1½' above ground, in good condition, firmly set. Letters clear but M chipped. Most embellishments remain. Large chips all corners and south face. Protected by site.

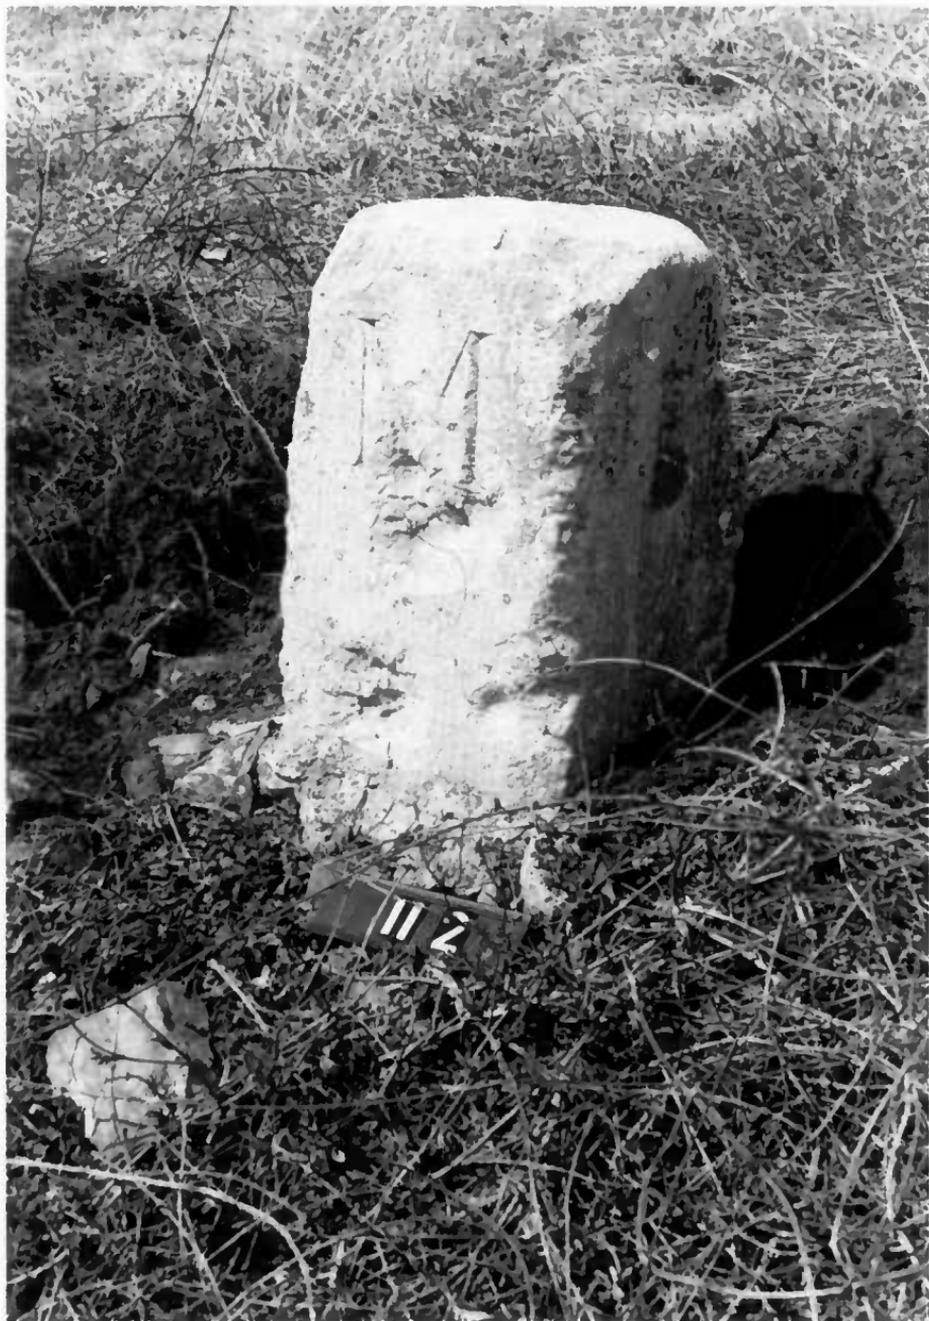
MASON DIXON WEST LINE MILESTONE 112 (126)
SE CORNER (1714)

S face (MD): 12¼" wide x 18" high; M clear but damaged by chips; some fluting & bits of margin remain; face scarred by several large chips; big chips top corners

PHOTO: ALICE MARTHA BISHOP (1981.11.25)

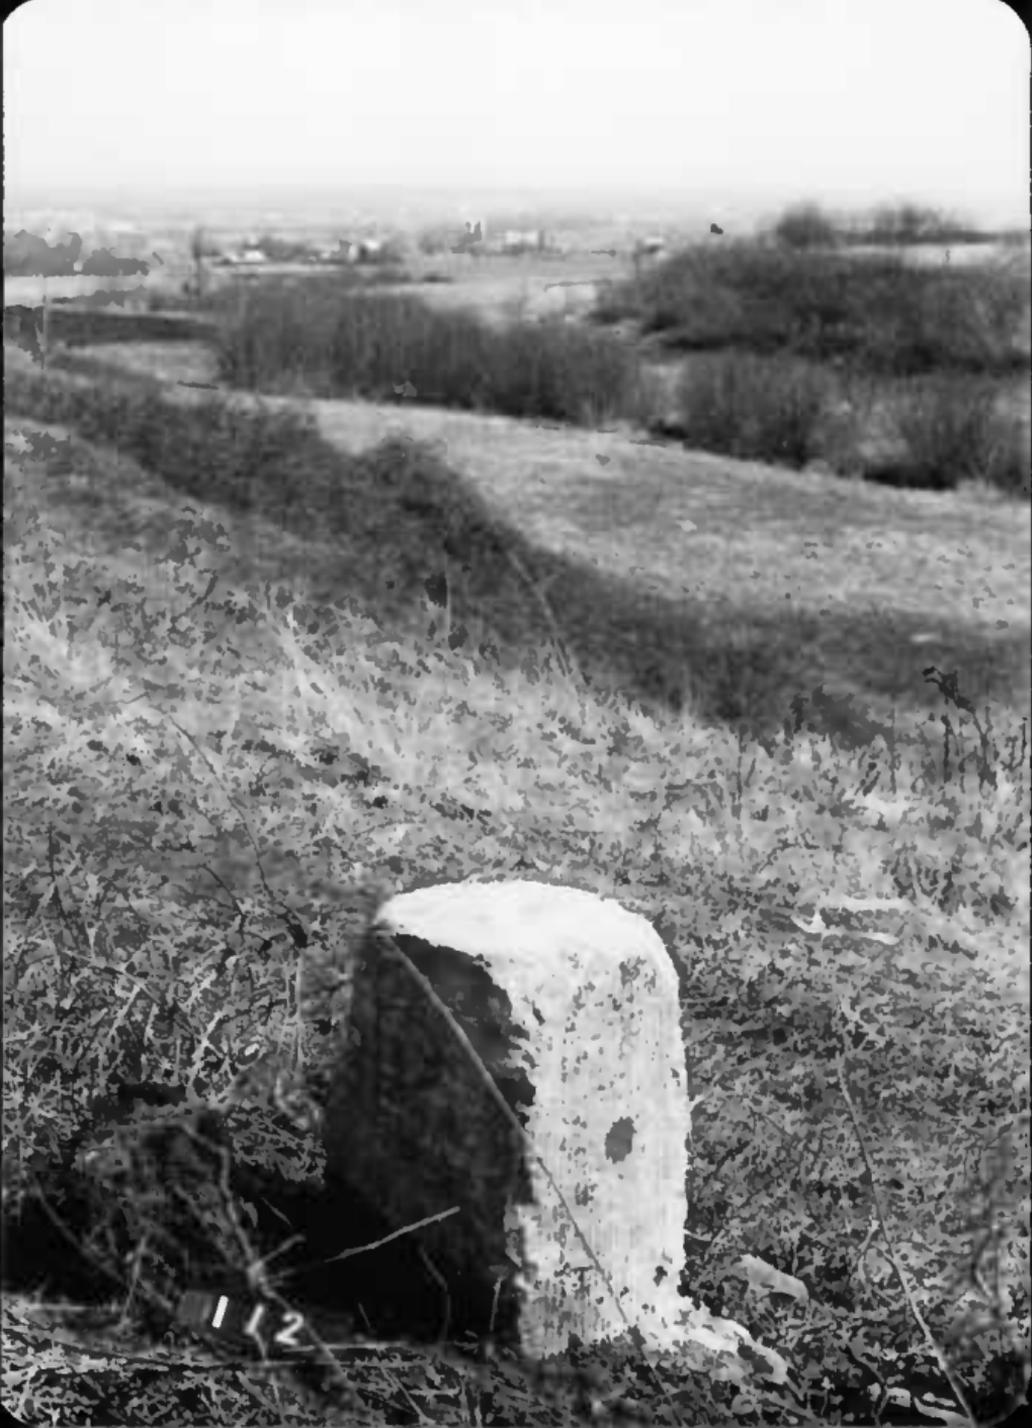
MIDWEST LINE: MILESTONE 112 (116)
VIEW SE OF STONE & SETTING
~~LOOKING TOWARD MERCERSBURG~~
ROAD — ↑

PHOTO: ALICE MARTIN 3/28/81
(1981.11.29)
