AL-I-B-026 Swain Farmhouse
Swain Rd.
Bellegrove, Allegany Co. MD
Not Eligible

INVENTORY FORM FOR STATE HISTORIC SITES SURVEY

HISTORIC Swain Farmhouse

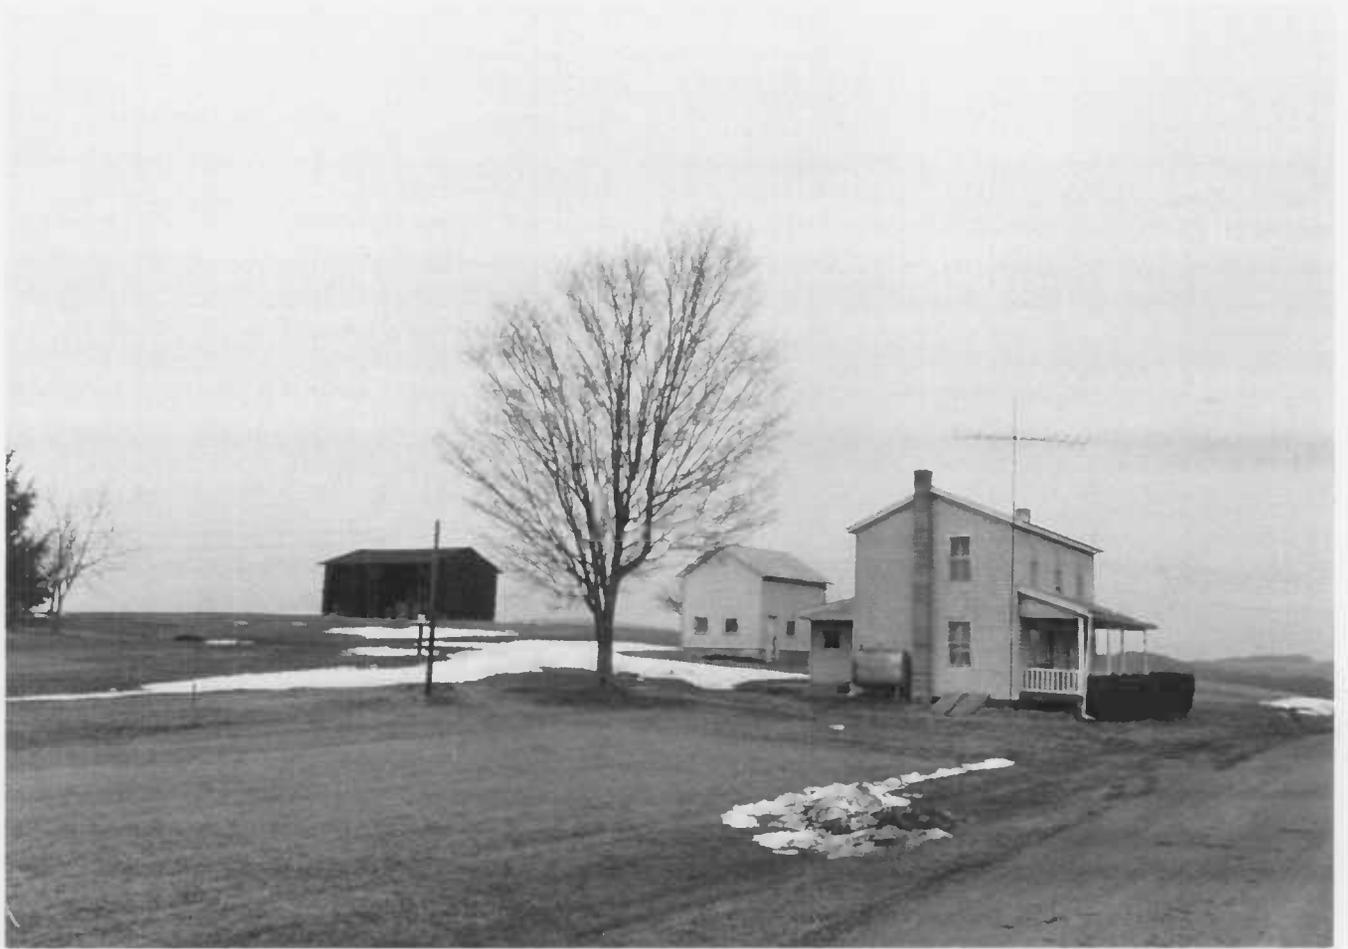
View of Swain Farmhouse (A1-I-26).

This two-story frame farmhouse faces Swain road to the east. The gable roofed dwelling includes a front porch and a small one-story addition at the rear. Concrete block chimneys appear at the south and north ends of the house. An exterior cellar entrance opens under the south end. The four bay long facade includes two central doors. Plain flat boards frame the 2/2 sash windows and aluminum siding covers the walls. The house stands on a stone foundation.

This building is a two story, four bays wide rectangular frame structure with insulbrick siding. The house rests on stones on the corners with no water table. The gable flank roof is covered with ribbed tin. Eaves consist of a cornice with fascia. Two outside end chimneys are made of cinderblocks.

Two entrances in the center of the southeastern facade have original doors and hardware. Two over two light windows are nailed with wooden slipsills. A rear shed roofed porch on the northwest has been enclosed. A shed roofed porch on the southeast has four chamfered posts and plain railing.
