AL-III-B-013

FISHER FARM HOUSE  
Spring Gap, Maryland  
Early 19th Century

INVENTORY FORM FOR STATE HISTORIC SITES SURVEY

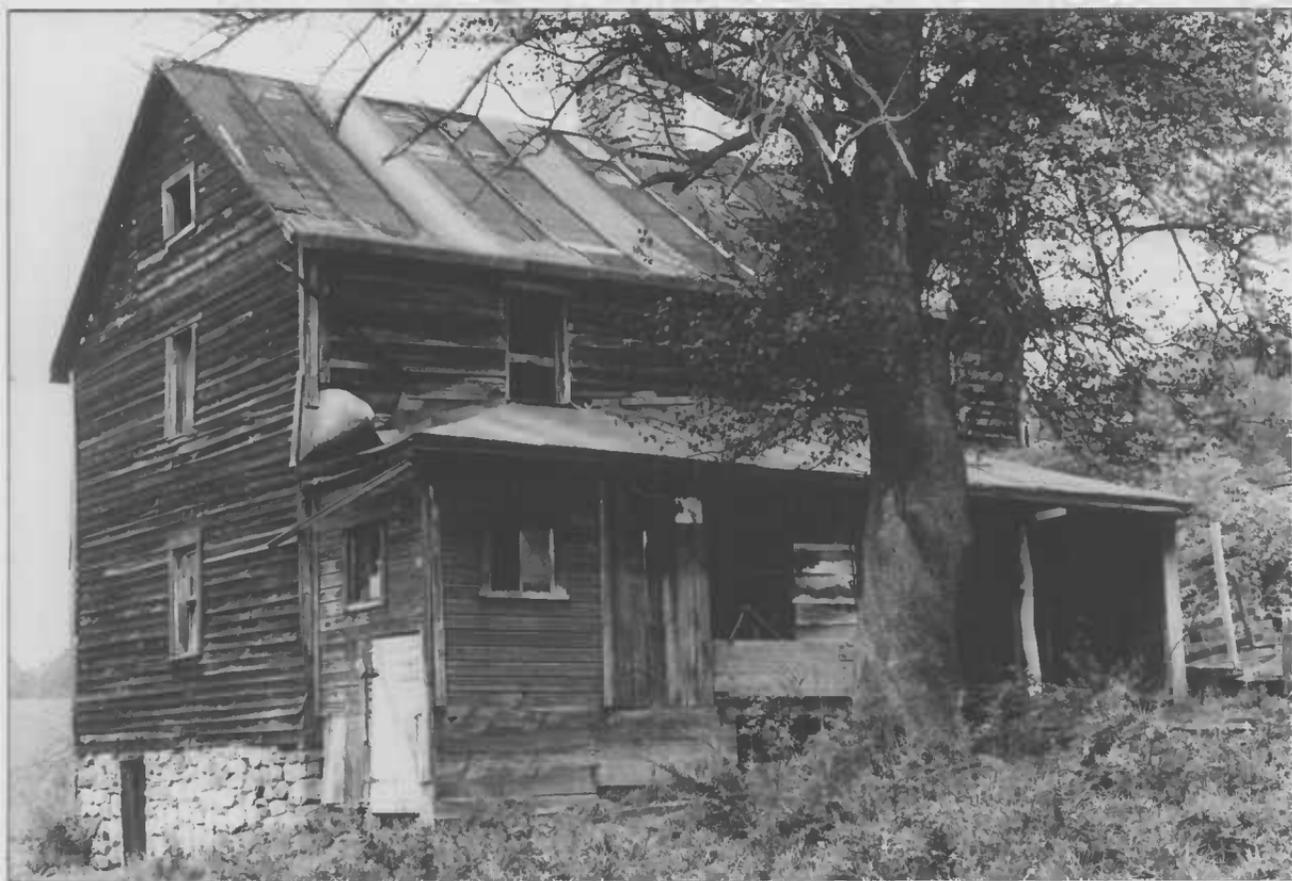
West - Northwest

The structure is still fairly sound, but has been un-maintained for a few years. Some of the clapboarding on the southern rear side has fallen off revealing the original log construction.

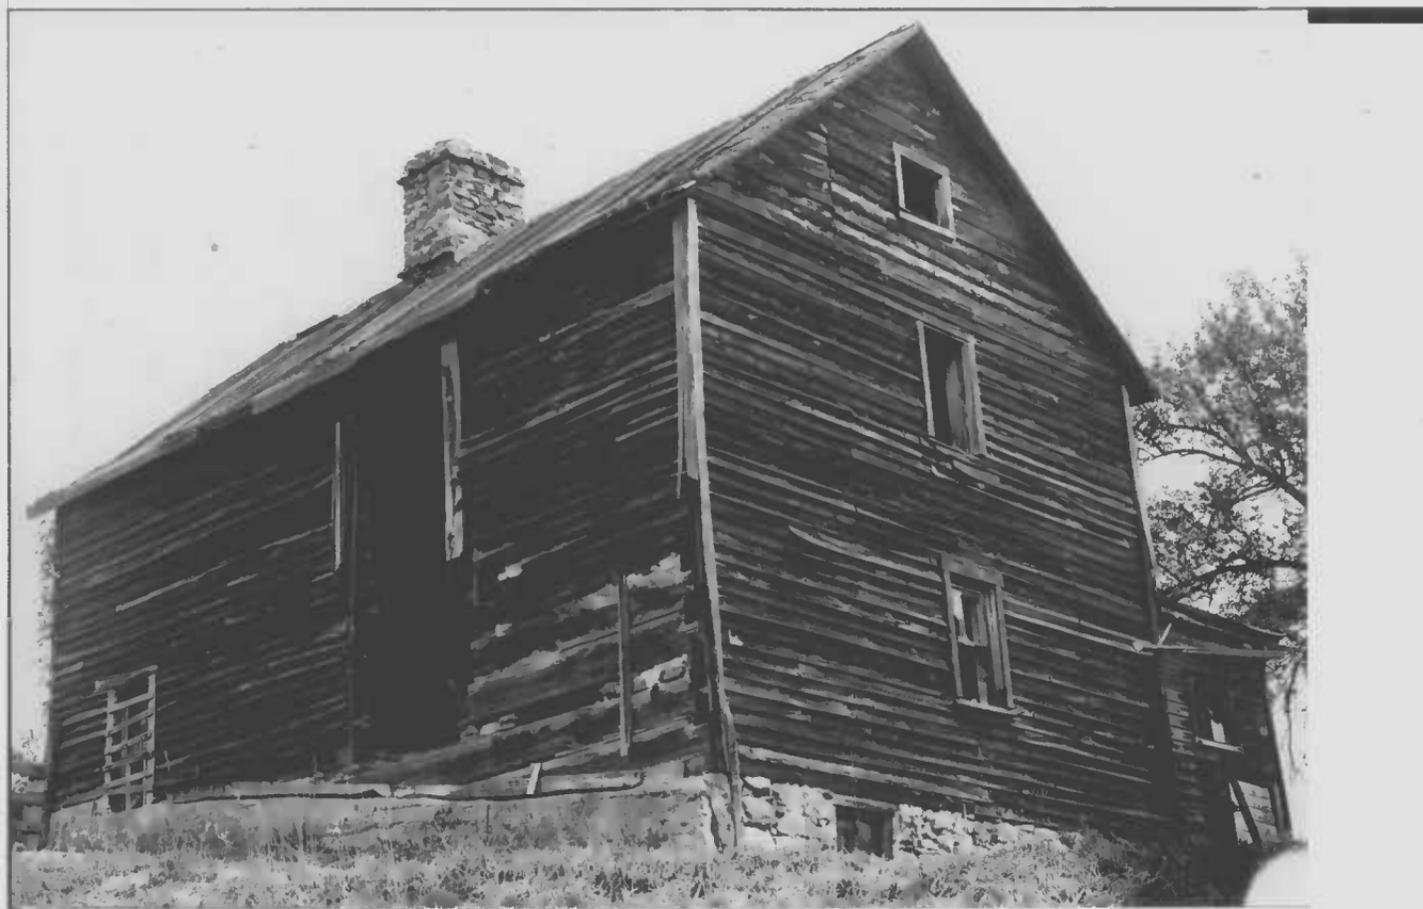
Northeast

The Structure consists of a two story, three bay wide rectangular shaped block. It was originally log, but has been since covered with clapboarding. The foundation is a low stone one with a plain water table. Windows are double hung wooden sash frames with 2 over 2 lights and plain trim; however, most of them have been knocked out. The roof of the structure is gabled and has been re-covered with asphalt materials. The main entrance is on the east side of the dwelling, but the front door area has been completely knocked out and that area is now used as a cattle shelter. A front porch with hipped roof was added to the main block. The structure features one original, stone, corbeled chimney which is centrally located.
