CROW FARM HOUSE

AL-V-A-047

.5 mile east of Route 36, Shaft
ca. 1820

INVENTORY FORM FOR STATE HISTORIC SITES SURVEY

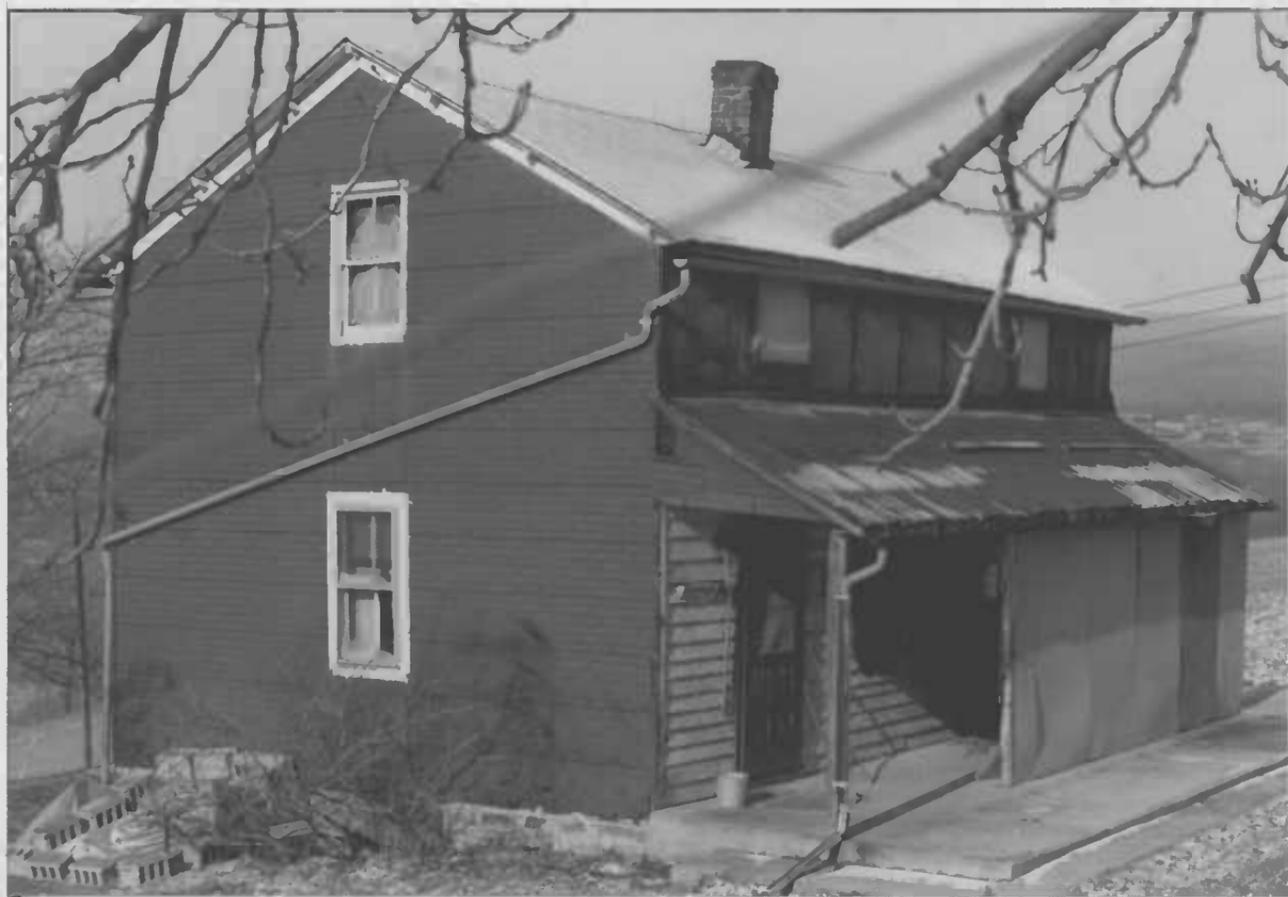
Northwest

A rectangular shaped, two story, three bay wide frame structure describes the Crow Farm House. It was built upon a low stone foundation, and has walls built of old, rough-cut clapboards. Red insul brick now covers three sides of the dwelling. Windows include double hung wooden sash frames with both two over two and six over six lights. Two entrances are found on the east facade, one original and one replaced and have doors with verticle panels. Rafter ends are found under the eaves of the gabled roof; replaced asphalt materials now cover the roof. A three bay wide shed-roofed front end porch now abuts the structure, and rests on a wide concrete foundation. The north end of the house was formerly abutted by a four room, two story log cabin, but has since been torn down. One original corbeled brick chimney lies to the interior of the structure.

The general appearance of the Crow Farm House has been altered somewhat with the addition of red insul brick, and it stands in fair condition. The barn is in near deteriorated condition, but has a very sound frame of sturdy logs.

Crow Farm House

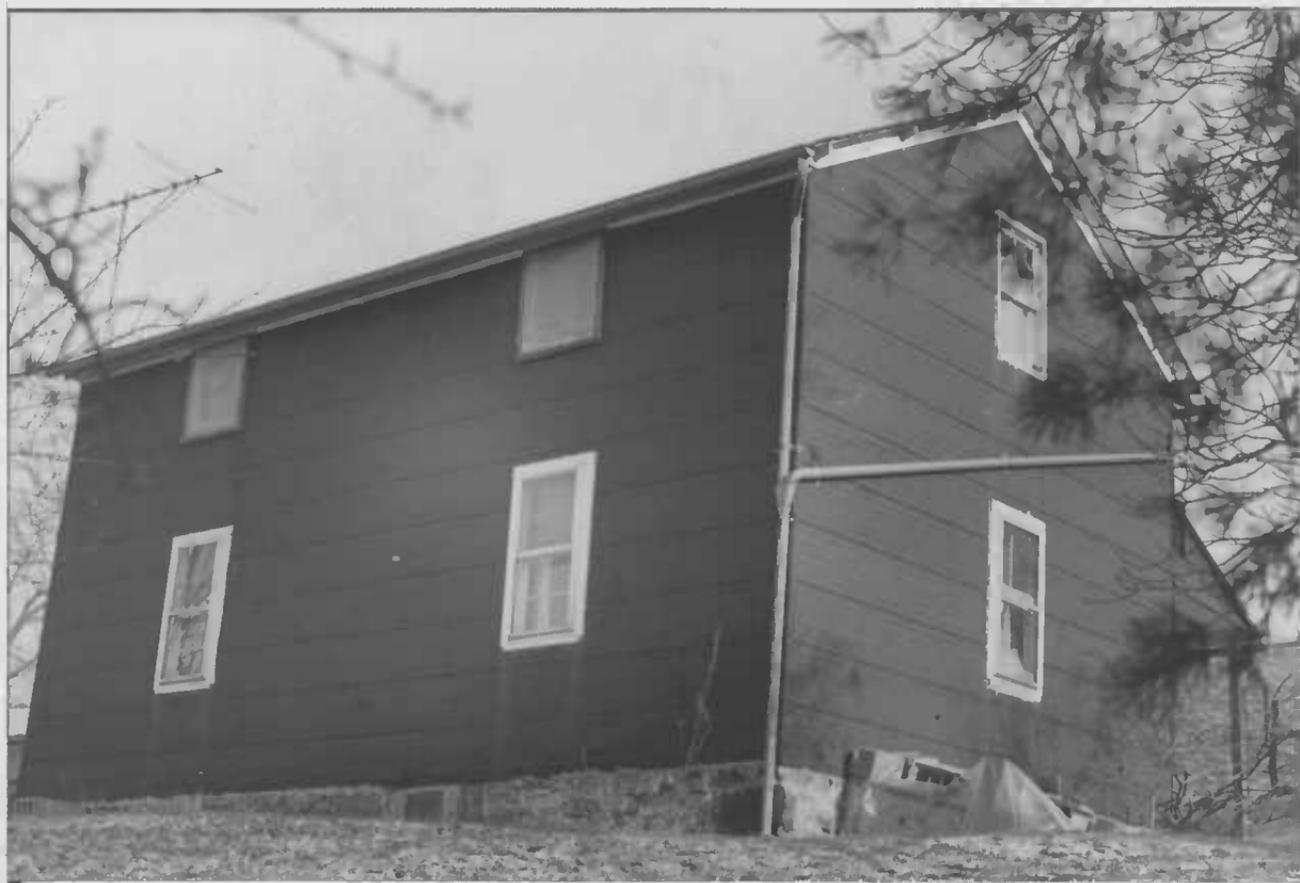
Northeast

Crow Farm House

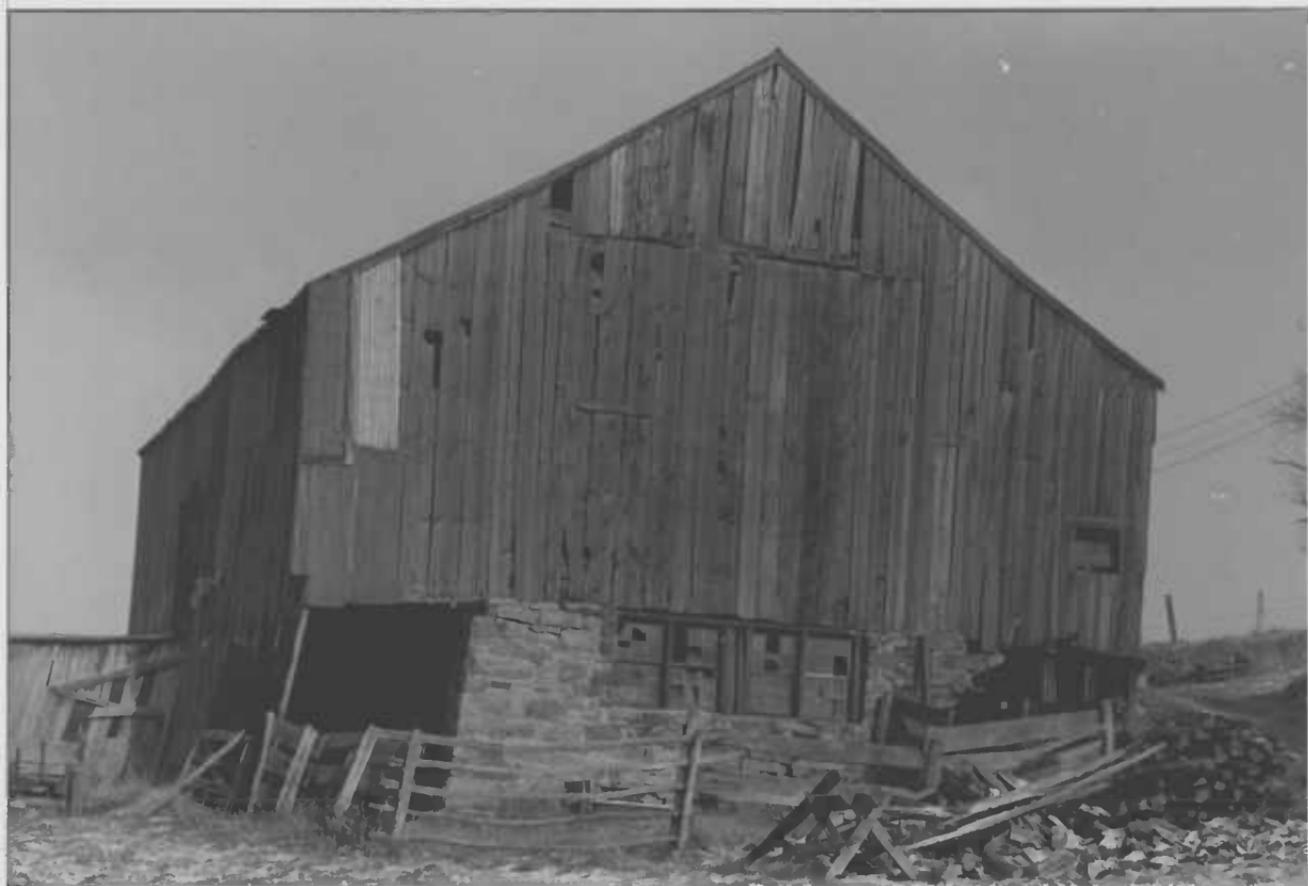
Northeast

A rectangular log barn built upon a high stone foundation now stands enlarged on the property as a 60' x 52' frame structure covered with verticle boards. Logs as long as 45 feet comprise the original barn to the interior of the present structure. Very tightly fitting "V" notching binds the corner joints of the large, hand-hewn logs. Windows with six over six lights are found in the upper half of the high stone foundation. Tin presently covers the gabled roof.

The farm site has always served as a subsistence type of farm since its construction by the Crow family.¹ Of particular interest is the large log barn which stands several hundred feet north of the dwelling house. The barn is constructed of logs up to forty five feet long and are jointed with "v" notching and mortice and tennon pins.

Crow Farm House (Barn)
