AL-V-B-090
Hemming Log Cabin
Cash Valley Road
Ca. 1840's

INVENTORY FORM FOR STATE HISTORIC SITES SURVEY

Log Cabin - Hemming

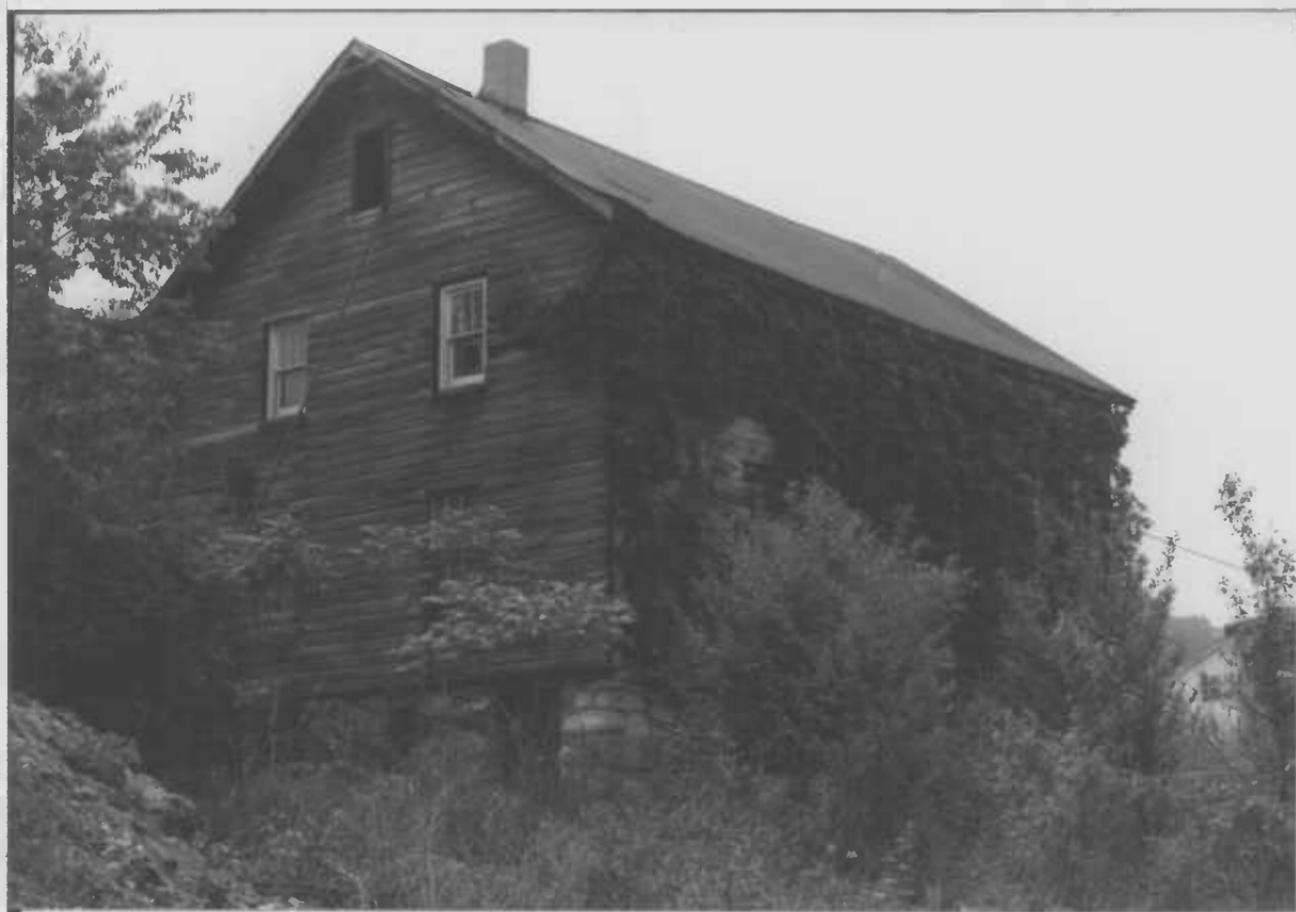
South

This two and one-half story, three bay wide building of log construction featuring mud and wood chinking was in all probability once a farmer's house. Today it stands in deteriorating condition partly covered with clapboards.

Hemming Log House

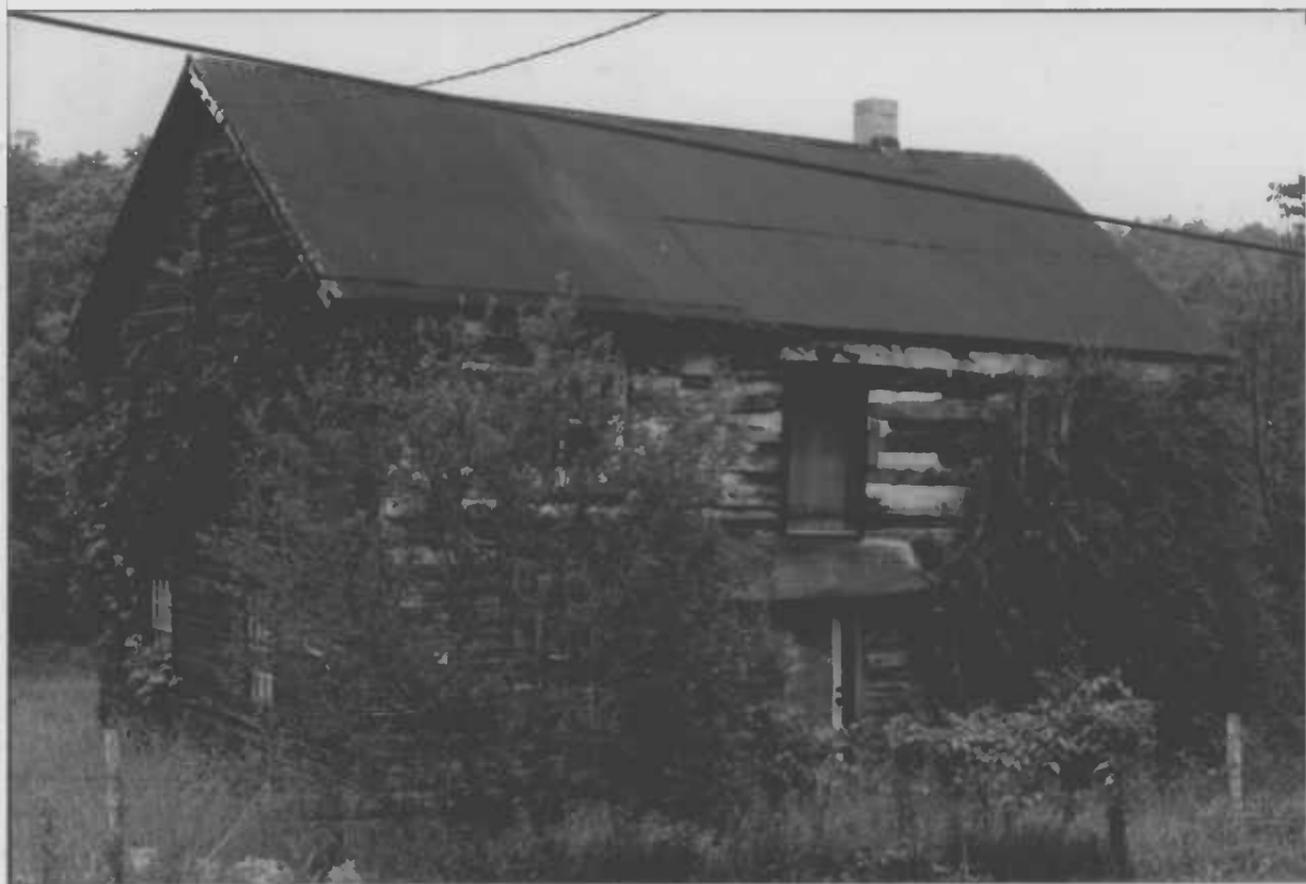
North

Hemming Log House
