State Historic Sites Inventory Form

Lawson Duckworth House

Survey No. AL-VI-B-104

LAWSON DUCKWORTH HOUSE

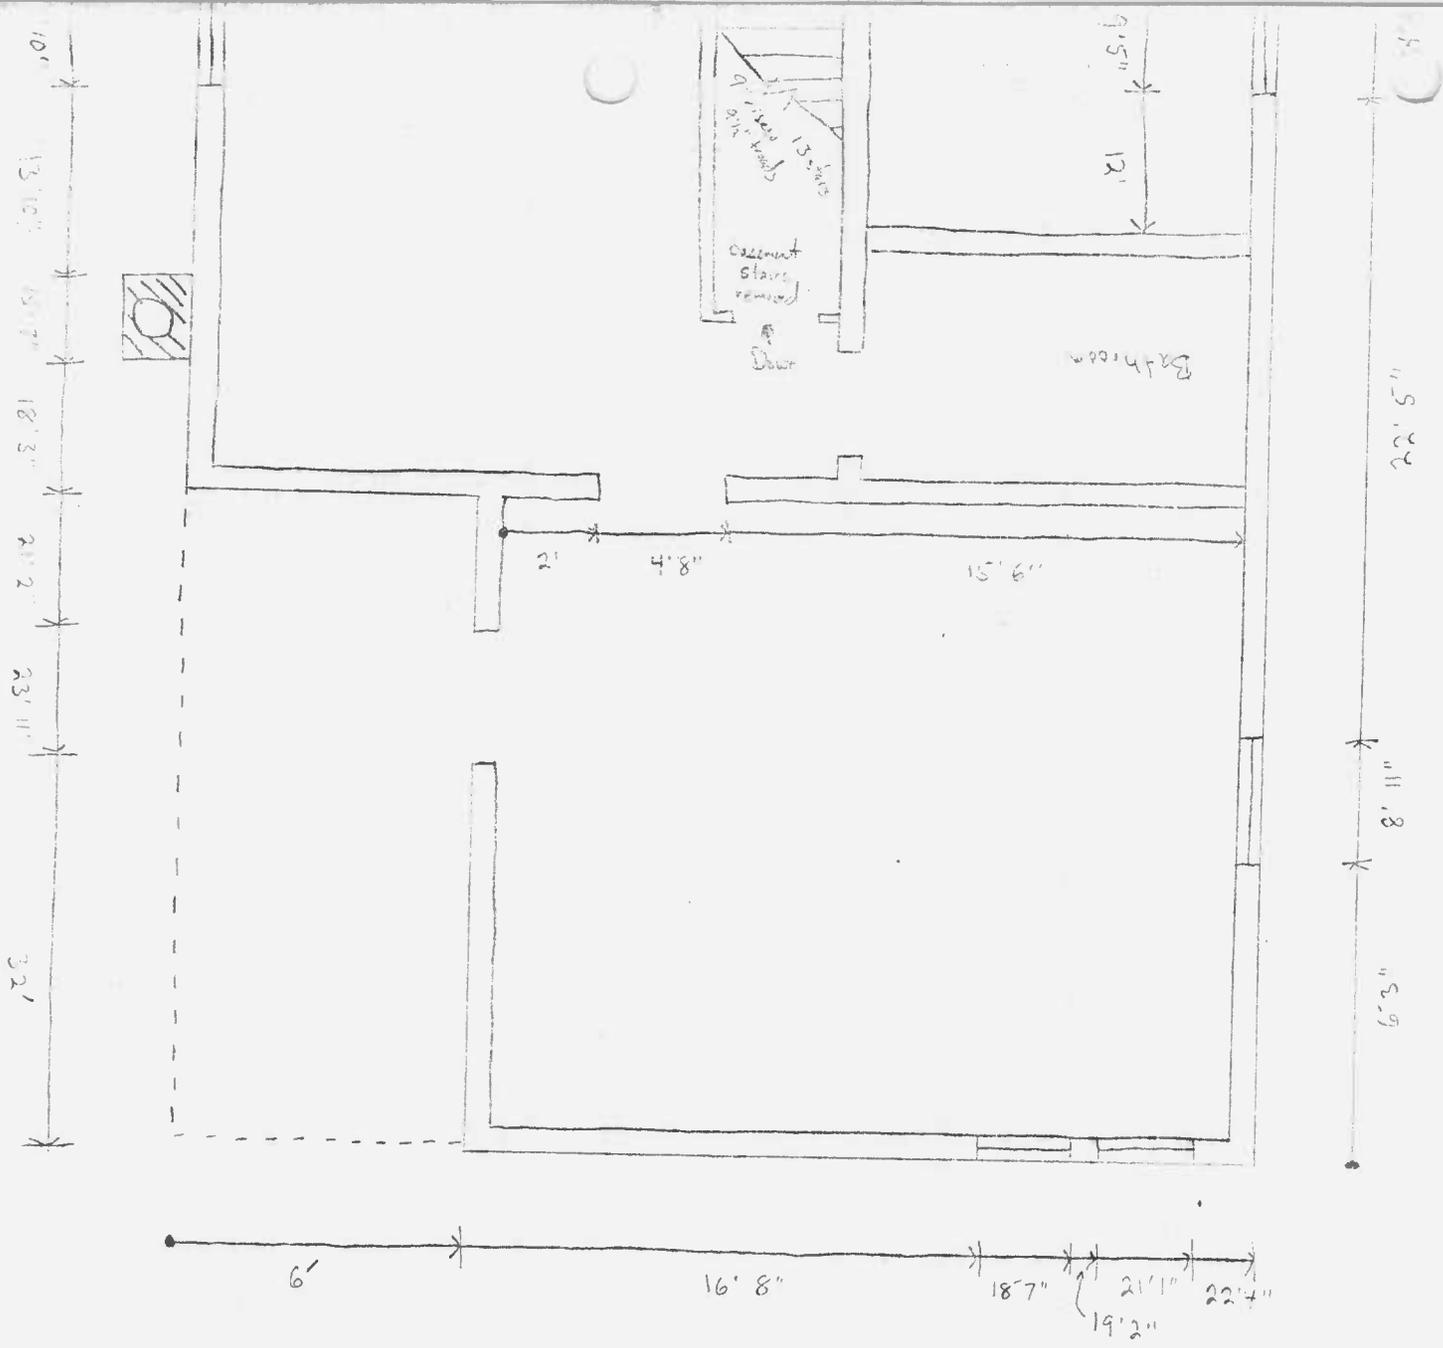
First Floor Plan

The Lawson Duckworth House is a two-story, three-bay by one-bay structure with a one-bay ell, ~~wing~~. The structure has a stone foundation that is constructed into a slope so that there is a full story on the main (west) facade. The structure has a gable roof with a box cornice that returns at the corners. The roof is covered in sheet metal.

The main facade has a central entrance with one-over-one sash windows on the outer bays of the first story and the three bays of the second story. Window and door frames are plain

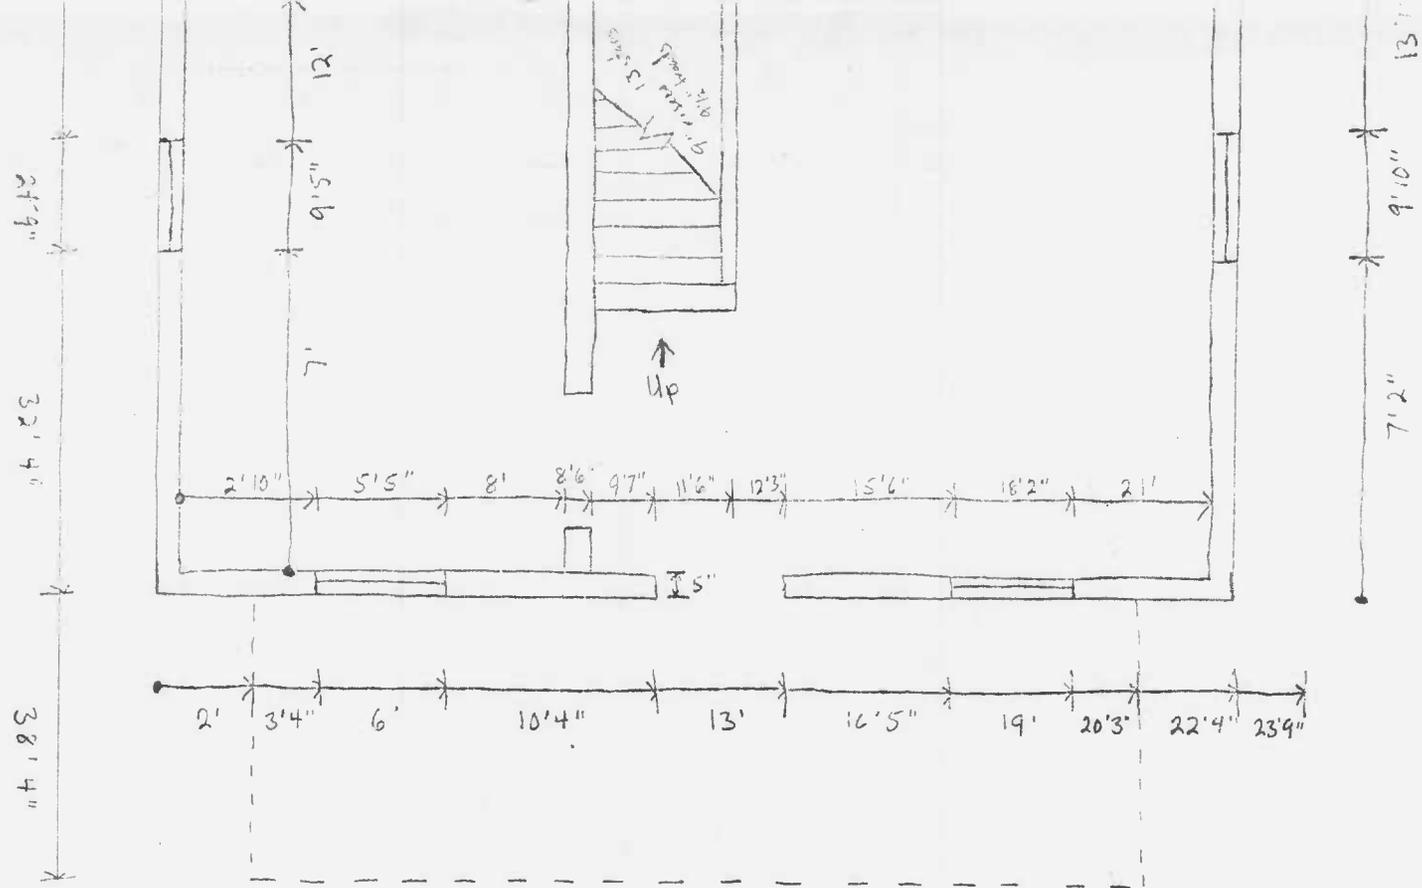
The interior of the structure has a two-room plan with a central enclosed stairway in the main section and a single room for a kitchen in the ell. The northern room in the main section has slightly more elaborate woodwork with panels below the windows and an eight inch baseboard with molded lip. This room probably served as a parlor. It has been shortened by the installation of a bathroom at the rear of this room in the mid-twentieth century. The second floor plan is similar with two rooms in the main section and a single room in the ell.

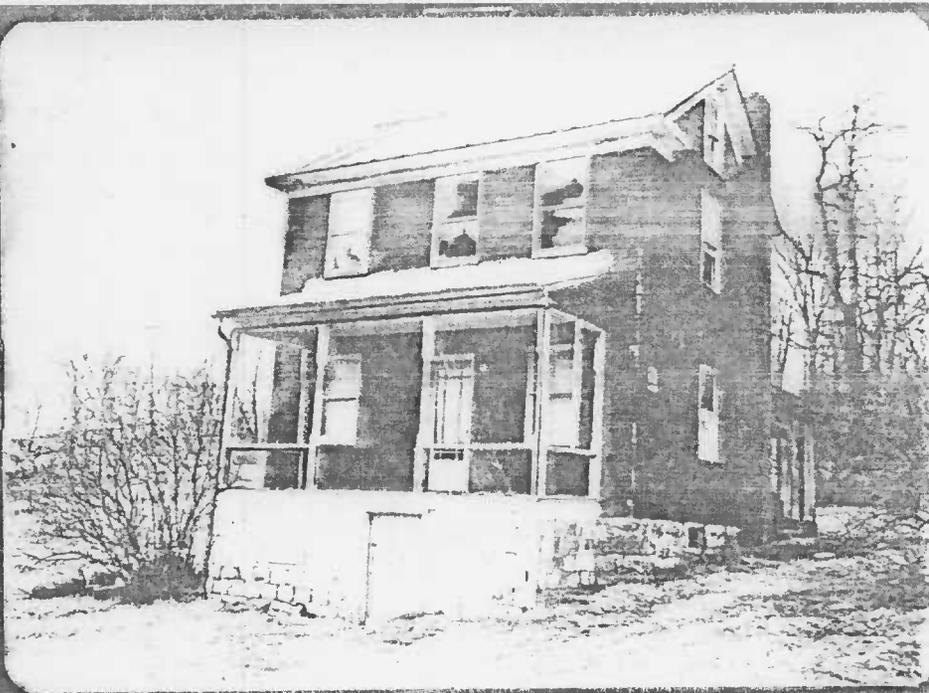
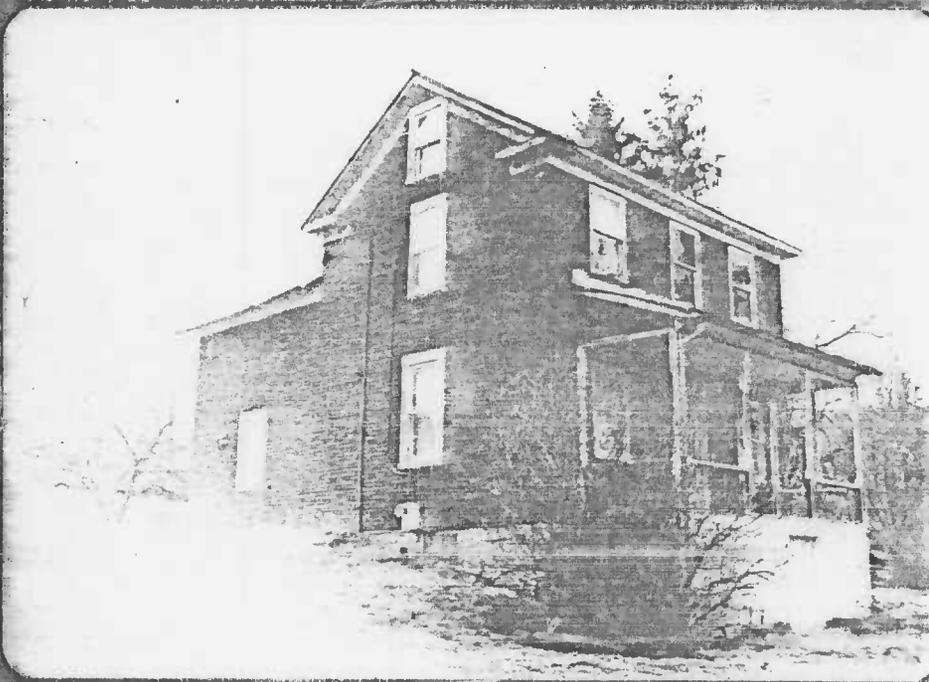
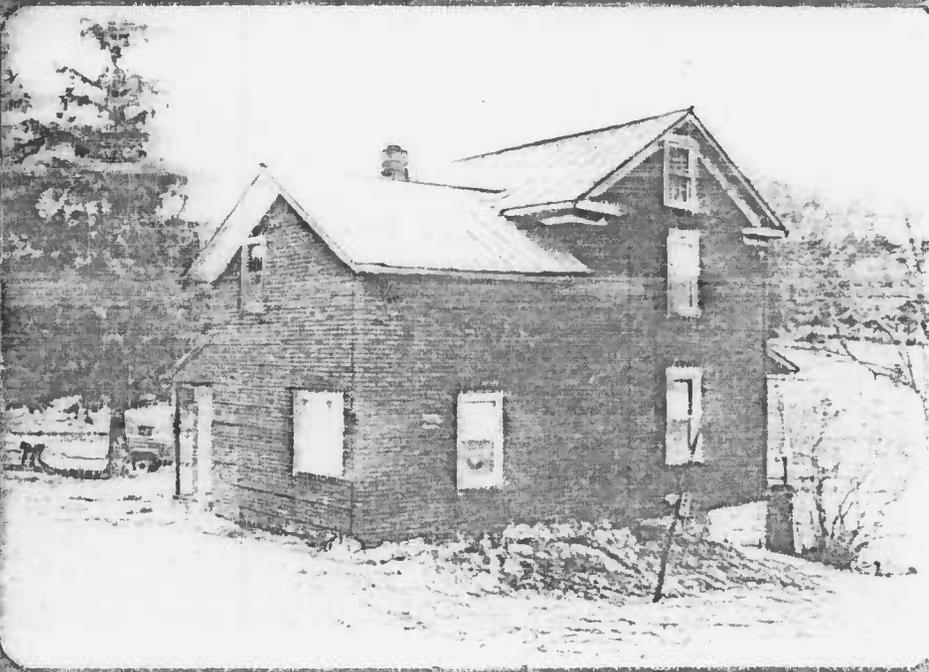
top West & South Facades
center West & North Facades
bottom North & East Facades

Each gable end of the main section has a single one-over-one sash window on each story and a small six-over-six sash window in the gable. The windows in the gable have molded frames while the other windows have plain board frames. The ell wing has a one-story porch with a shed roof on the south side of the structure. While the porch has a modern floor and screen framing, the roof ^{and} other features make it appear to be original. The east gable end of the ell has a double window on the first story and a single window on the second story. The north facade of the ell contains a single window on the first story.

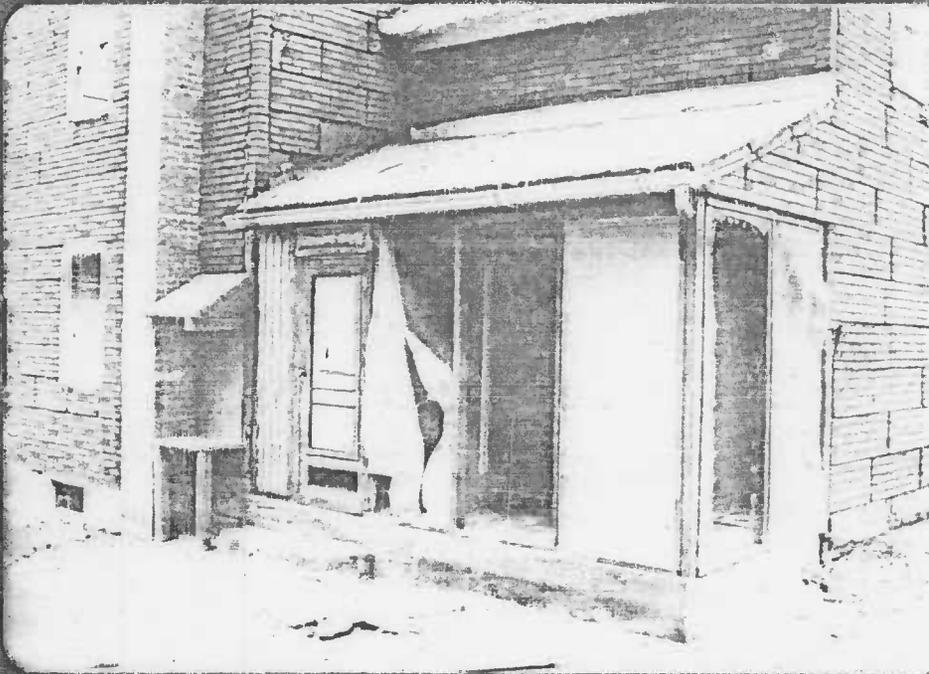
Porch Detail South Facade

board frames. A one-story porch with a shed roof and turned posts is supported by a high porch foundation constructed of a red clay block. The surface of the blocks are twelve inch by eight inches. In the center of the foundation level porch is a doorway that enters into the basement of the building. The foundation of the building is constructed of a squared stone that appears to be a type of regional sandstone that was easily shaped for constructing foundations.

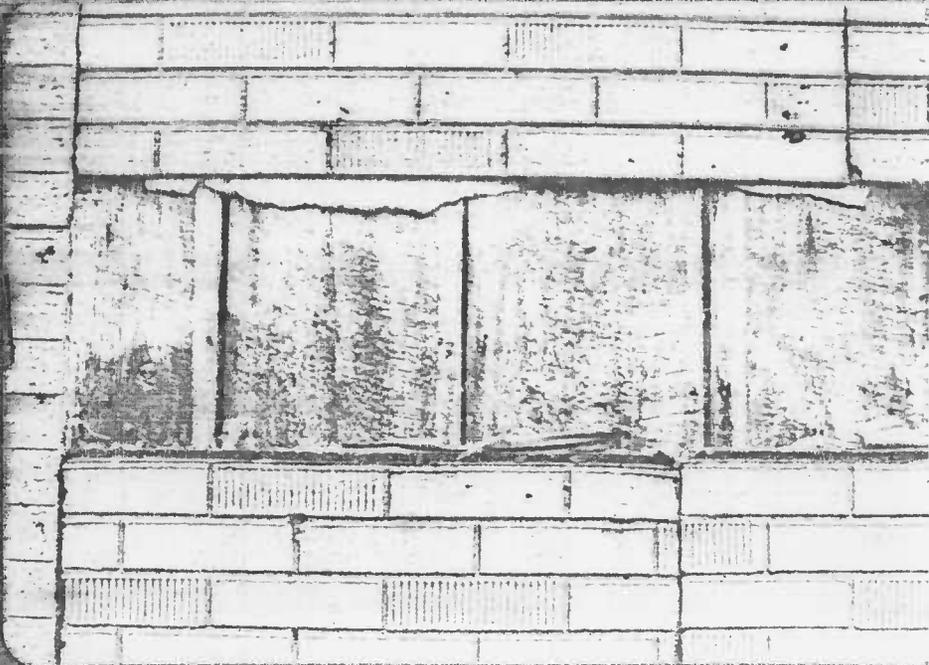
Vertical Board Construction

The building is constructed of a wood frame structure with two-by-two studs. The studs are then covered with vertical boards that vary in width from eight to ten inches. The vertical board structure is then covered in a asphalt siding that imitates brick. From the construction details, it appears that the ^L~~ell~~ shaped plan of the structure is original but that the front porch is a later addition. It may be that the porch foundation is later but the porch posts and roof are reused from an original porch on the structure. The present ranger at Dan's Mountain who lived in

The structure was a practical farmhouse for a resident of this area. In construction techniques it was easy and inexpensive to construct. Local stone was used in constructing the foundation. A wood frame covered in vertical boards ^{is} ~~was~~ also a frequently found construction technique in this area. It was then covered with a modern type of siding. As in many houses, ornamentation is sparse and ~~pretty-much~~ confined to the porch and its turned posts. An unusual feature in this house is the six over-six sash windows in the gable with their molded frames.

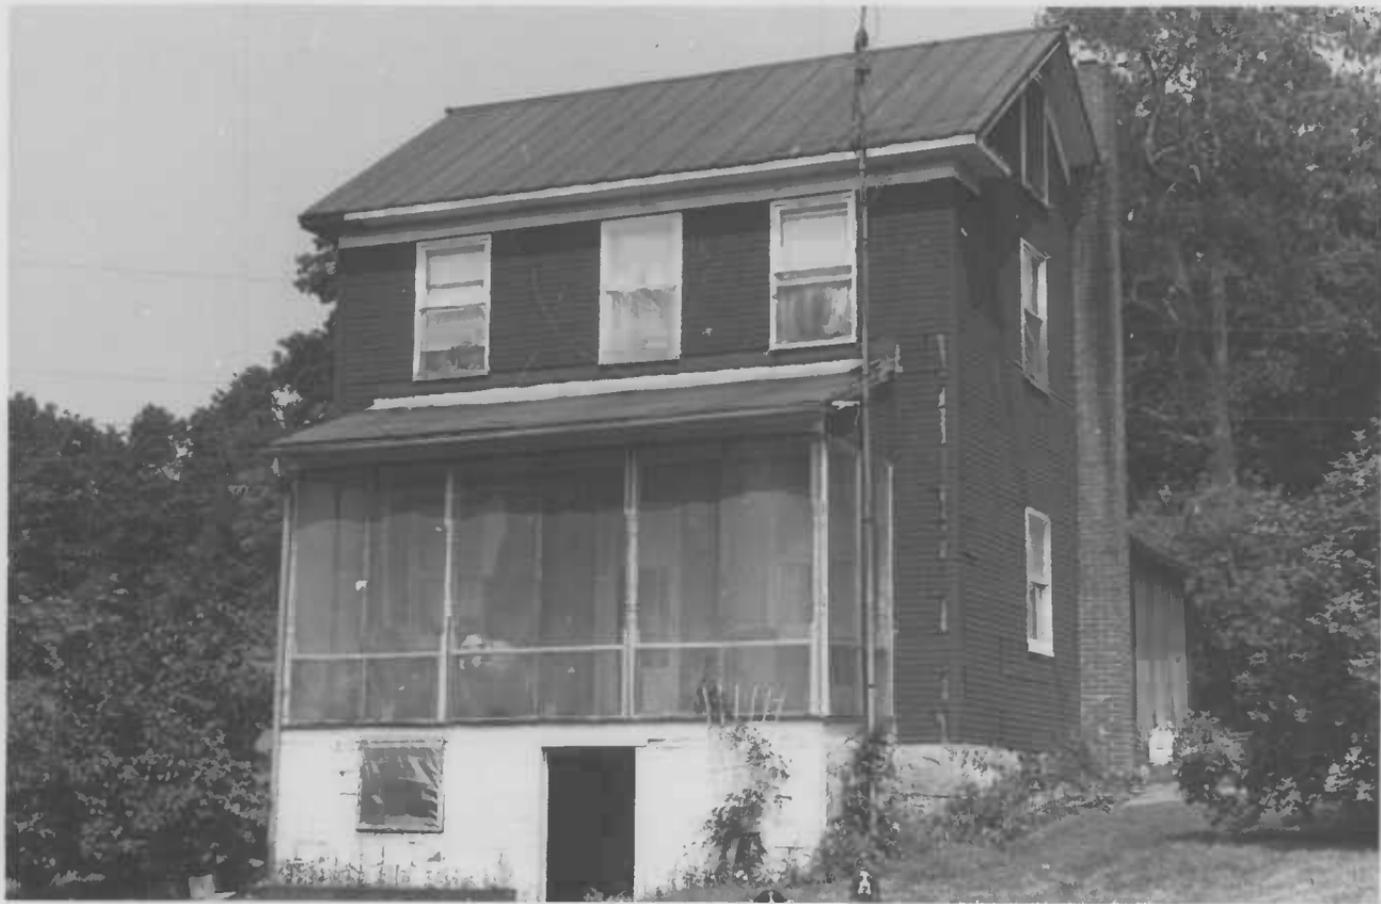
A-1

Frame House
