Maryland Historical Trust State Historic Sites Inventory Form

and/or common Buskirk Log Farmhouse and Barn

Survey No. AL-VI-B-231

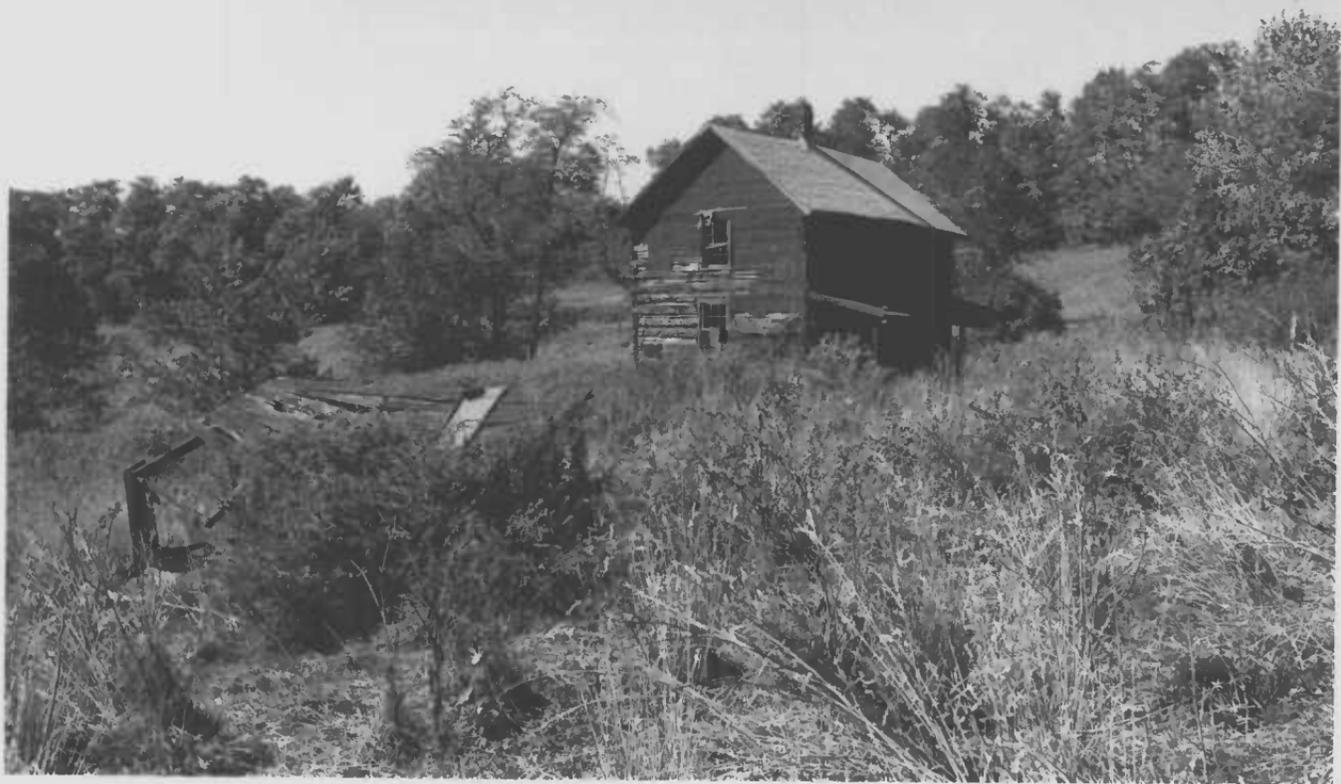
Southern Elev.

The Buskirk Log Farmhouse, a 2 story, 3 bay by 1 bay half dove-tail notched log dwelling, is situated on the western slope of Dans Mountain just north of Water Station Run Road. This abandoned dwelling appears to be the shell of an old log house that has been altered, including the addition of a new gable roof. The log walls are covered with asphalt siding, but in places the logs are exposed revealing plaster daubing. The house rests on a stone foundation.

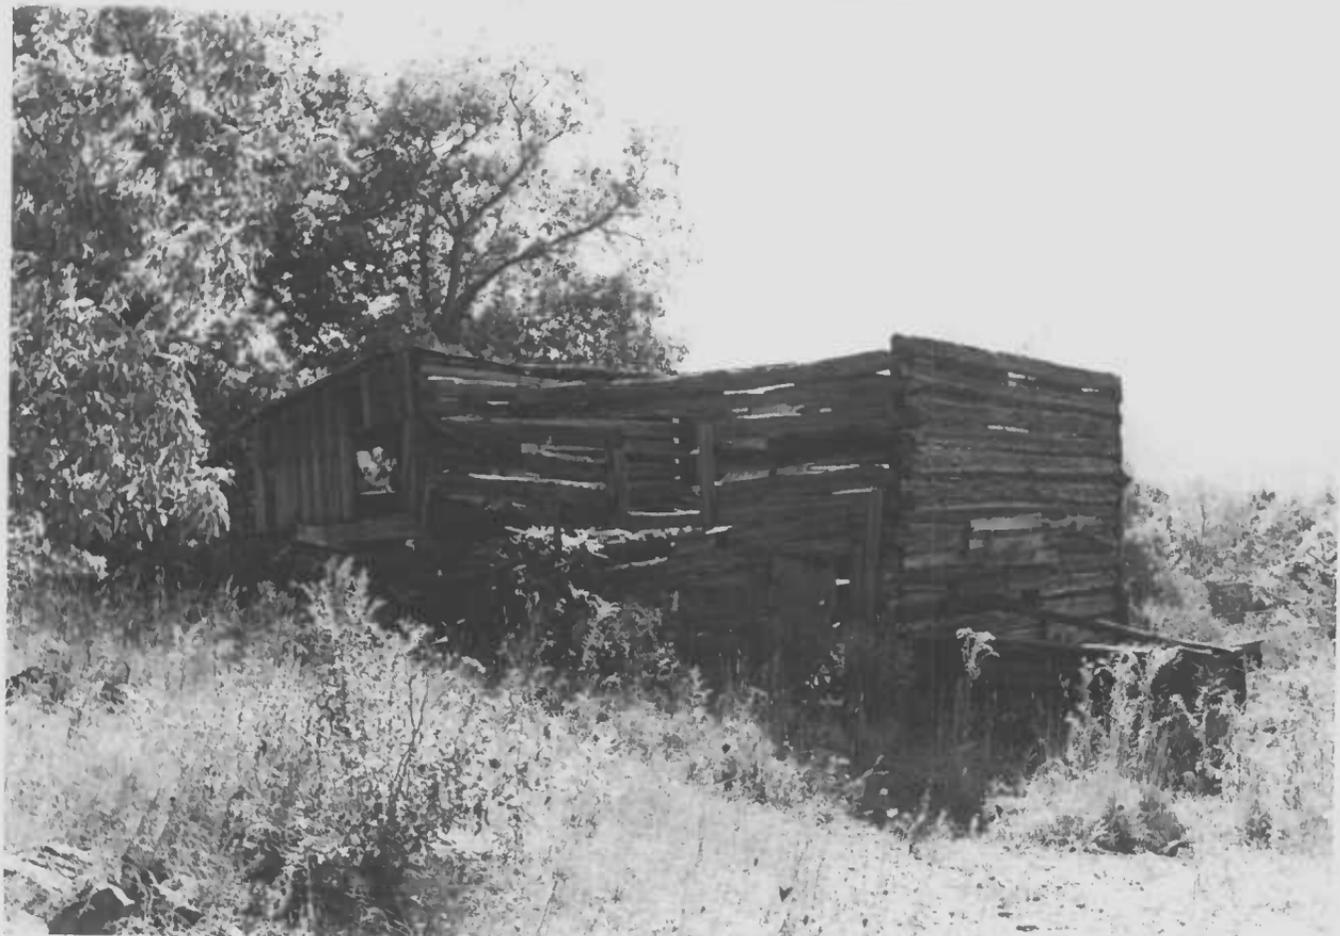
AL-VI-B-231
Buskirk Log Farmhouse
Allegany County
David Dorsey 10/80
Eastern elev.

The facade faces east and has a one story shed roof porch covering a double entrance. A 6/6 sash window pierces the facade wall at the first story between the two entrances. The window is situated closest to the southernmost entrance. The remaining windows are 6/6 sash except for two 6/3 sash windows at the second story facade and a 4-pane window at the north gable end peak.

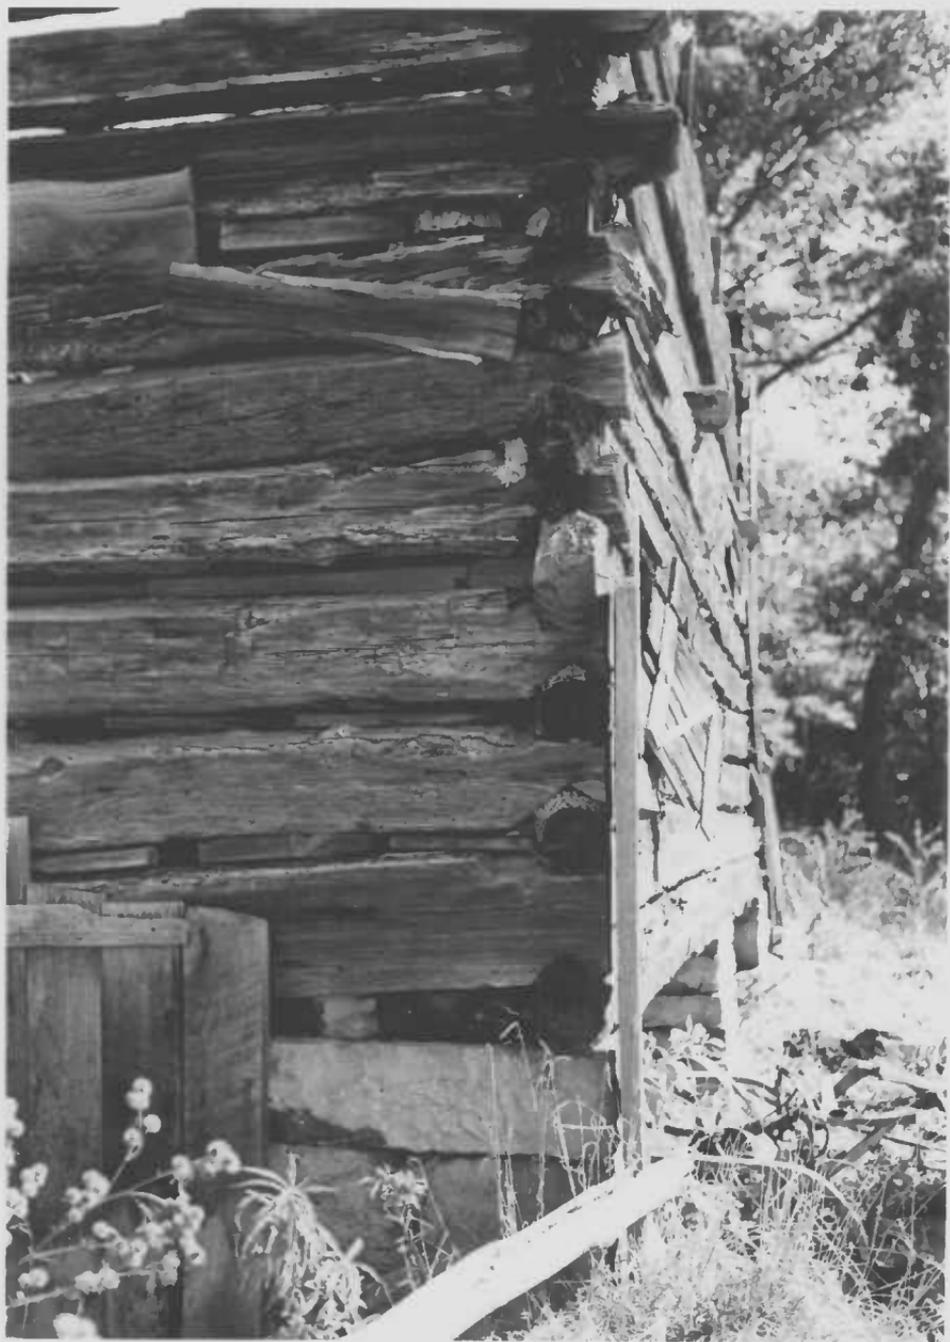
AL-VI-B-231
Buskirk Log Farmhouse
Allegany County
David Dorsey 10/80
Barn West elev.

A single pen, v-notched log barn with a frame shed addition on the south elevation lies in ruins just southeast of the house. The west elevation of the log section is supported by flat cut stone pillars. There are 3 frame outbuildings, also in ruins, associated with this site. A dry stone wall and drainage ditch descend the hillside north of the farm.

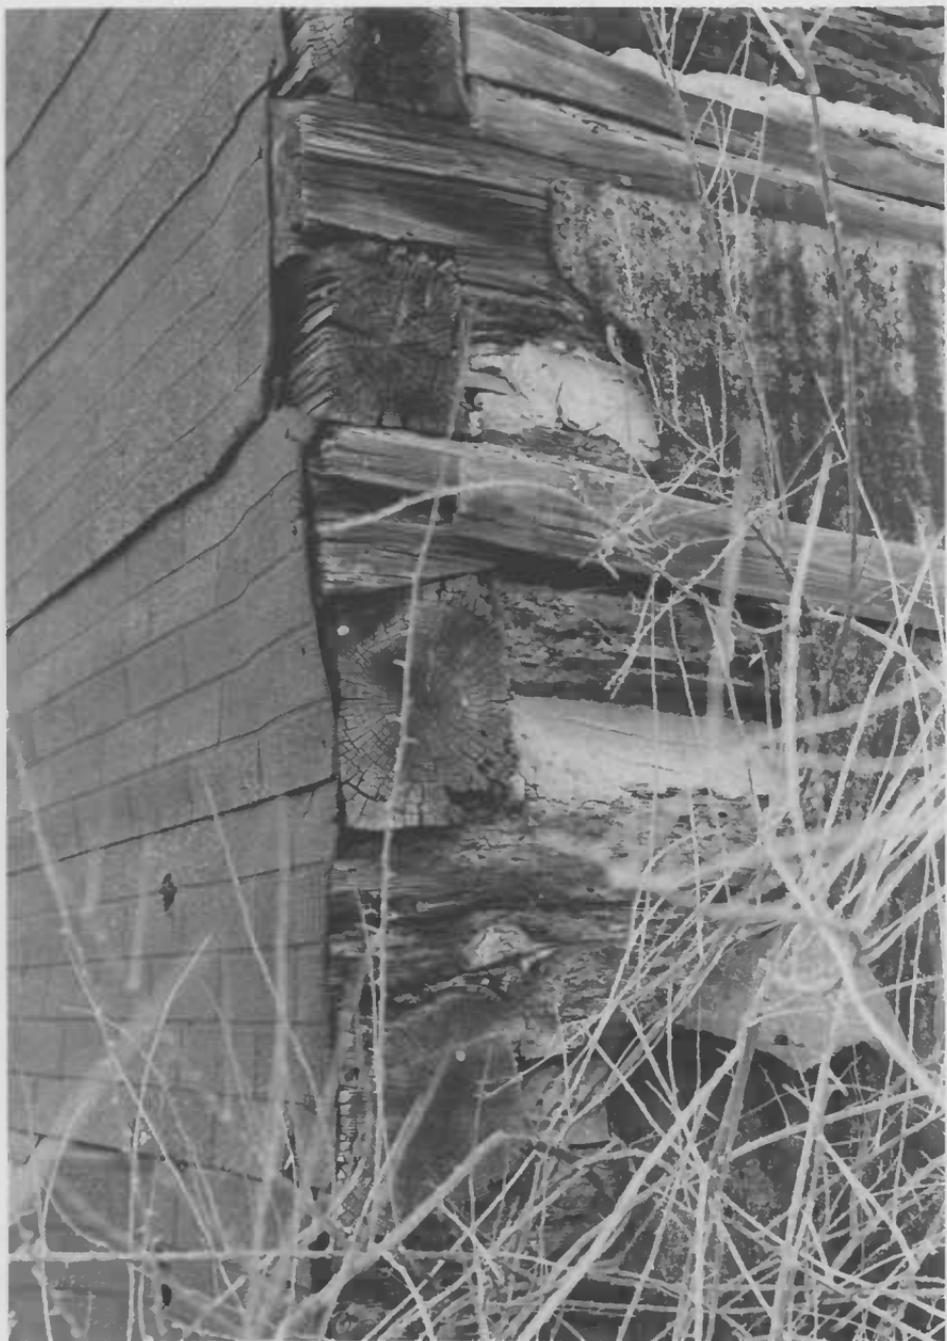
Notching: West elev.

The farmhouse displays locally rare half-dovetailed corner notching.
