AI - VI - ~~E~~ - 025
Frankhouser House
Dawson

INVENTORY FORM FOR STATE HISTORIC SITES SURVEY

Frankhouser Frame House

INVENTORY NO. A1-VI-E-025

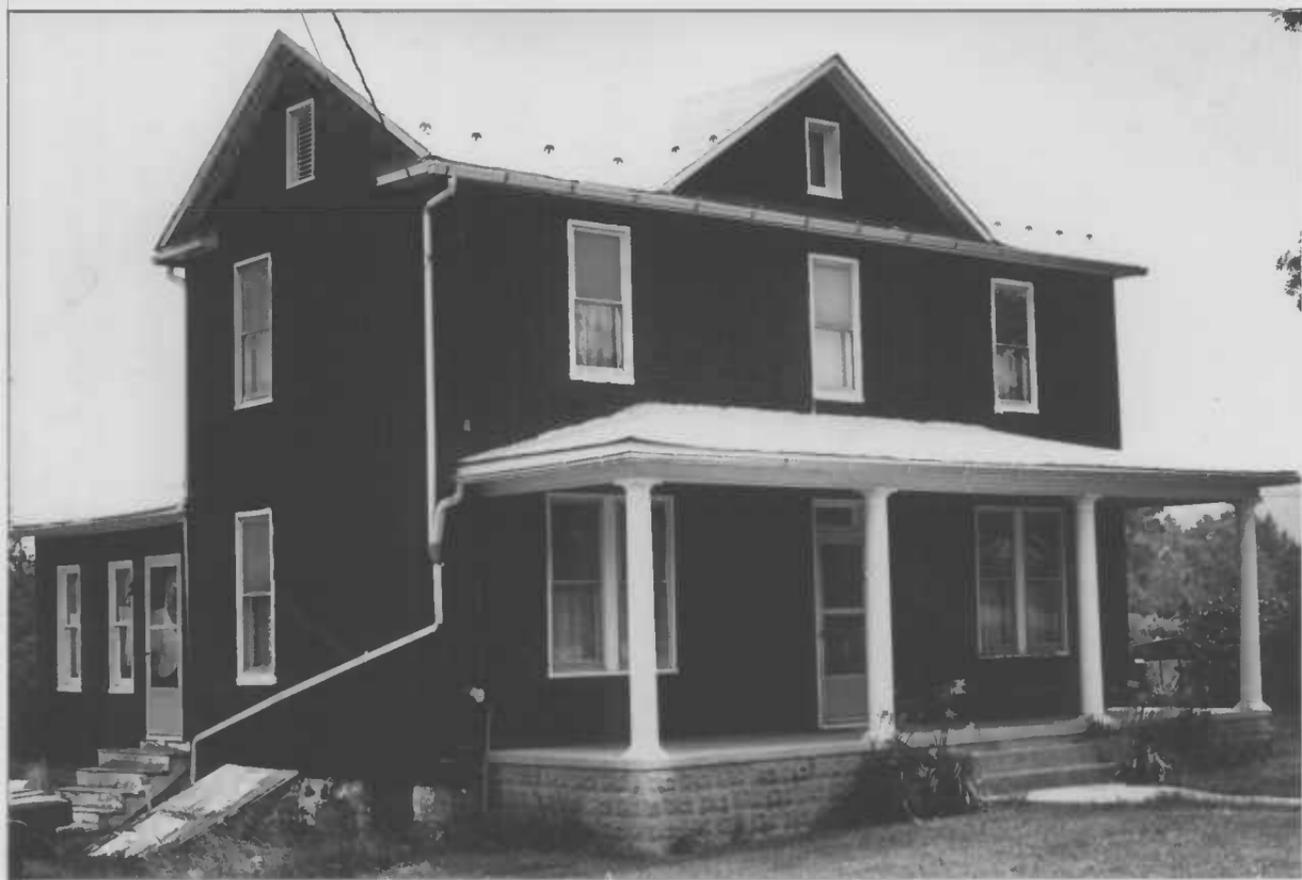
Frankhouser Rural Italic Frame

The Frankhouser House is a two story, three bay wide facade which was built between 1915 and 1920. The building is a frame structure which is covered with insul brick siding and is supported by a low stone foundation with a plain water table. The main entrance is covered by a three bay end porch with a hipped roof supported by four cushion capital columns.
