AA-9
Building 6865
Golf Course Clubhouse
Anne Arundel County

Maryland Historical Trust State Historic Sites Inventory Form

and/or common Building 6865/Golf Course Clubhouse

7.1 Description

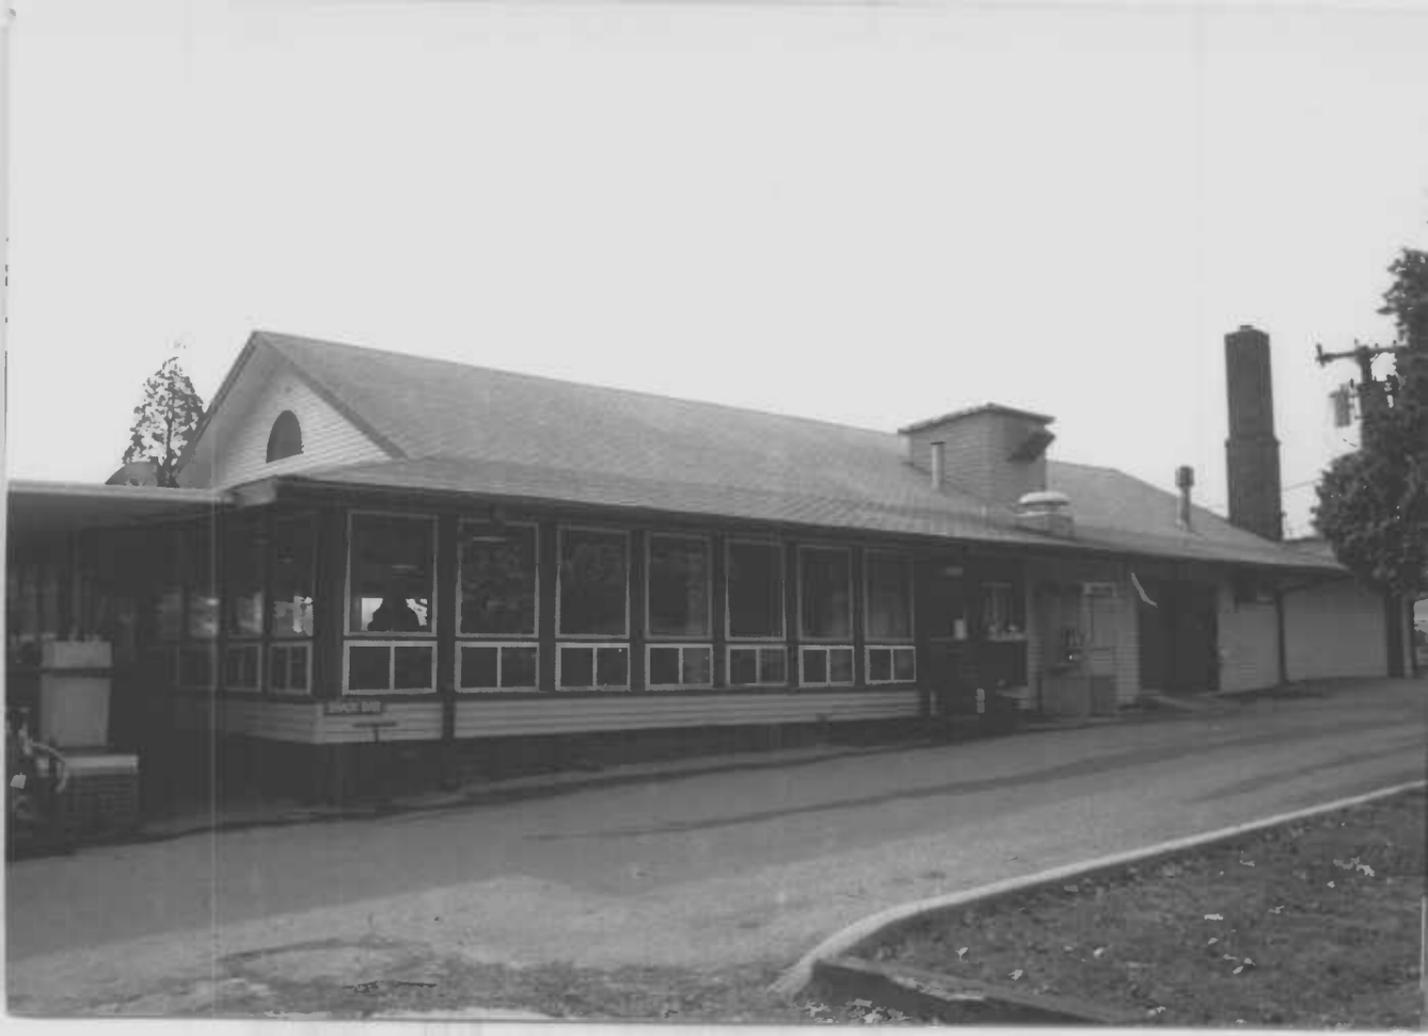
AA-9
Building 6865
Anne Arundel Cty
1/3

The north elevation has two door openings: one in the center, the other on the side. There is a sliding casement window near the side door opening. A ribbon of wall-length fixed windows, 1 light over 2 lights, runs from the east wall to the center of the elevation. The south elevation is similar to the north elevation with a ribbon of wall-length fenestration. The elevation also has two door openings and a sliding casement window.

north elevation

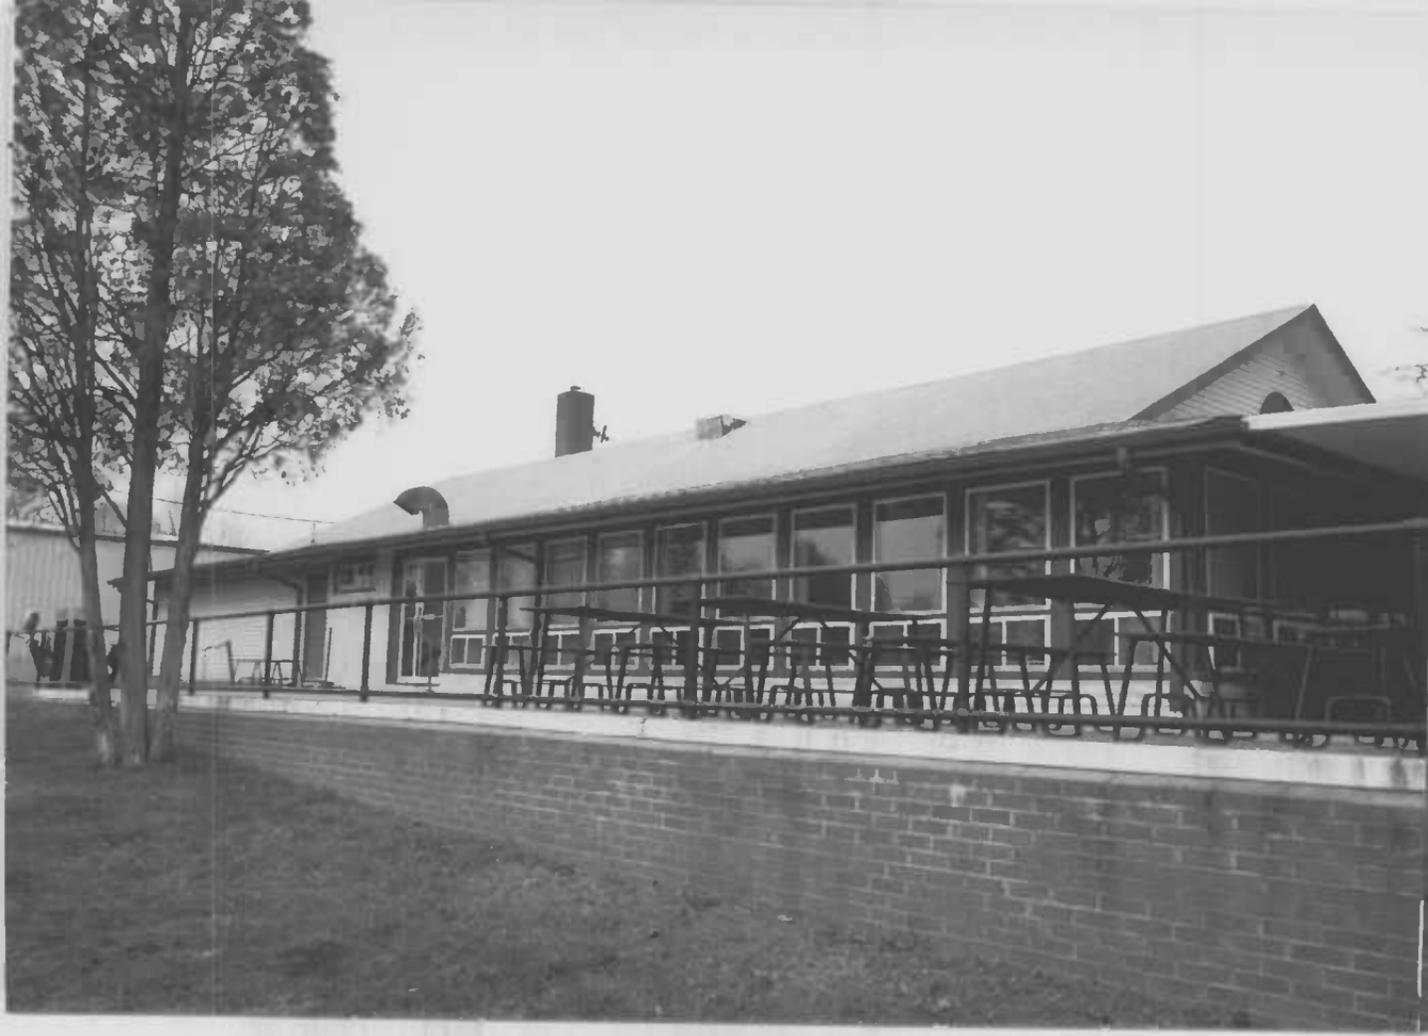
AA-9
Building 6865
Anne Arundel Cty
2/3

south elevation

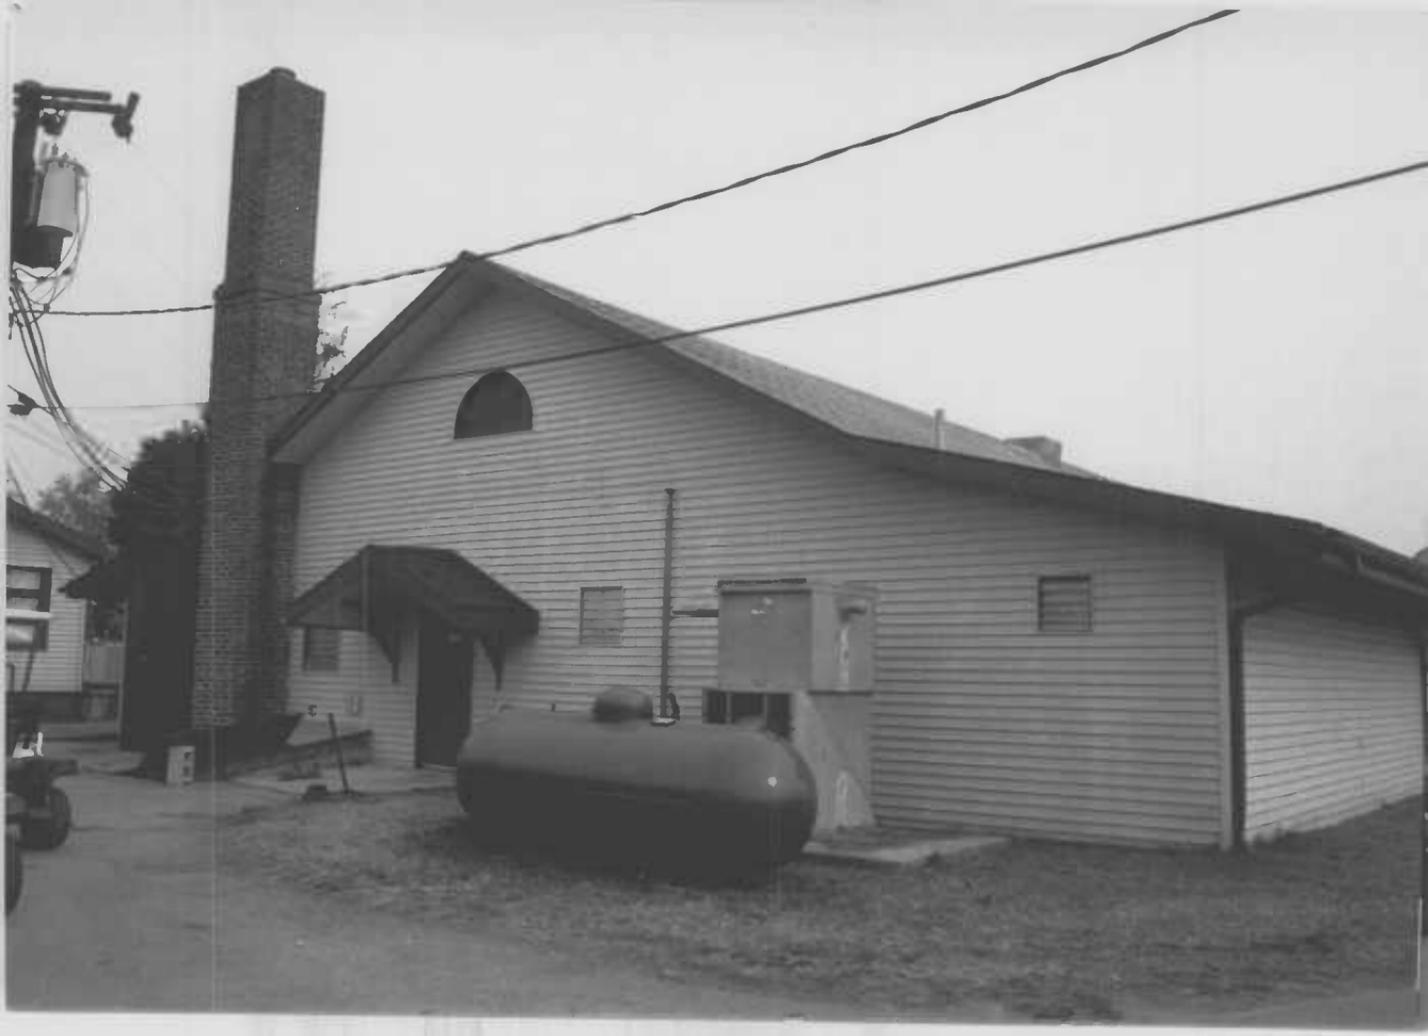
AA-9
Building 6865
Anne Arundel City
3/3

The west gable end has an arched, louvred vent window in the gable. A center door opening is covered with an entry hood. The exterior end brick chimney is located to the north side of the elevation.

west elevation
