MARYLAND HISTORICAL TRUST WORKSHEET

AA-269

COMMON:  
 Old Colony Cove Farm House

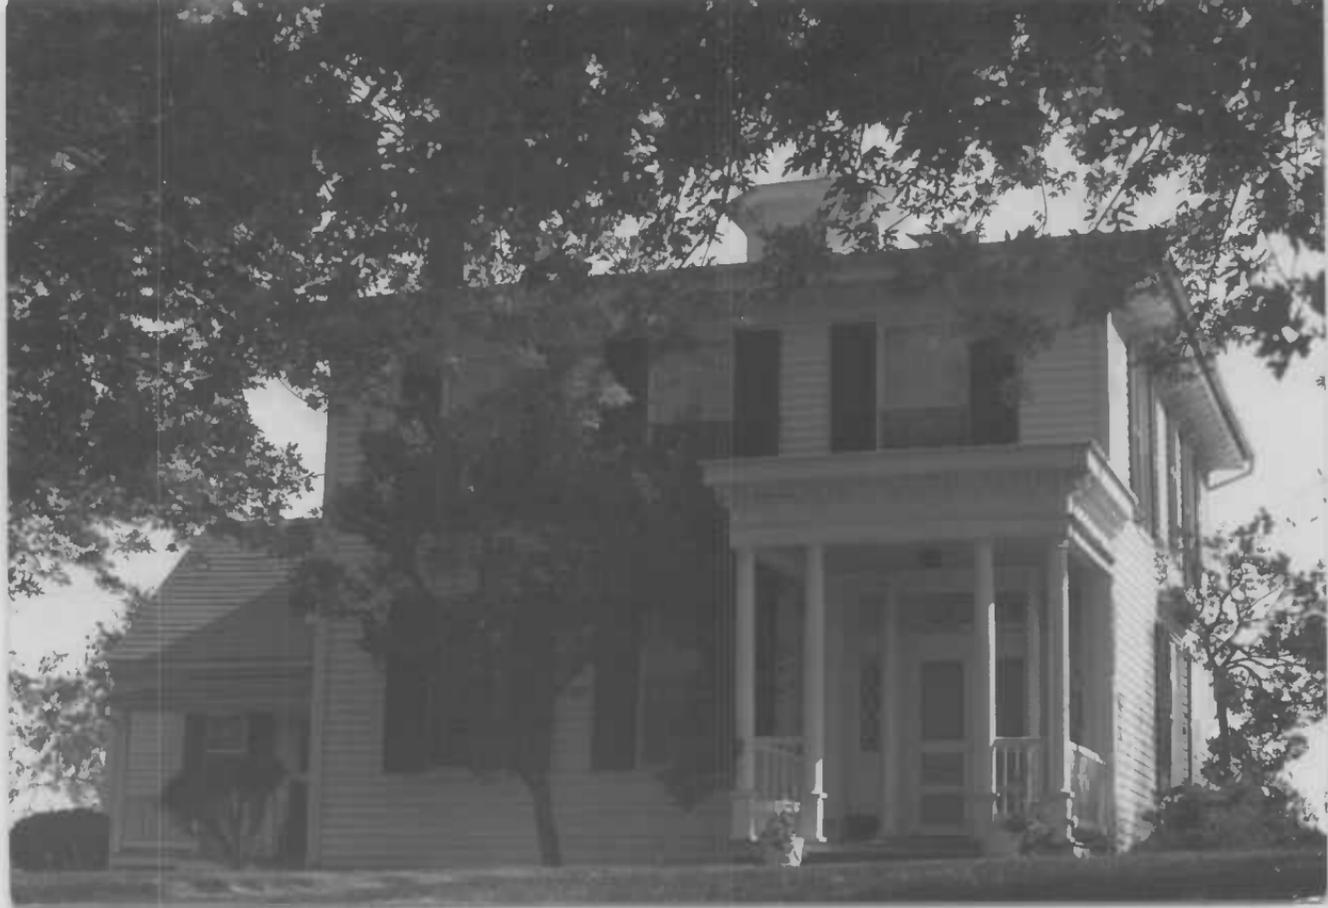
West Elevation

The eaves of the main roof have a similar bracket treatment. The entrance to the house, on the west side, has an elaborate wooden porch, supported by four plain, round columns. Each side is enclosed with a railing and has a low bench. The roof of the porch has a slight overhang decorated with closely-spaced scroll cut brackets. The front door is double. It is framed by two columns and diamond-pane transom and side lights. The east and west sides of the house have three bays each. The windows have large panes (6/6), with shutters. The south side has a large 3-part window in the middle of the first floor. This lights the stair and the hall. The center of the three parts is a standard 6/6 double-hung sash. The side parts are narrow, have a diamond-pane sash and are shuttered. The whole window is covered by a bracketed architrave with a slight overhang. There are two 6/6 pane windows and one 4/4 pane window on the second floor of the south side. The east side of the house has a wide screened porch covering the length of the first floor. It is probably a 20th century addition.

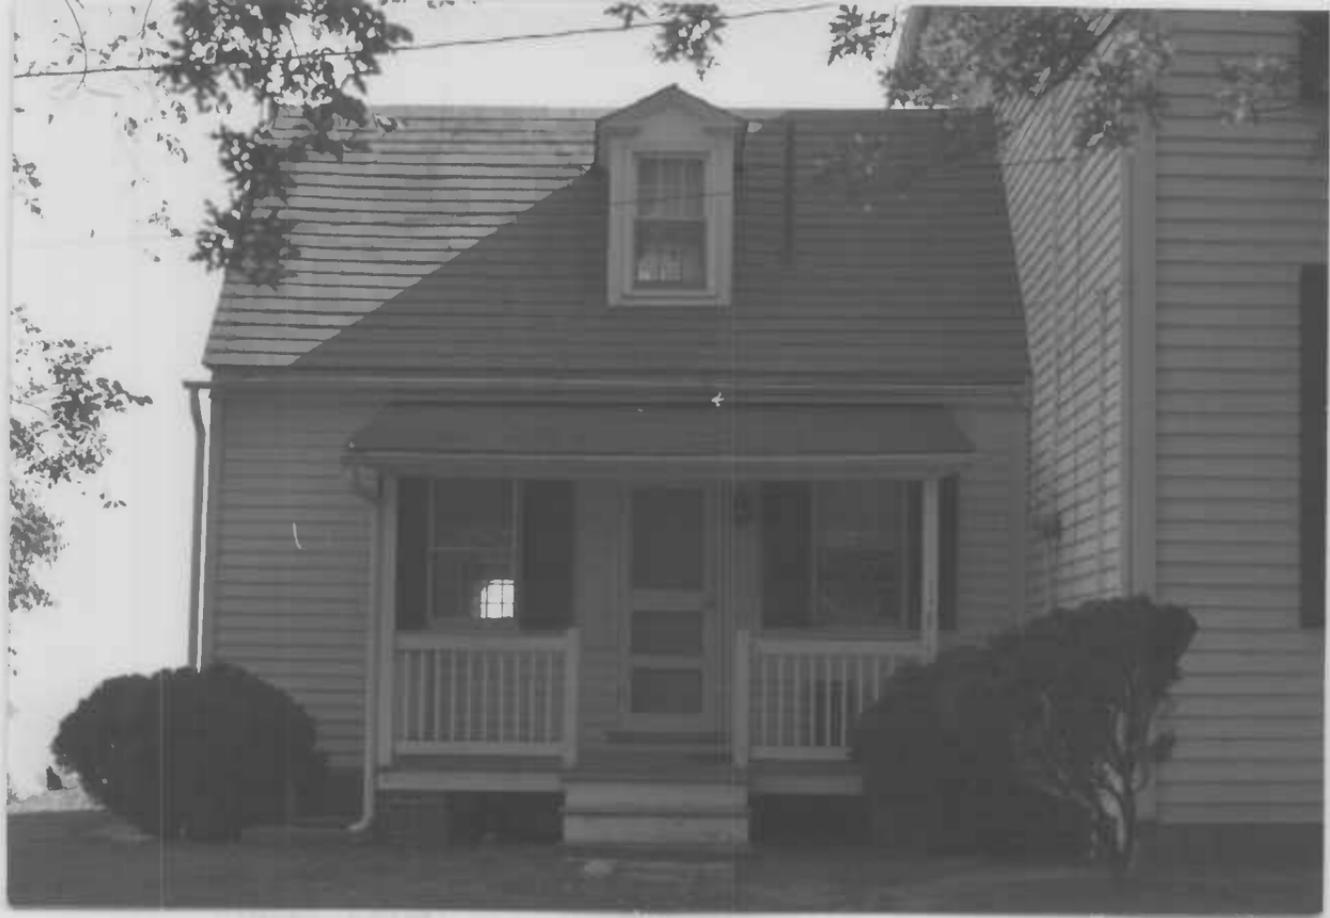
(map 34) aa-47-T-a  
"Old Colony Cove  
Farm House"  
West Elevation  
Kitchen

There are two 6/6 pane windows with a door between them on either side of the kitchen. Over the openings on the west side there is a small porch with railings.
