AA-373

HISTORIC SITES SURVEY FIELD SHEET  
Individual Structure Survey Form

COUNTY: Anne Arundel
TOWN: Annapolis
LOCATION: 97 Cathedral Street
COMMON NAME:
FUNCTIONAL TYPE: Res Map 30 Par 565
OWNER: Paul Panneton ADDRESS: 3102 Tinder Place Bowie, MD 20715
ACCESSIBILITY TO PUBLIC: Yes (X) No ( ) Restricted ( )
LEVEL OF SIGNIFICANCE: Local (✓) State ( ) National ( )

97 Cathedral

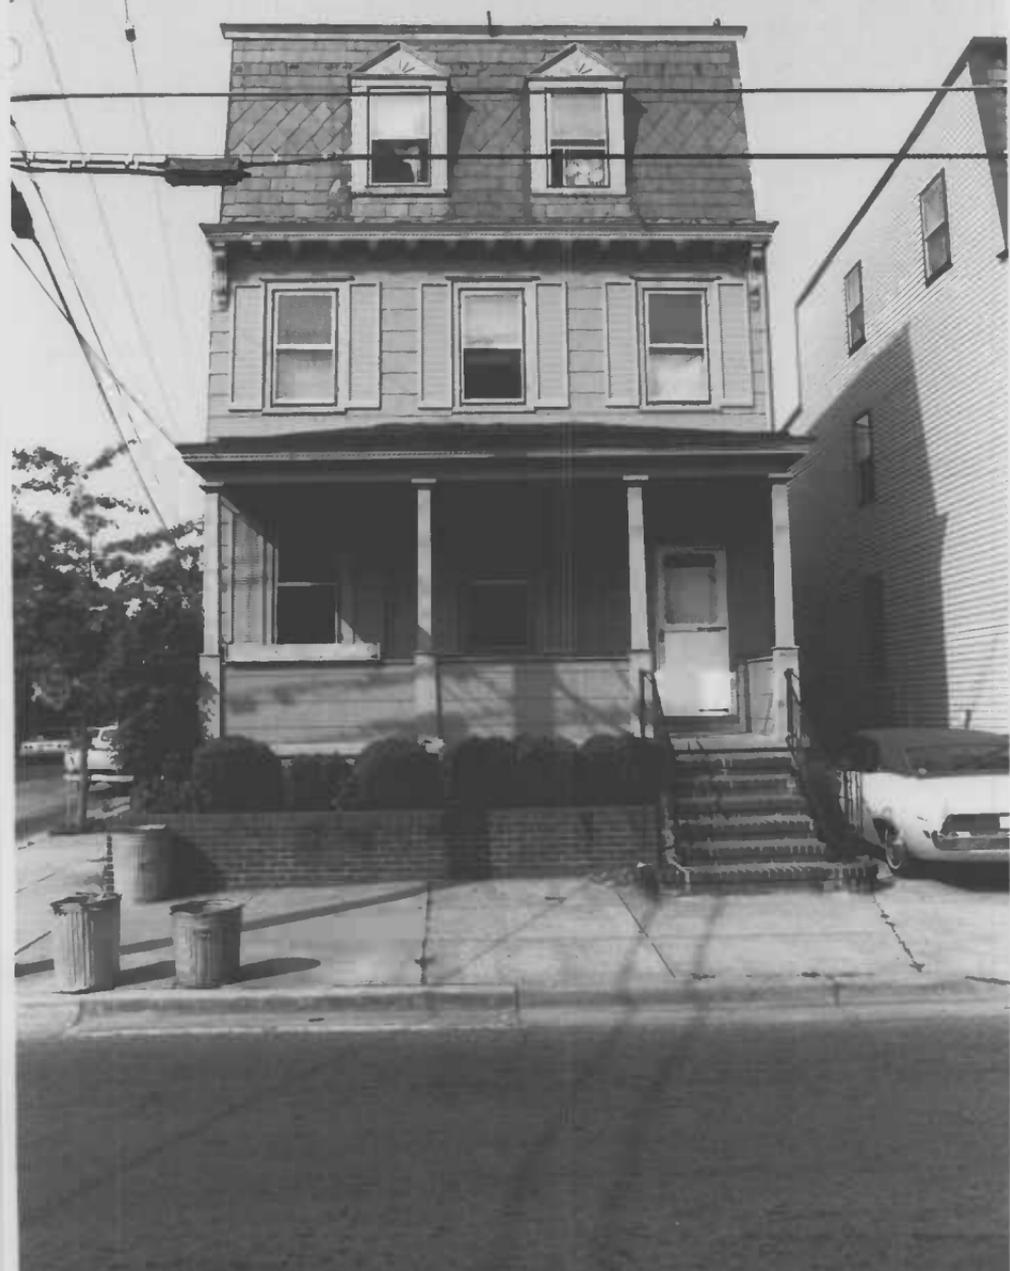
NW Elevation/camera facing SE
