AA-974

Morgue and Pump Houses

Crownsville Hospital Center

Maryland Historical Trust State Historic Sites Inventory Form

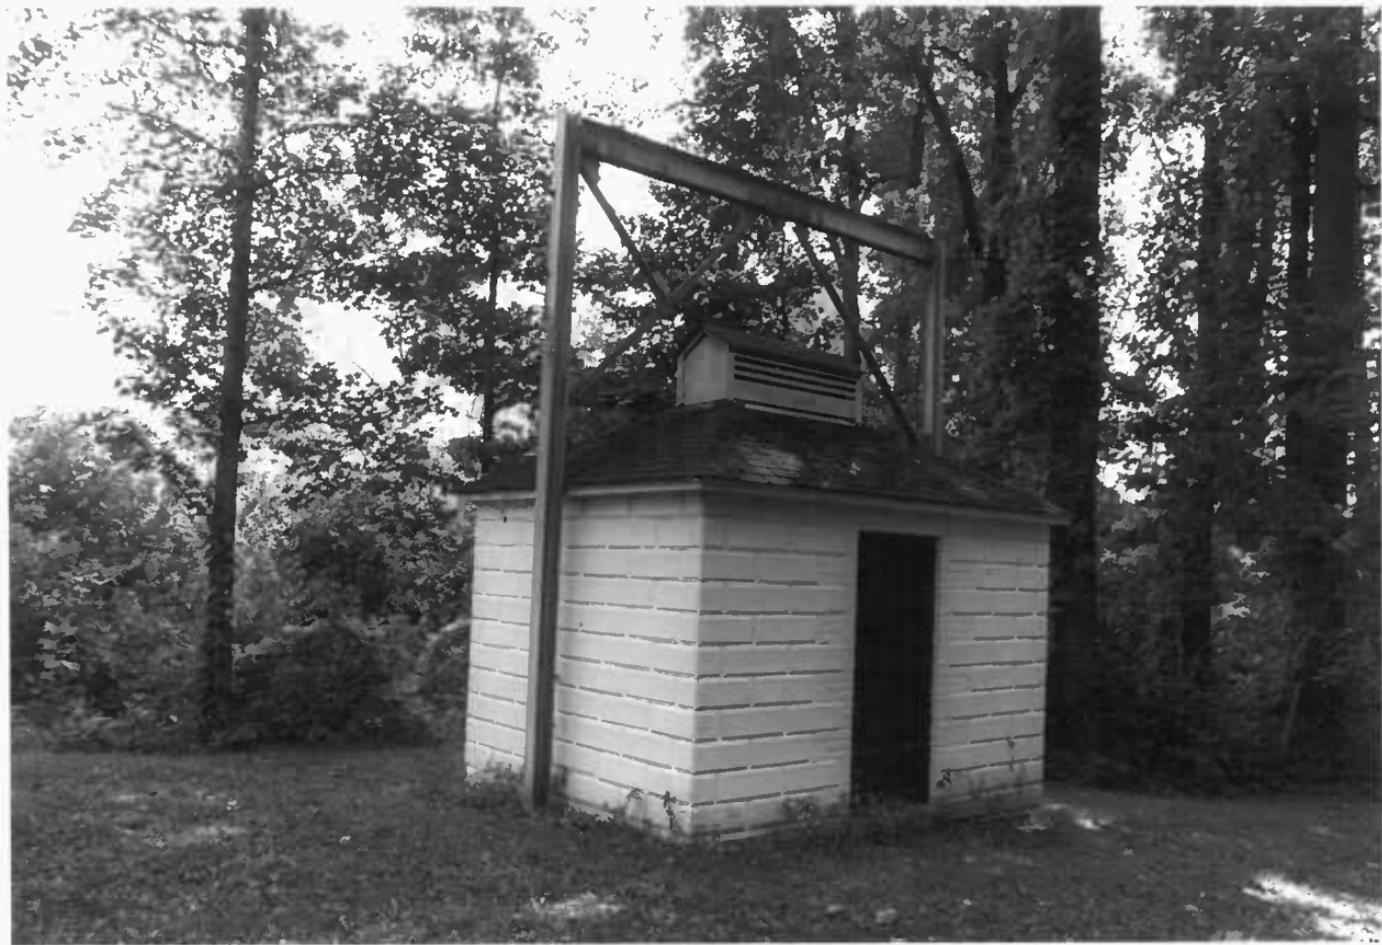
Pump House

NORTH AND WEST

The two pump houses have such similar appearances that one description will suffice for both. The simple structure is square, one bay by one bay. Rising one story in height, the pump house is constructed of the familiar molded concrete blocks. A slate covered hipped roof rises above the boxed cornice. Each building has two openings: one door and one window. The openings are decorated with brick Gibbs surrounds and vertical joint lintels. The french windows have brick sills as well. The southern pump house has a small wooden cupola of louvered sides and gable roof.

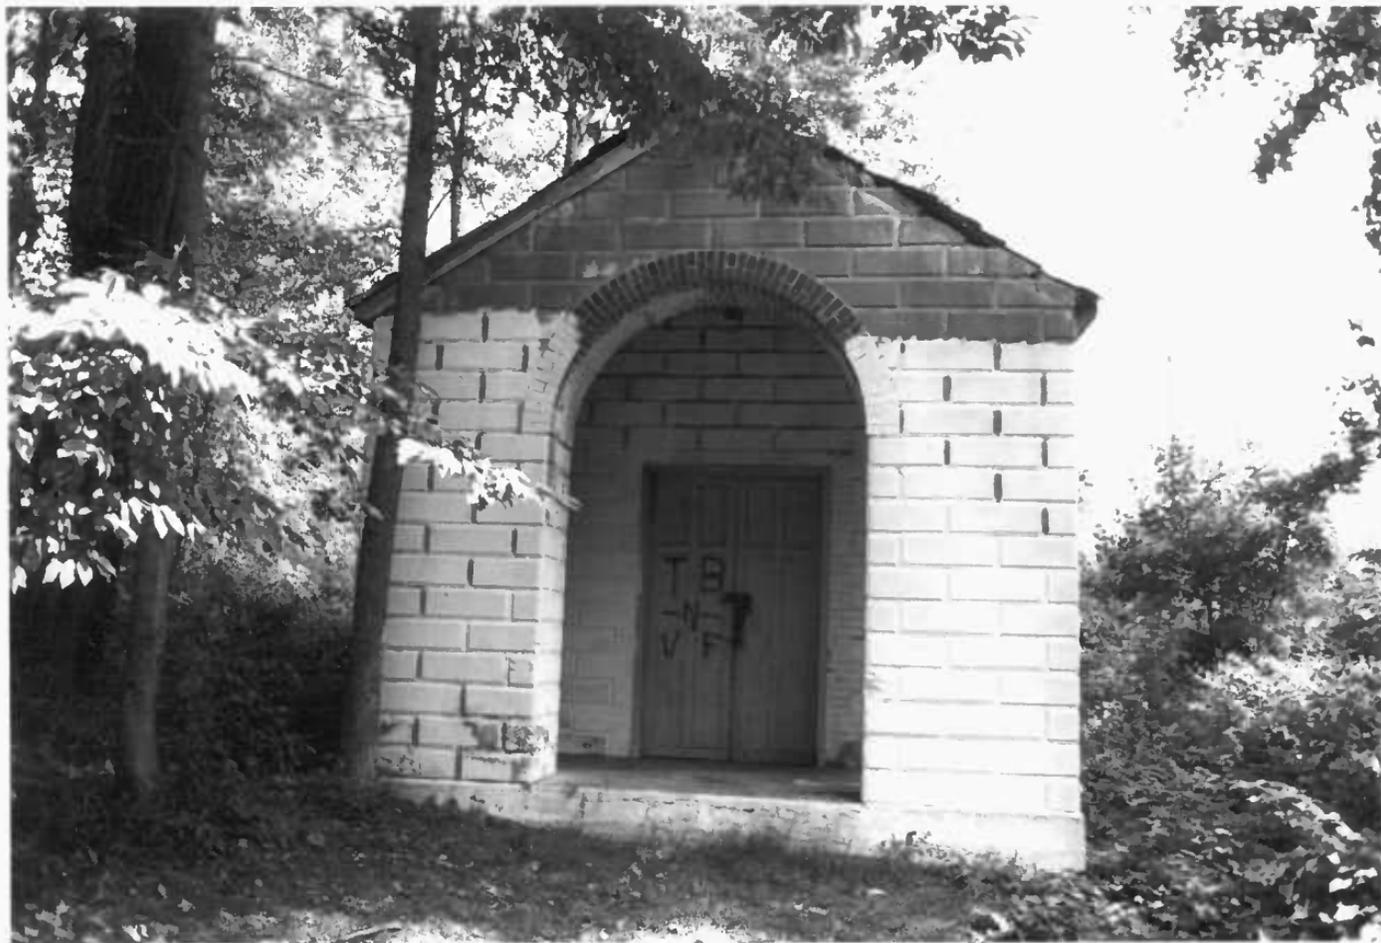
Old Morgue & Pump House
Crownsville Hospital Center
Crownsville, Maryland

West

The Morgue is a one-and-a-half story structure constructed of molded concrete blocks. Capped by a slate covered, gable roof, the building measures two bays wide and three bays deep. The main facade faces west. This west facade has an engaged portico with a central archway. A brick lintel decorates the rounded arch. The door and windows are detailed by brick surrounds and vertical joint lintels. The casement windows have protective metal screens. A boxed cornice lines the raking eave while the gable ends have cornice fascia.
