MARYLAND HISTORICAL TRUST WORKSHEET

NOMINATION FORM for the NATIONAL REGISTER OF HISTORIC PLACES, NATIONAL PARKS SERVICE

COMMON: Belmore BCHS #118

BELMORE

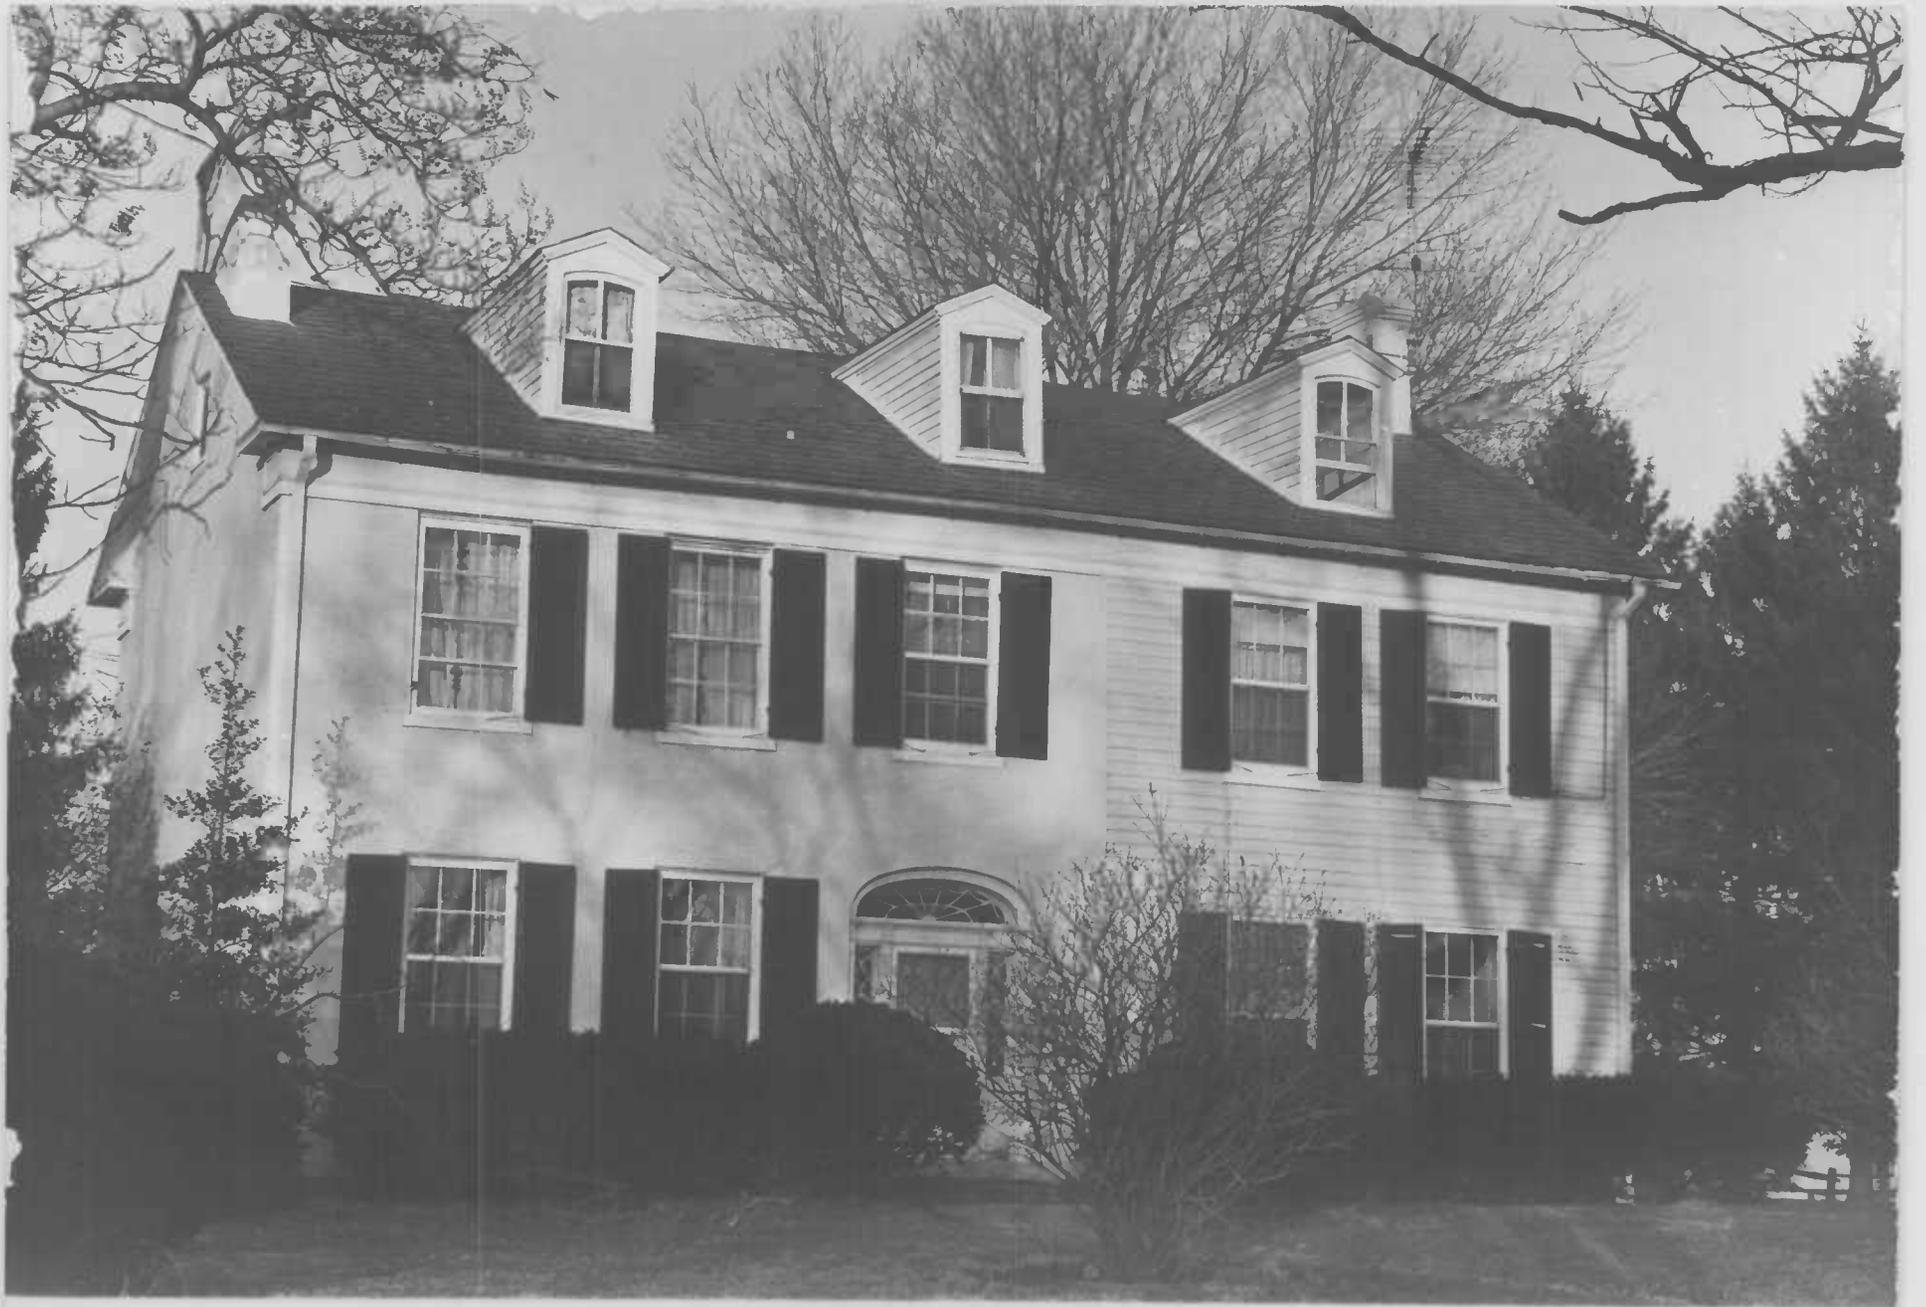
BA-118

1. NAME			
COMMON: Belmore			
AND/OR HISTORIC:			
2. LOCATION			
STREET AND NUMBER: Northeast corner intersection Markee and Monkton Rds.			
CITY OR TOWN: Monkton			
STATE: Maryland	CODE	COUNTY: Baltimore	CODE
3. PHOTO REFERENCE			
PHOTO CREDIT: R.M.N. Crosby, M. D.			
DATE OF PHOTO: January 1975			
NEGATIVE FILED AT: Maryland Historical Trust 21 State Circle, Annapolis, Md.			
4. IDENTIFICATION			
DESCRIBE VIEW, DIRECTION, ETC. South (front) facade

South (front) Facade
