MARYLAND HISTORICAL TRUST WORKSHEET

COMMON: **Belmont**

STREET AND NUMBER: **Belmont Road**

CITY OR TOWN: **Glynden**

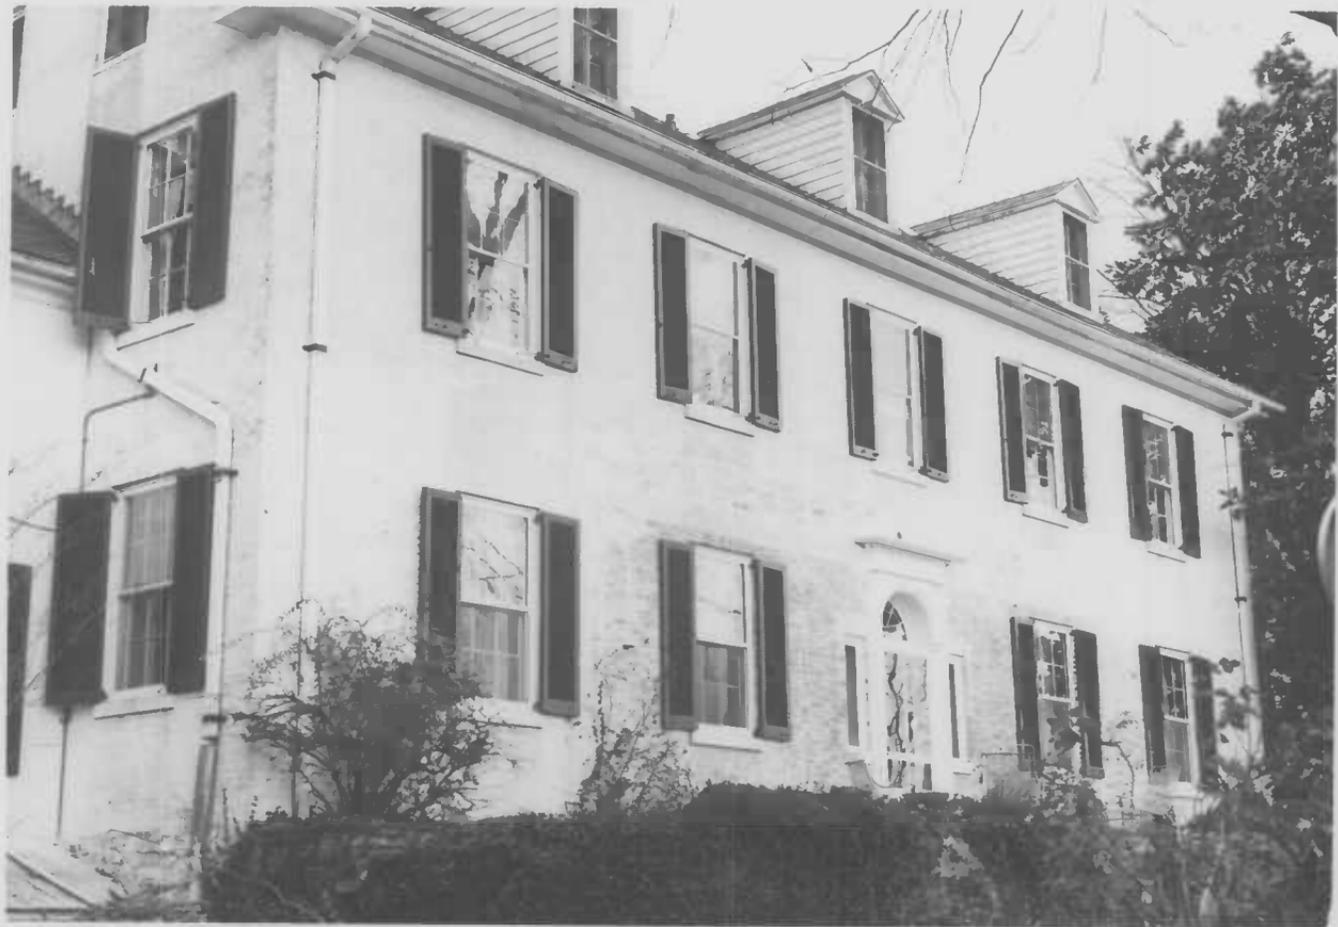
BA-169

The principle (south) front is laid in Flemish bond without closers, with narrow mortar joints with insignificant grapevine. The centered entrance is embellished with Tuscan pilasters supporting a paneled frieze with a boldly projecting shelf cornice. An arched, leaded transom is above the eight paneled door; the panels of the door, with matching panels in the jambs, are arranged as six equally sized smaller panels above a wide lock rail, with two taller panels below. Window frames are of a double bull-nose profile, and sash are 6/6; sills are of marble and jack arches one and one-half bricks in height, support the masonry above. Louvred blinds are hung on strap hinges, and are secured open or closed with a flush bolt. Small windows on each side of the entrance appear to be later insertions.

S-face/de

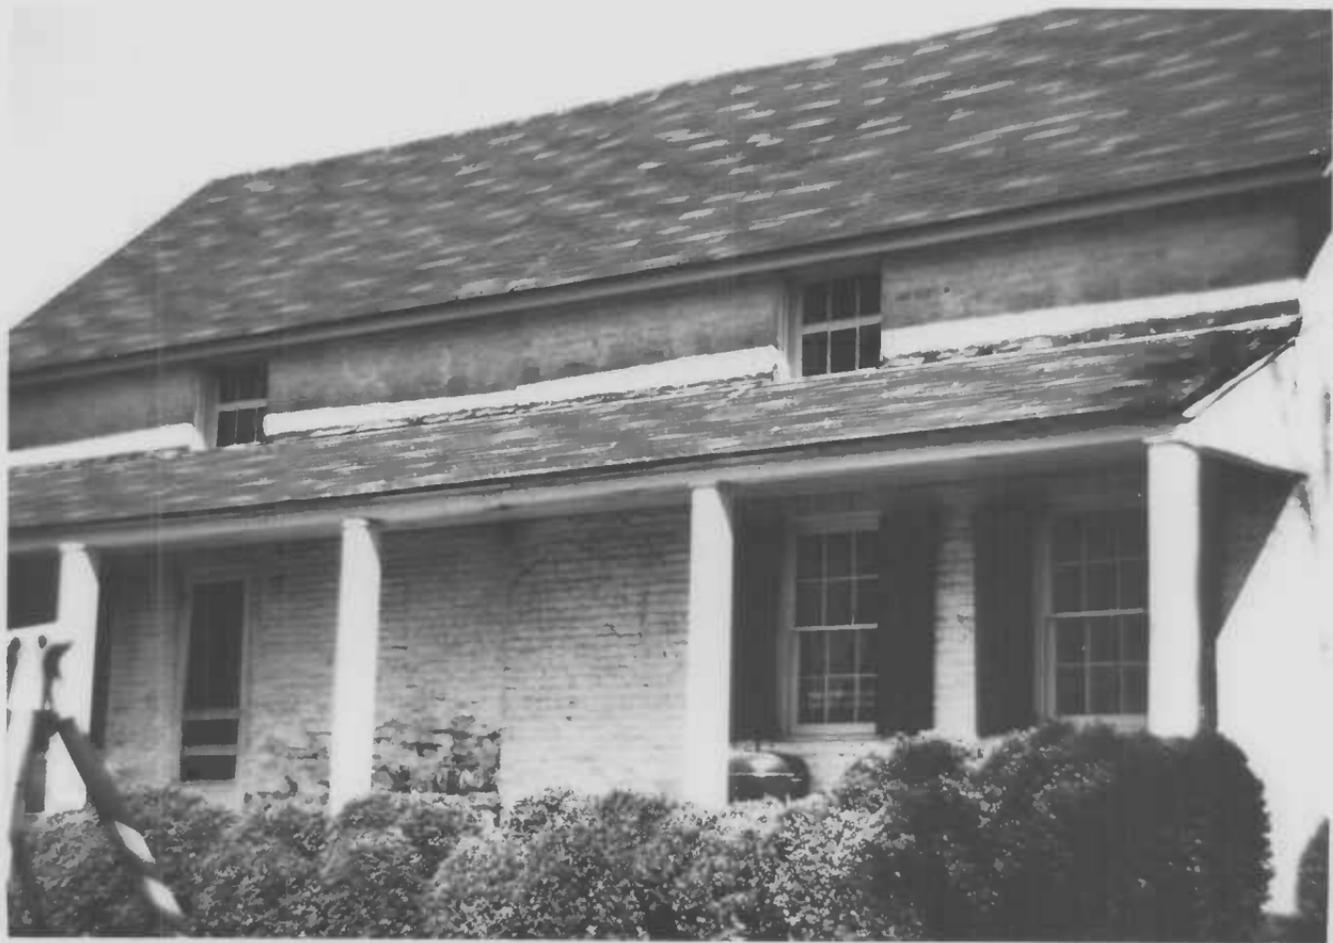
BA-169

The old slave quarters was built in two two-bay sections, each about the same size, with irregular fenestration. It is of brick above a high stone foundation, one and one-half stories in height, the plate being several feet above the second floor. A chimney is not visible externally, but was probably between the two halves.

Belmont - old quarters  
from southeast
