INVENTORY FORM FOR STATE HISTORIC SITES SURVEY

HISTORIC OREGON FURNACE STORE

AND/OR COMMON KURTZ HOUSE

OREGON FURNACE BUILDINGS

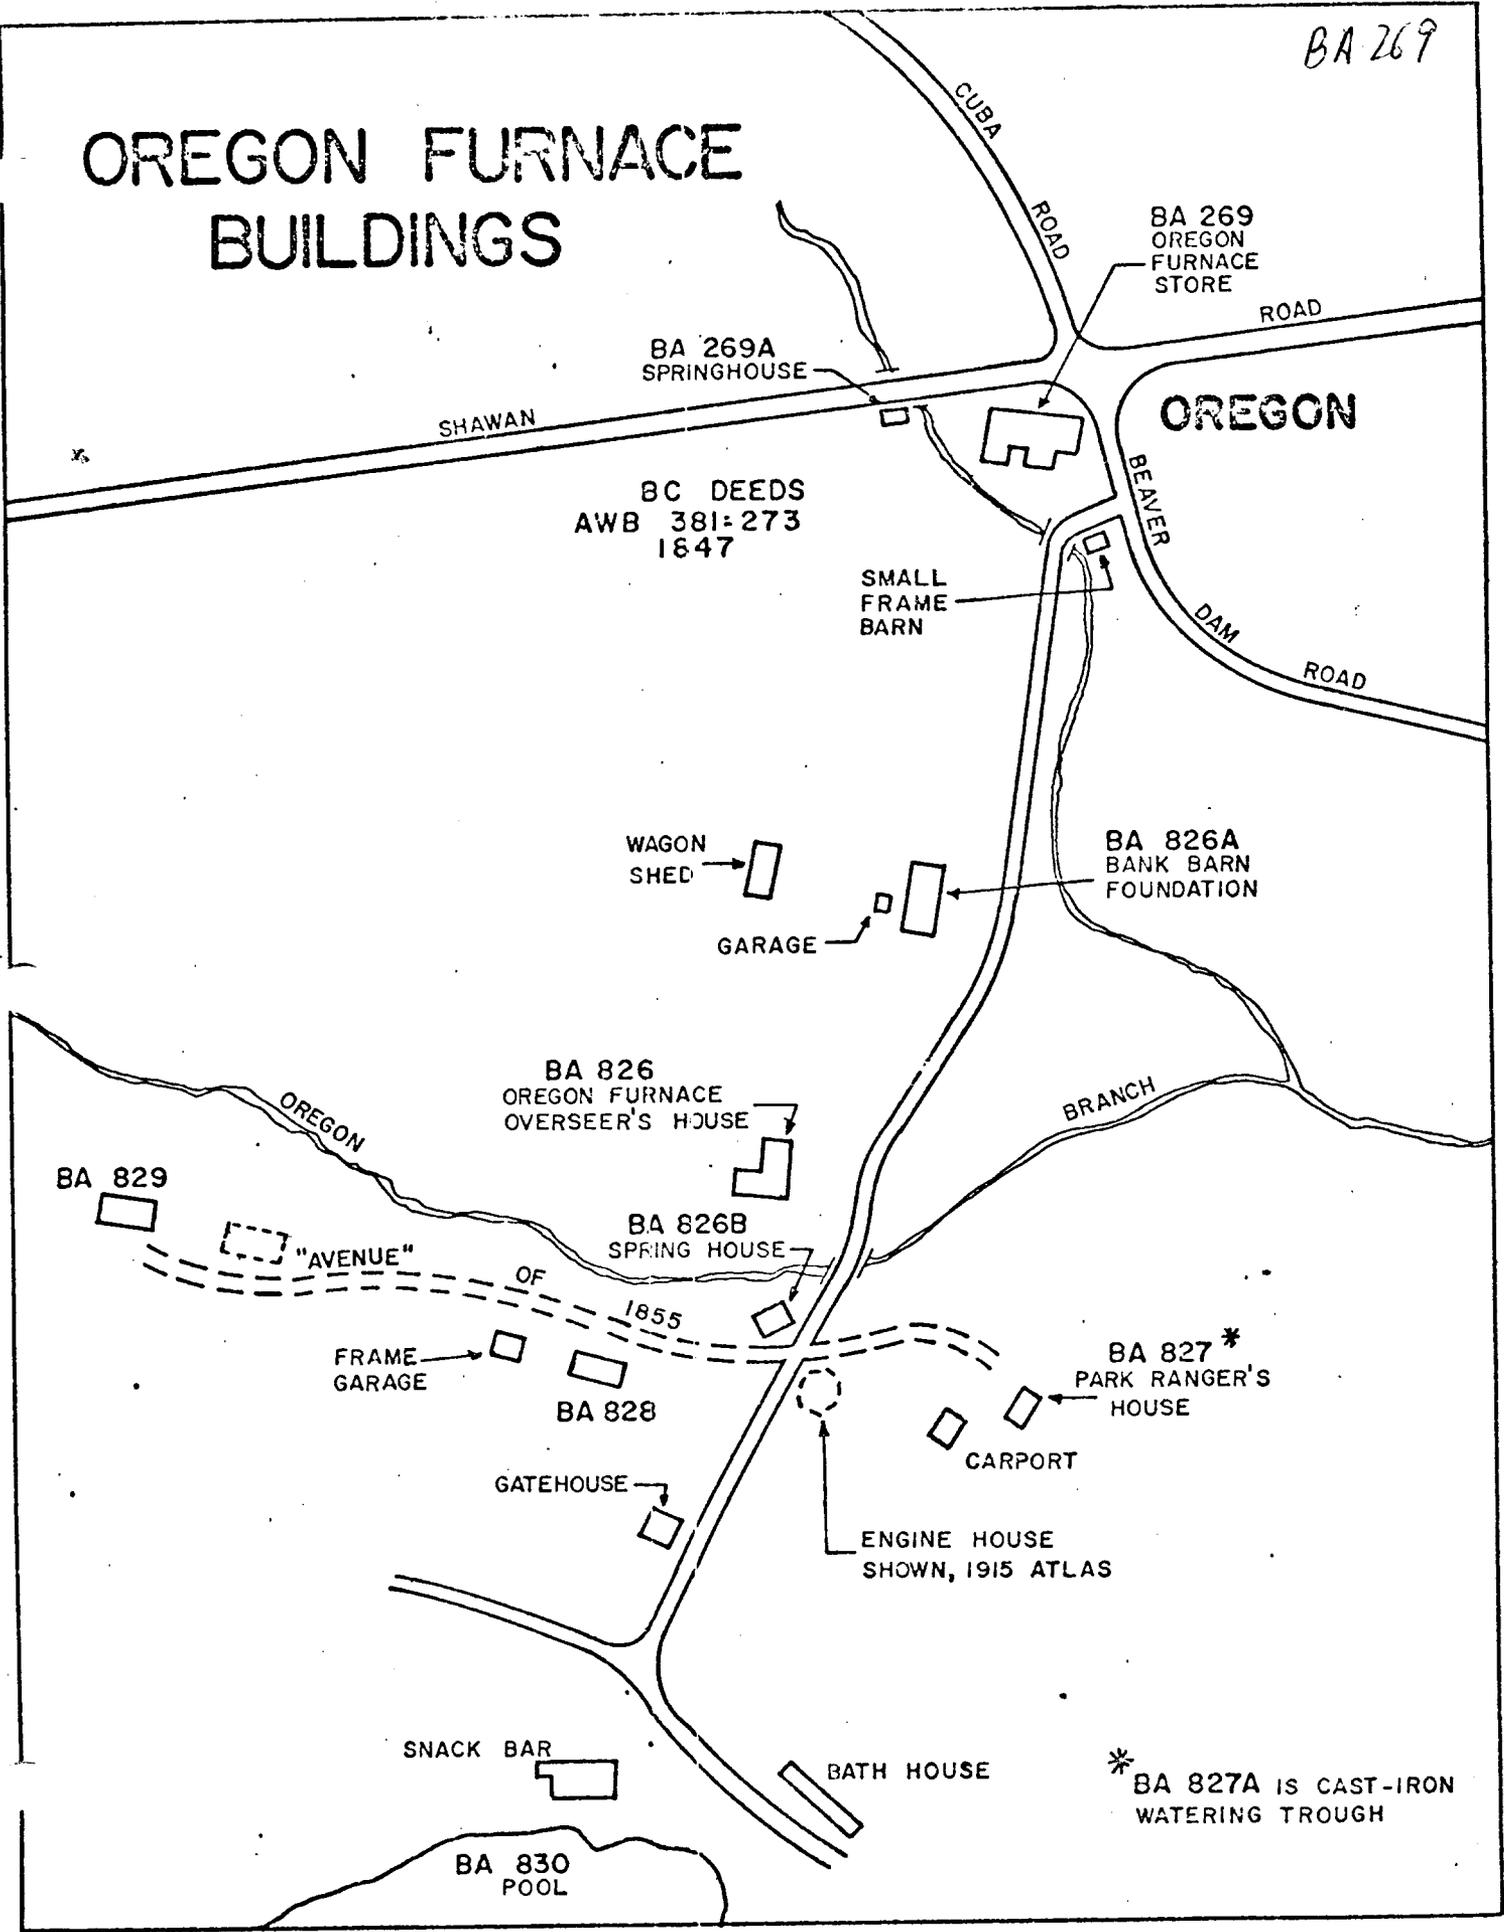
BC DEEDS
AWB 381-273
1847

BA 269
OREGON
FURNACE
STORE

BA 269A
SPRINGHOUSE

BA 826A
BANK BARN
FOUNDATION

BA 826
OREGON FURNACE
OVERSEER'S HOUSE

"AVENUE"
OF
1855
