1. STATE **Maryland**
 COUNTY **Baltimore**
 TOWN **Lutherville** VICINITY
 STREET NO. **1505 Front Avenue**
 ORIGINAL OWNER **Rev. Benjamin Stadtler**
 ORIGINAL USE **residence**
 PRESENT OWNER **Mrs. Nancy Armstrong**
 PRESENT USE **apartments**
 WALL CONSTRUCTION **frame**
 NO. OF STORIES **2**

HISTORIC AMERICAN BUILDINGS SURVEY
INVENTORY

2. NAME
 DATE OR PERIOD **c. 1860**
 STYLE orig.: **Italianate**
 ARCHITECT
 BUILDER

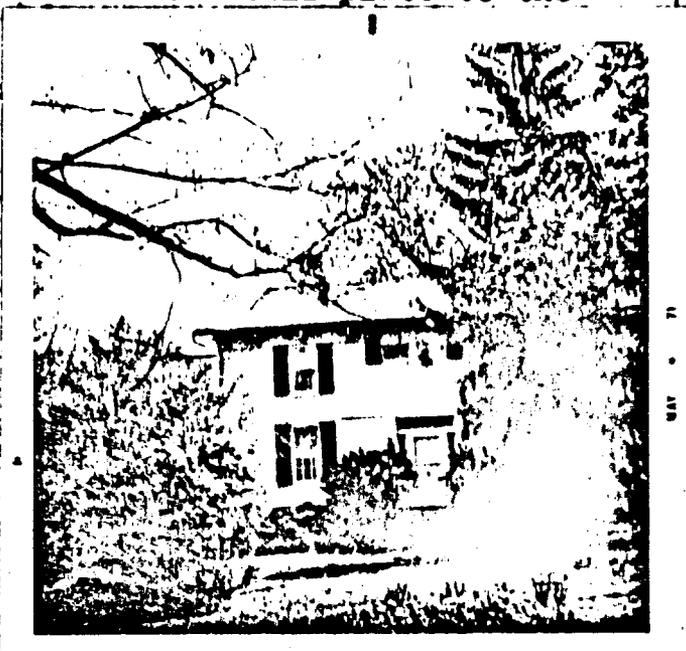
A simple house of low symmetrical proportions, it sits at the rear of a very deep, narrow lot facing Front Avenue and has a two story side wing set back from the main facade. Unornamented except for the small sparsely spaced brackets supporting the eaves of the low pitched, gabled roof, the house presents a three bay facade with a central sidelighted and transomed front door flanked by windows with six over six sash. Similar windows directly above at the second floor are slightly smaller scaled. Over the front door an awkward pair of low double windows interrupt the cornice frieze board.

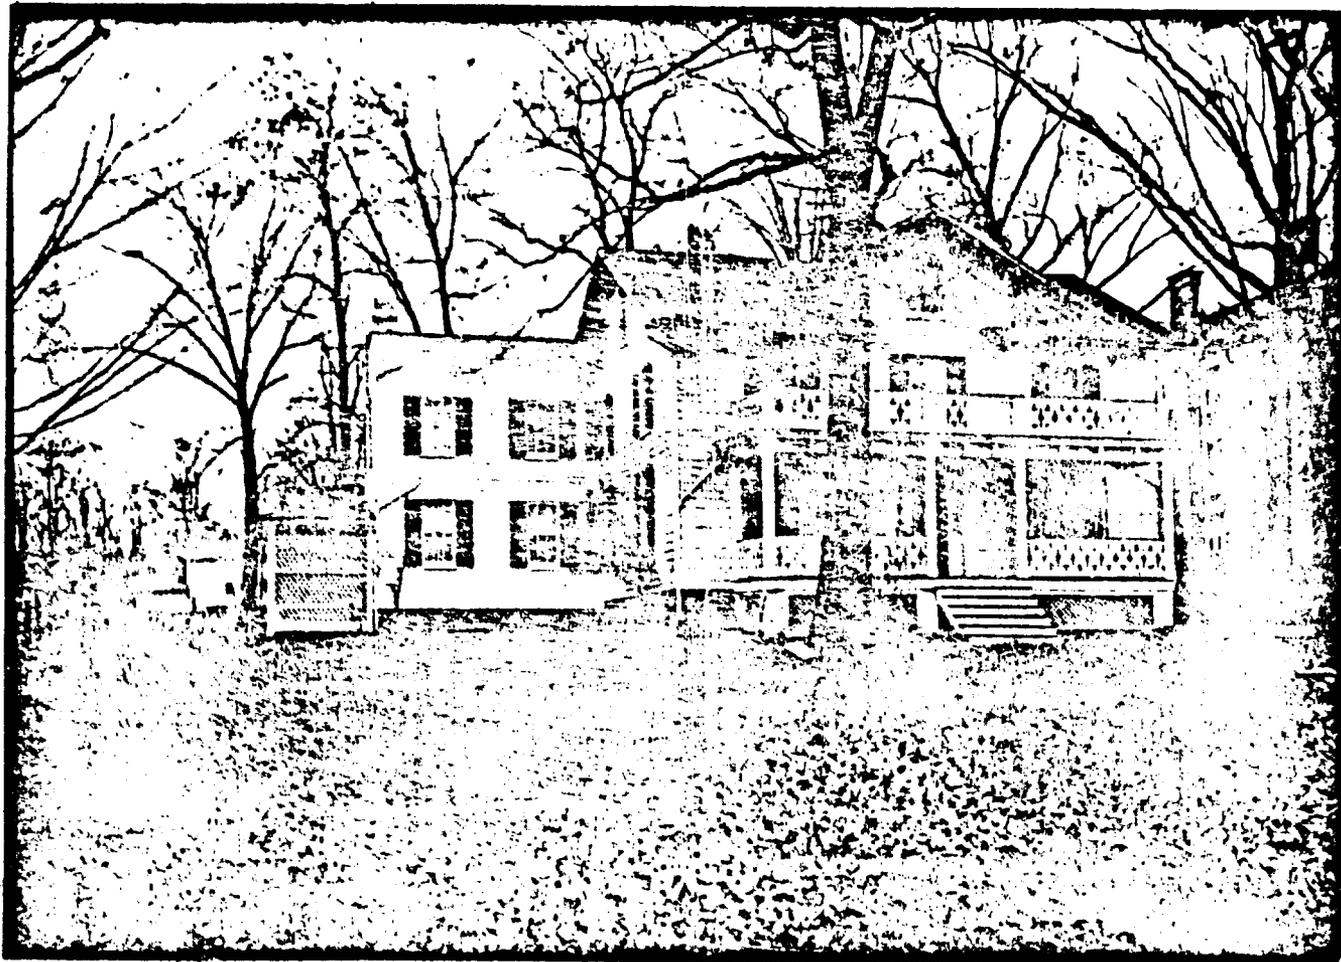
This existing house is the product of a 1940's remodeling which removed, as seen in the accompanying old photograph, an interesting central gabled motif in which the front wall of second floor extended through the eaves and appeared as a short tower form with a gabled roof, its ridge at the ridge of the main roof. This vestibule tower had large brackets at its verges and a semi-circular arched window which lighted the attic. Below this window there was a six over six window which was replaced with the double windows. The original porch was also removed with its square columns supporting a bracketed cornice and a balcony balustrade. Like the balustrade at the main level of the porch, it had unusual jig-saw out slat balusters in an 'X' pattern. Still existing, though, and seen clearly in the old photo is the particularly interesting use of clapboard siding nailed in a diminishing exposure to the weather from the sill plate to the eaves. Also the original windows still retain their louvered

An early view of the house circa 1915
