**MARYLAND HISTORICAL TRUST
NR-ELIGIBILITY REVIEW FORM**

Property Name: Hereford Baptist Church Inventory Number: BA-909
 Address: Mount Carmel Road (Mount Carmel and York Road) City: Monkton Zip Code: 21111

Maryland Inventory of Historic Properties Form

HEREFORD BAPTIST CHURCH AND CEMETERY

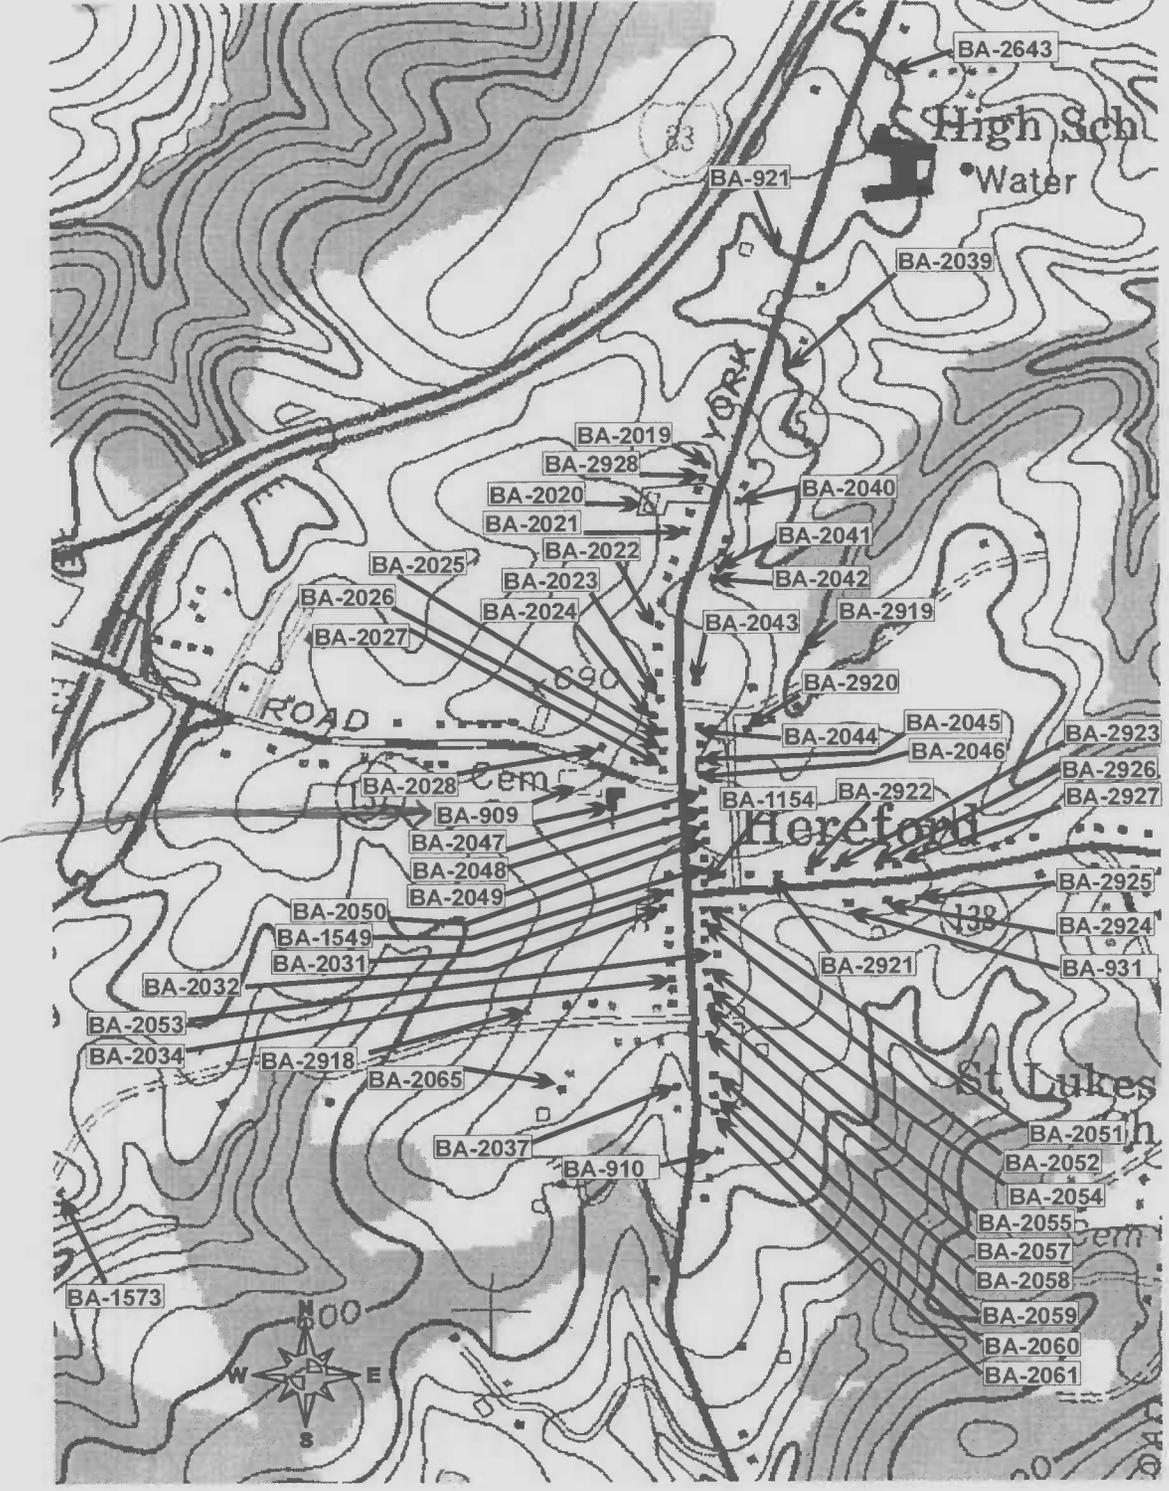
1/3

Hereford Baptist Church and Cemetery

Hereford Baptist Church to the west.

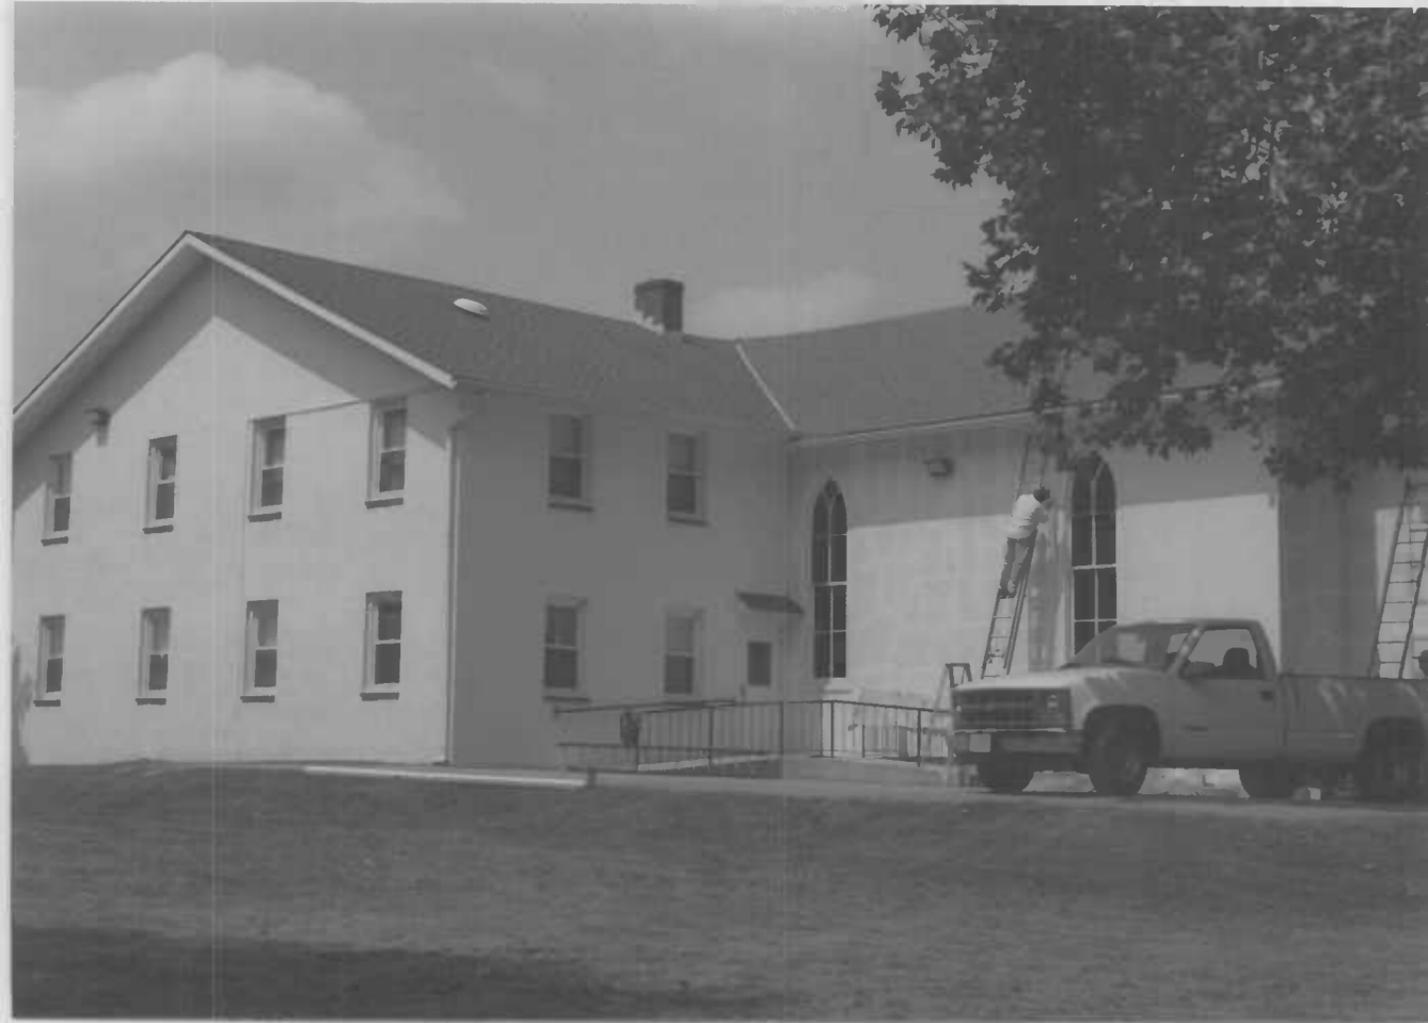
2/3

View of Hereford Baptist Church, to
the west, showing rear addition.

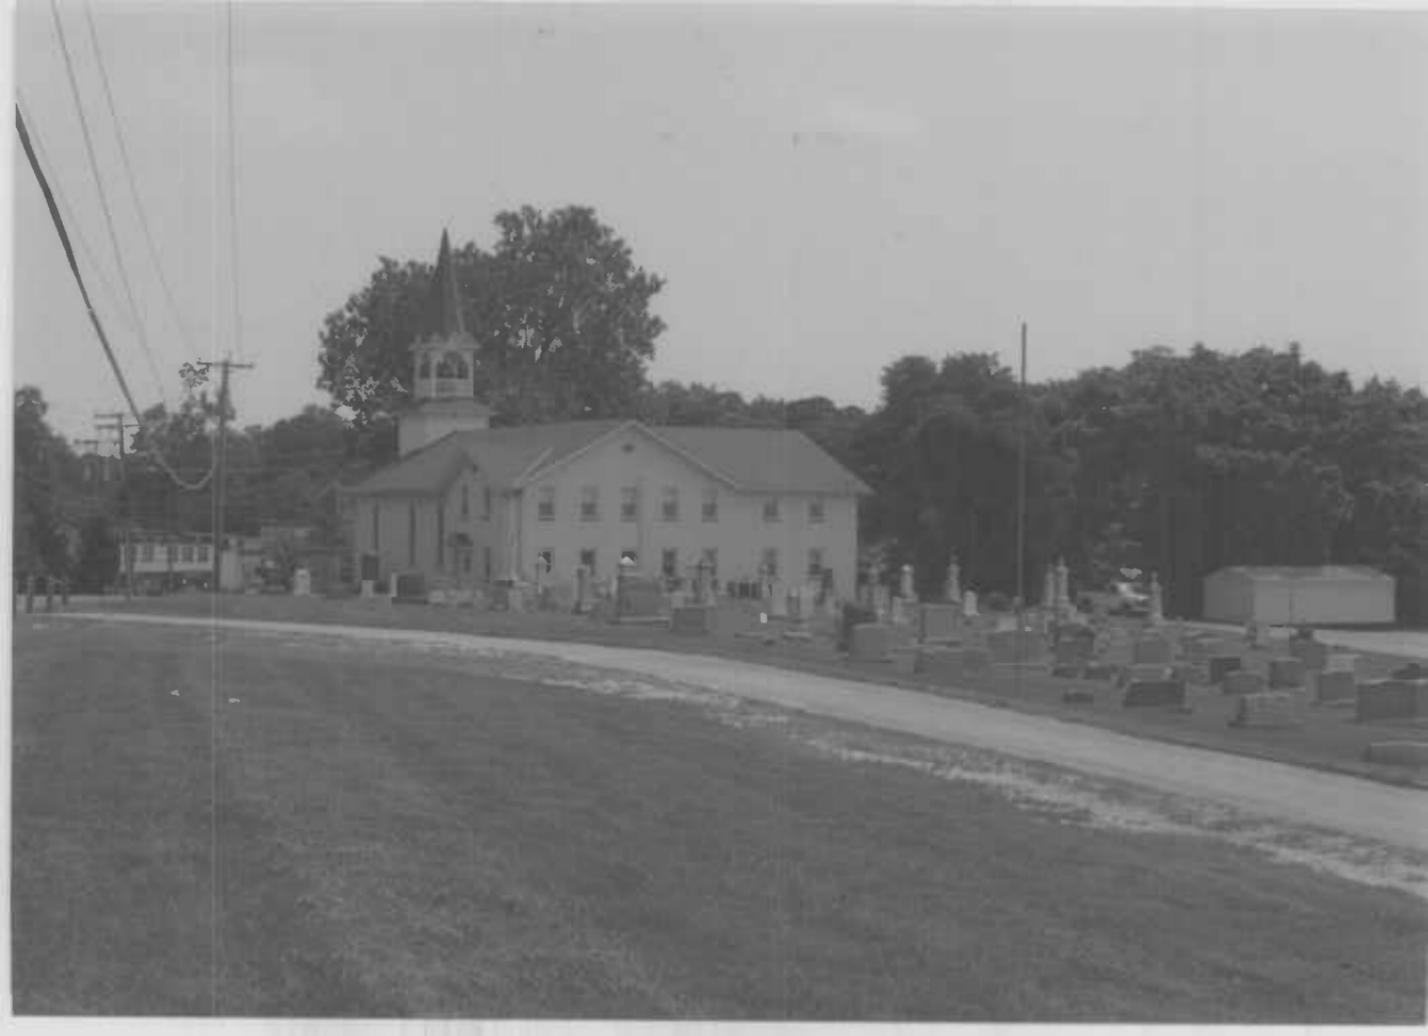
3/3

View of Hereford Baptist Church and cemetery,
to the east, from Mount Carmel road

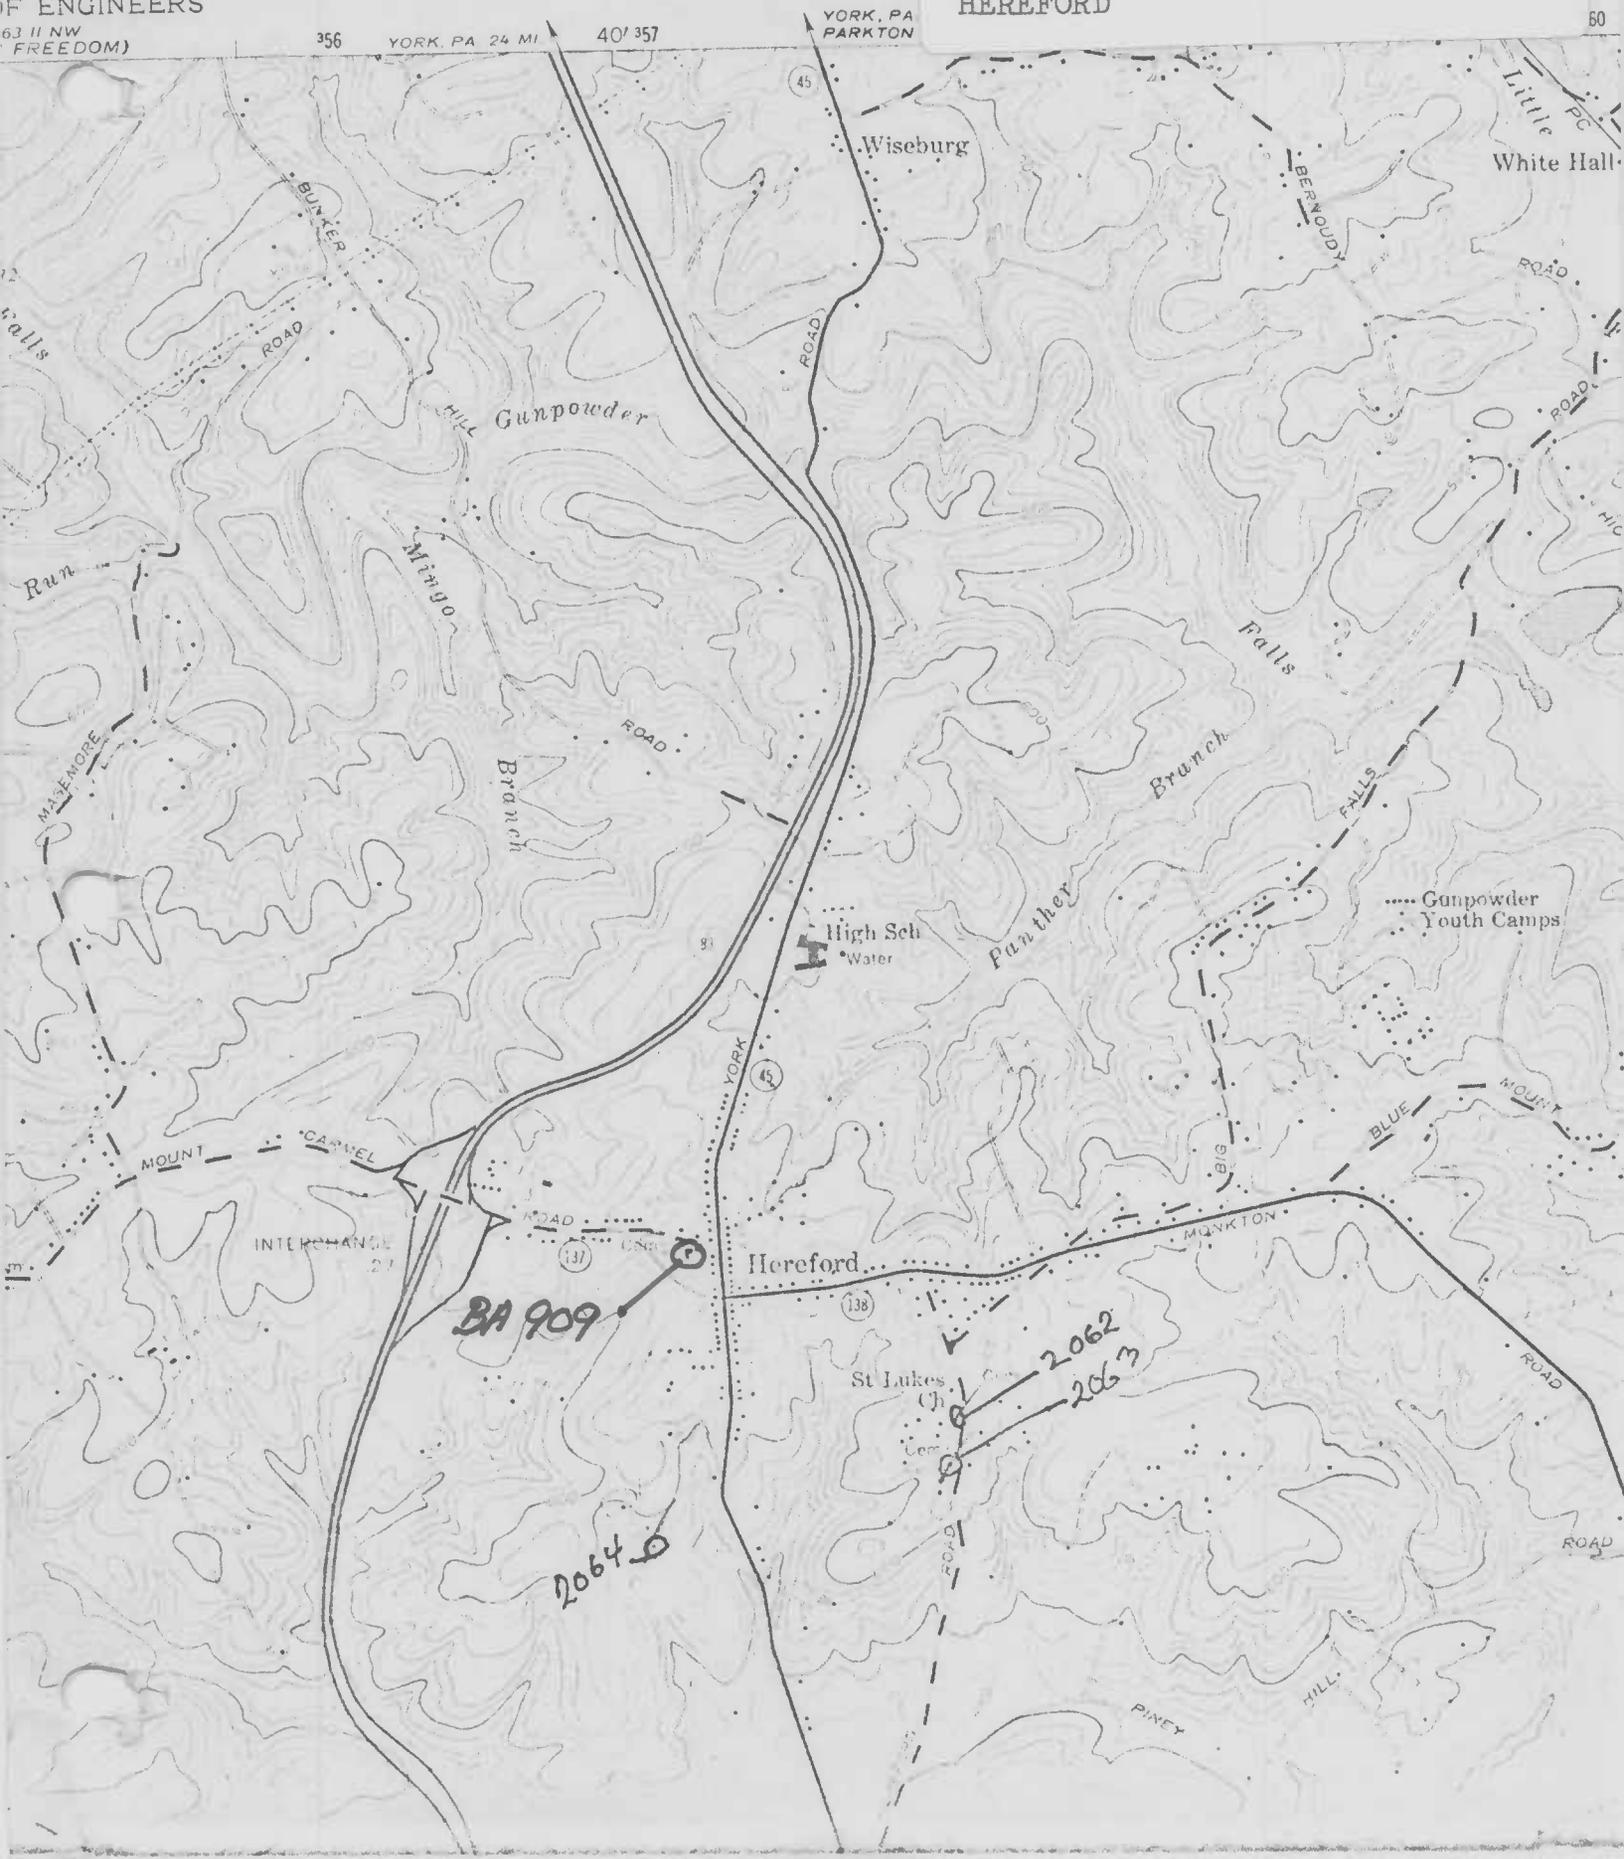
HEREFORD BAPTIST CHURCH BA 909
Baltimore County, Maryland
J. McGrain, OCT 1979
Neg. located at MHT
North side and school annex

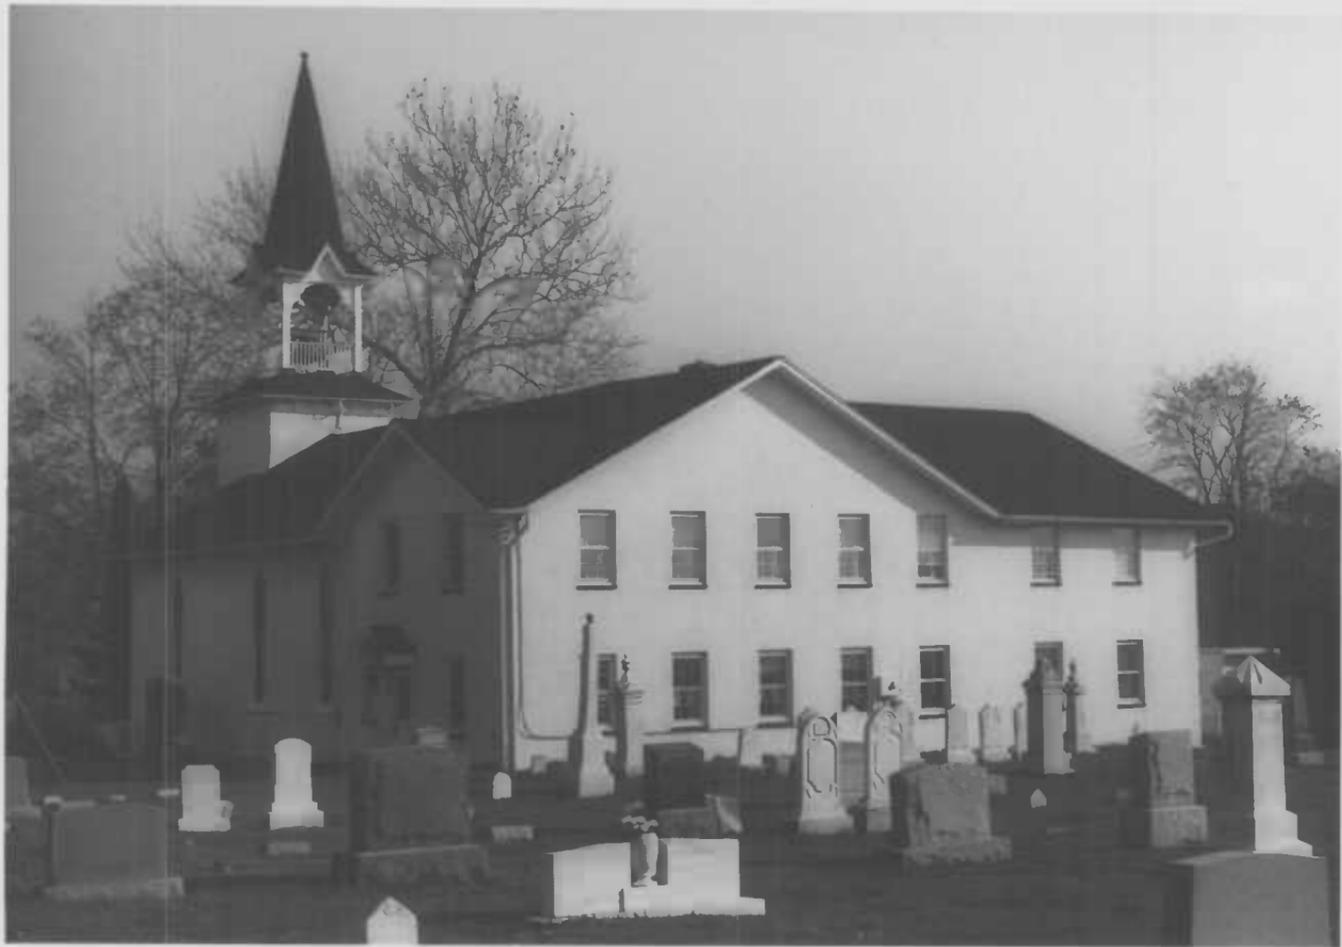
The upper part of the entrance tower is covered with wood shingles in the fish-scale style. The rest of the church is stone, coated with stucco. A large two-story educational building of very plain design extends both south and west from the rear wall of the basic church of 1842.

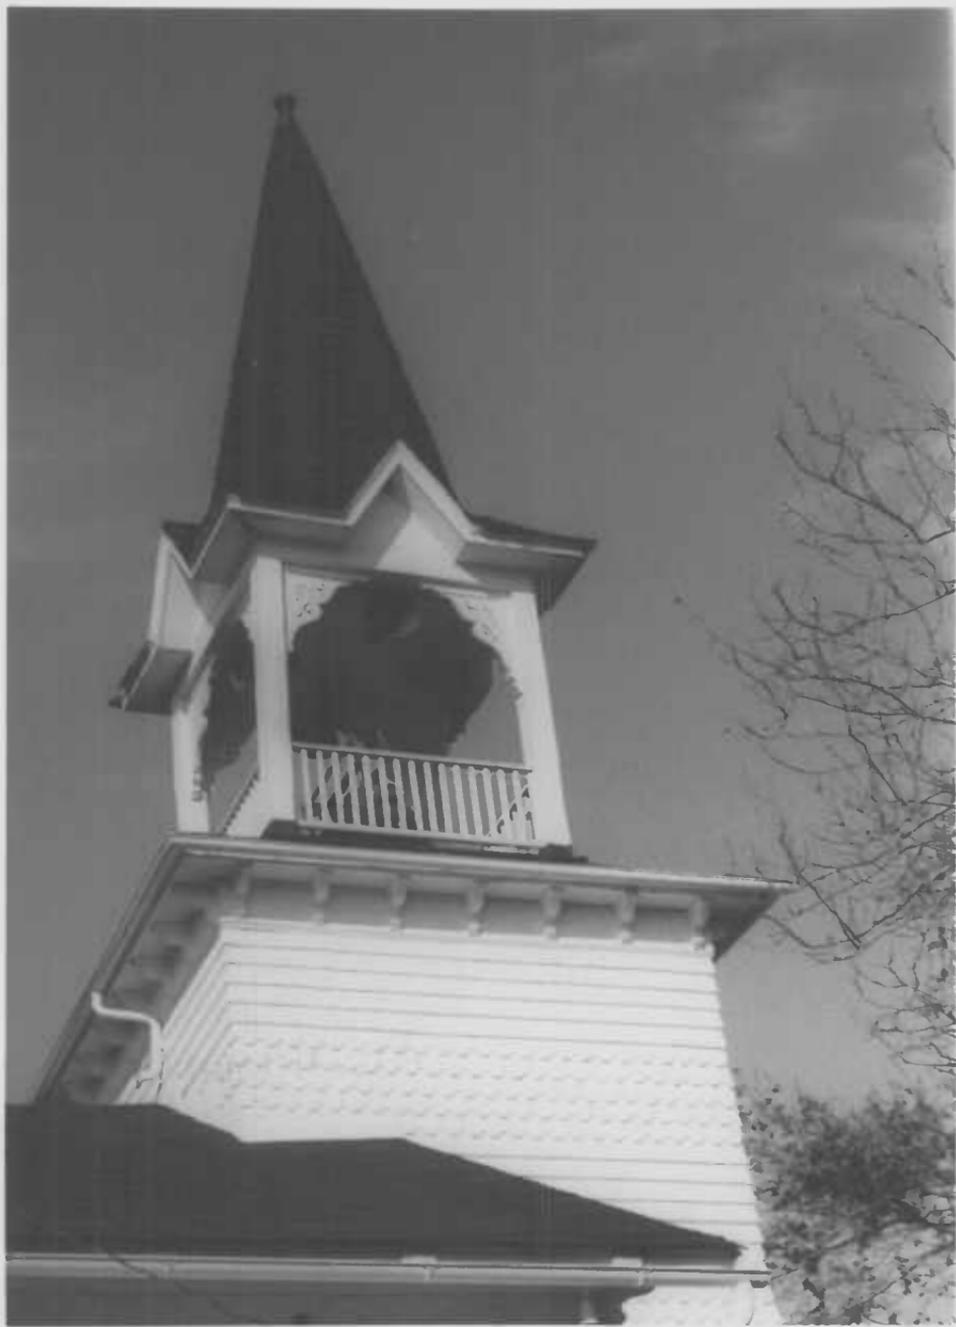
In the 1906 alterations, the church was extended to the east and a vestibule and entrance tower were added; the old spire at the west end was removed. The entrance tower is topped by a graceful open belfry and spire. The double entrance doors are topped by a Gothic-pointed transom or fanlight. The square entrance tower is flanked by brightly colored glass windows of lancet design, set in the vestibule extension of the old church. The main block of the old church was three bays deep. The old windows have been replaced by lancet-windows with colored glass panes.

HEREFORD BAPTIST CHURCH BA 909
Baltimore County, Maryland
J. McGrain, OCT 1979
Neg. located at MHT
Detail of belfry

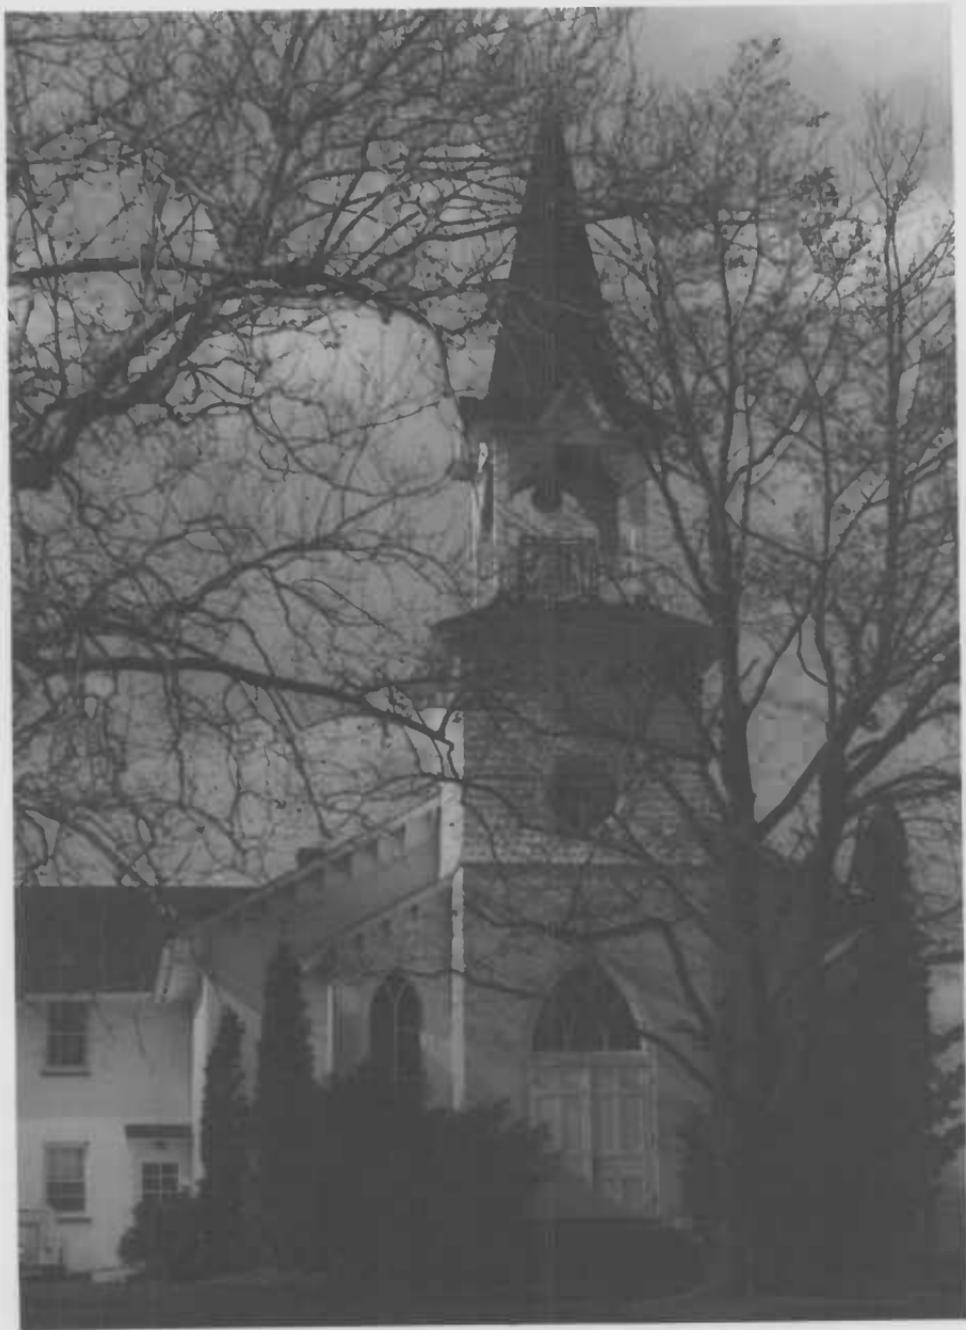
HEREFORD BAPTIST CHURCH BA 909
Baltimore County, Maryland
J. McGrain, OCT 1979
Neg. located at MHT
Main (E) facade from east

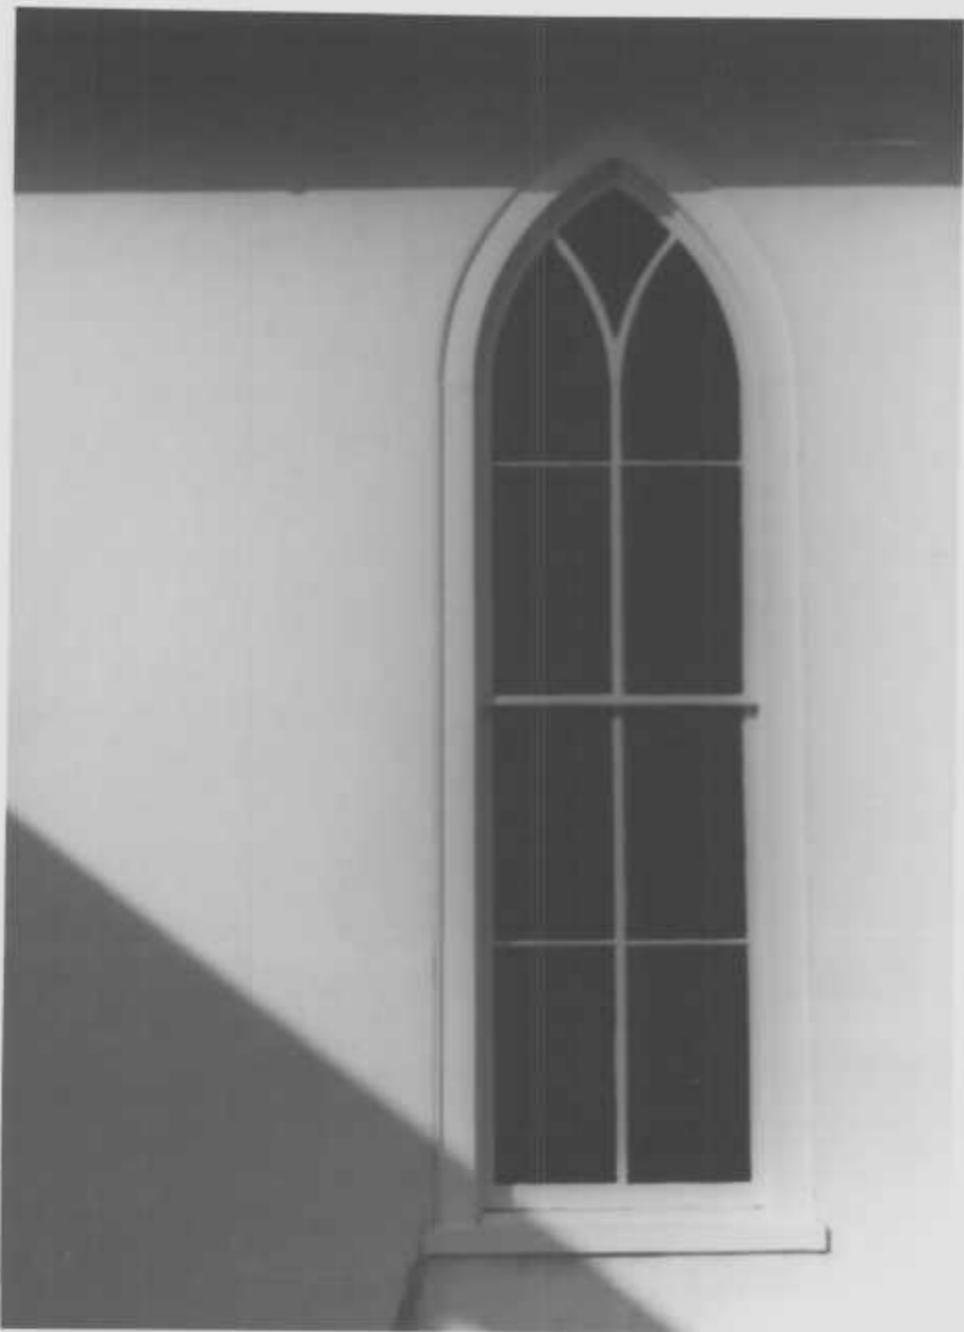
HEREFORD BAPTIST CHURCH BA 909
Baltimore County, Maryland
J. McGrain, OCT 1979
Neg. located at MHT
Detail of lancet window on south
