INVENTORY FORM FOR STATE HISTORIC SITES SURVEY

Weiss House

117 Susquehanna Ave.

Towson

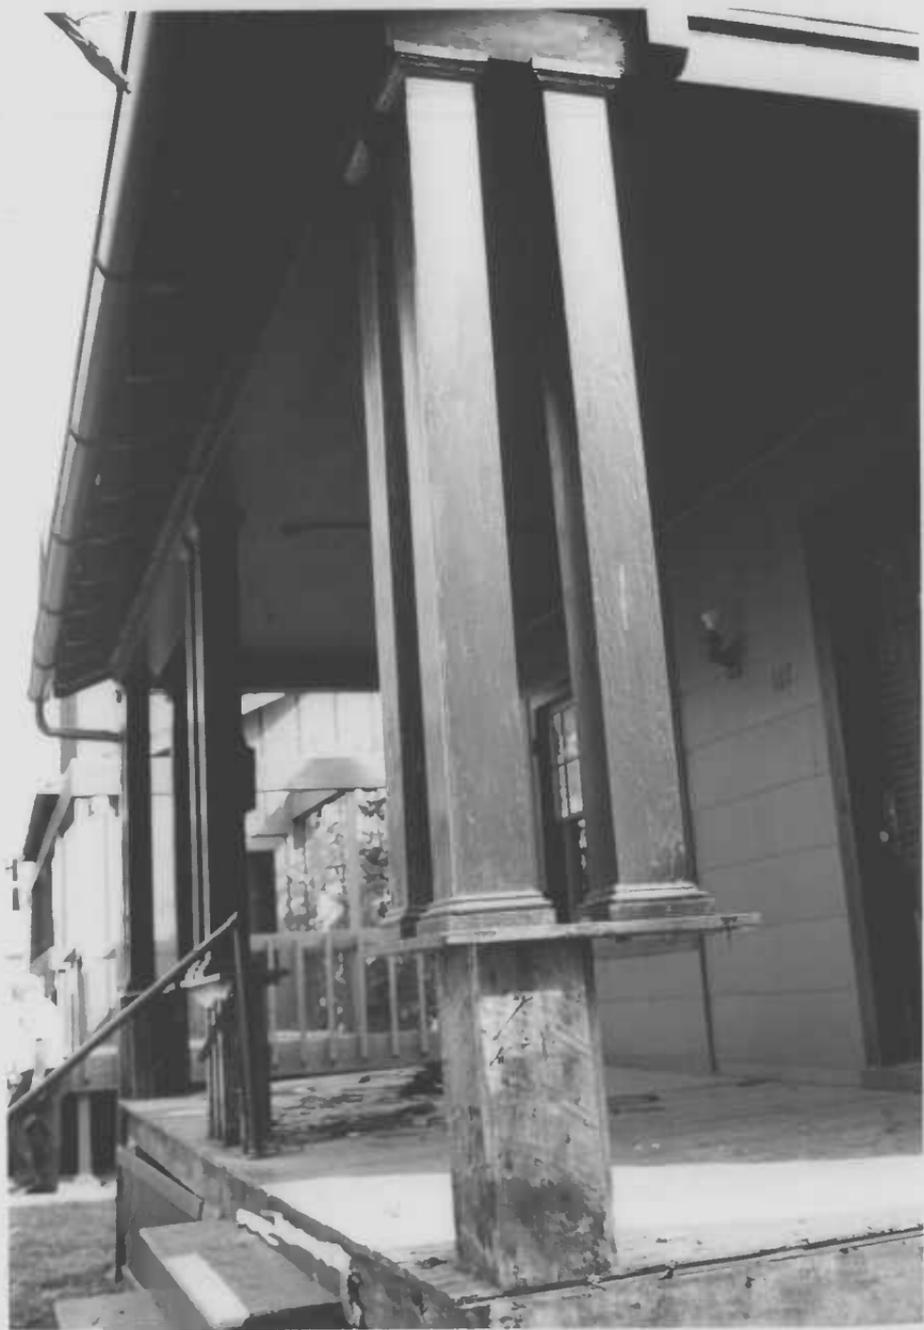
#117 SUSQUEHANNA AVE.
N. FACADE DETAIL

The north side of the house facing the street is the main facade. The most prominent feature is the oversized dormer, now covered with modern asbestos shingles, centrally located above the porch roof. This dormer is vented by a pair of 6/1 sash windows and has a gable-end roof.

The porch, an essential part of the bungalow style, rests on rock-face formstone piers. The space between the porch and ground is filled with lattice. The railing is partially enclosed with brown shingled panels. The roof of the porch, which has a tongue-and-groove ceiling, is supported by clusters of square columns, three per cluster.

A glass entrance door occupies the westernmost bay of the first level, while a pair of 6/1 sash windows occupy the east bay.

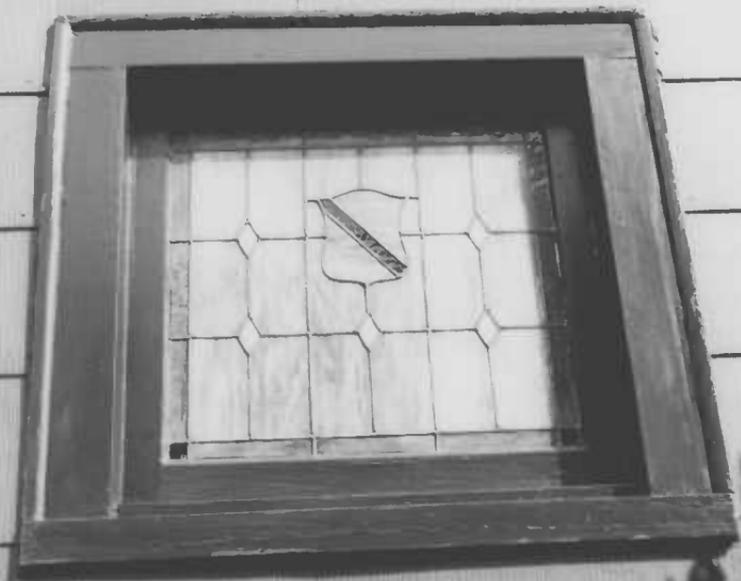
117 SUSQUEHANNA AVE.
W. FACADE DETAIL

The west facade is characterized by the irregular fenestration. There is a single 6/1 sash in the upper south bay, a casement window on the first level providing light for the staircase within and a single casement for the cellar.

The overhanging eaves of this gable end contain tongue-and-groove soffit. A corbeled brick flue chimney rests on a formstone block foundation and pierces the eaves of the roof just south of the ridge.

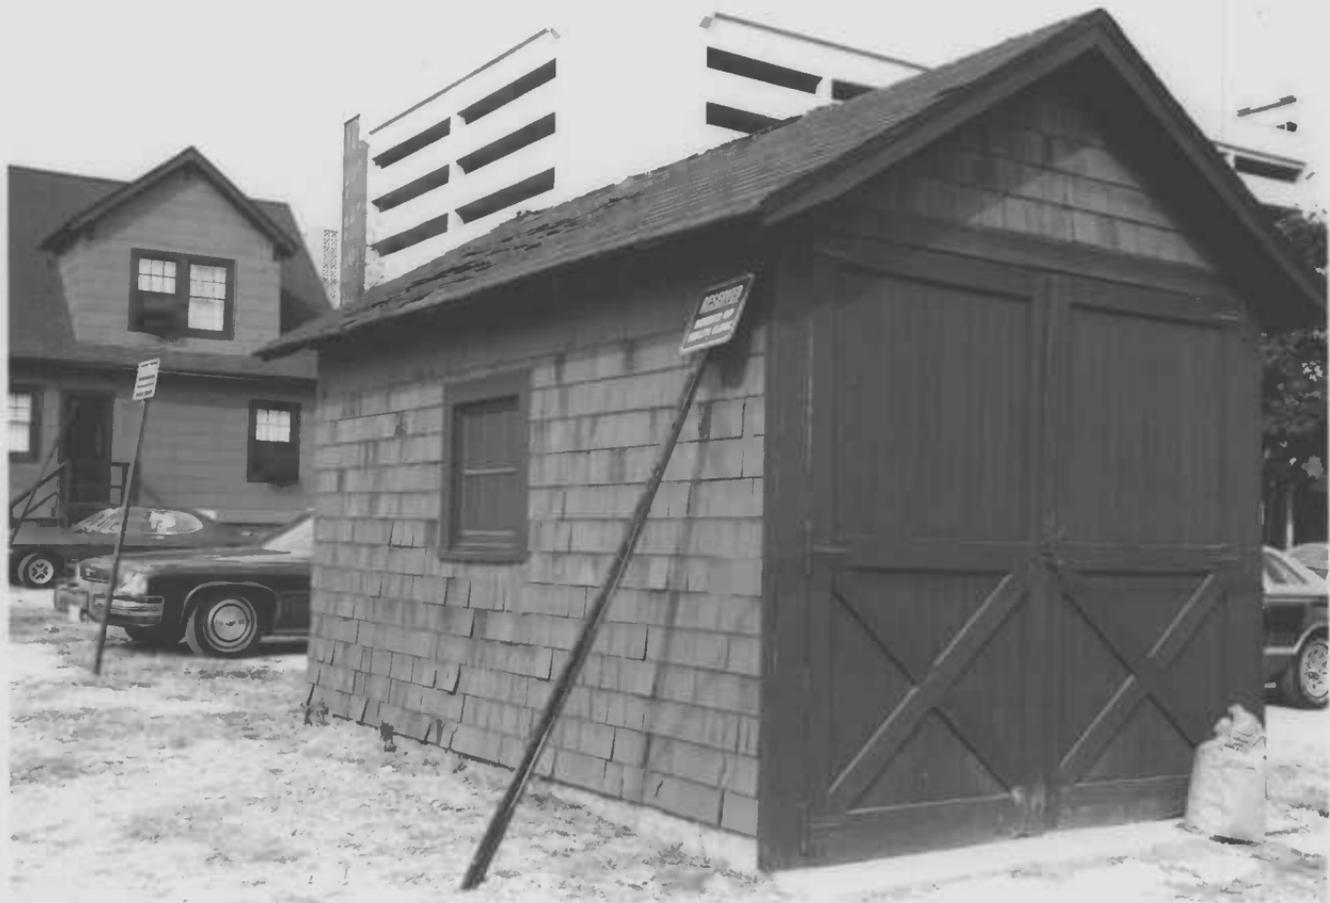
ONE CAR GARAGE
117 SUSQUEHANNA AVE.
S.W. CORNER

A single car garage stands behind this building. The frame structure is covered with brown wooden shingles and has a gable-end roof.
